Coal Bumps in an Eastern Kentucky USA Longwall Coal Mine 1989 to 1997

COAL BUMPS IN AN EASTERN KENTUCKY USA LONGWALL COAL MINE 1989 TO 1997

John Hoelle¹

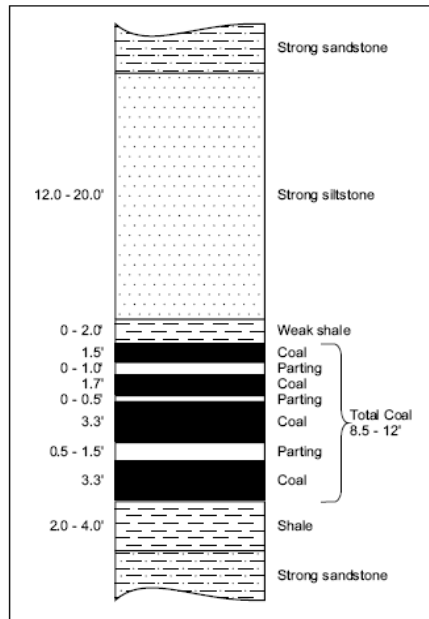
Figure No 1 - Typical stratigraphical section

2.5 to 3.7 m in economical mining thickness. The seam occurred in four benches and in some areas, the parting between the upper bench and the three lower coal benches or the parting between the lower bench and the three upper benches became too thick to mine. A typical section is shown in Figure 1. The seam dipped 2 to 3 degrees to the south. The access portals were drift portals with four additional sets of intake and return portals – all drifts were located at the north-end of the reserve. The overburden gradually increased as mining advanced to the south with overburden thicknesses up to 670 m.

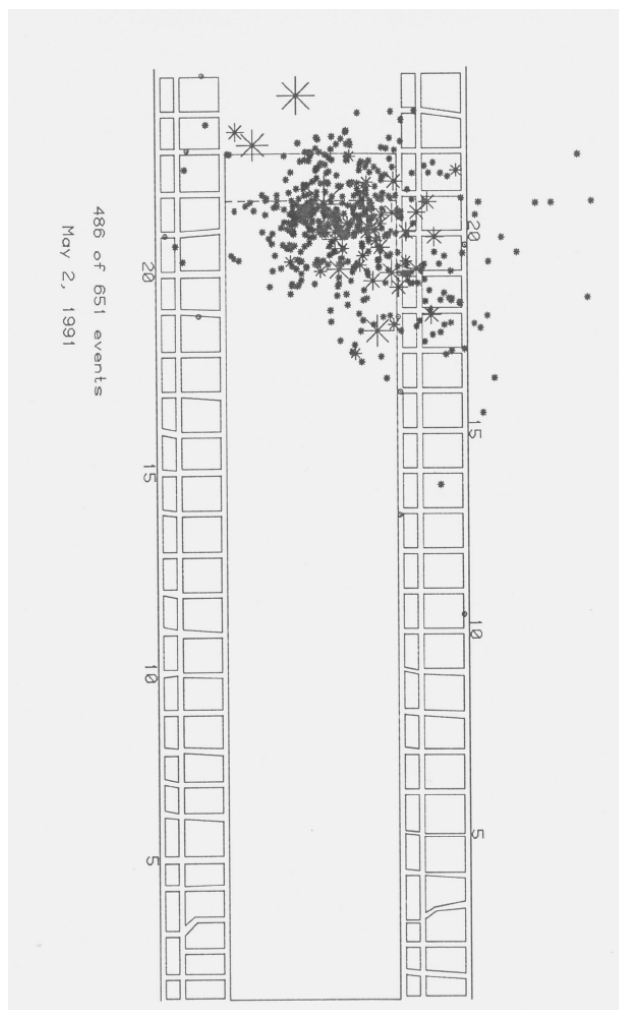
Figure 5 - Microseismic activity, Group 4, Panel 4

- The US Bureau of Mines installed geophones in the head and tail gates starting in Panel 4 of Group 3 with the objective of determining if precursors of events could be obtained. An example of the number of events that were recorded in one of the panels (Group 4, panel 4) is shown in Figure 5. However, a definitive precursor was never determined (Coughlin and Rowell, 1993). Microseismics were recorded from mid 1989 until mid 1993.
