Longwall Mining Through Faults at Moranbah North

LONGWALL MINING THROUGH FAULTS AT MORANBAH NORTH

Chris Hanson¹, Brett Moulle², Chris Strawson³, and Andrew Laws⁴

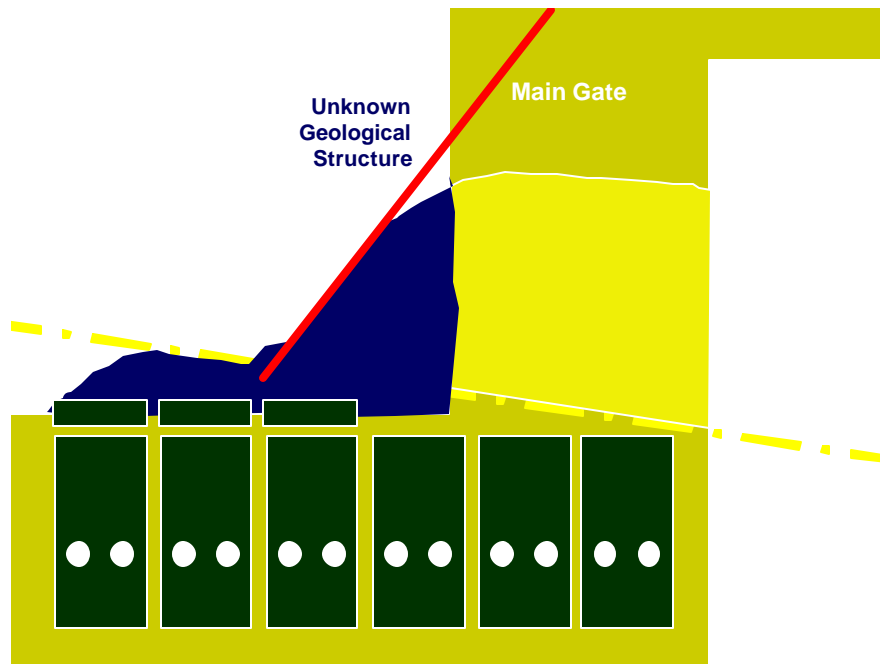
The longwall mine through is detailed later, however, a failure occurred, which delayed the longwall by 18 days. Back analysis of the delays highlighted the need for improved accuracy of the model, and improved support strategies. Figures 3 and 4 show details of the failure area.

Fig 3 – Plan view of LW102 maingate end roof failure

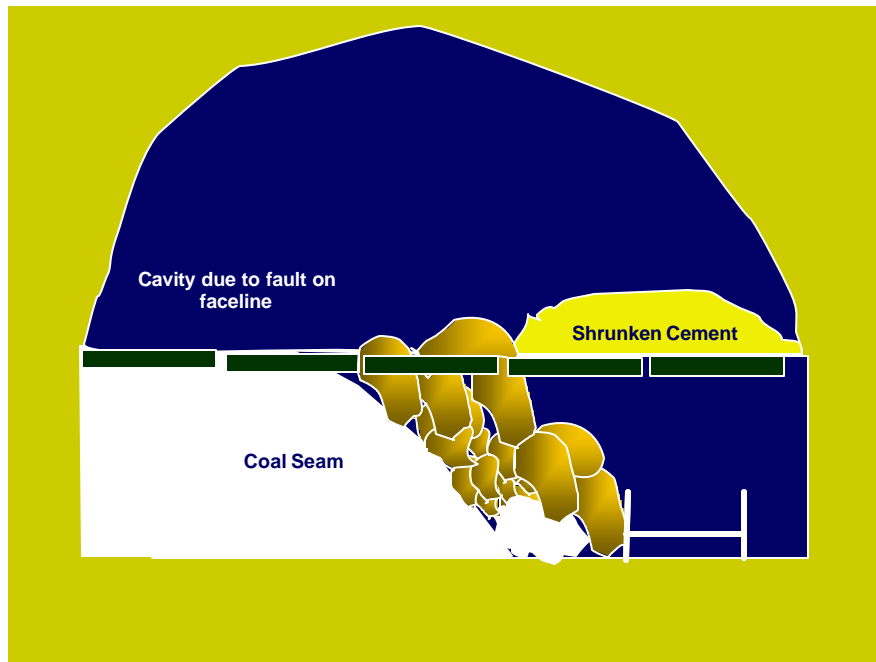
Fig 4 – Section view of LW102 maingate end roof failure

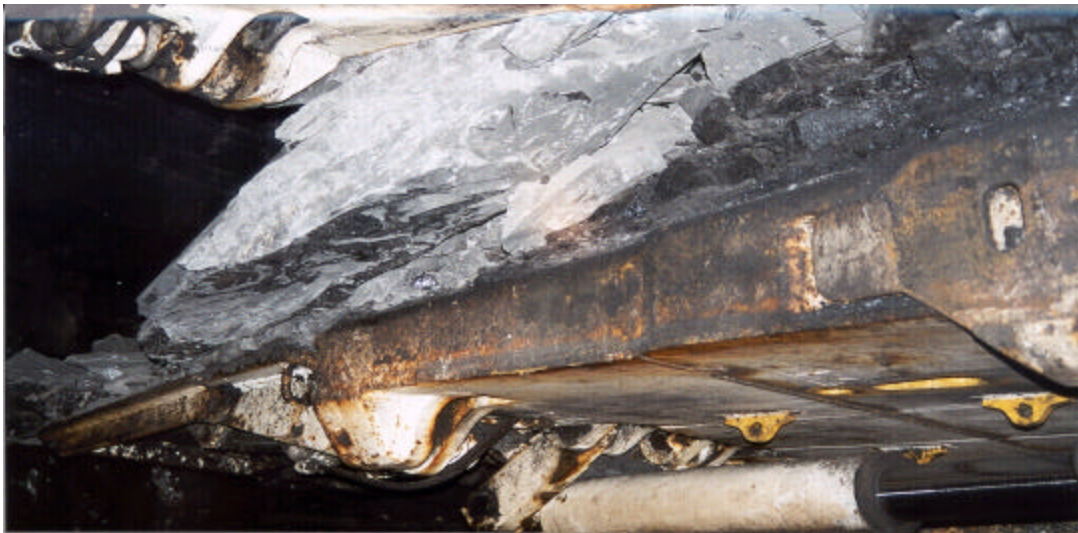
During mining of the last 8m of the fault zone in the maingate, a failure of the rib along the jointing, (running sub parallel to the gate road), allowed a large fall to occur in the maingate, and on the face, see Figure 13. A significant quantity of material had to be removed from this area, and blasting of the stone in the fall was required.

Fig 13 – Open cavity above the gate end supports at the maingate LW102

The grouted false roof, installed to allow the maingate chocks to push forward, came loose, and added to the fall. In addition, the cut height on the face, was 750mm lower than planned, mainly due to soft floor. This exposed more block side rib, possibly assisting in the rib failure. 18 days were lost due to this failure.

- Stability of the maingate block side rib is crucial where the faulting intersects the gateroads.
- The provision of an accurate fault 'Flight Plan' is vital to success in mining faults. It is important that all the longwall equipment parameters are fully known and understood. (i.e. in some cases manufacturers figures bear re checking)

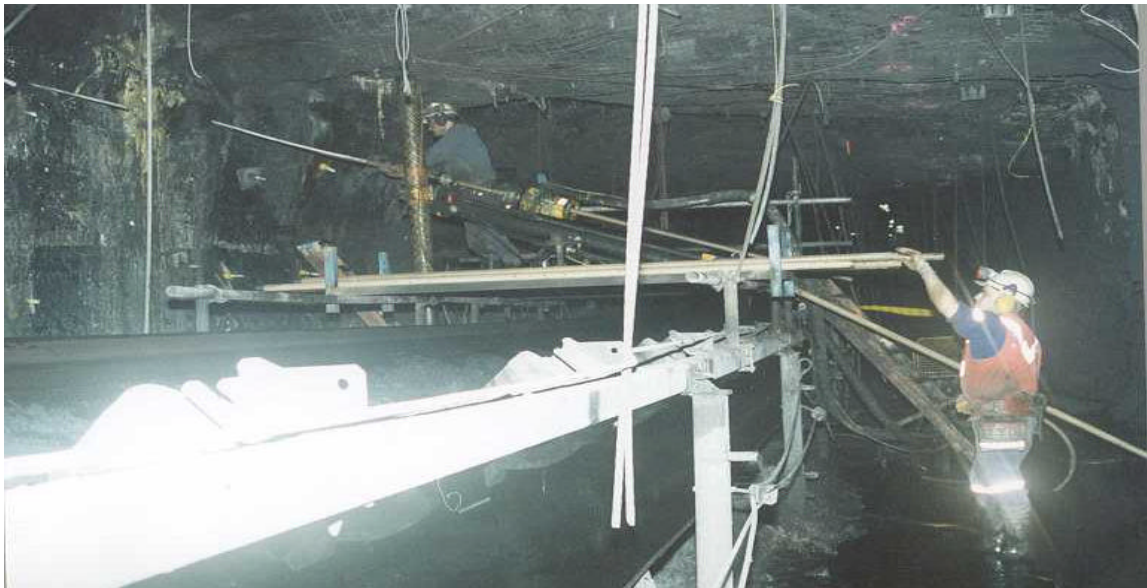
- Great improvement in the prediction of the position, and nature of the faults / Fault Zone.
- This improvement allowed for confidence in the placement of grouted steel spiles over the block, to stabilize the fault zone. 30mm thick walled boiler pipe was installed in parallel pile holes, drilled in the block, over the fault zone. A total of 34 holes, varying in length from 15m to 130m and 56mm diameter were drilled at 90 degrees to the roadway. The holes were spaced approximately 1.5m apart, and once the steel pipe had been inserted, were pressure grouted using microfine cement. The drilling of the holes over an operating longwall belt shown in Figure 14 proved to be difficult and slow. One of the contractors drill steels caused considerable damage to the longwall belt.

Fig 14– Drilling of the spile holes over the longwall belt. LW103

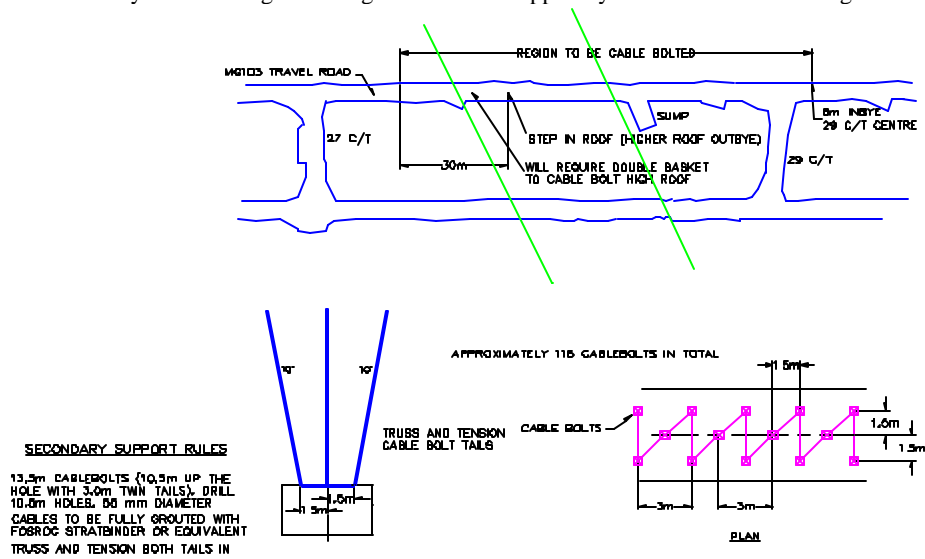
- The support in the maingate was increased. 14m fully grouted, and trussed minicage cables installed in the 'high area', as well as inbye the fault zone. These cables were adequate to provide stability to the maingate during retreat. The support system is illustrated in Figure 15.

Fig 15 – Maingate cable support in Fault Zone

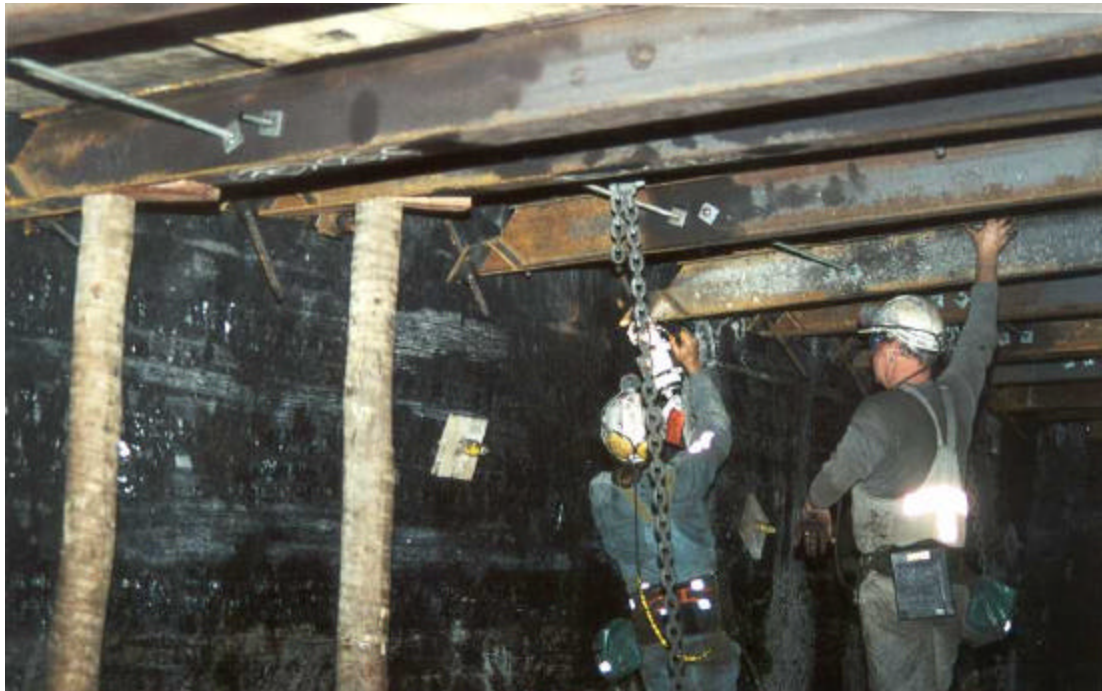
- In addition to the cable support, it was decided to install steel sets on a 1.2m spacing through the fault zone. These were supported on steel legs on the pillar side, and were bolted into the rib, and supported on timber legs on the block side as illustrated in Figure 16. The steel sets provided the base for the false roof.

Fig 16 – Installing steel sets in the maingate LW103

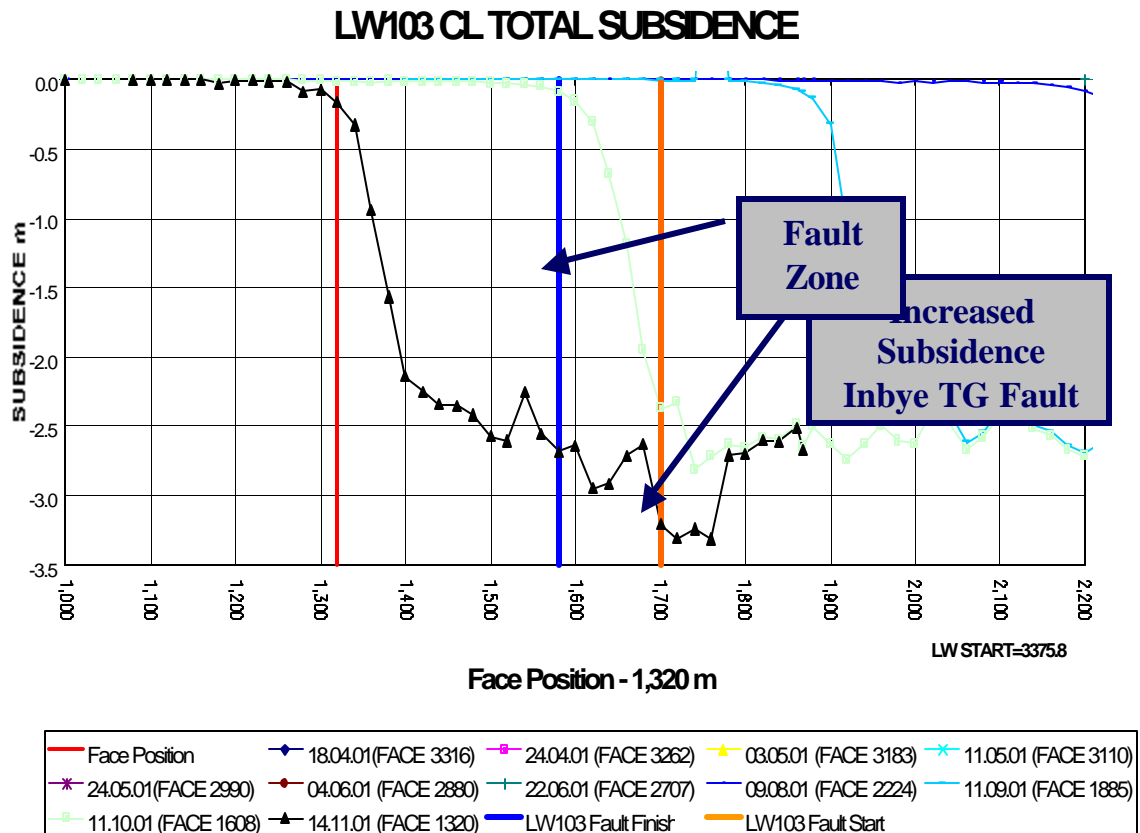
The increased relative level of subsidence recorded inbye of the fault position at the tailgate end is clearly visible. It should be noted that this area is in close proximity to the roof fall in LW102 MG, where a substantial quantity of material was removed.

Fig 18 – Centre line surface subsidence plot LW103

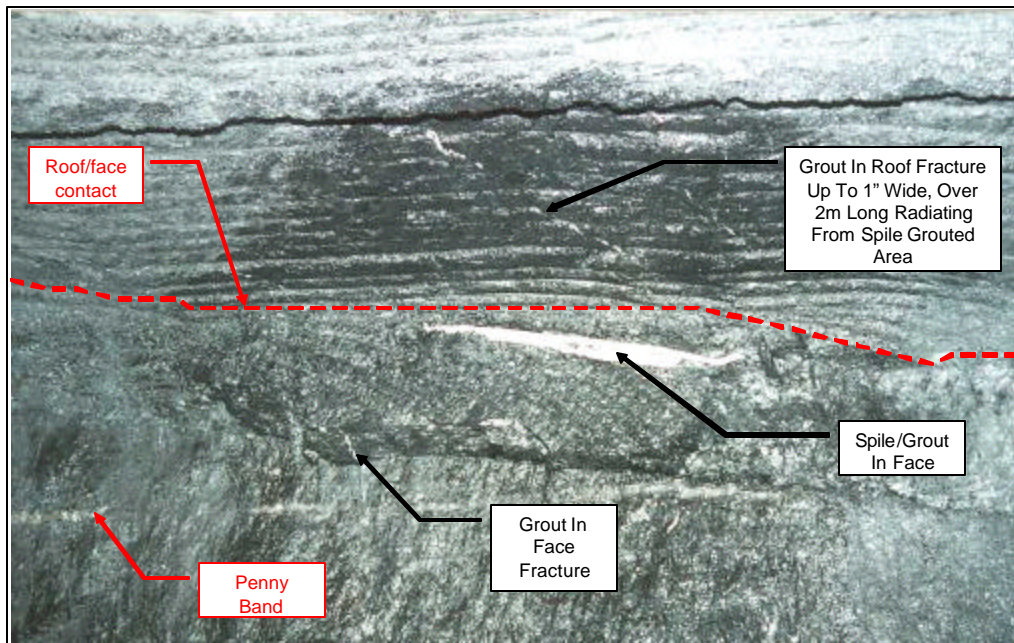
Fig 20 – Grout permeation in face due to pressurized grout injection – LW103
