A review of fatal outburst incidents in the Bulli Seam

C. R. Harvey
NSW Department of Mineral Resources

R. N. Singh
University of Wollongong

A Review of Fatal Outburst Incidents in the Bulli Seam

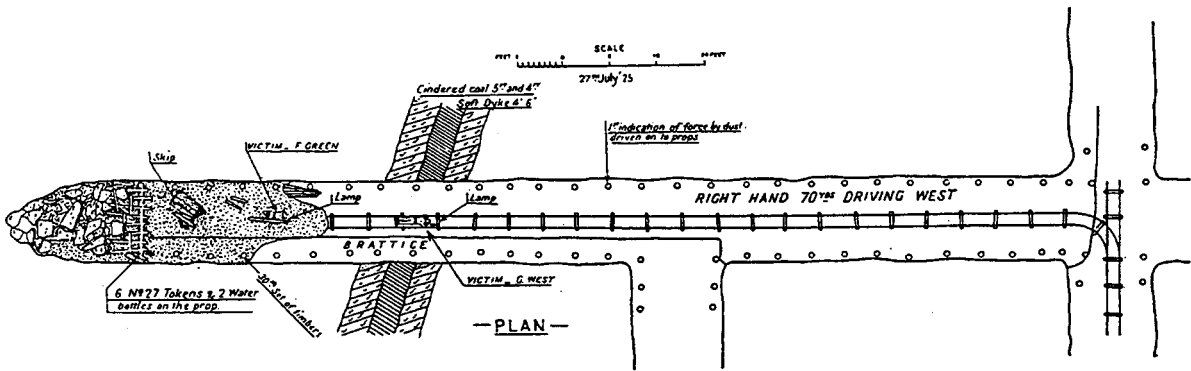
On 27th July 1925, two men were killed by an outburst of natural gas and coal at the Metropolitan Colliery (George West and Fredrick Green). The men were suffocated by the gas emitted (identified in 2 samples as being between 50% and 62% CO₂) from the outburst site and was associated with an upthrow fault immediately adjacent to a dyke in the 70 yard heading of the Western area section of the mine (see Figs 1 and 2). Approximately 220 tones of coal was ejected with the gas concentration being sufficient to kill a horse approximately 115 yards away from the outburst site.

Similarly the mechanism underlying the principles behind outbursts in the Bulli Seam were alluded to when the same inspector commented "The last four feet or so of coal worked by the miners in this place was harder than usual, and no gas had been given off..." "This hard section of coal may have acted as a dam and retarded the escape of the gas which is given off freely from the coal faces in this section."

Fig. 1 - Scene of fatal accident to F Green and G West, outburst of gas Metropolitan colliery

Hence the comments of the Inspector reporting on the fatality and the mechanisms used to alleviate outburst problems are quite telling: - "Since the outburst, boreholes have been kept ahead in all places in the near vicinity of the fault and these have given off a little gas which has proved to be practically pure carbon dioxide".

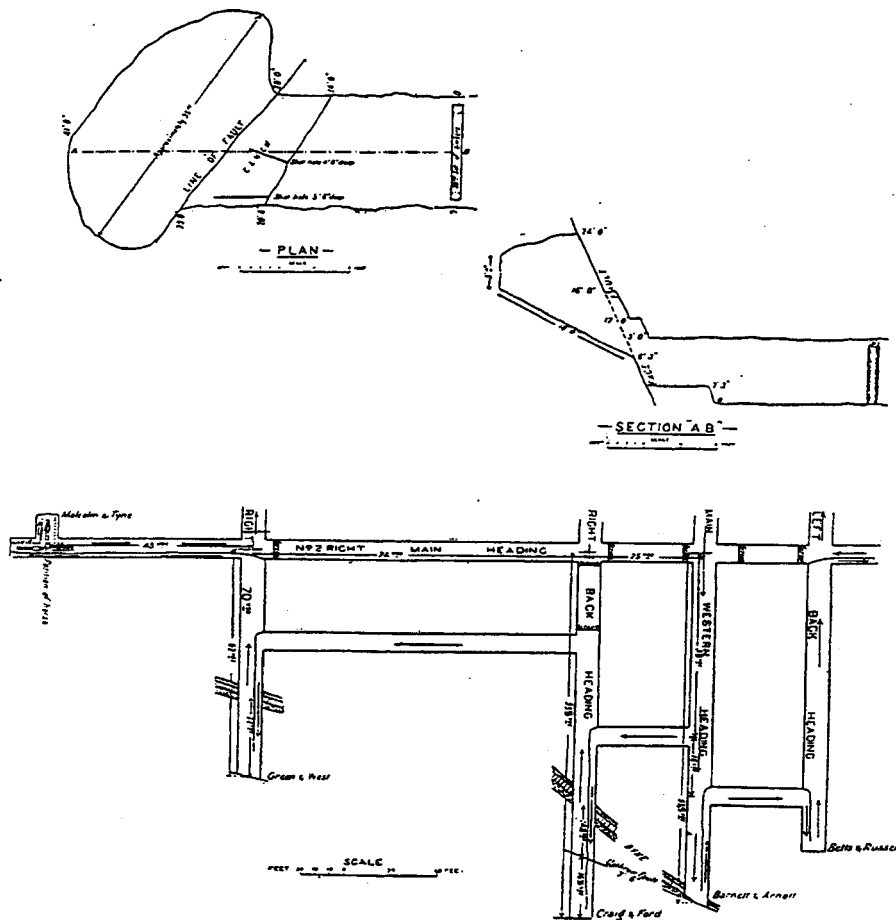
Fig. 2 - Outburst of Gas - Metropolitan Colliery

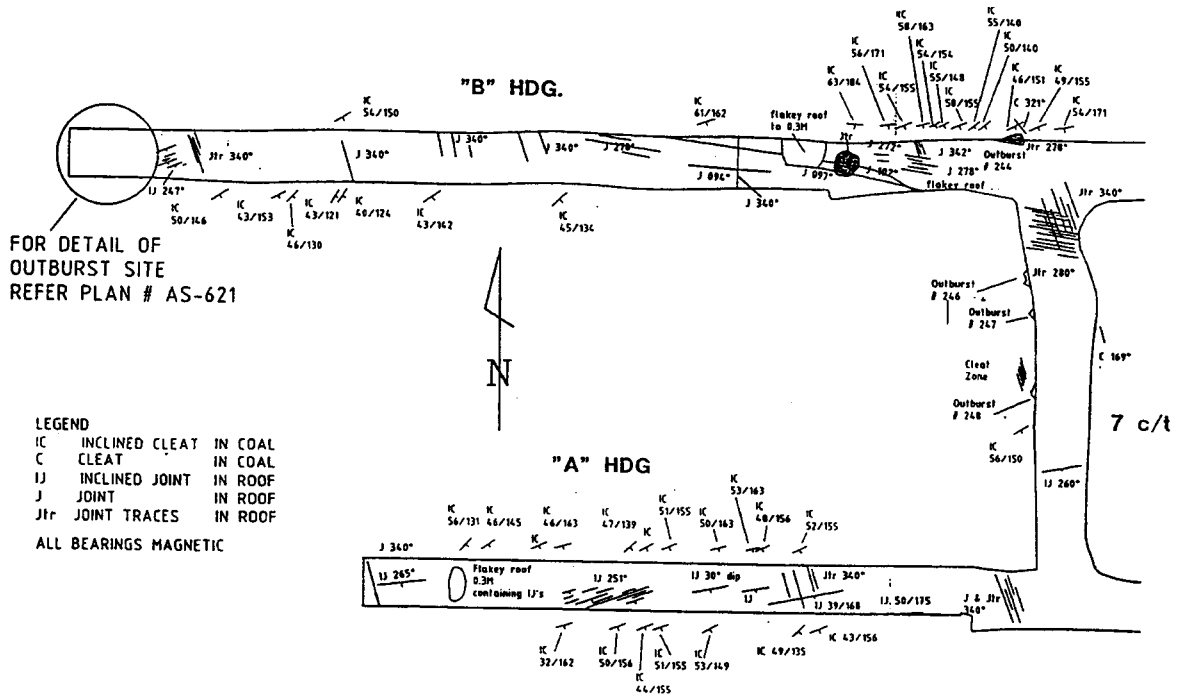
As shown in Figs 3, 4 and 5, the outburst was associated with a combination of two strike slip fault zones (one trending 350°, the other 280° magnetic). The intersection of these two fault structures created a zone of intense shearing/jointing resulting in lower coal permeability and increased stress in the coal and associated roof strata. This in combination with the presence of Mylonite and gouge material was believed to account for the volume of gas released.

The dominant 350° fault zone appeared to have a similar alignment with strike slip fault structures identified in previous mining, associated with development headings for panels 484 and 485. Drilling immediately in advance of mining, in "B" heading of 486 panel did not accurately identify the location of this structure. Gas drainage holes drilled from 485 panel failed to reach across the longwall block and effectively drain the development heading of 486 panel. Also whilst holes had been drilled in advance of mining in 486 panel, they had not penetrated the structure. These holes had deviated to the left (south) and were identified in the left hand rib and face.

Fig. 3 - West Cliff Colliery 486 right panel outburst and fatal accident geological mapping

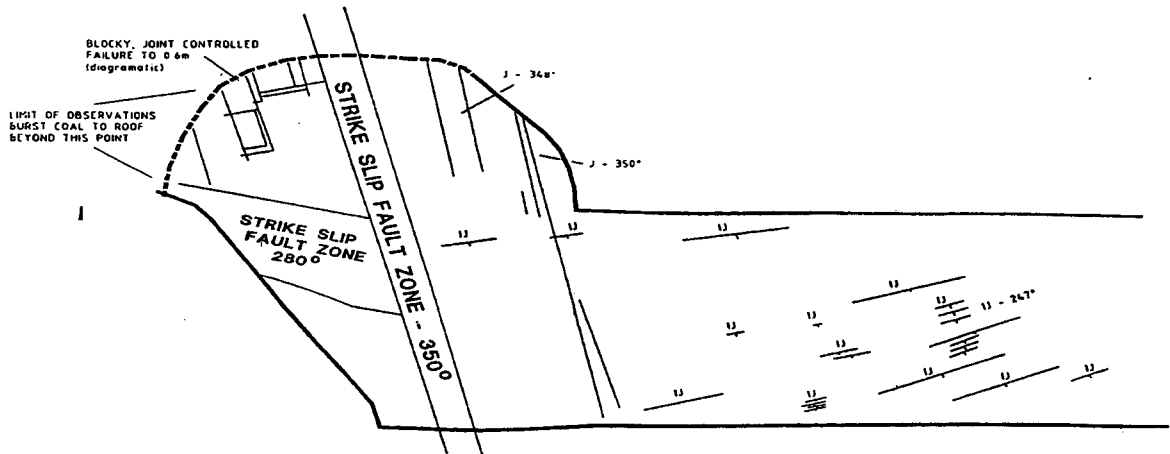
Fig. 4 - West Cliff Colliery 486 right panel outburst and fatal accident site geology plan

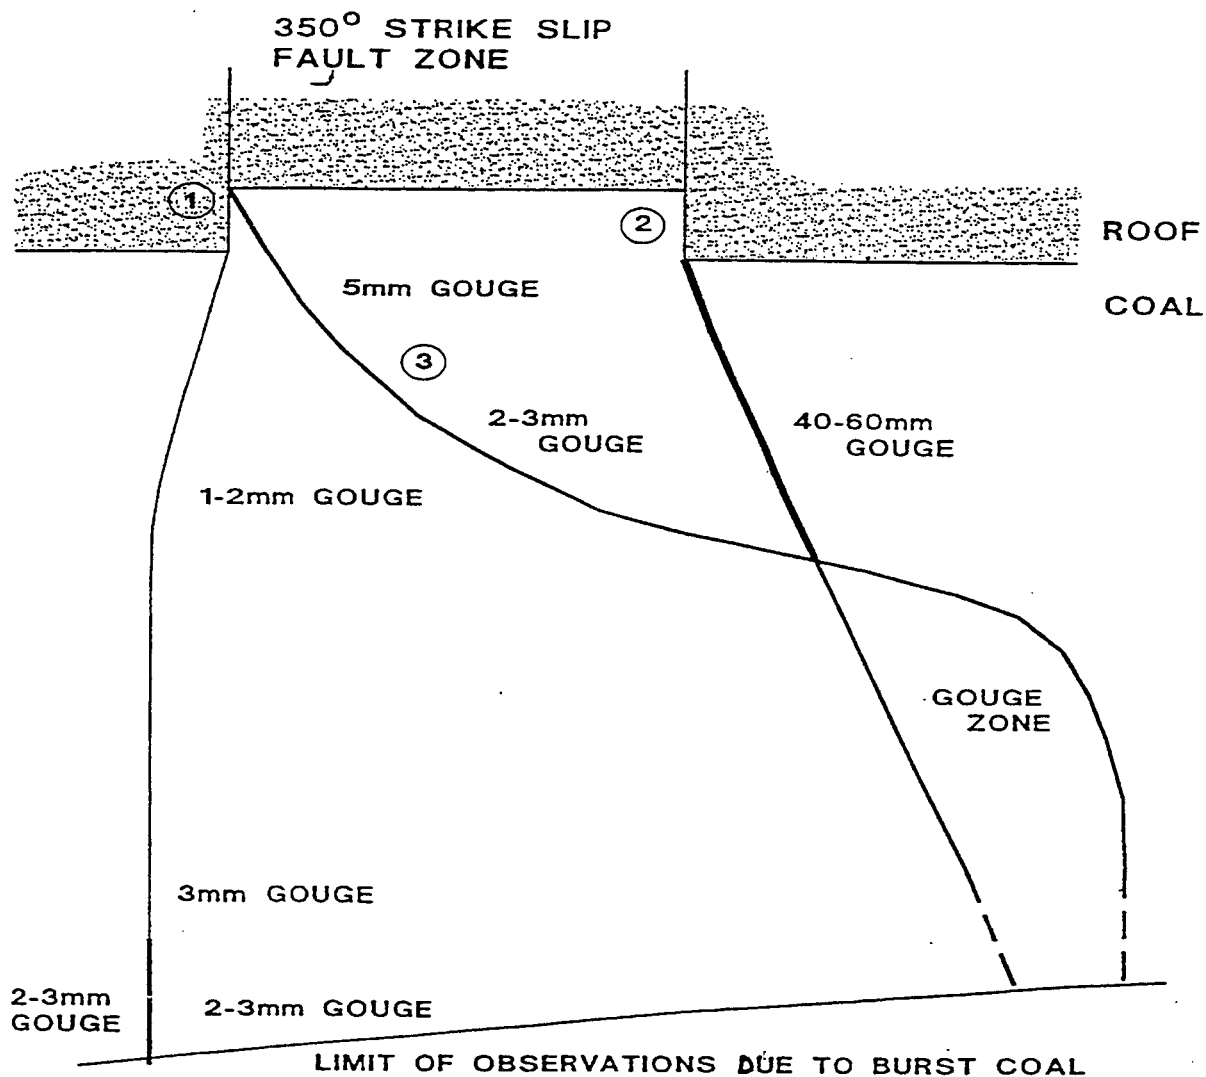
- OBSERVATIONS
- 1 88° to 264° MAGNETIC STRIKE SLIP
 - 2 STRIKE SLIP
 - 3 DIP SLIP

Fig. 5 - West Cliff Colliery 286 right panel outburst and fatal accident section through strike slip fault "b" heading southern rib
