EVALUATION OF NEW TECHNOLOGIES TO SUPPORT ASSET MANAGEMENT OF METRO SYSTEMS

GUNASINGAM RAVINDRAN

**A thesis submitted in partial fulfilment of the requirements for the award
of the degree Doctor of Engineering (Eng.D) at the
University of College London**

August 2020

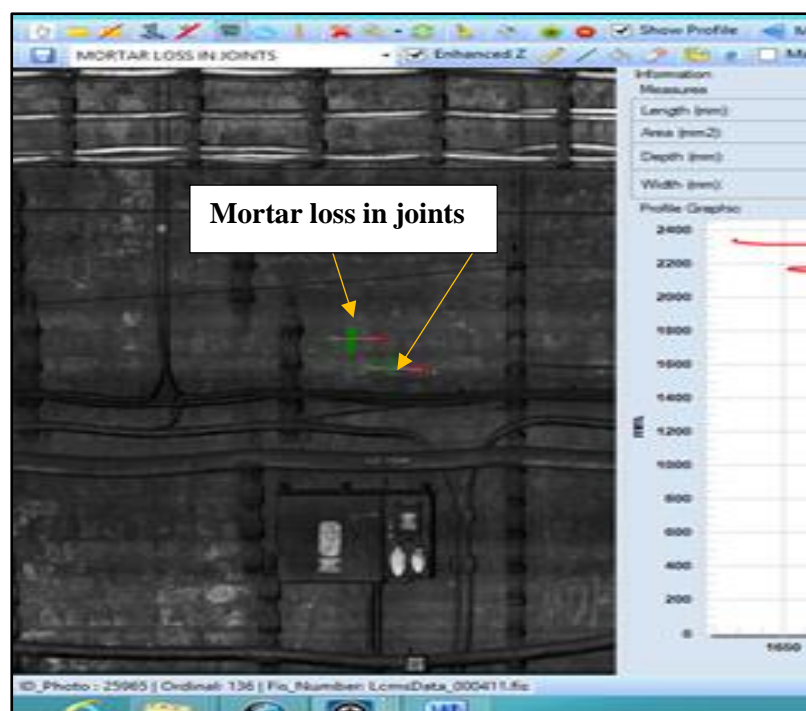
Figure 3-35 Laser inspection Mortar loss in joints- TL17 (LUL, 2011)

The view of typical spalling and mortar loss in joints in the arch soffit at chainage 65 of tunnel 17 (left side) is shown in Figure 3-35 and Figure 3-36 and was identified by both inspection methods.

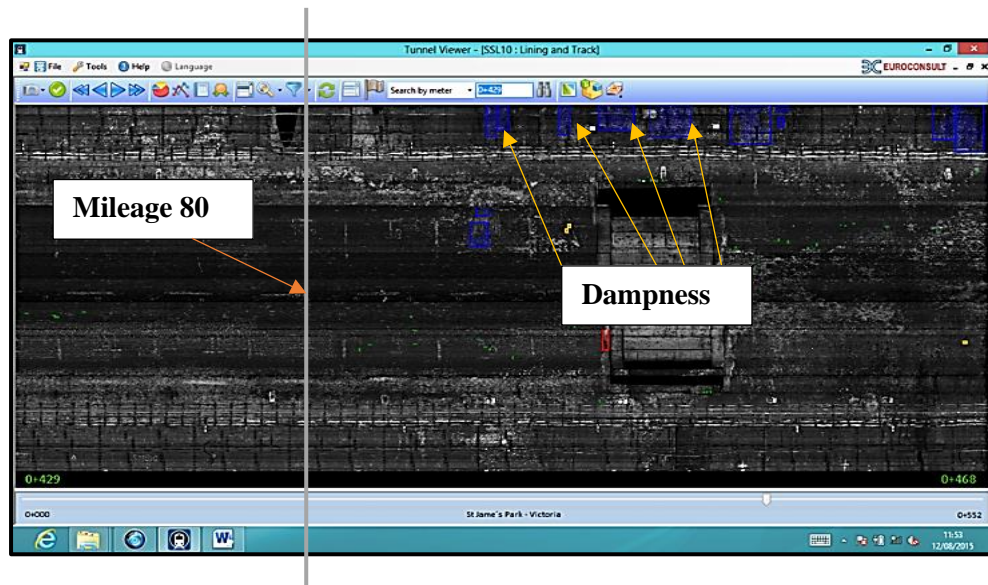
Figure 3-37 Laser inspection Dampness TL-17

The active water seepages between chainage 80 and 100 were identified as damp patches in the laser survey shown as a blue rectangle in Figure 3-37. The visual inspection tunnel chart (see Figure 3-38) shows this defect using standard defect notification “w” (wet and damp area) at the left sidewall.

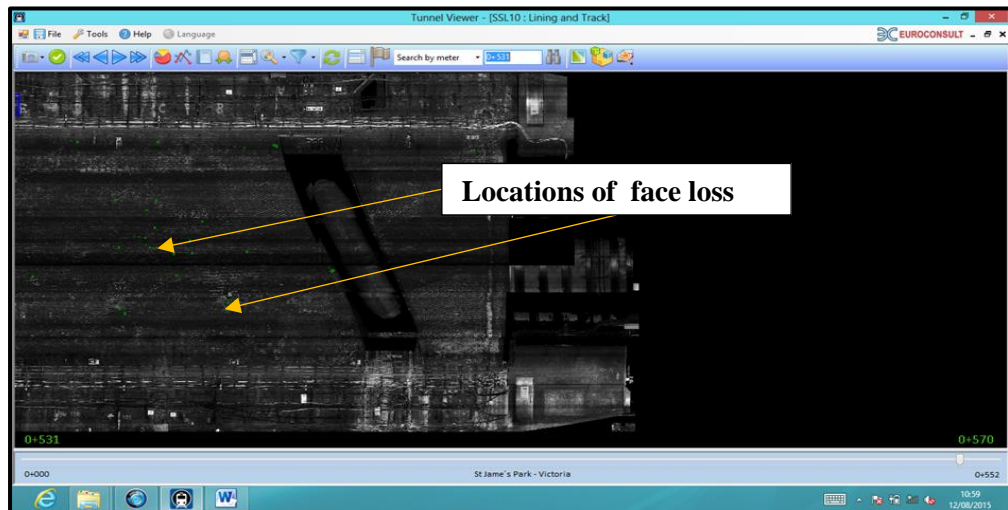
Figure 3-39 Face loss in the arch soffit-TL17

Figure 3-39 shows face loss in brick arch soffit area (scattered green dots). However, this defect was not identified by the visual inspection because it may have appeared after the visual inspection (there was a 3-year gap between the two inspections).

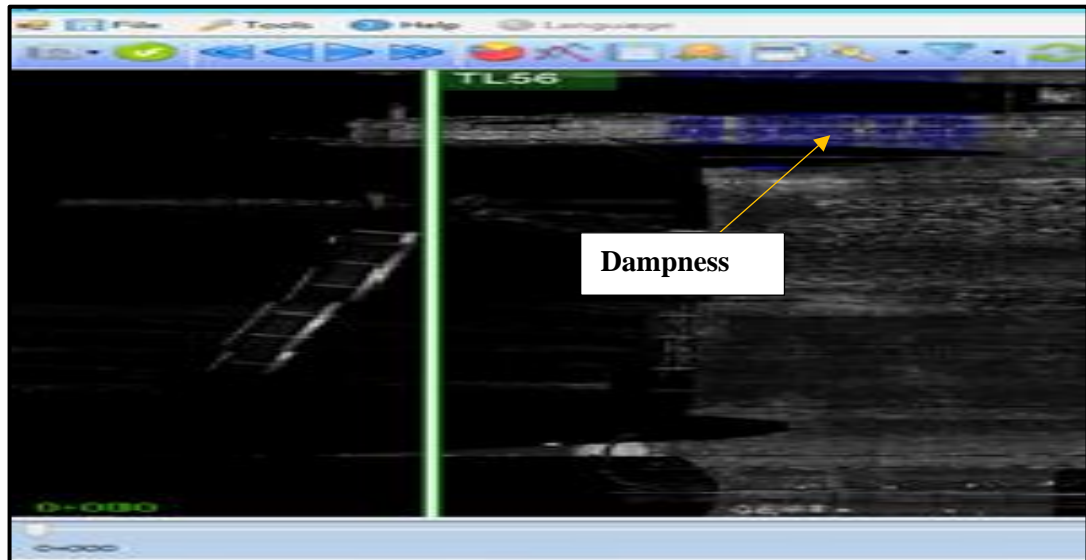
Figure 3-41 Laser Inspection Dampness- TL56

Figure 3-41 shows that the left side wall was wet due to seepage between chainage 0 and 5. This wet area was identified by the laser inspection and is shown as the blue rectangle in Figure 3-41. The visual inspection also identified this defect as a wet area.

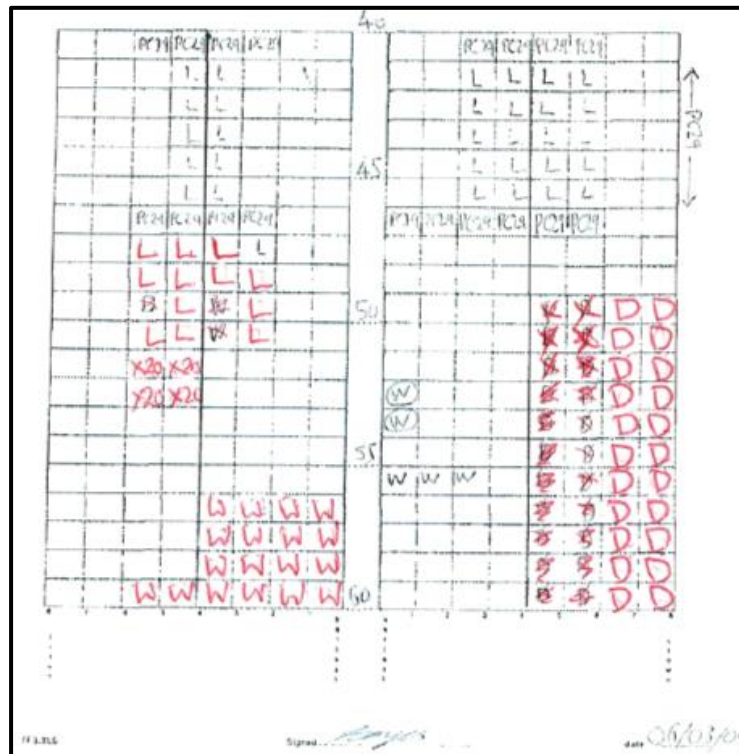
Figure 3-61 Tunnel 17 (D104 / TL17) visual inspection chart

Defects identified by visual inspection were computed from Tunnel 17 (D104 / TL17); its inspection chart is shown in Figure 3-61. Each square denoted by “W” (water seepage) was added to the whole distance of the tunnel to calculate total defects of dampness identified by the inspector visually. Similarly, other defects were also calculated and plotted in Figure 3-64 to Figure 3-67.

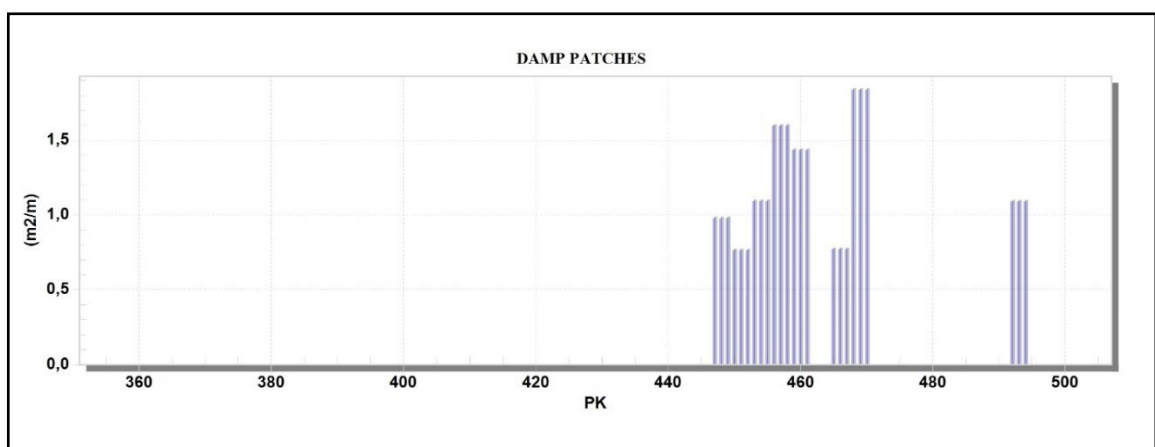
Figure 3-62 Dampness show in laser inspection 2014 (Euroconsult, 2016)

Figure 3-62 for damp patches. Similarly, other defects were also collated from graphs mentioned in the Laser Inspection of the 2014 report and replotted in Figure 3-64 to Figure 3-67.

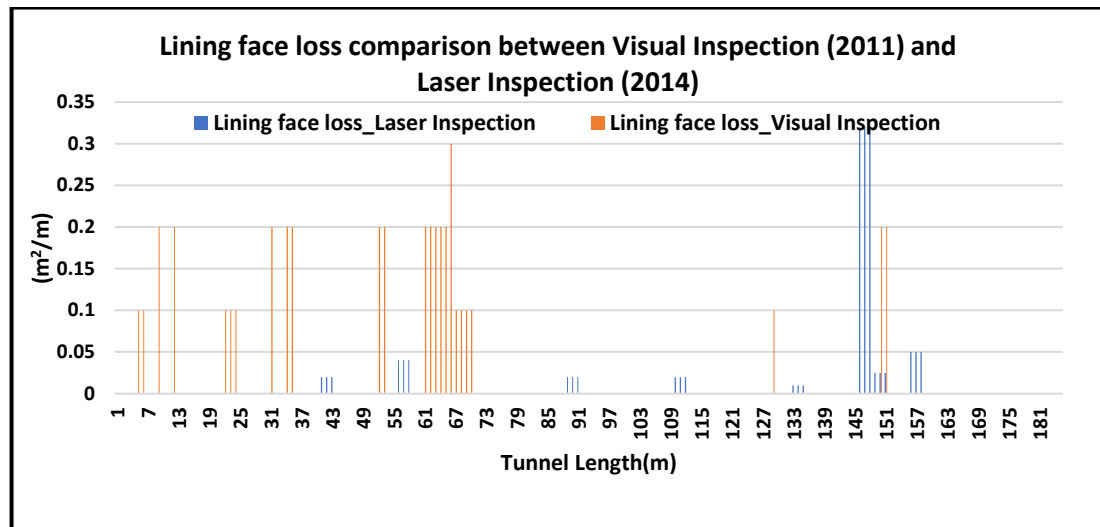
Figure 3-66 Lining face loss comparison between Visual Inspection and Laser Inspection

laser scanner are in different positions and it is not clear if the defects mentioned in the visual inspection were rectified or not.

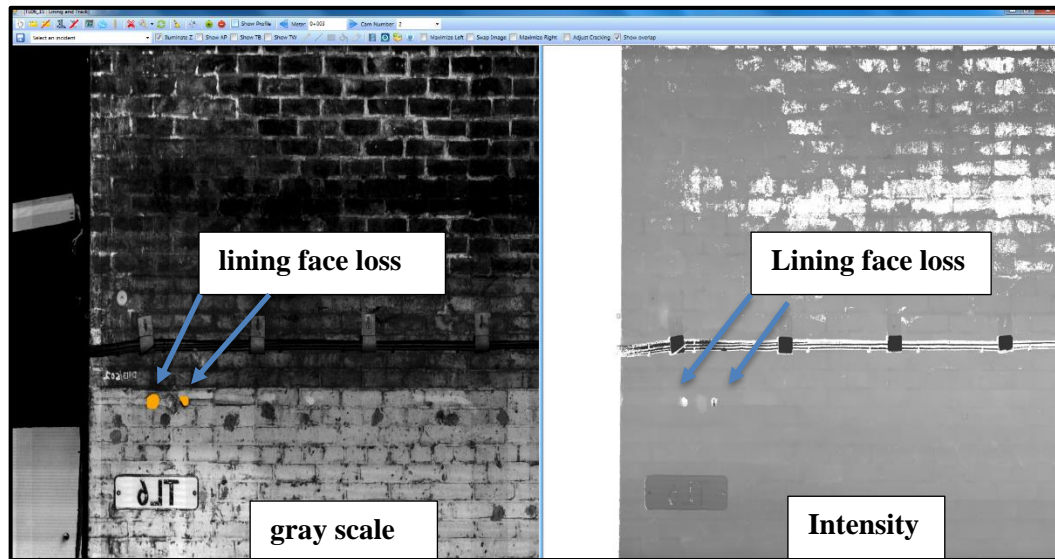
Figure 3-76 TL6 lining face loss at chainage 3- 2015 Laser inspection

Figure 3-76 shows that two locations of lining face loss were identified at chainage 3, by the laser inspection in 2015. However, this defect did not appear in the 2014 laser inspection, therefore it is a newly formed defect.

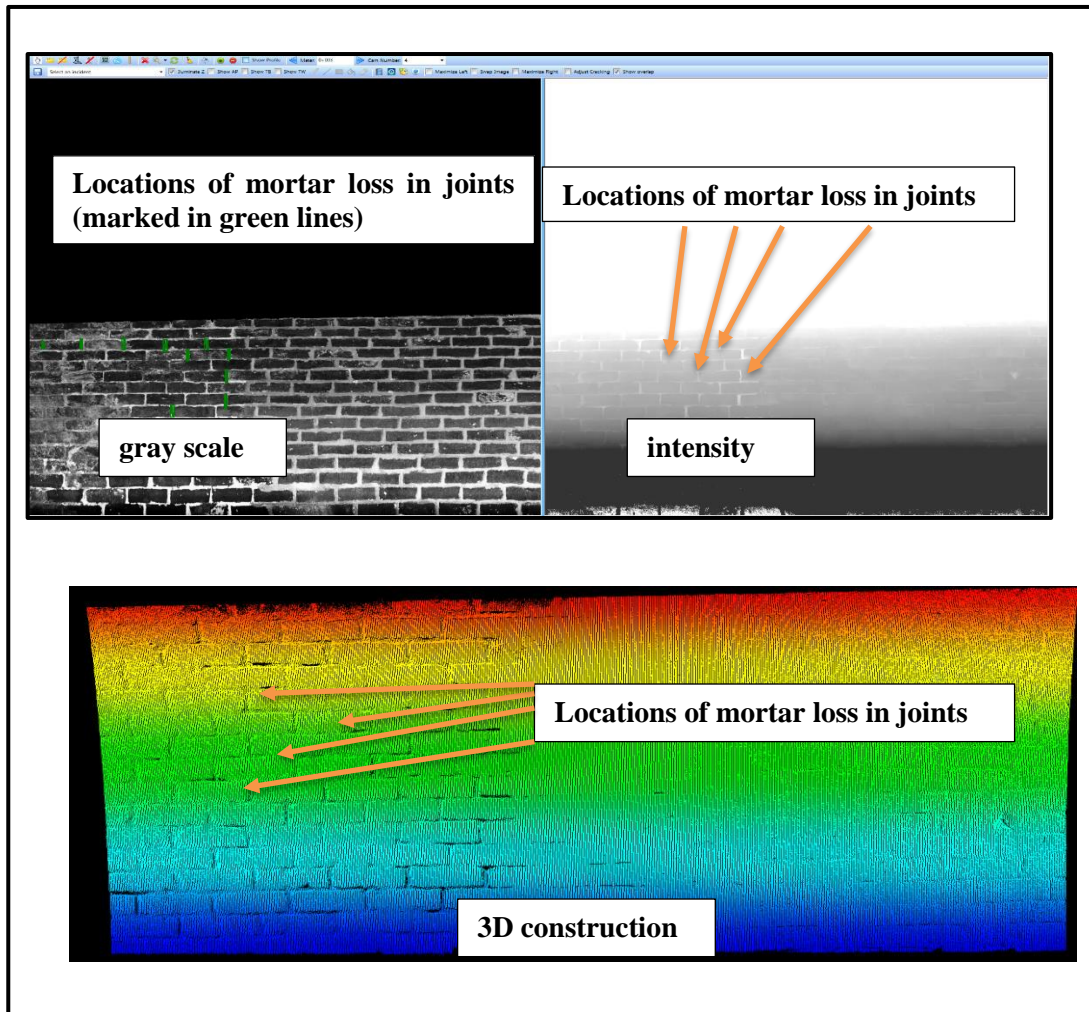
**Figure 3-77 TL 6 Scattered mortar loss in joints at chainage 4
2015 Laser inspection**

Figure 3-77 shows locations of mortar loss in joints (their dimensions are shown in Table 3-30) at chainage 4. This defect was identified by the laser inspection in the 2015 scan and did not appear in the 2014 scan.

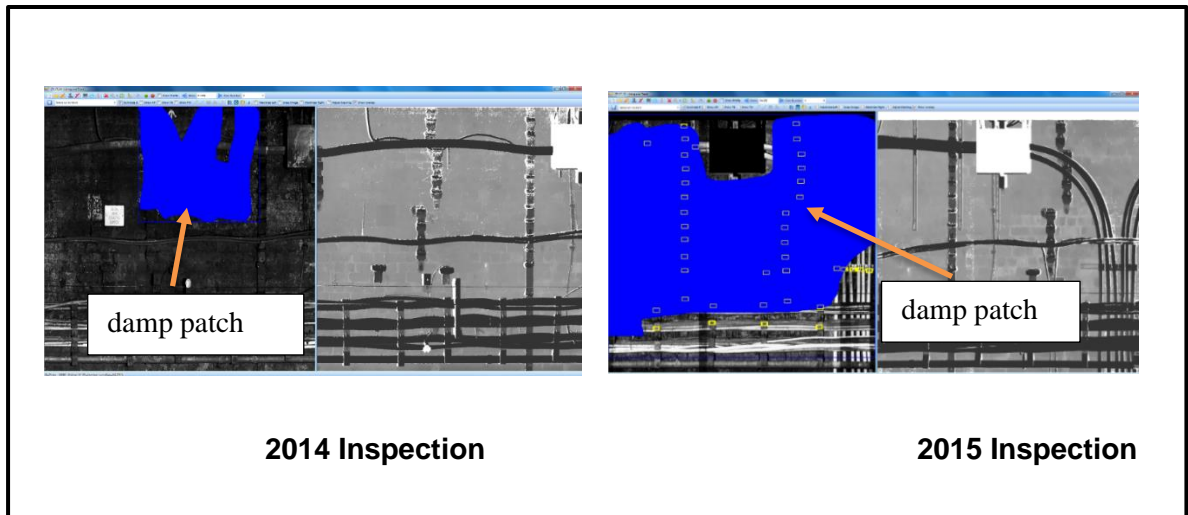
Figure 3-81 TL 17 area of damp patches at chainage 102 2014 and 2015 Laser Inspection

works were not carried out between the two inspections and the severity of the defect increased, as can be seen by the larger water seepage area on the 2015 Laser inspection.

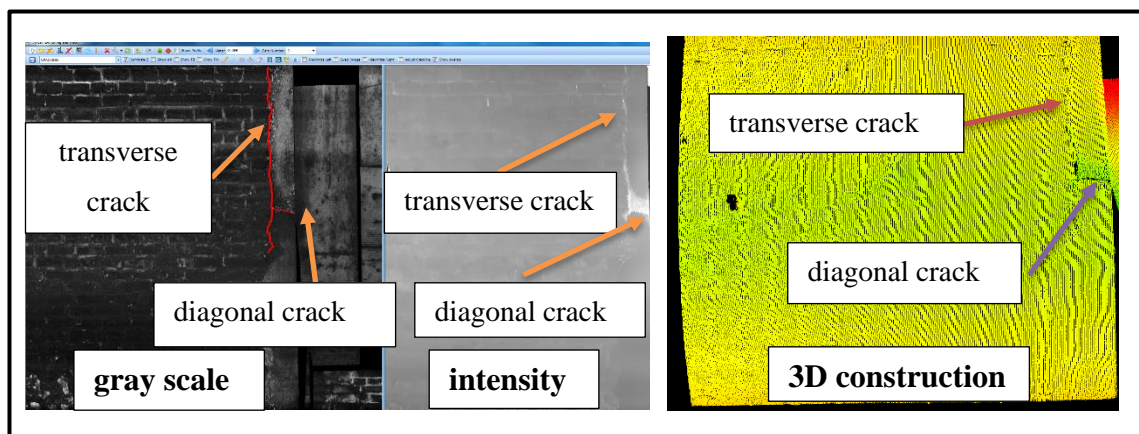
**Figure 3-84 TL17 transverse and diagonal cracks at chainage 101
2014 inspection**

Figure 3-84 shows transverse and diagonal cracks, on TL17, at chainage 101 in the 2014 inspection. The dimensions of these cracks can be seen in Table 3-35.

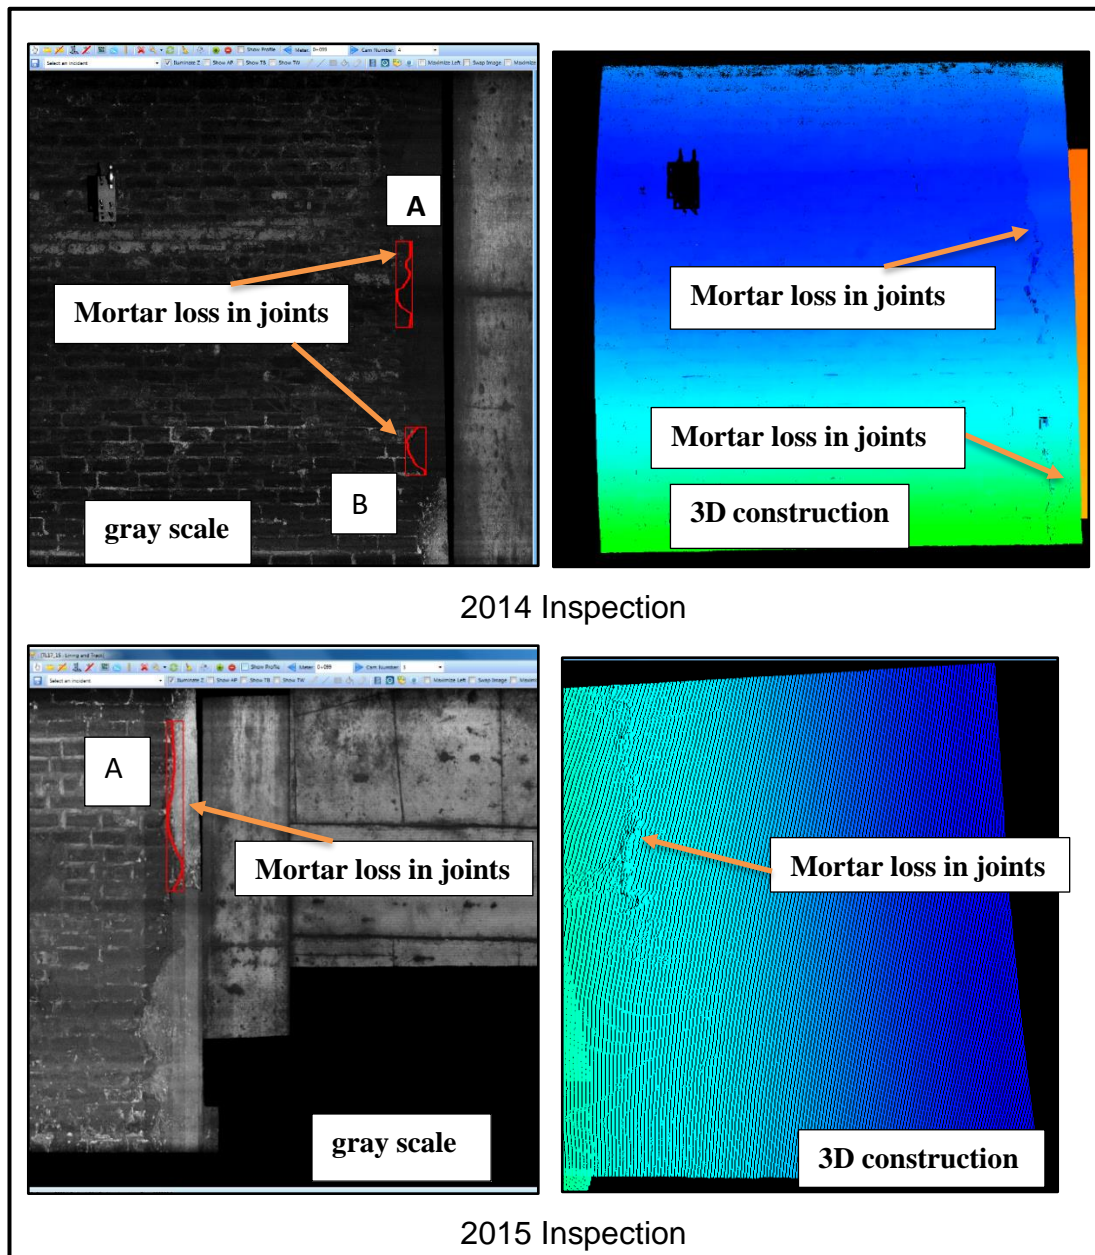
**Figure 3-85 TL17 mortar loss in joints at chinage 100
2014 and 2015 Laser Inspection**

brick tunnel and concrete. Imperfections that are likely to be linear will always show as mortar loss by this system.

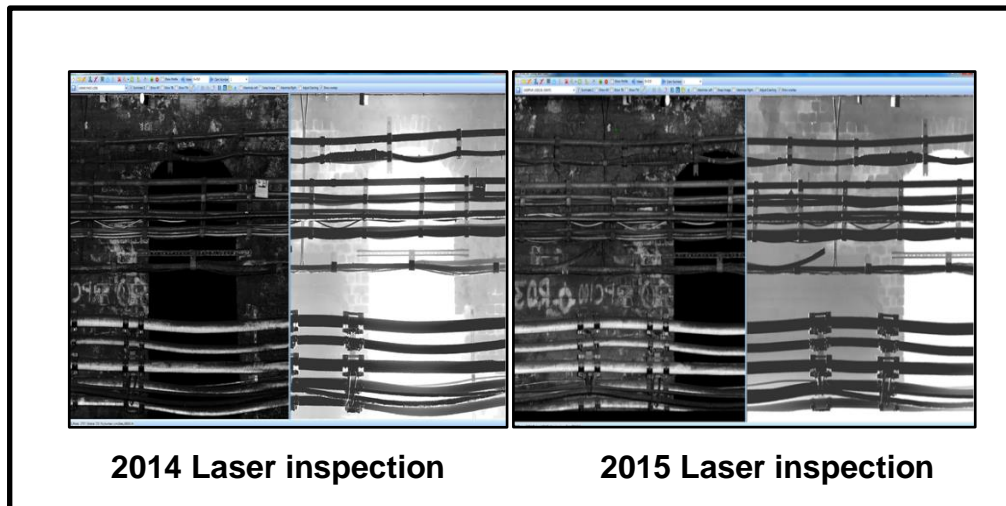
Figure 3-89 TL17 no spalling around recess area at chainage 513m

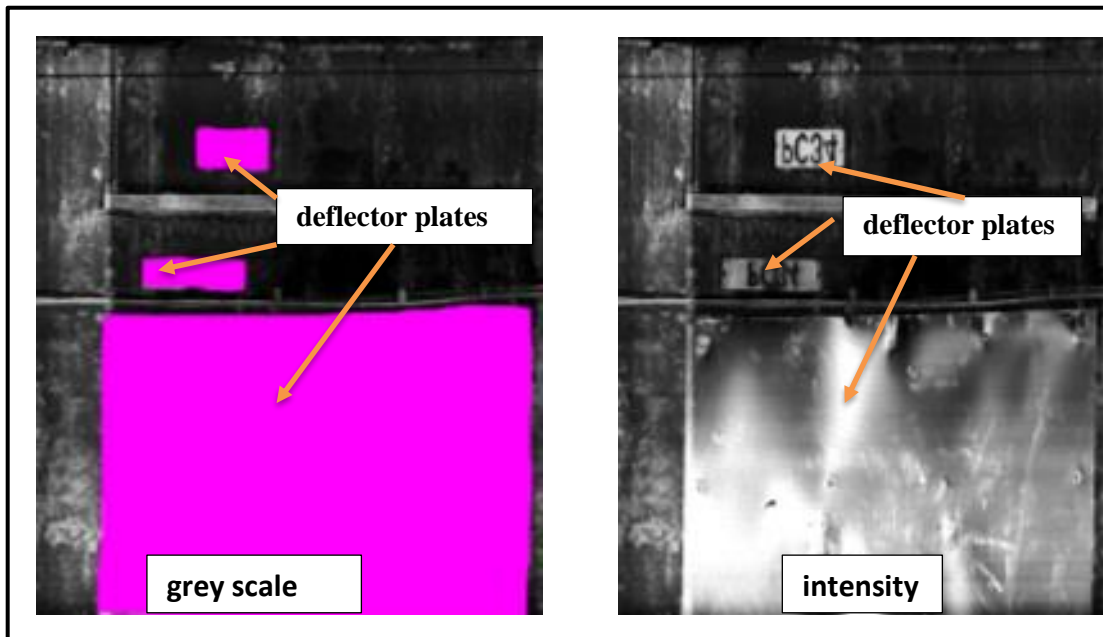
Figure 3-90 Deflector plates

The defects behind the deflector plates cannot be seen by the laser method. Therefore, a separate inspection regime must be in place, and appropriate details are given as additional information or as part of the principal inspection report.

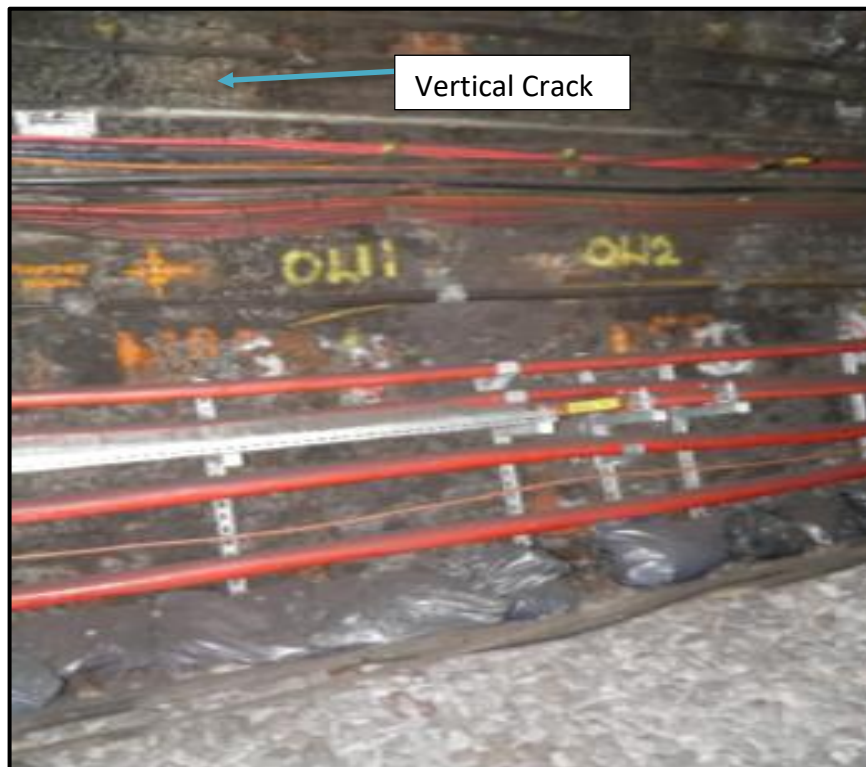
The vertical crack which was identified by the principal inspection on 18th of May 2013 was also identified by the laser inspections of 2014 and 2015. The location of the defect was identified by the visual inspection of the South abutment 581m from the West shown in Figure 3-92.

Figure 3-92 TL53 vertical crack at south abutment 581m from west visual inspection

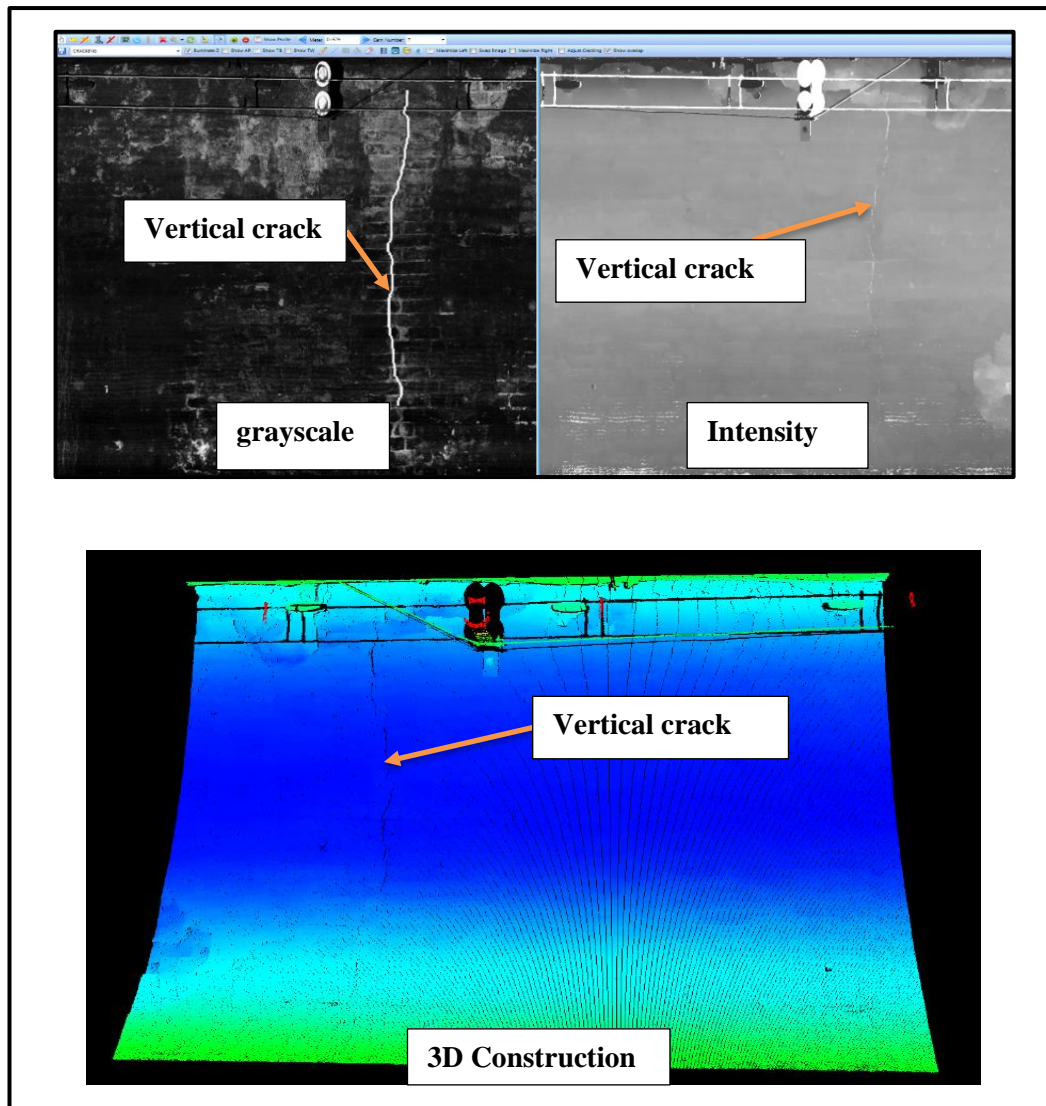
Figure 3-93 Vertical crack at South abutment 581m from West-2014
Laser inspection

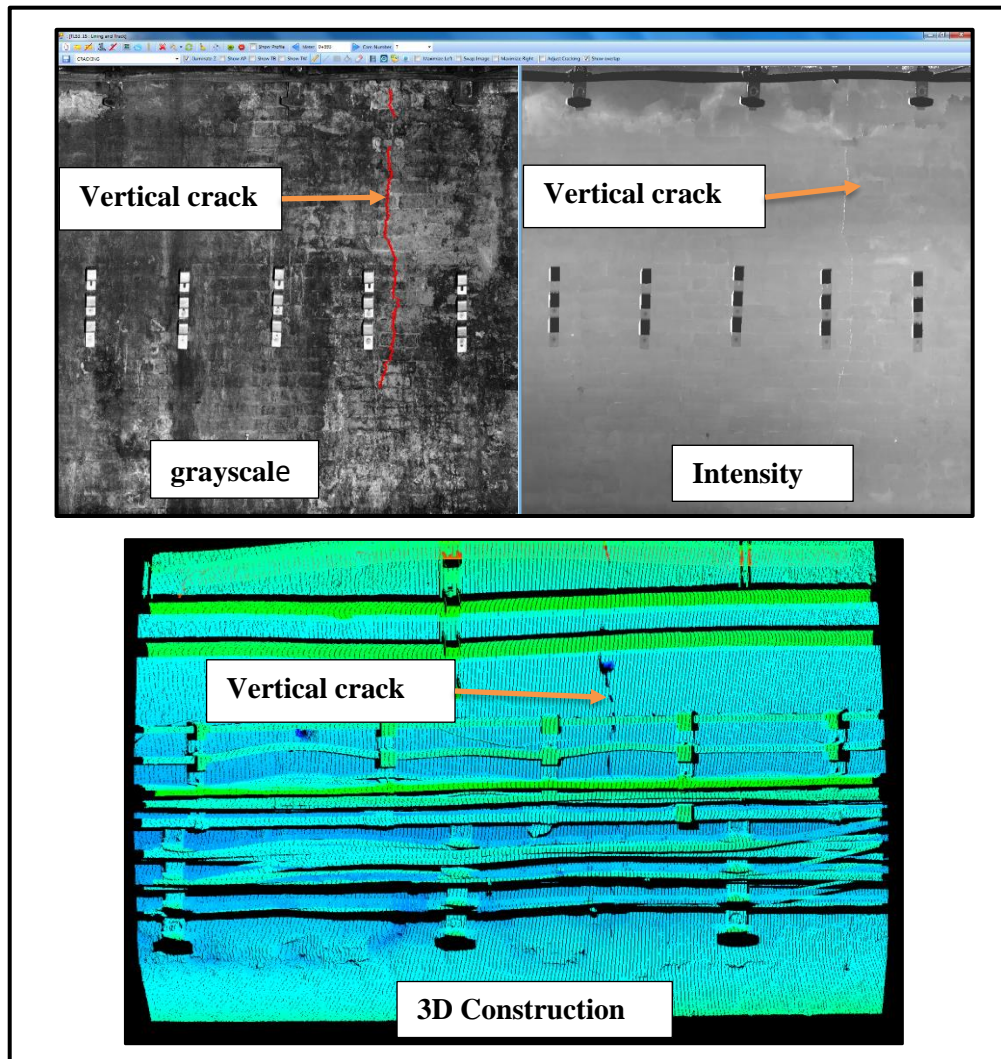
Figure 3-94 Vertical crack at South abutment 581m from West-2015 Laser inspection

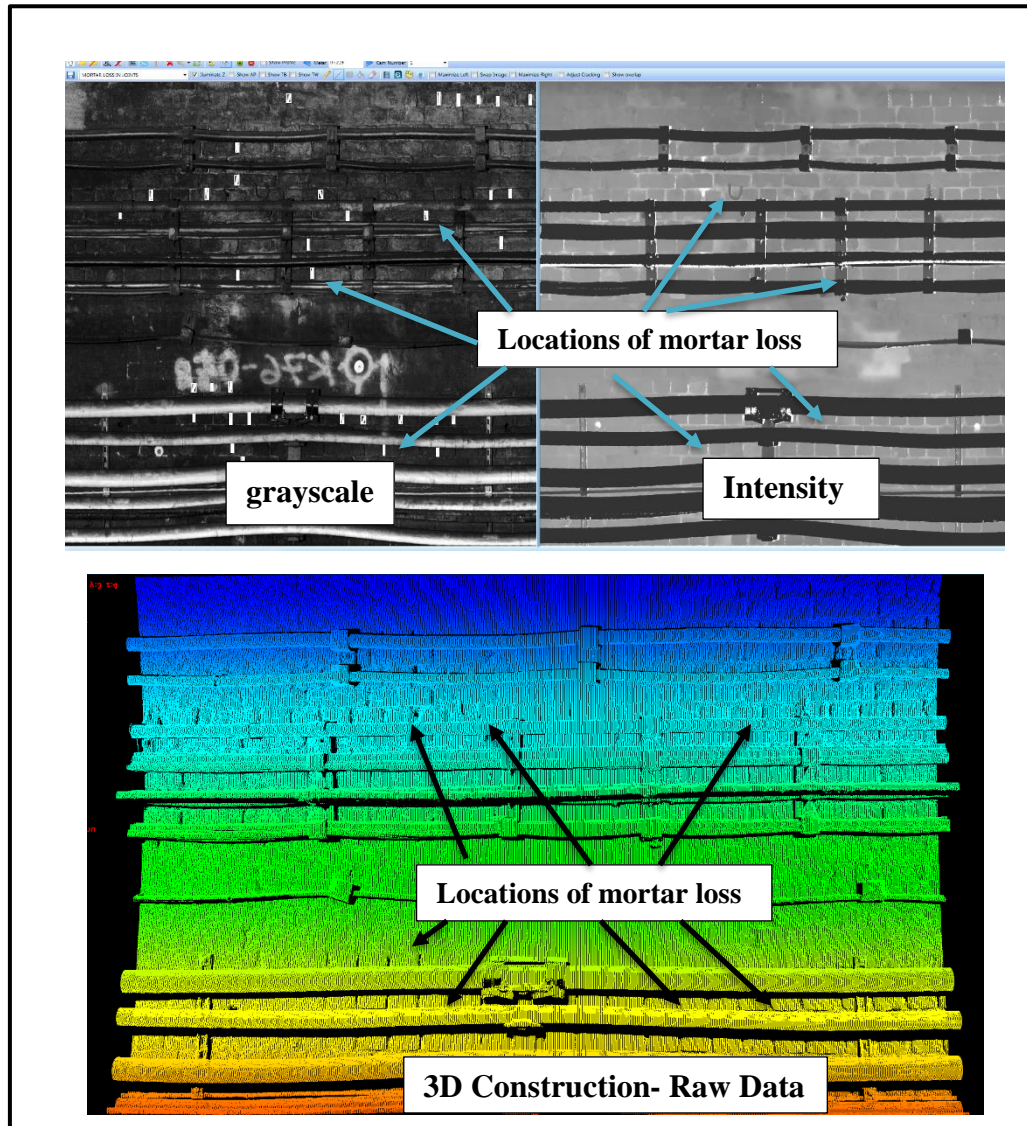
**Figure 3-98 TL 53 Locations of mortar loss in joints at chainage 220
2014 Laser inspection**

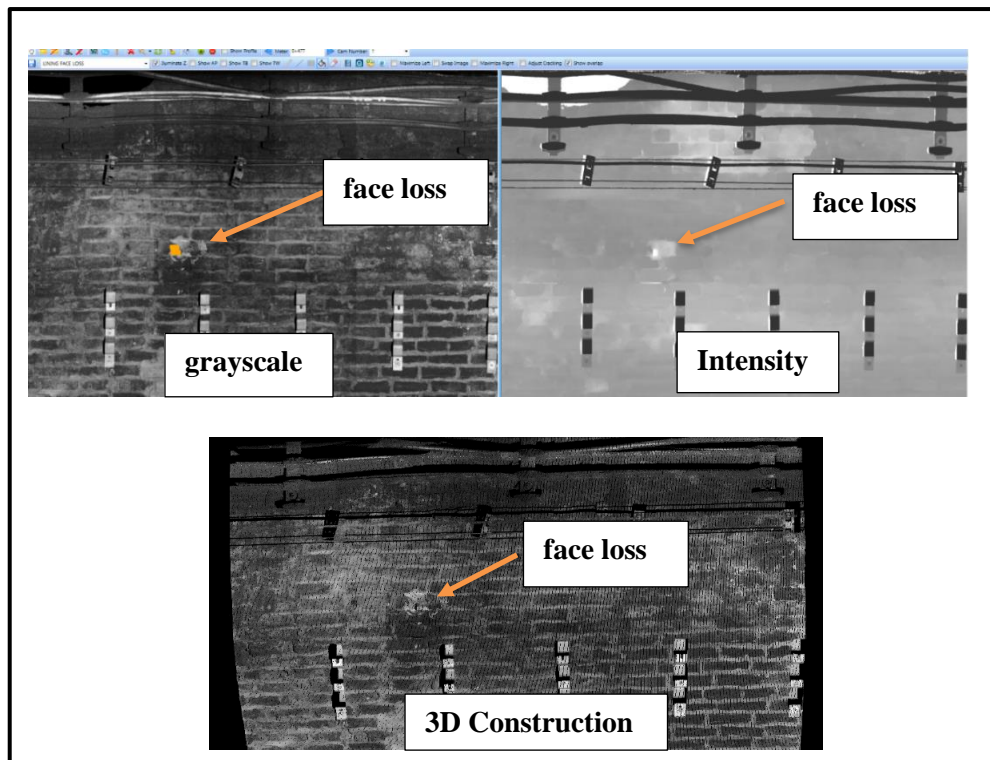
**Figure 3-99 TL53 face loss at chainage 470 2015 Laser survey**

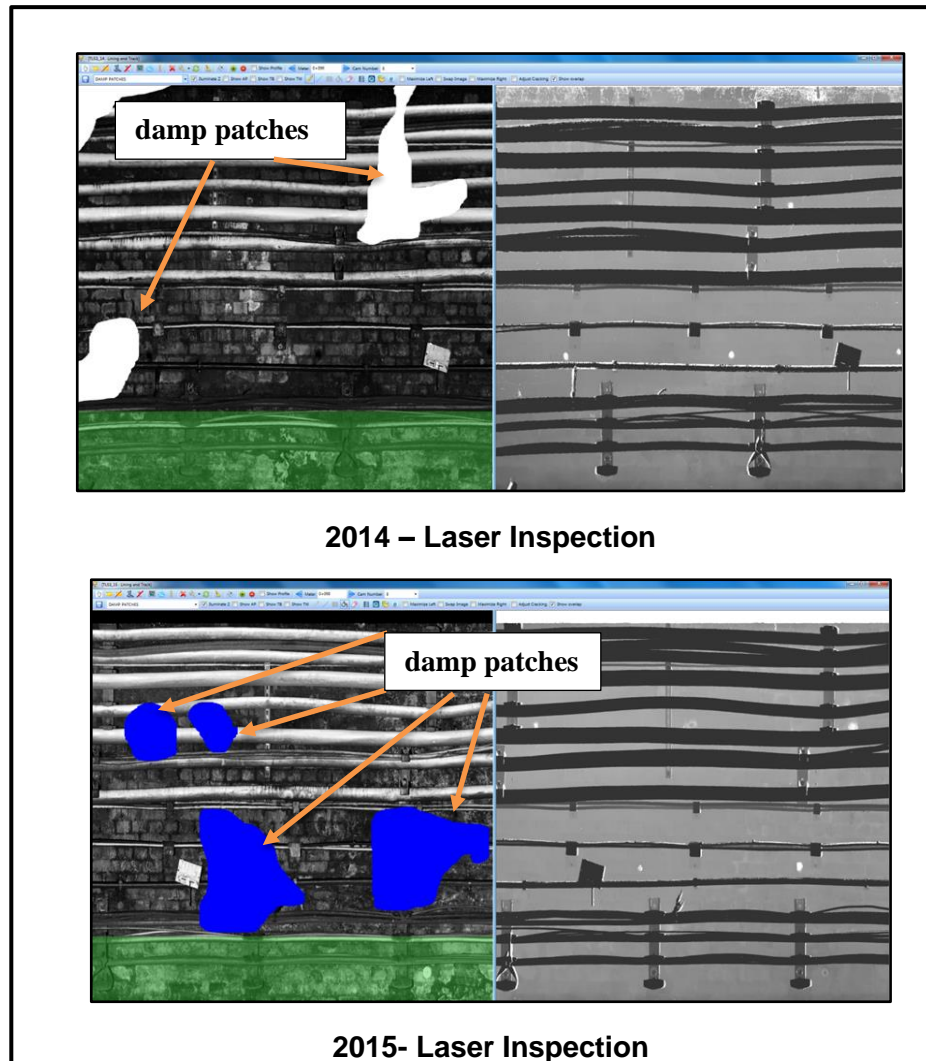
Figure 3-102 TL53 water seepage between chainage 95m and 100m

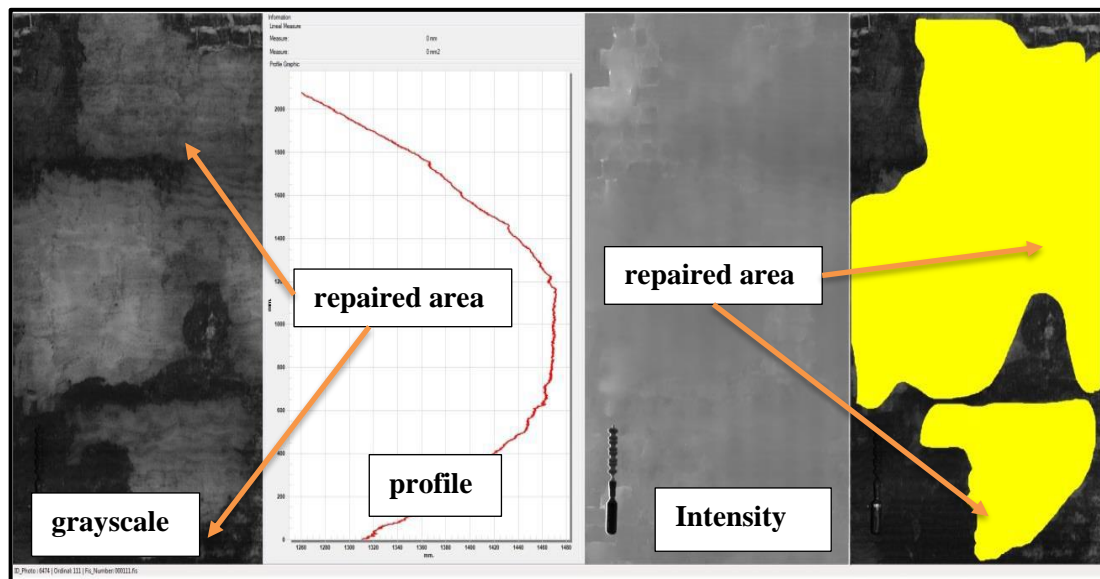
Figure 3-103 TL53 repaired area
