Factors for Improved Fish Passage Waterway Construction

Final Report

**SPR 654
OTREC-RR-11-19**

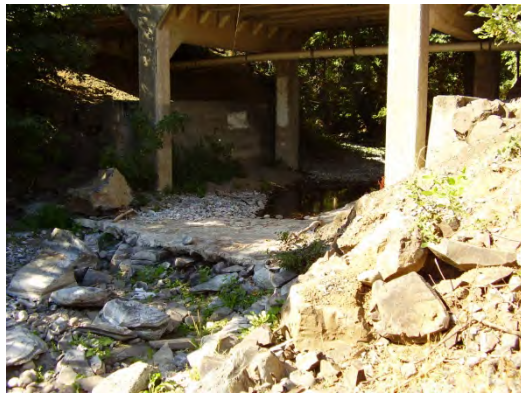
Some history was available for this structure: Repairs to the channel located under the remnant bridge were performed in September of 2006 by applying concrete to the eroded streambed and placement of compacted streambed materials over the concrete base to provide fish passage to steelhead and salmon. Chenoweth Creek had exceptional winter flows in 2006 just after the concrete bed was installed. This resulted in structural failure of the concrete, extensive streambed material movement and loss of fines. In August 2007, subsurface flow was observed under the concrete channel liner and remaining streambed material immediately downstream of the structure as shown in Figure 4.13. Large boulders served to concentrate stream flow, created backwater and flow vortexes in the channel. In September 2007, ODOT made further repairs to this passage by removing the mid portion of the concrete bed and replacing streambed materials (NMFS Washington 2008).

Figure 4.13: Site 10 – Chenoweth Creek failed under-structure concrete lining

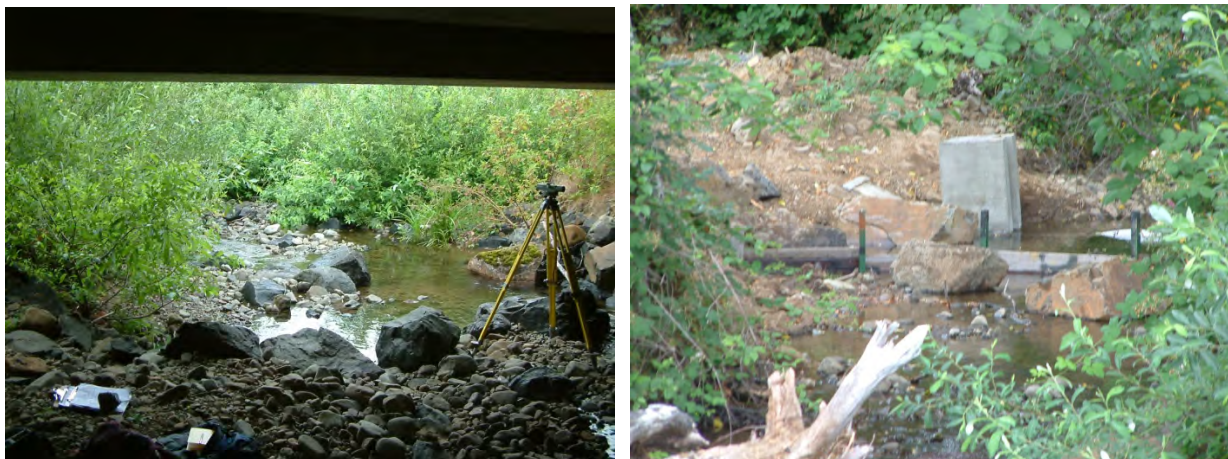
Figure 4.18: Site 16 - Jackass Creek downstream and upstream

Jackass Creek is located in Polk County and crosses highway 18 at MP 19.16. Access to the creek was from the downstream side (Figure 4.18 left) and was not particularly difficult. There were no problems in gathering any of the information and slopes and cross-sections were obtained easily. The upstream side of the creek (Figure 4.18 right) had an artificial block that created a small pool. In addition, the upstream channel had several high jumps (greater than 12 inches (30 cm)).
