A plane slide that occurred during construction of a national expressway in Chongqing, SW China

Z.Q. Yue and C.F. Lee

Quarterly Journal of Engineering Geology and Hydrogeology 2002; v. 35; p. 309-316
doi:10.1144/1470-9236/01004

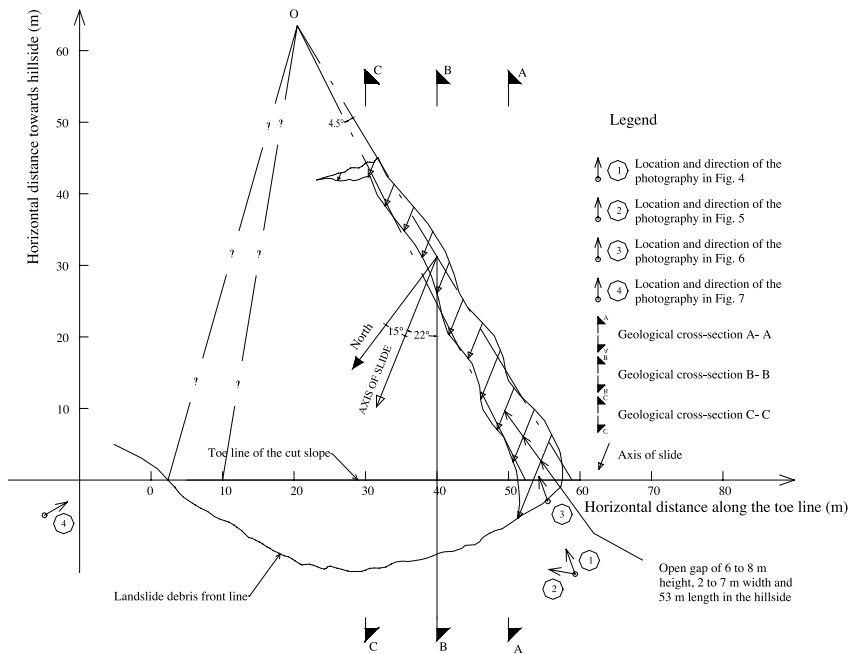
Fig. 3. Location plan illustrating the direction and extent of the landslide movement and the locations of the site photographs and geological cross-sections.

Figure 3 provides a plan view of the direction and extent of the landslide movement. The landslide is a typical planar failure. The failed block of weathered mudstone slipped down following the dip direction of the sandstone basal plane. The direction of the slide had an angle of 22° with the dip direction of the cut slope face. As a result, the open gap in the hillside had its widest portion at between 50 and 60 m of the local horizontal distance along the toe line (Fig. 3). This open space became progressively narrower towards the upper hillside. The open space has the two vertical tension crack surfaces as its boundaries (see Figs 9 & 10). The open space has a narrow wedge-shaped configuration in plan. The wedge has an angle of 4.5° with its tip located at the point O, as shown in Figure 3.

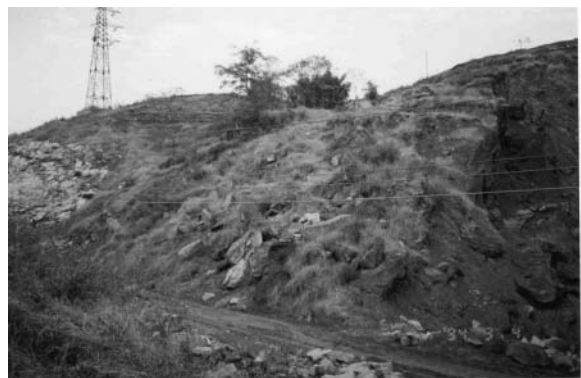
Fig. 5. The landslide debris comprising mainly weathered mudstone that travelled about 13 m onto the platform for the road subgrade, looking NE. Thick sandstone can be seen in an adjacent cut slope below the transmission tower.

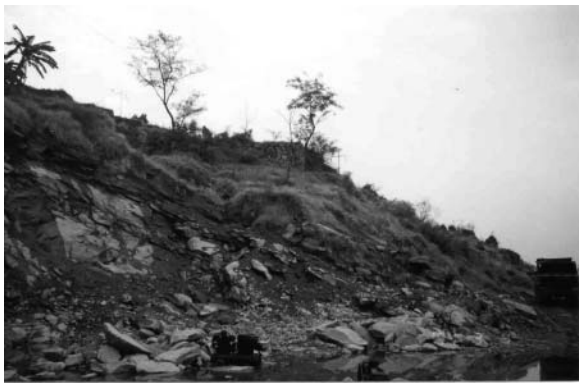
Fig. 7. A side view of the landslide debris comprising mainly weathered mudstone, looking south. Thick sandstone can be seen underlying the deformed weathered mudstone, and seepage from the contact bedding interface between the weathered mudstone and the sandstone is also visible.

Site investigation revealed that the sliding basal plane was the upper bedding surface of the thick sandstone unit that underlies the thick weathered mudstone. The sandstone surface was exposed on the upper hillside adjacent to the two-storey house shown in Figure 4. The thick sandstone might have acted as an impervious or relatively impermeable bottom layer that led to the formation of a perched ground water table in the weathered mudstone above, as evidenced by the water seeping out of the bedding interface in Figure 7. The thick sandstone strata adjacent to the landslide site can also be observed in Figures 5 & 7.

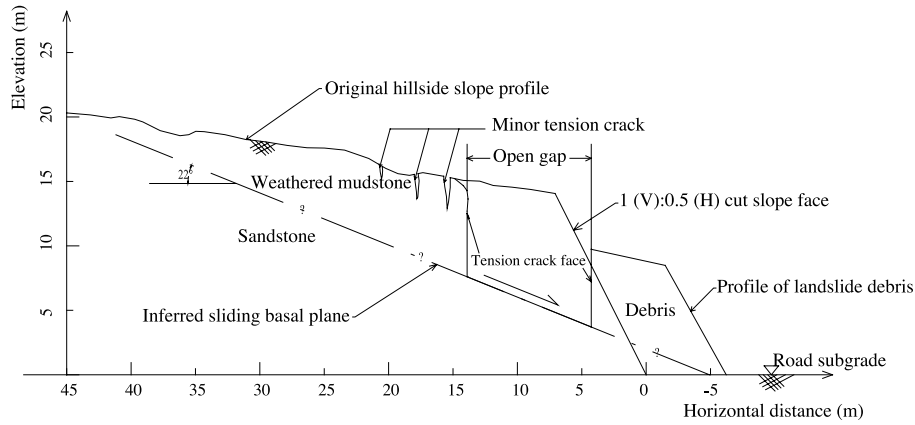
Fig. 9. Geological cross-section A-A.

For simplicity, the geological sections A–A and B–B are used in the stability analysis to verify if the causes postulated above are theoretically admissible although they do not fall along the direction of sliding. The results of the slope stability analysis are presented in Figure 12 for a plane failure in the cut slope. In the analysis, the factor of safety was assumed to be unity. The heights of the perched water table in the tension cracks (Z_w) were assumed to be 0, 1, 3 and 5 m, respectively. Figure 12 illustrates the relationship between the total cohesion c and the total frictional angle φ under the conditions of a *FOS* of unity and the perched groundwater tables. The following can be deduced from Figure 12:

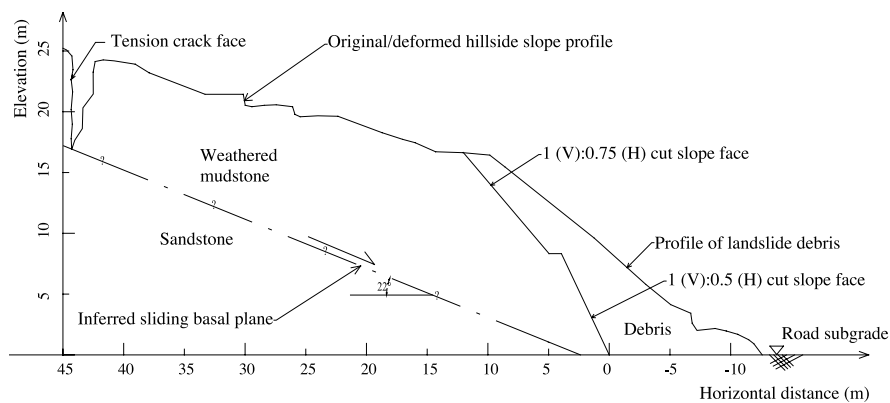
Fig. 11. Geological cross-section C-C.

Interestingly, the open space discontinues at the position where it intersects with the line of geological section C–C. At the cut slope toe of the section C–C, the sandstone sliding basal plane was about 0.5 m below the excavated road platform and not exposed on the cut slope surface. The unexcavated weathered mudstone above the basal plane and in front of the cut slope could offer some resistance to the landslide. The open space therefore discontinues and terminates at the upper region of the section C–C.

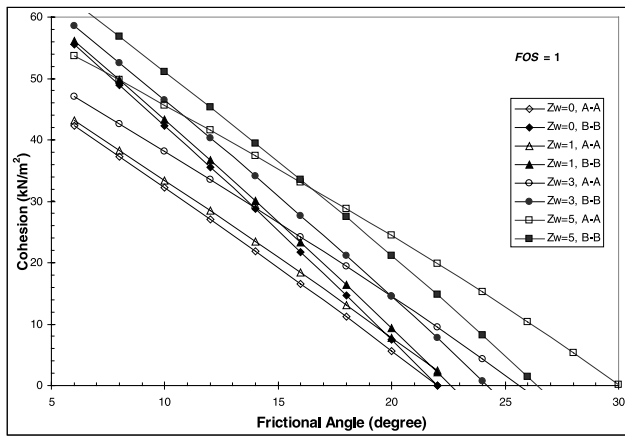
- If both Sections A–A and B–B have a *FOS* of unity and the same Z_w , the values of (c , φ) are equal to (0, 22°), (3, 21.8°), (15, 20°) and (33, 16°), for Z_w equal to 0, 1, 3 and 5 m, respectively.
- If Section A–A is dry (i.e., $Z_w=0$) while Section B–B is not dry (i.e., $Z_w \neq 0$), it is not possible for both Sections A–A and B–B to have a *FOS* of unity under the same values of (c , φ).

Fig. 12. Relationship between the cohesion and the frictional angle of the weathered mudstone for sliding along the mudstone and sandstone bedding interface and for a factor of safety (FOS) of unity, with reference to the sliding blocks in Section A–A and B–B under different perched groundwater table (Z_w) in the tension cracks.

- If Z_w in Section A–A is less than that in Section B–B, it is not possible for the two sections to have a FOS of unity under the same values of (c , ϕ).
- If Z_w in Section A–A is greater than that in Section B–B, it is possible for the two sections to have a FOS of unity under the same values of (c , ϕ).
- The possible range of (c , ϕ) for the two sections to have a FOS of unity is from (0, 22°) to (52, 7°).

From the above stability analysis, it can be deduced that the possible range of (c , ϕ) for the landslide to occur in the mudstone is much lower than that of the intact weathered mudstone in Table 1, but is close to those of the surficial deposits (silty clay and clay soils) in Table 1 and the clay soils at bedding interfaces in Table 2. This may indicate that the soil forming the incompetent weathered mudstone and the competent sandstone bedding interface had low shear strengths similar to those in Table 2. Such low strength bedding interface soil may indicate that the incompetent mudstone and competent sandstone layers had experienced bedding shear due to folding tectonic movements. (Tanner 1989; Hutchinson 1988, 1995; Gordon *et al.* 1996; Scott *et al.* 1997). The bedding interface of the mudstone and sandstone could be a pre-existing tectonic shear plane. The shear strength of the interface soil can reach the residual strength of the weathered mudstone in Table 2. Hence, failure can occur without unusually high water pressure. The presence of vertical tension cracks in the hillside slope before the major landslide may also indicate that progressive failures had occurred along the bedding interface at ordinary rainfall conditions.
