**EUROPEAN COMMISSION
JOINT RESEARCH CENTRE**

NEDIES PROJECT

Lessons Learnt from Maritime Disasters

EUR 20409

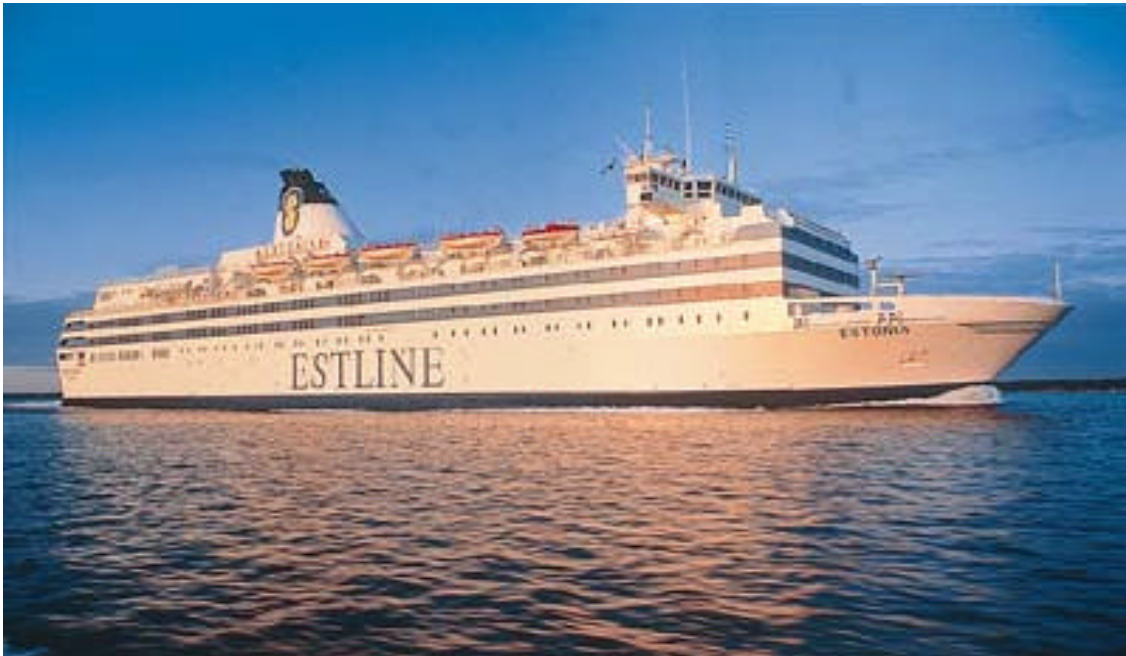
*Figure 2.1.a - The ro-ro passenger ferry ESTONIA.
© Accident Investigation Board Finland*

- The locking devices and the hinges of the bow visor failed fully under one or two wave impact loads on the visor shortly after 01.00 hrs, due to wave-induced impact loads creating opening moments about the deck hinges.

- The visor attachments were not designed according to realistic design assumptions, including the design load level, load distribution to the attachments and the failure mode. The attachments were constructed with less strength than the simplistic calculations required. It is believed that this discrepancy was due to lack of sufficiently detailed manufacturing and installation instructions for certain parts of the devices.

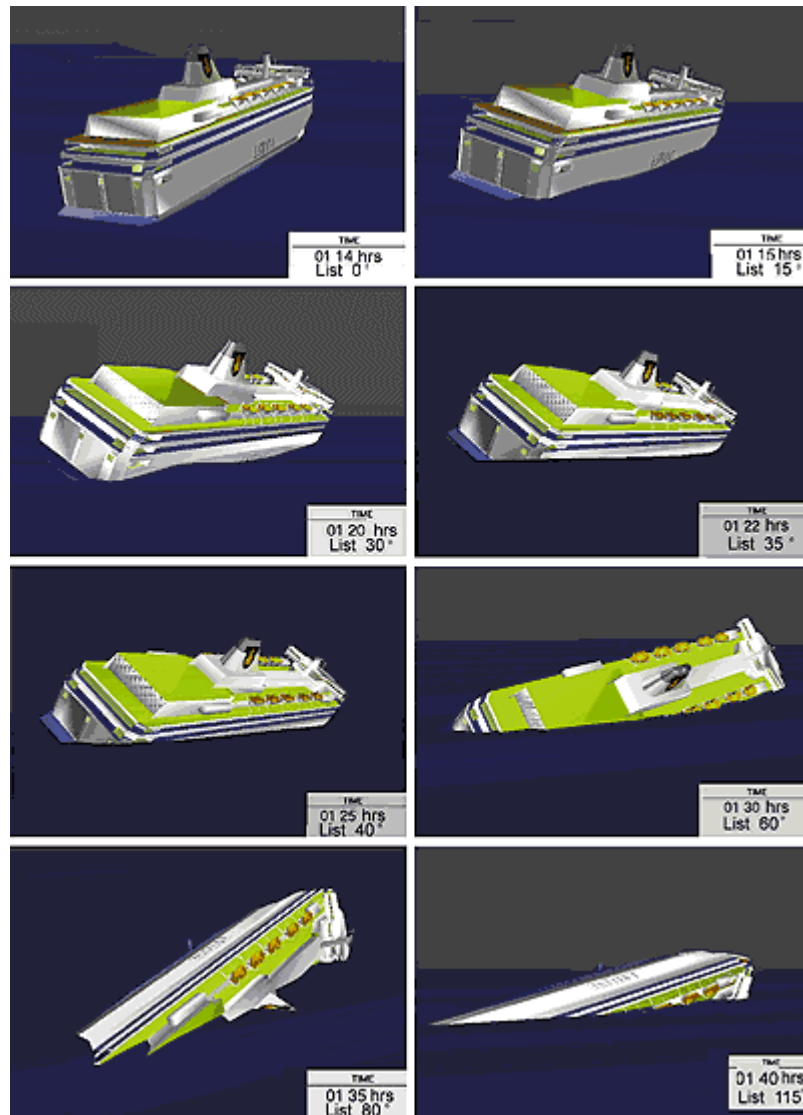
*Figure 2.1.c - Computer-generated pictures illustrating the development of the list and sinking of the vessel.
© Accident Investigation Board Finland*

- The ESTONIA capsized due to large amounts of water entering the car deck, loss of stability and subsequent flooding of the accommodation decks.
 - Large amounts of water entered the car deck and in a few minutes a starboard list of more than 15° developed.

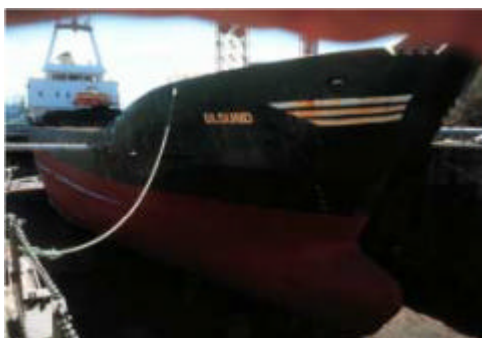
Figure 2.3.a – The MV Ulsund.
© Accident Investigation Board Finland

1. Due to the bad weather, the excavator/traverse beam, weighing a total of approx. 45 tonnes, may have come loose and damaged, or even removed, the hatch covers with, for example, the excavator arm or the grab. In the bad weather, with W-NW winds of 30 knots and a significant wave height of 5-6 m, vast amounts of seawater may have entered the hold.

From video recordings of the wreck in the summer of 1999, it may be concluded that the excavator/traverse beam was not locked as described in the certificate for the above-mentioned equipment, i.e. that the traverse beam was not locked by inserting steel bolts into the brackets at the aft end of the loading hatch, since none of the steel brackets were deformed or damaged.

2. The crew members who sailed on the ship in the autumn of 1997 and the winter of 1998 have stated of the occasional leaking of water into the double bottom tanks and occasionally into the hold. Such leaks could also have occurred on the casualty voyage, which has meant that the ship had little freeboard, and would thus be subjected to enormous stress on its hull, particularly on the bow. In the bad weather, with a significant wave height of 5-6 m, cracks may have formed in the bow section, resulting in large amounts of water leaking into, among other things, the hold, thus causing the casualty.
 - It is important that investigators deal seriously with water ingress and leakages. If there is water ingress in a vessel, for instance to tanks or holds, such problems must be resolved before the ship puts out to sea.
