Deterioration of Stone and Mineral Materials from the Roman Imperial “Villa of the Antonines” at Ancient Lanuvium

Gregory A. Pope, Deborah Chatr Aryamontri, Laying Wu,
and Timothy Renner

Abstract

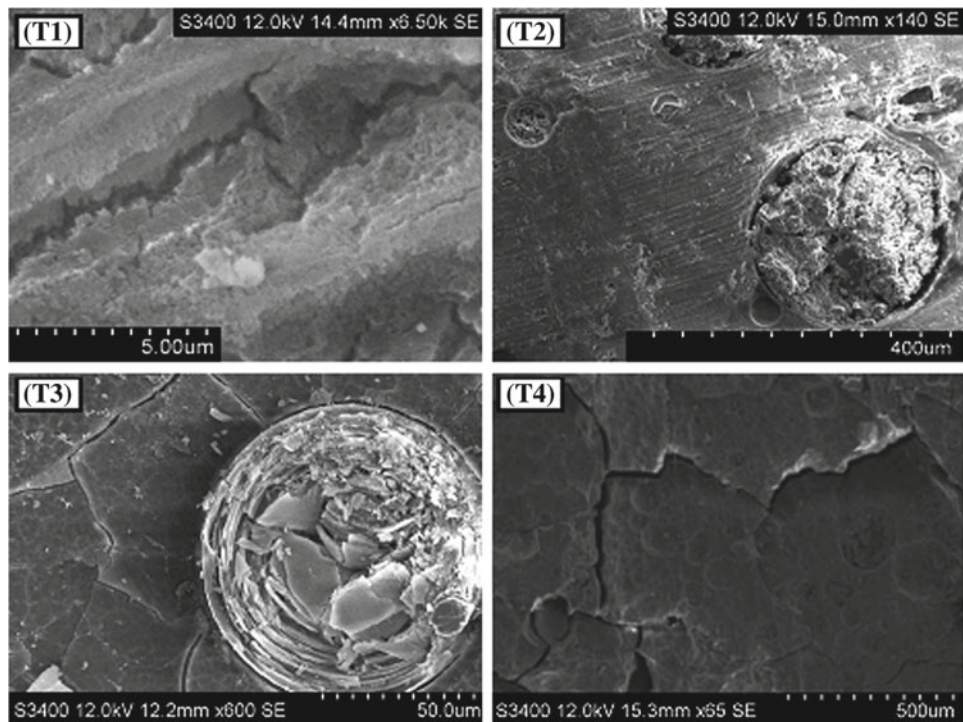
Four of the glass tesserae were analyzed thus far (Table 87.2), two each of green or red color, specifically selecting examples of both more and less deterioration. A general state of deterioration was visible at the macroscopic level. These macroscopic observations translated to later microscopic analysis (Fig. 87.4).

The most common features of the tesserae were shallow circular pits or craters, occasional on some surfaces such as T1 but ubiquitous and extensive on other surfaces, such as T3 and T4 (Fig. 87.4 lower right). The craters ranged in size from 20–80 μm in diameter and in depth $<5 \mu\text{m}$. We interpret these to be weathering features as they were limited to exposed surfaces and appeared to overlay manufacturing features, such as the striae. Cratering is probably related to chemical dissolution, described by Branda et al. (1999). Craters are not to be confused with often larger and deeper circular vesicles, interpreted as being bubbles in the glass, a product of manufacturing (Croveri et al. 2010). Bubbles do play a role in the surface deterioration, however. In the T1 sample, organic material filled several of these bubbles, which act as a protective location but also serve to retain biological weathering agents. (Fig. 87.4 upper right). In T3, an 80 μm bubble was completely filled with a flaked material, probably now clay (Fig. 87.4 lower left). This may have been an unmelted inclusion in the glass, perhaps of the sodic flux added to the raw material. It weathered into plates concentric to the circumference of the bubble.

Fig. 87.4 Surface weathering on tesserae: parallel cracking in grooves (**T1**); vesicle filled with organic material (**T2**); vesicle filled with clay, surrounded by mosaic fractures (**T3**); mosaic fracture patterns and shallow craters (**T4**)

surface stress, but from various causes. The smallest cracks define small ($<20\ \mu\text{m}$) polygonal flakes, best seen on T3 (Fig. 87.4 lower left) and T4, but not observed on T1 and T2 (concordant with the visibly better condition of T1 and T2). The cracks and polygonal flakes are shallow surface features. Likely, polygonal cracking is a result of glass corrosion in either a subsoil or subaerial environment, described by Römich (1999). Atmospheric or soil acids are capable of leaching the alkaline elements of the sodic components. While SEM-EDS identified the presence of alkaline elements on the glass surface (Fig. 87.5), specific element loss (compared to the interior of the specimen) awaits cross-sectional microanalysis.

Fine polygonal cracks were in some instances contained within angular surface blocks, defined by larger cracks up to $20\ \mu\text{m}$ wide. On the T4 specimen, these larger cracks cut through shallow craters or pits (Fig. 87.4 lower left and lower right). The crack-defined areas, $\sim 100\text{--}500\ \mu\text{m}$ in diameter, resemble macroscopic exfoliation seen on rock surfaces, and may be caused by temperature stress, salt crystal growth, hydration or dehydration of glass (which may originally contain up to 20 % water, Römich 1999), or

The third type of cracking, linear cracks (Fig. 87.4 upper left), appeared parallel to striations. We believe the striations, hundreds of μm long and $5\text{--}10\ \mu\text{m}$ wide, to be manufacturing artifacts, possibly from irregular cooling or mixing of raw material, from cutting the glass into tesserae, or from polishing the glass. Striations were not apparent on all surfaces, and linear cracking not apparent on all striations. The linear cracks, $\sim 0.5\ \mu\text{m}$ wide, formed in the “troughs” of the striations. Linear cracks may be the result of cooling and shrinking during manufacture, from post-manufacture exposure to temperature extremes, glass hydration/dehydration, clay expansion, or salt crystal growth below the plates (given the presence of Cl, Na, and K identified within the glass matrix, Fig. 87.5). The linear cracks are likewise large enough to allow entry for weathering agents, extending the deterioration feedback. Thin overgrowths or coatings were identified on flat surfaces, particularly on striated surfaces. These overgrowths are probably secondary deposits of silica.
