Failure analysis and numerical simulation of slab carrying clamps

Branislav Đorđević, Simon Sedmak

HBIS Group Serbia Iron & Steel Ltd., 11300 Smederevo, Serbia

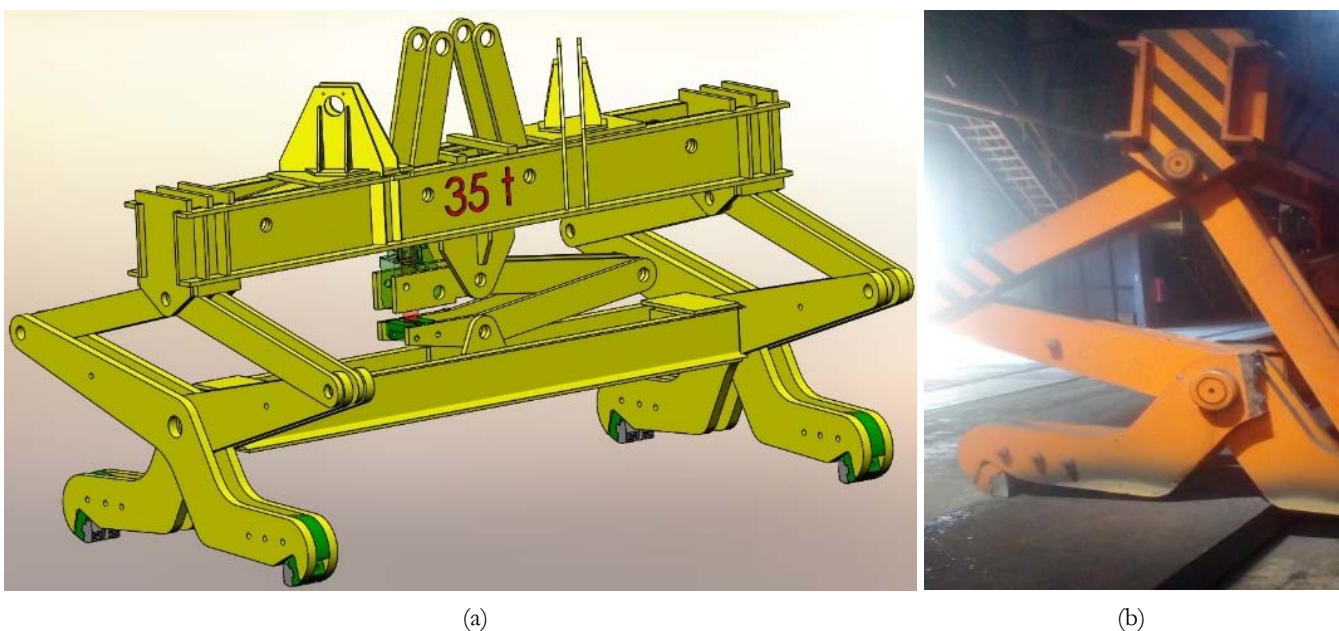
Figure 1: a) 3D model of the slab carrying clamps; b) One of the clamp levers where the failure occurred.

This paper presents the analysis of slab carrying clamps failure, in the part of the clamp used for transporting slabs through the steel mill, wherein these slabs are used for further manufacturing of sheets in the hot-rolling facility. Clamps are exposed to static loads during their work life. In order to determine the reasons behind this failure, analytical and numerical calculations (using FEM) were performed, wherein numerical simulations were performed using ABAQUS software. Additionally, visual inspection of the entire equipment was performed, along with the chemical analysis of the fractured surface, which will be presented here in detail. Fig. 1a shows the 3D model of the clamps, whereas Fig. 1b shows the appearance of the broken support lever, i.e. the location of the failure. An additional complication arose due to the fact that the visual testing revealed a welded joint in one of the support levers, which resulted in the need for additional analyses, including the determining of the chemical composition of the fracture surface and discovering the reason why fracture had occurred. Based on the aforementioned figure, i.e. figure of lever fracture, it can be observed that the influence of welding was noticeable, but despite of that the following questions arose: why did failure occur and why was it not located in the central hole of the support lever?

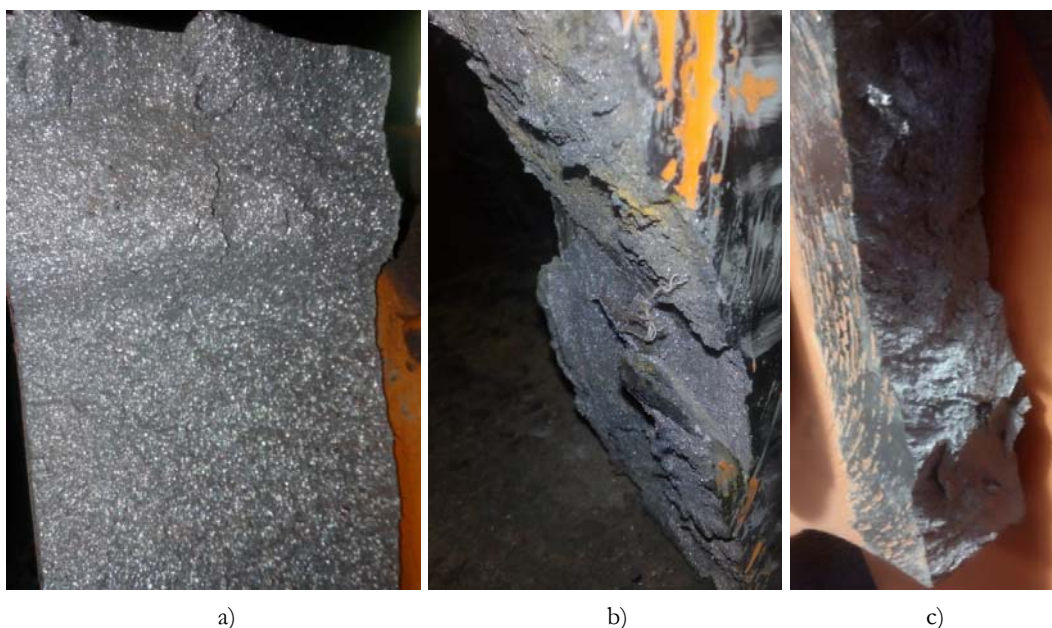
As can be seen in the above figure, one pair of clamps, with a carrying capacity of 35t consists of two levers. Fracture occurred in both of these levers, due to exploitation conditions, in service, which resulted in loads far exceeding the expected, i.e. calculated values. The second lever most likely failed after the first one broke, as it could not carry the full load on its own. On the Fig. 2 are presented fracture surfaces of the levers after performed visual inspection. This inspection also revealed that one of the lever was actually welded. This was initially assumed based on the fracture surface appearance, due to the presence of fusion lines. Figs. 2a and 2b show the fracture surface of the welded lever, whereas Fig. 2c shows the fracture surface of non-welded lever. Differences in these surfaces of the two levers can be easily observed. In order to verify the above assumption that one of the levers was welded, hardness testing was performed on both levers, in the fracture location. This measuring was performed using adequately calibrated equipment, and is given in HB units of hardness. Fig. 3a shows the measuring points on the lever which was welded. It can be seen that the region in the vicinity of the fracture surface has higher hardness (236 HB), compared to the region further away (191 HB), which indicates that this was the heat affected zone of the weld. Fig. 3b shows the measuring point in the lever which was not welded, also located in the vicinity of the fracture surface. No significant differences in hardness values were observed in this case, suggesting a much more homogeneous material, i.e. that there was no welded joint in this lever. Magnetic flux method of the NDT examination revealed no other cracks in the vicinity of fracture surfaces of both broken levers.

Figure 2: a) Appearance of fracture surfaces of the welded lever; c) fracture surface of the non-welded lever.

Failure of the slab carrying clamp support lever had occurred in the heat affected zone of the welded joint. It can be concluded and repeated from the introduction that welding had its influence, more accurately, lever failure was likely caused by inadequate preheating (taking into account the 70 mm thickness of the welded joint), which contributed to the forming of cold cracks specific for ferritic base material. This led to a significant decrease in the toughness of the welded joint, which made it more vulnerable to calculated exploitation conditions. Performed and presented analytical calculation shows that highest stresses were indeed in the part of the lever where failure had occurred. The second lever failed in an identical manner, since it could not carry the load for both ones, it is simple remark that is not questionable. The following fact about structures like these is well-known: lever used as a load-bearing element should not have been welded and exposed to a high temperature. Non-uniform chemical composition of lever has its influence and indicates that allowed stress in analytical calculation has a different, lower, value. Exposing to high temperature may have had an influence on grain size of the lever microstructure as well, which can lead to a brittle and unpredictable fracture.

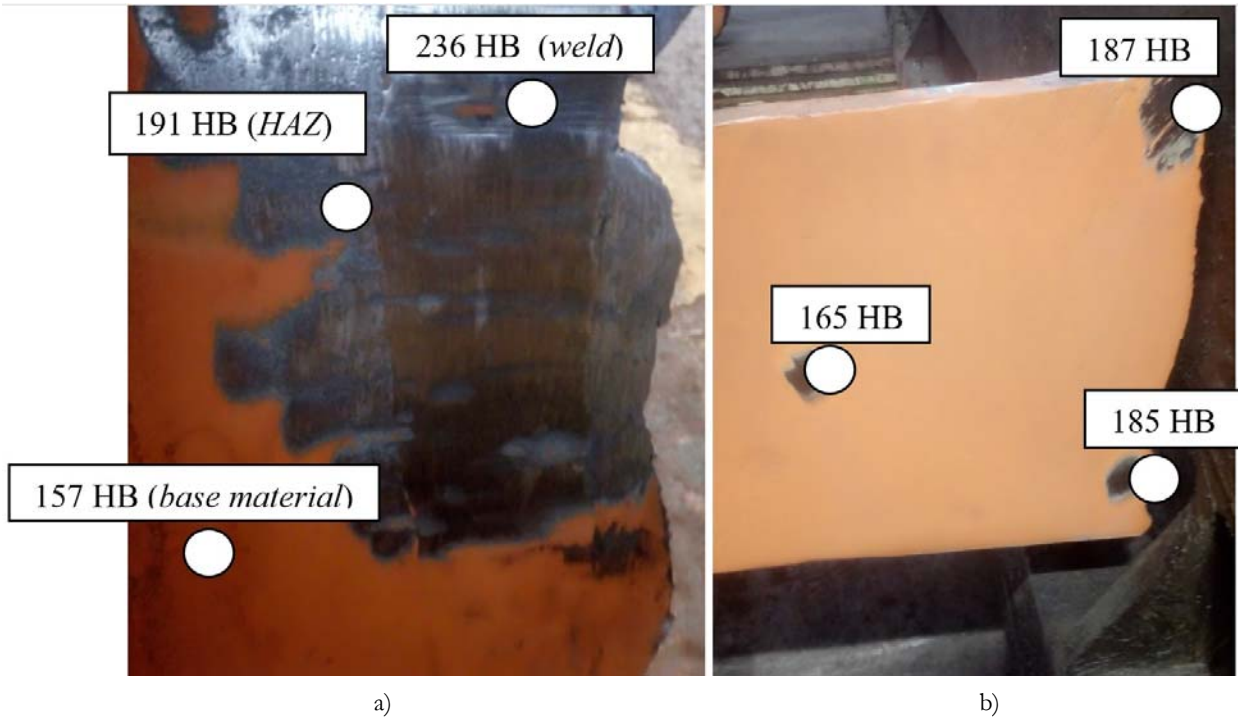
Figure 3: a) Hardness values and measuring locations on the welded lever; b) Hardness values and measuring location on the non-welded lever.

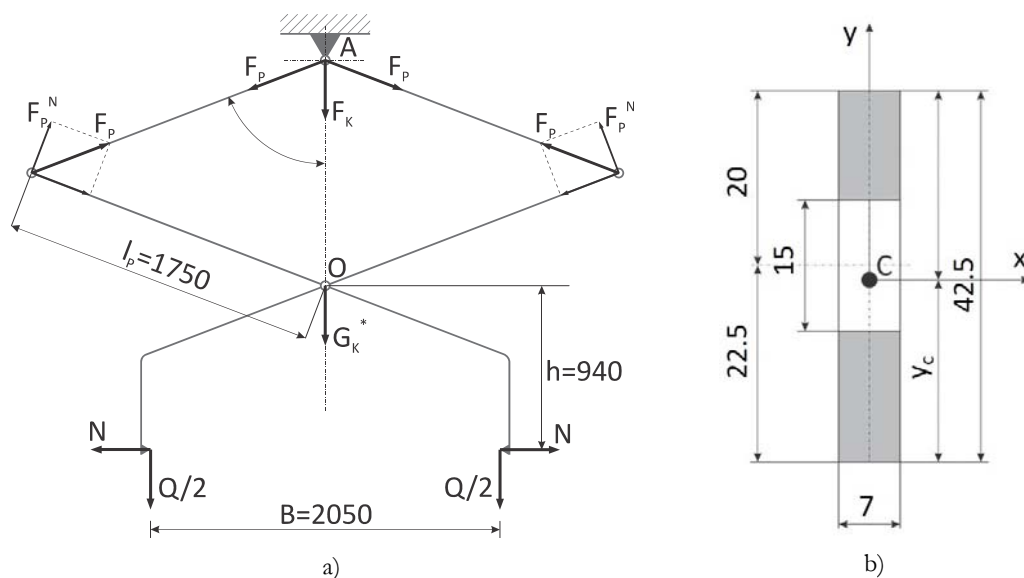
Figure 4: a) Loading scheme of the levers, with their dimensions; b) lever cross section at the support O location and its dimensions.

By decomposing the forces along the directions of the levers and their normal components, and by using the well-known statics relation given by (1), the moment for point O is obtained, i.e. for the circular opening approximated with it. This moment equals 72688 kNcm. Since this moment is transferred onto four levers, the moment for each levers is equal to 18172 kNcm according to (2).

Fig. 4b shows the cross-section of one of the levers at the support, along with the dimensions. Basic concepts of strength of materials were used to determine the cross-section centre mass, moment of inertia and the elastic section modulus in the “upper” and the “lower” zone (denoted as U and L), and the stresses in both these zones were obtained for a lever which was subjected to compression in the “upper” and tension in the “lower” zone, as shown by relations (3) and (4). Values of stresses obtained by these calculations were as follows: -93 MPa for the upper zone (negative due to the fact these were compressive stresses), and 88.4 MPa in the lower zone of the cross section. These values were below the allowed stress for the lever, which was 230 MPa. This value was determined based on the yield stress of the base material and the safety factors which are adopted in these cases (and are usually around 1.5).

In the case of extremely non-uniform load, to be accurate, when only one pair of clamps is subjected to the full load, maximum values for the “upper“ and “lower“ zones are obtained -186 MPa and 176.8 MPa, respectively. Even though these values are, as expected, two times higher than the stresses obtained in the case of uniform load on both pair of clamps, and they are still below the allowed stress levels. These remarks and afore obtained load level leave the space for numerical simulation and FEM analysis, because analytical calculation did not give the answer of reason for fracture occurrence.

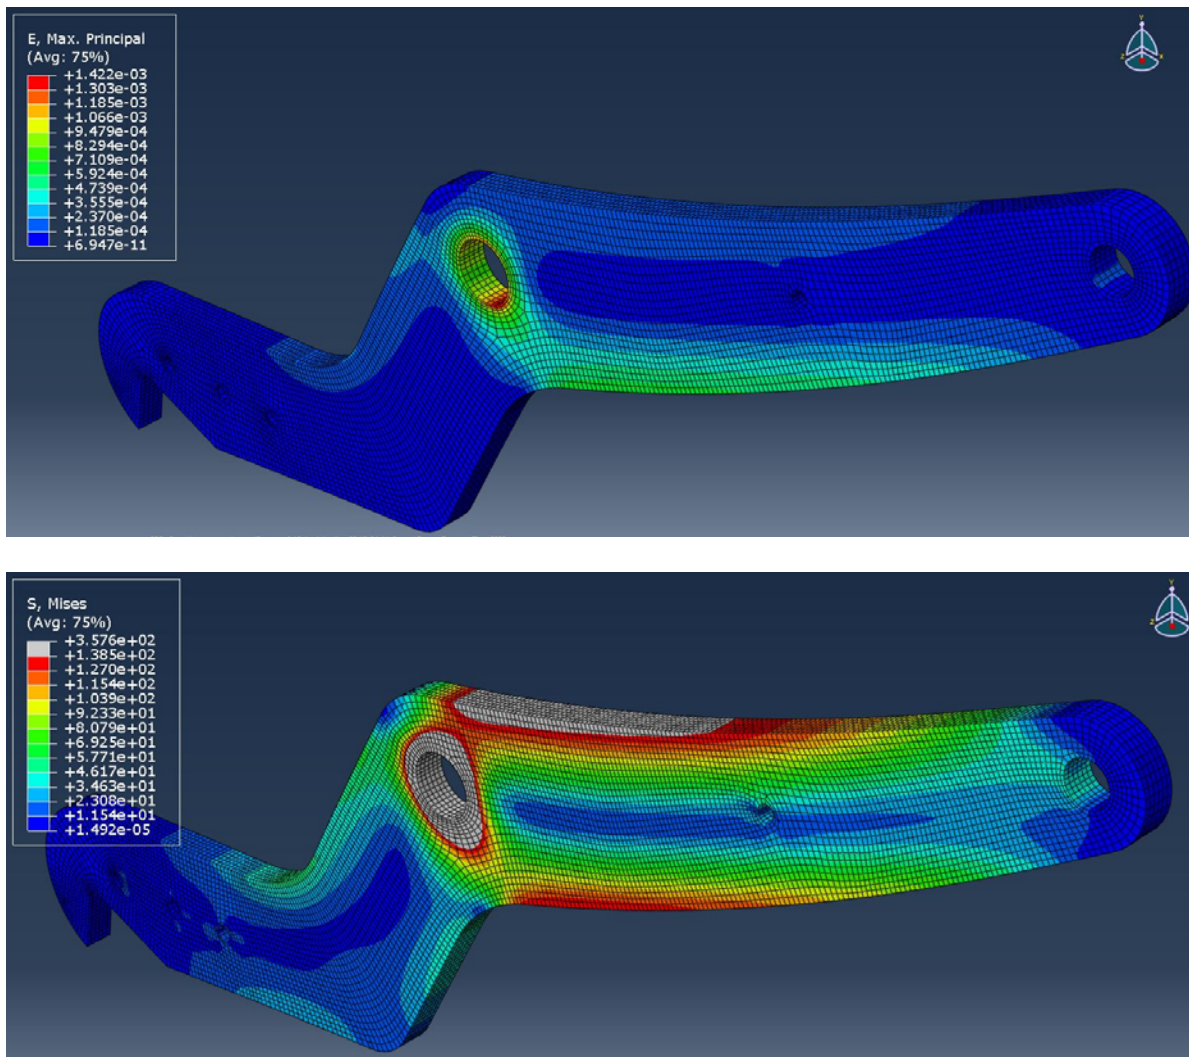
Figure 7: Strain (top) and stress (bottom) distribution in the numerical model.

The results, including stress and strain magnitudes and distribution, are shown in Fig. 7 below. As can be seen, there are some very high stress values obtained in certain locations, which suggests that a more detailed approach is necessary in order to make a fully functional model. However, the goal of this initial version was to determine the location of the maximum tensile stresses, which is denoted by the red colour in the aforementioned figure. The areas with much higher stresses (grey) can be neglected in this case since they are:

- In the support, which is a commonly encountered case in static numerical simulations, and can be ignored.
- In the upper zone of the lever, where compressive stresses are dominant. Since these stresses have no influence on crack initiation, they were also not relevant.

Strain distribution indicated that the most deformed part, outside of the support, was the region where highest tensile stresses, with a magnitude of 138.5 MPa, had occurred. If this is compared to the real situation, it can be seen that there is good agreement between the locations of highest tensile loads, i.e. the potential crack in the model would be initiated near the location where the actual support lever broke. The stress value in this case is still considerably below the allowed stress, although it is over 50% higher than the analytical, which also confirms that the model needs to be improved.
