European Laboratory for Structural Assessment (ELSA)

The Garda Area (Italy) Earthquake of 24 November 2004: A Field Report

S. Dimova, E. Mola, P. Negro, A.V. Pinto

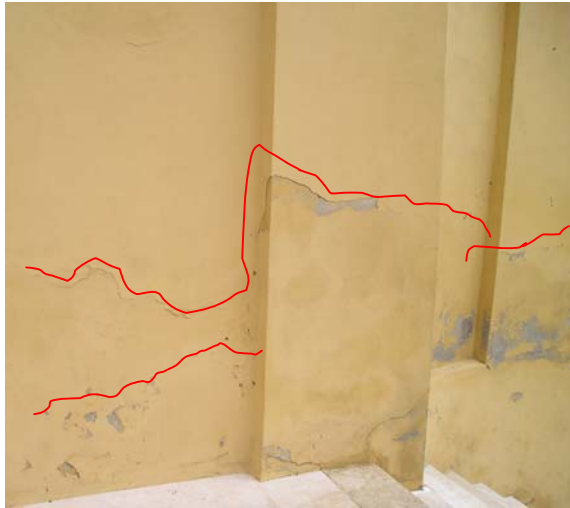
Very slight non-structural damage was observed in isolated buildings of class A and class B: hair-line cracks in plaster of the walls, as shown in Figures 3.1 and 3.2. A vertical crack in the masonry wall and fall of plaster was observed in one building, as illustrated in Figure 3.3. Having in mind the above observations **EMS intensity of V** and **Modified Mercalli intensity of 5** are assigned to the part of Vobarno located along the river.

Figure 3.1. Cracks in the plaster in a church in Vobarno

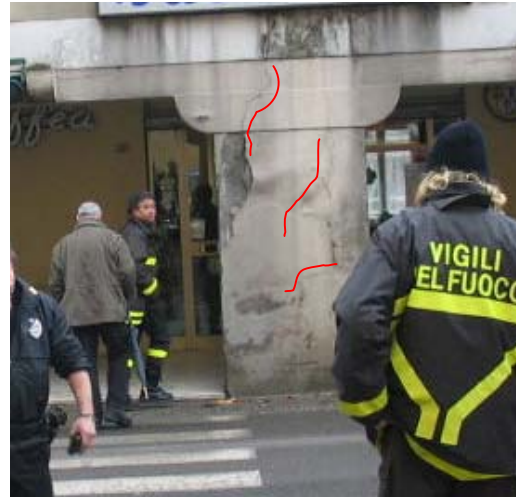
Figure 3.2. Cracks in the plaster of a Building in Vobarno

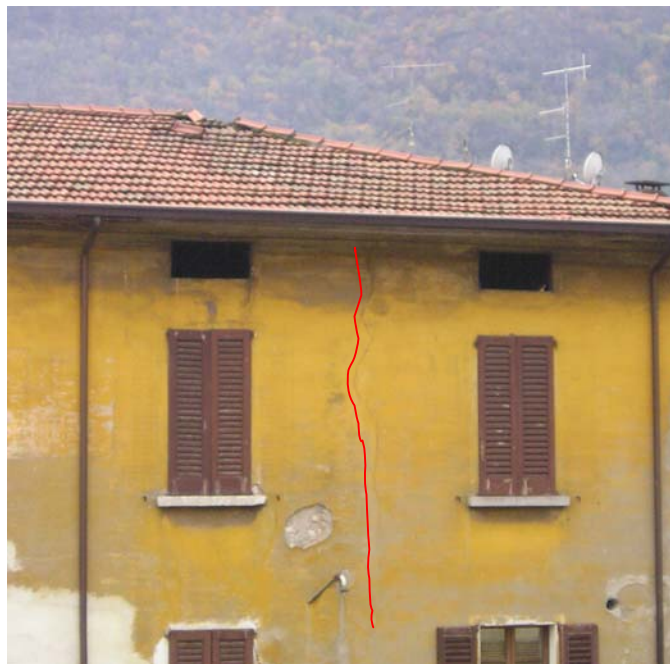
Figure 3.3. Vertical crack in the masonry wall and fall of plaster in Vobarno

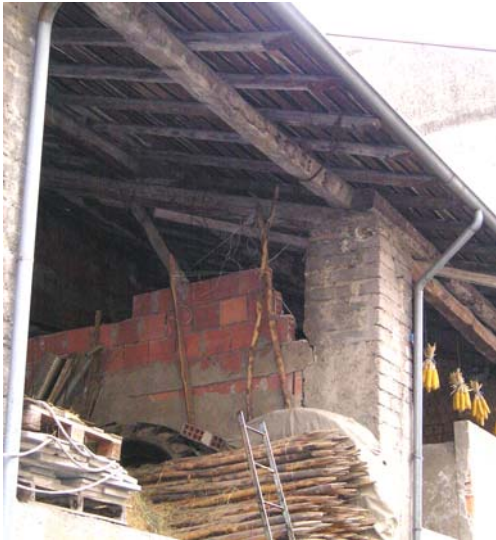
Figure 3.4. Fall of loose bricks in Collio

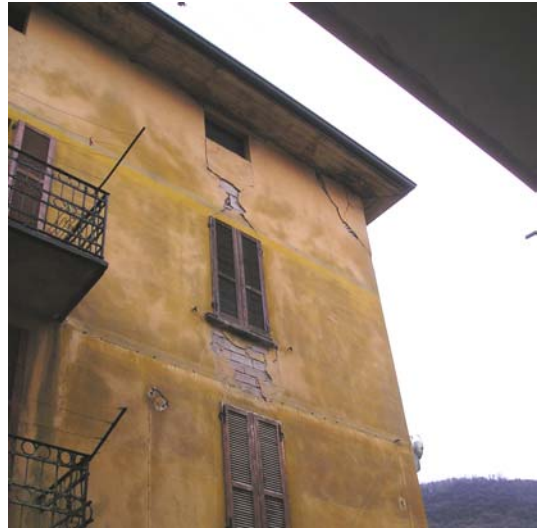
Figure 3.5. Cracks in the masonry walls

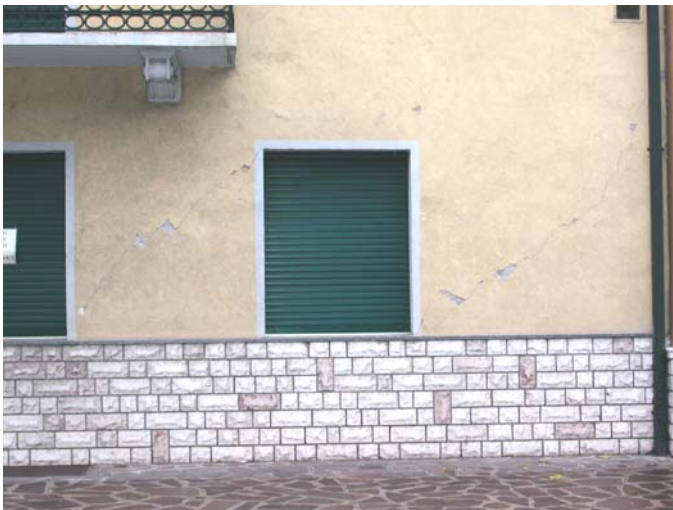
Figure 3.6. Failure of masonry wall

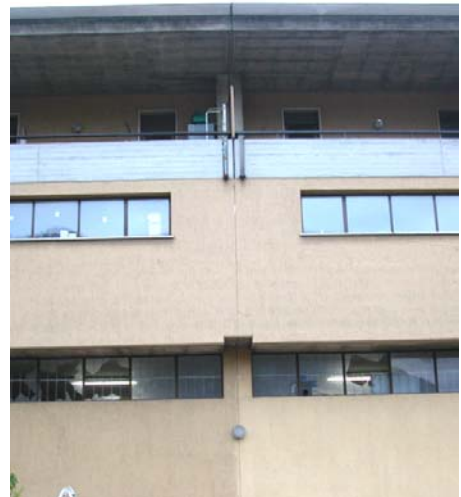
Figure 3.7. Separation joint in RC building

No major damage was observed in RC structures. The separation joints acted in some buildings, as shown in Figure 3.7. A slight non-structural damage was observed only in an irregular RC building in Collio, where masonry walls separated from the RC frame. The irregularity was created by the absence of masonry walls in a considerable part of the first story in connection with its exploitation as a workshop (Figure 4.22). The absence of masonry walls in this part affected torsional unbalance and to a certain extent a 'soft first storey'. The resulted separations of the masonry walls in the second storey and in the first storey are shown in Figure 4.22 and Figure 4.23, respectively.

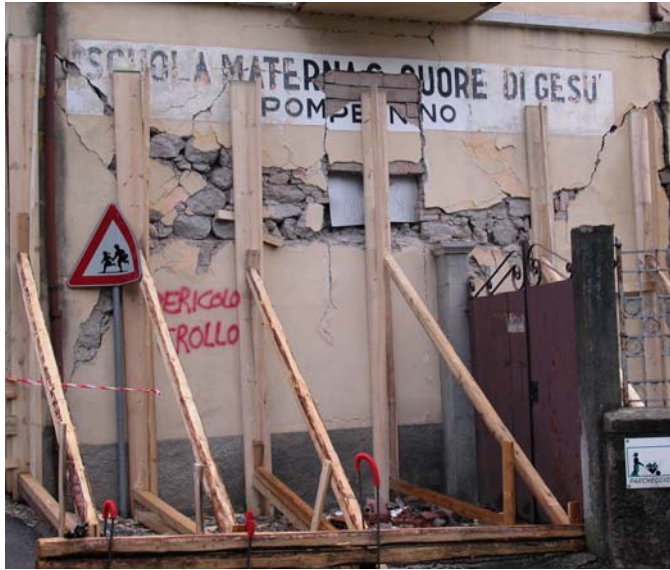
Considerable damage of the masonry structures was observed in Pompegnino: failure of masonry walls of poor quality (Figure 3.8), out-of-plane deformation and cracking of masonry walls (Figure 3.9), failure of masonry due to the lack of separation joints between buildings with different levels of the horizontal elements (Figure 3.10), separation of masonry walls from the RC slab, disintegration and failure of the unconfined masonry under the roof structures (Figure 3.11), cracking of windows piers. The upper part of the church bell tower suffered shear failure, it was cracked considerably due to pounding with an adjacent building, and the façade walls of the church were considerably cracked in the upper part.

Figure 3.8. Collapsed masonry wall

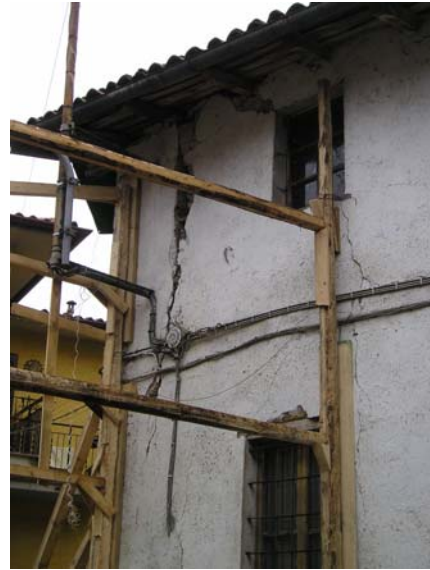
Figure 3.9. Out of plane deformation and cracking of a masonry wall

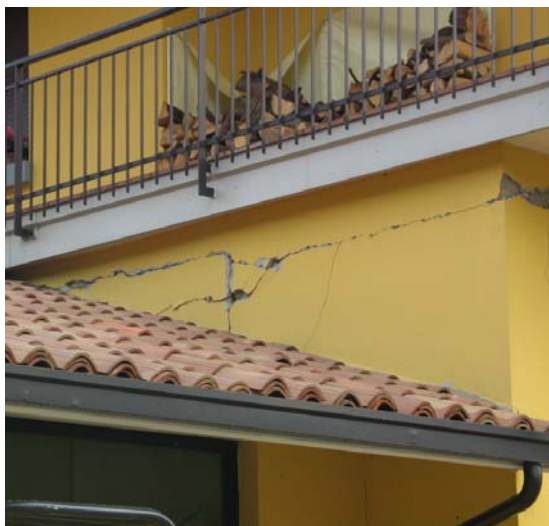
Figure 3.10. Lack of separation joint

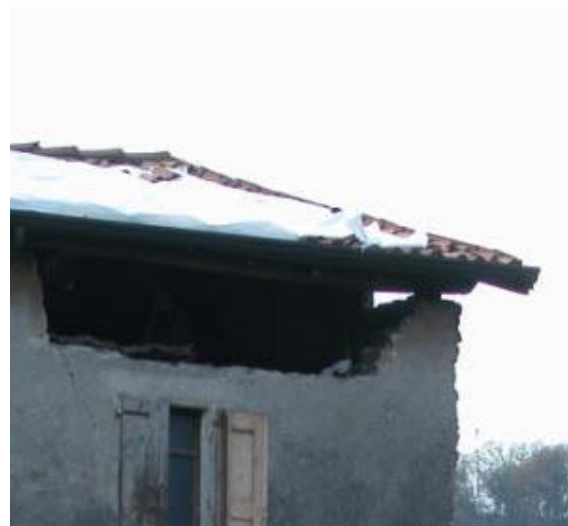
Figure 3.11. Failure of the masonry under the roof

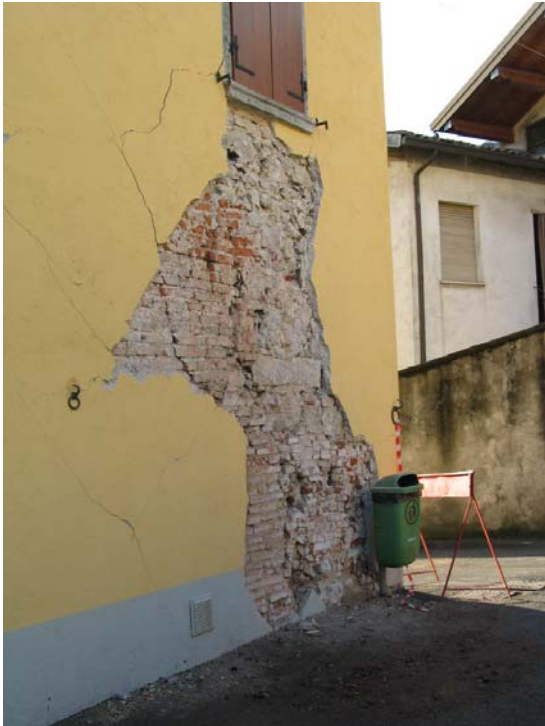
The historical centre of Pavone as well as some relatively new buildings suffered considerable damage. There, diagonal cracks in the masonry walls were observed, together with failure of walls with poor quality (Figure 3.12), shear failure of masonry columns (Figure 3.13), out-of-plane deformation and cracking of slender masonry walls (Figure 3.14), disintegration and failure of the unconfined masonry under the roof

Figure 3.12. Failure of masonry with poor quality

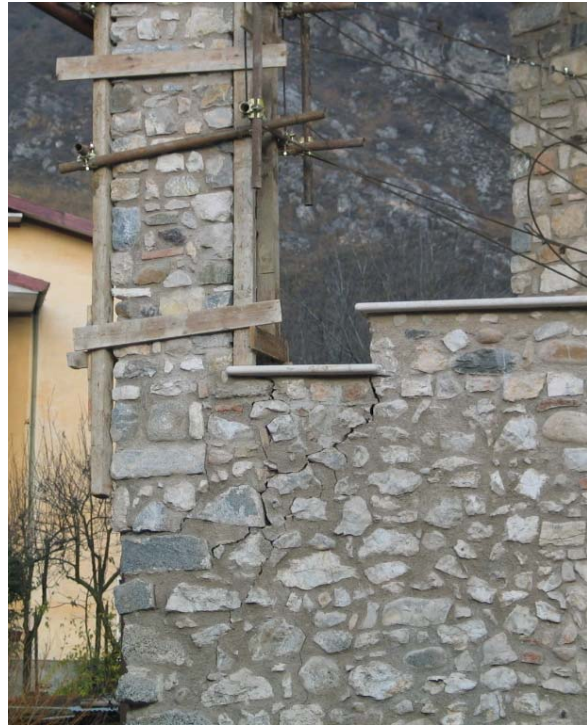
Figure 3.13. Shear failure of masonry

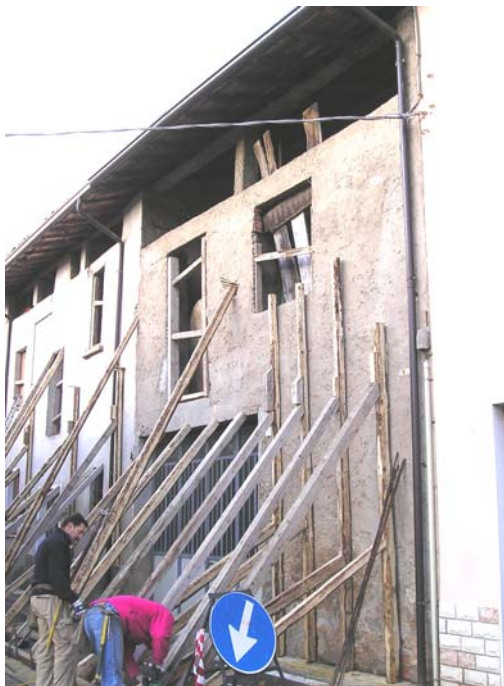
Figure 3.14. Failure of untied slender masonry wall

The prevailing part of the residential building stock in the observed affected area consists of two or three story masonry houses, built before the last World War. The most severely damaged parts of the villages were the historical centers where the houses are 200-300 years old. During their long exploitation they were subjected to many reconstructions, which, together with the building techniques from the past and deterioration of the materials contributed their seismic vulnerability. As shown in Figure 4.1, the execution of a large opening in the massive contra-force wall contributed its failure. The infills of the larger openings separated and cracked, as shown in Figure 4.2. The new-built untied slender masonry wall in Pavone suffered out-of-plane-deformation and cracked, as shown in Figure 3.14.

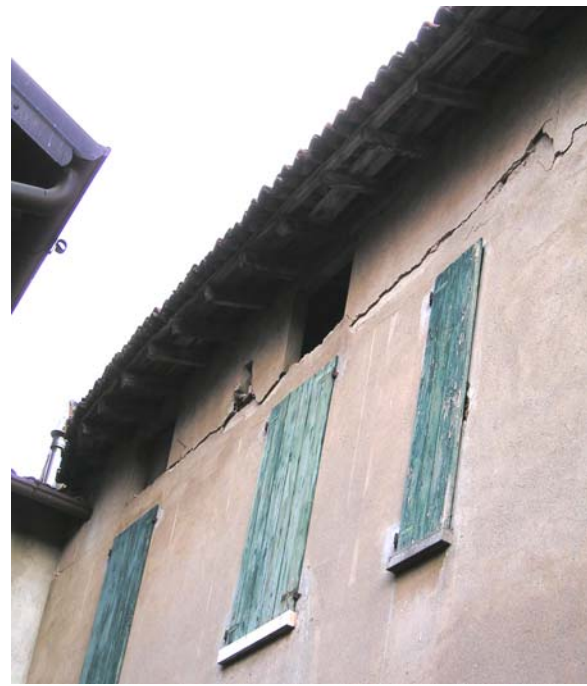
structures (Figure 3.15). The external observation of the Pavone church has shown a slight structural damage.

Figure 3.15. Failure of the masonry under the roof

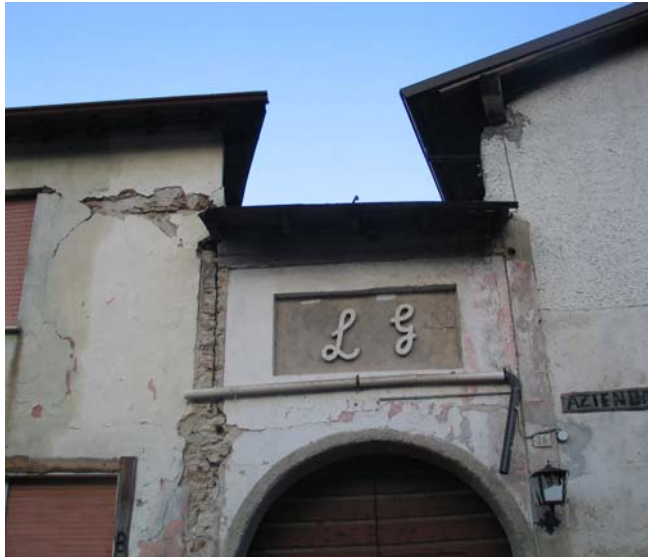
Figure 3.16. Pounding of adjacent buildings

The survey has shown diagonal cracks in the masonry walls of many houses, failure of masonry due to the lack of separation joints between buildings with different levels of the horizontal elements (Figure 3.16), disintegration and failure of the unconfined masonry under the roof structures. In many houses the 'coppi' tiles have fallen from the roof

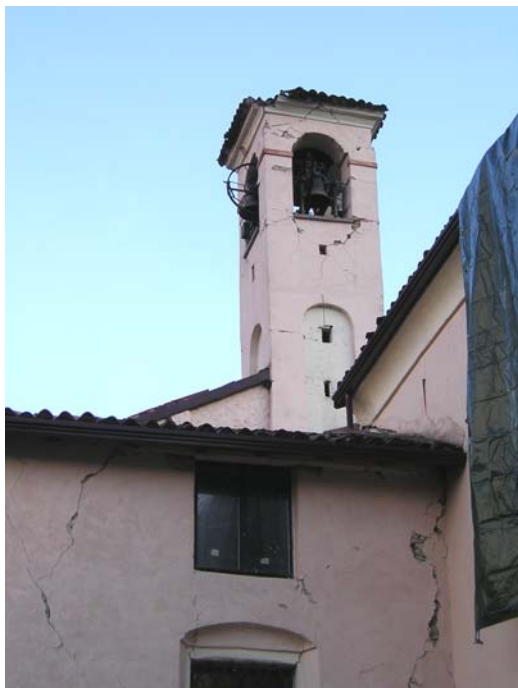
Figure 3.18. Damages of the church

(Figure 3.17). The church was considerably damaged: the upper part of the bell tower suffered shear failure (Figure 3.18), the masonry was considerably cracked in many places due to interaction with adjacent structures (Figure 3.18), shear effects and out-of-plane bending. Partial separation of the façade walls was observed (Figure 3.19). Near Clibbio a rock-fall caused damages of the road (Figure 3.20).

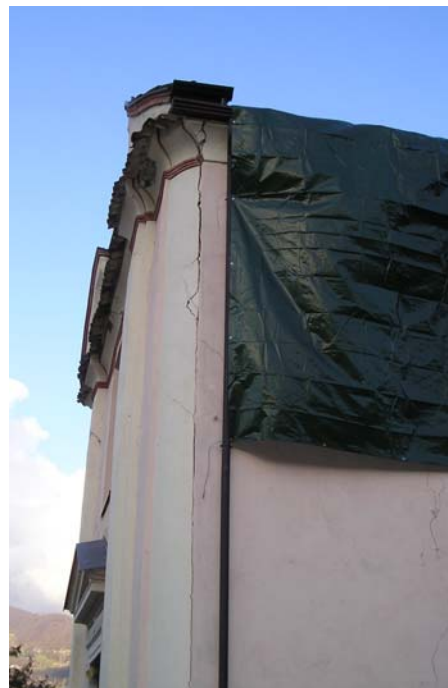
Figure 3.19. Partial separation of the façade walls

partial separation of the façade walls (Figure 3.19 and Figure 4.12) was most probably provoked by a weak connection between the walls and the roof.

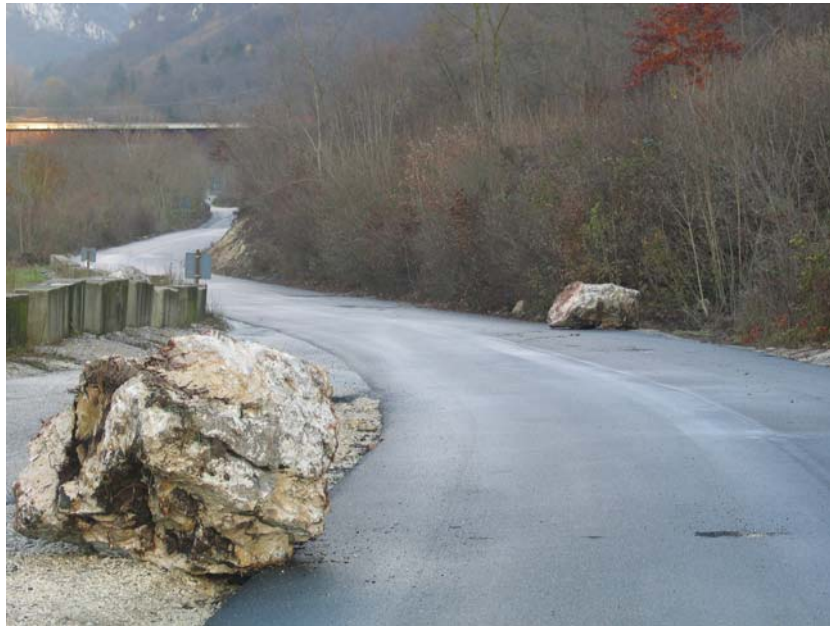
Figure 3.20. Rock-fall near Clibbio

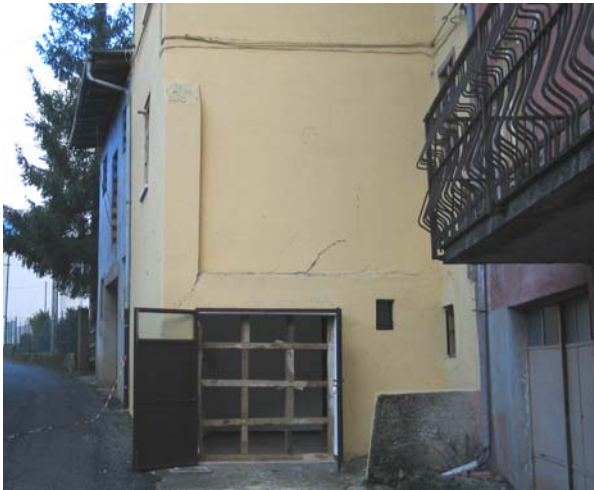
Figure 4.1. House in Clibbio with a large opening in the bearing wall

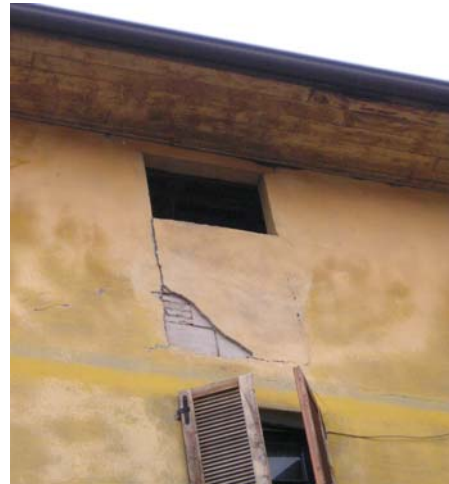
Figure 4.2. Separation of infills in Collio

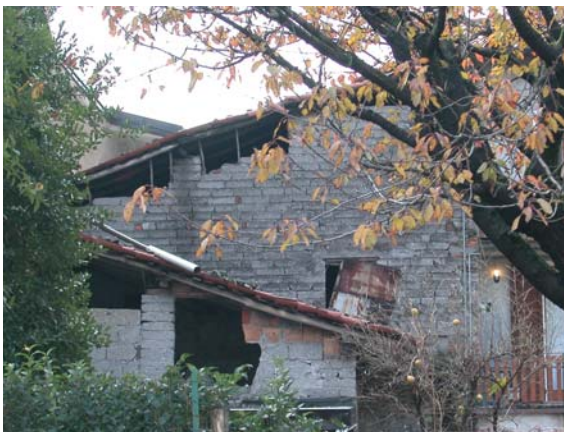
The weak connection of the roof structures with the unconfined masonry caused failure of the masonry (Figure 4.3) and, in some cases failure in the roof structure (Figure 4.4) due to the damaged supports.

Figure 4.3. Failure of the unconfined masonry under the roof in Pompegnino

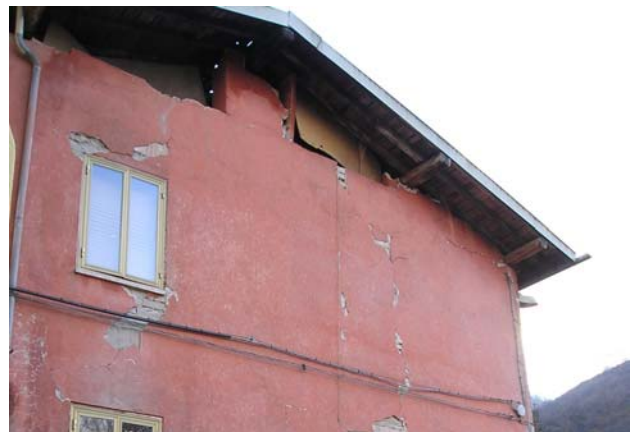
Figure 4.4. Failure of the masonry support and of the roof in Clibbio

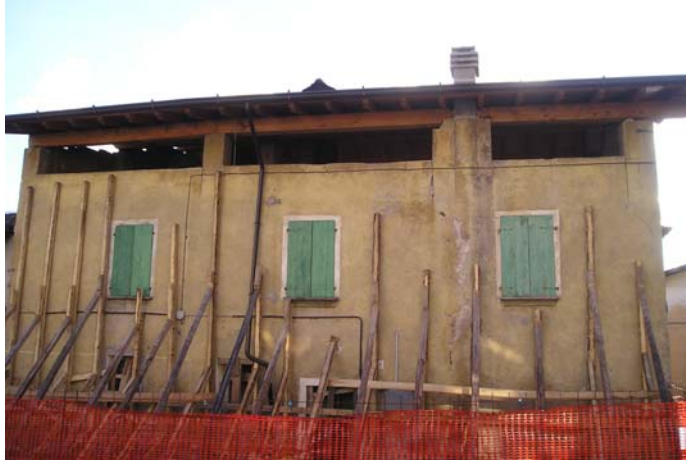
The weak connection of the floor and roof structures with the masonry as well as the insufficient in-plane stiffness of the floors and roofs did not allow the redistribution of the seismic forces between the individual walls. The walls separated along their joints and suffered out-of-plane deformation, as shown in Figure 4.5.

Figure 4.5. Separation of masonry walls in Pavone

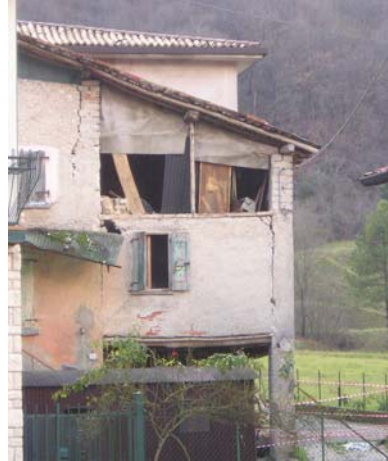
Figure 4.6. Irregular structure in Clibbio

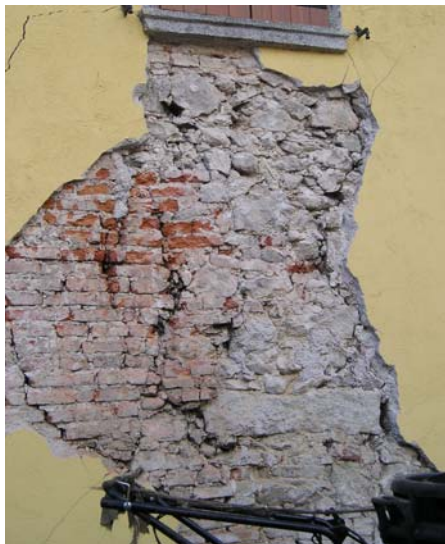
Figure 4.7. Failure of masonry in Pavone

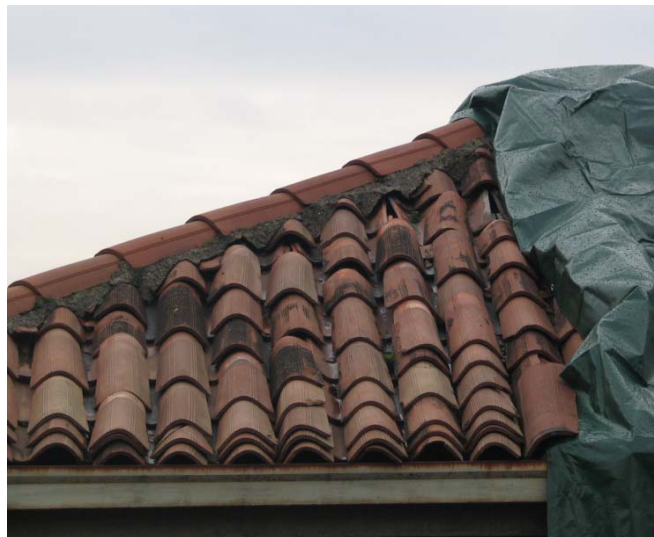
Another source of failure was the lack of separation joints between the houses. Adjacent structures with different height of the floors “bumped” against each other causing failure of the masonry in the neighbouring parts, as shown in Figure 4.16 for Collio. The irregular distribution of the stiffnesses and masses in-plan and along the height provoked failures in a house in Clibbio, as shown in Figure 4.6. The use of different materials for construction of the masonry walls caused their cracking and disintegration. In Figure 4.7 the failure of a masonry wall containing bricks and stones with different size is presented. The horizontal seismic loading caused sliding and failure of the ‘coppi’ tiles in many roofs in Clibbio and Pompegnino, as shown in Figure 3.17 and Figure 4.8.

Figure 4.8. Sliding of ‘coppi’ tiles in Pompegnino

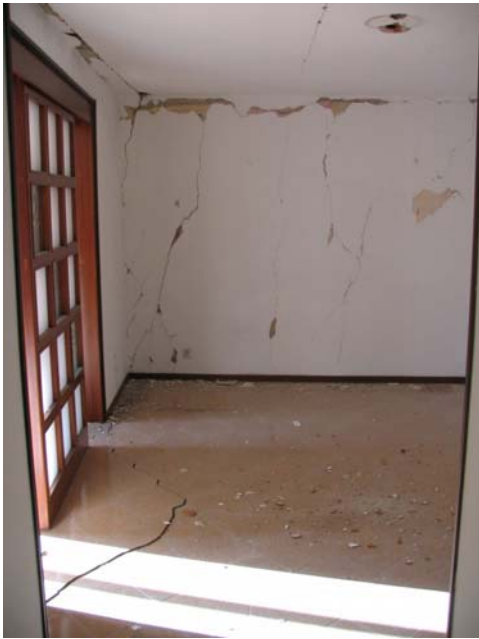
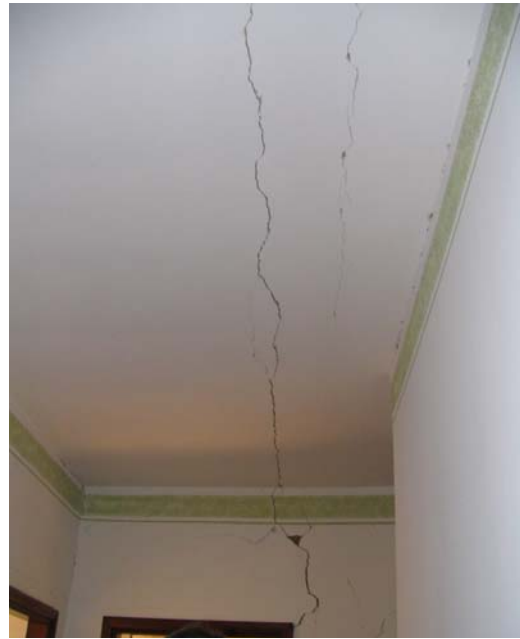
In Pavone, it was observed that old buildings that had even been retrofitted or partially rehabilitated shortly before the event suffered structural damage (Fig. 4.9-4.10). This

damage can be explained by the fact that the rehabilitation interventions had mainly been targeted to non-structural members and had been designed without taking into proper account the seismic hazard.

Figure 4.9. Renovated house in Pavone

Figure 4.10. Renovated house in Pavone

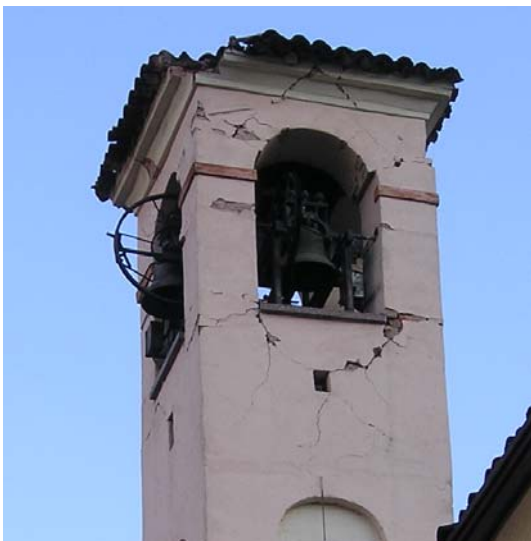
The most heavily damaged parts of the churches in Pompegnino and Clibbio were the bell towers. In the two cases the masonry columns framing the upper part at the level of the bells are heavily sheared, as shown in Figure 4.11 for Clibbio and Figure 4.12 for Pompegnino. These heavy damages are caused by the improperly weak cross-sections of the masonry columns in comparison with the earthquake-induced inertial forces to the heavy bells, as well as by a torsional unbalance connected with the positioning of the bells with different masses.

Figure 4.11. The bell-tower in Clibbio

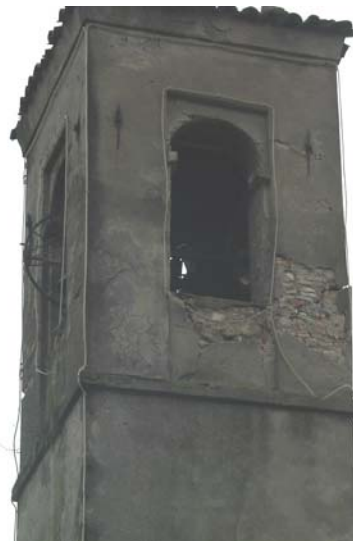
Figure 4.12. The bell-tower in Pompegnino

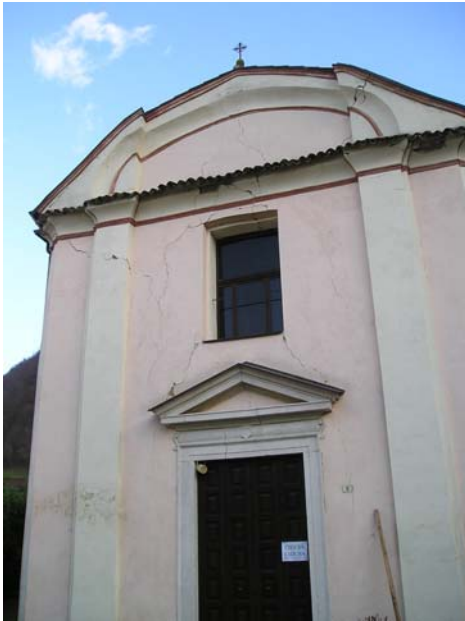
The slender façade walls of the two churches were cracked considerably in many places due to shear effects and out-of-plane bending (Figure 4.13 and Figure 4.14). The observed

Figure 4.13. The church in Clibbio

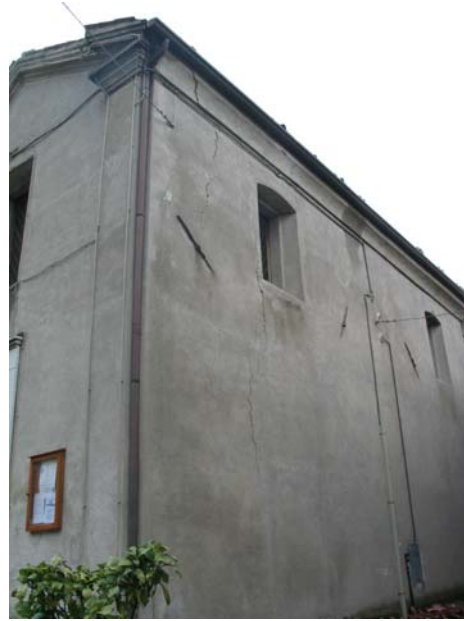
Figure 4.14. The church in Pompegnino

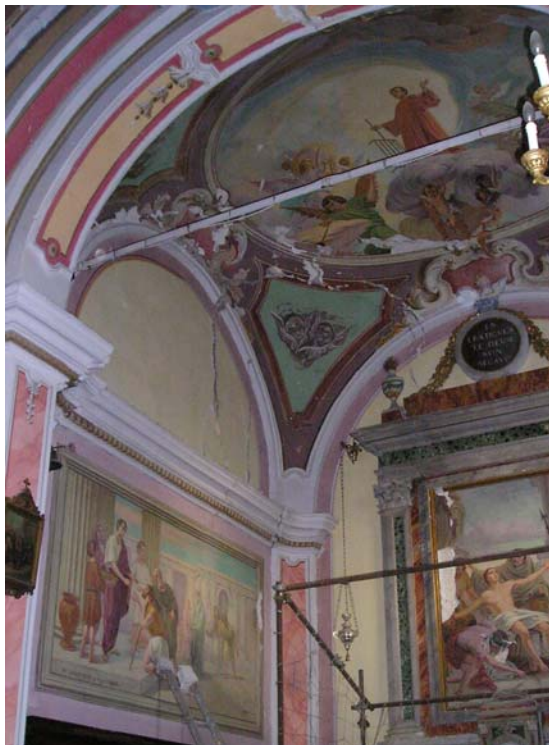
The vault of the church in Clibbio was cracked, as shown in Figure 4.15. The external observation of the church in Pavone has shown slight structural damage (Figure 4.16).

Figure 4.15. Cracks in the vault of the church in Clibbio

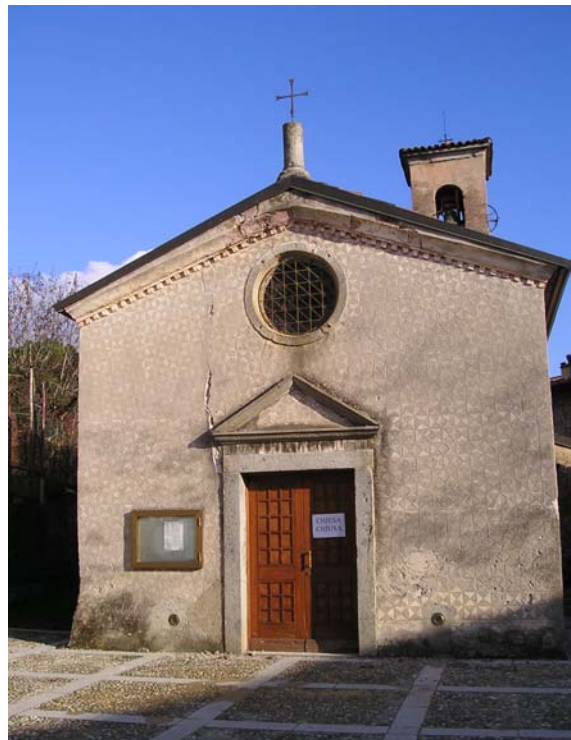
Figure 4.16. The church in Pavone

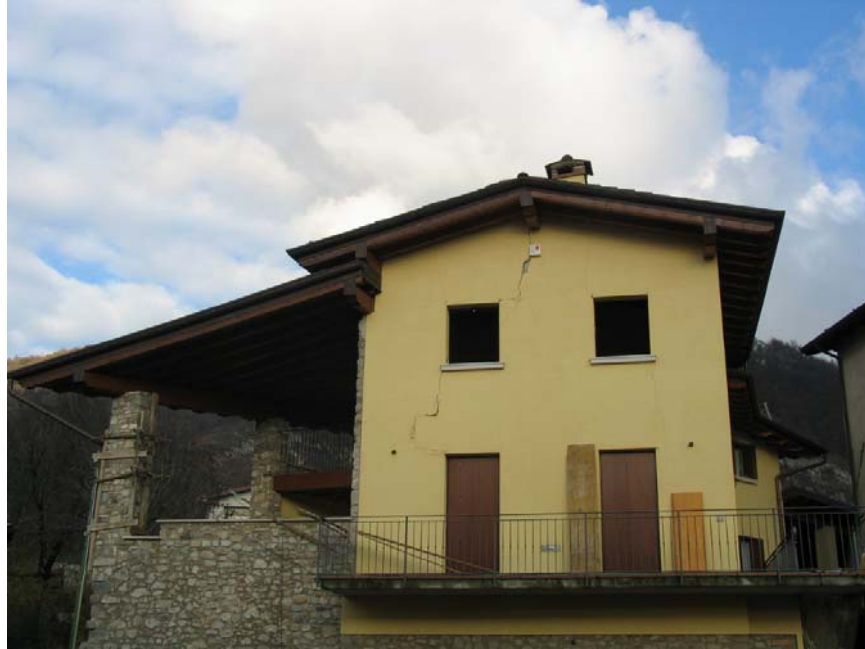
Figure 4.17. Irregular structure in Pavone

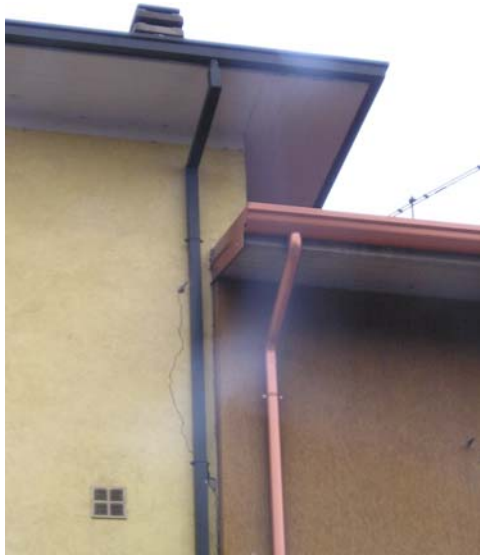
Figure 4.18. Pounding of adjacent buildings in Collio

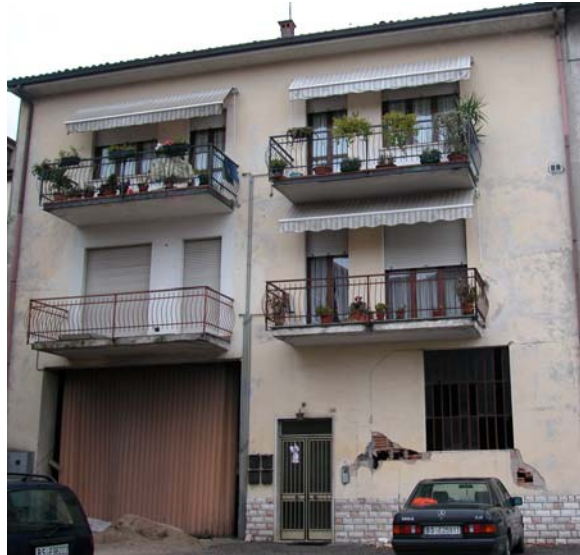
Figure 4.19. Failed thin masonry wall in Collio

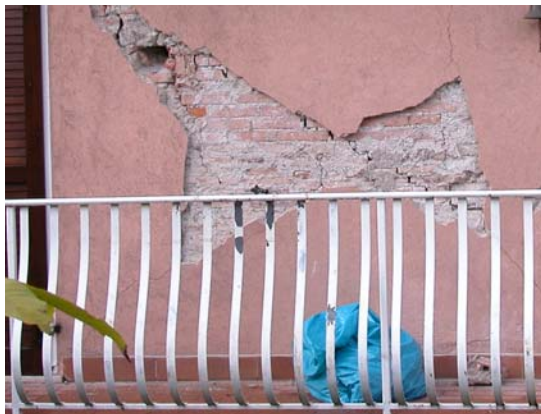
The quality of the masonry contributed substantially the damage of the walls. The poor quality of the workmanship caused the failure of the masonry wall shown in Figure 4.20. The hollow bricks with a small net cross-sectional area and insufficient thickness of the cross web and face shells used in some walls turned out to have much lower strength than the mortar (Figure 4.21).

Figure 4.20. Cracked masonry wall in Pompegnino

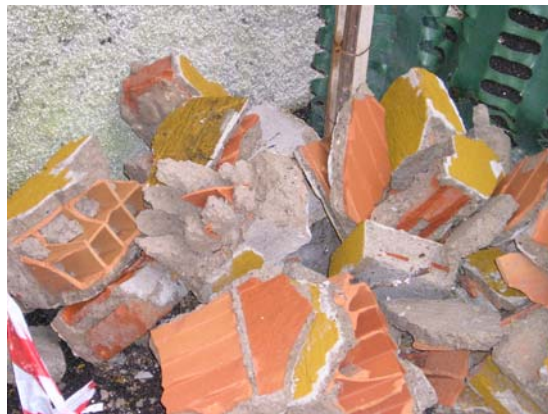
Figure 4.21. Hollow bricks used in Pompegnino

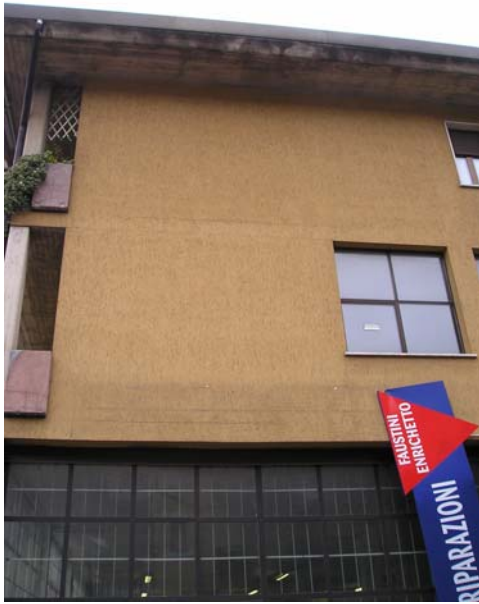
Figure 4.22. Irregular building in Collio

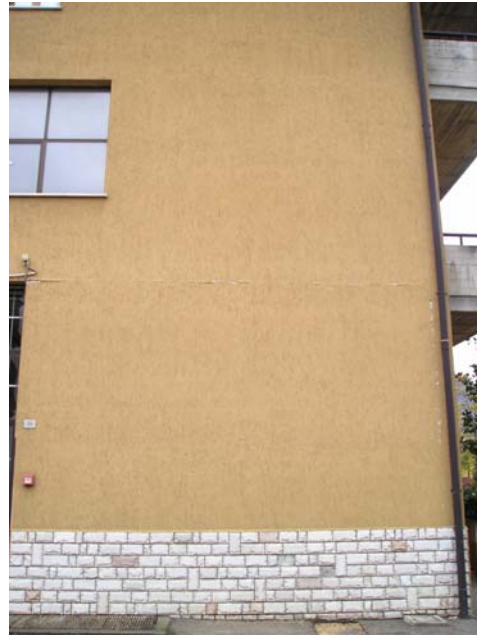
Figure 4.23. Separation of masonry walls

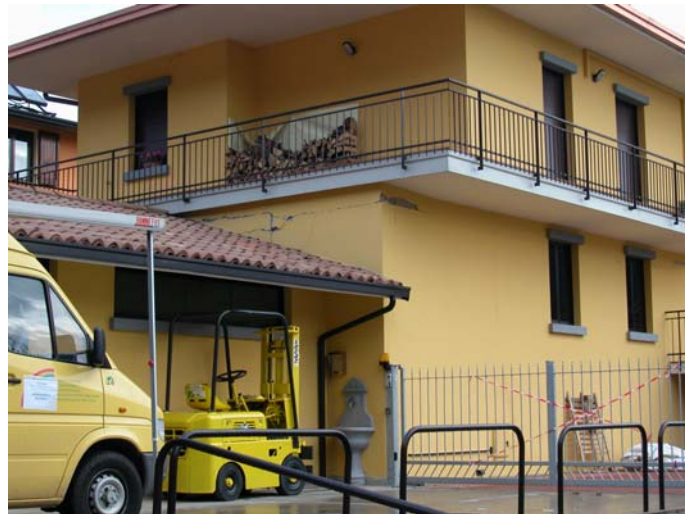
The lack of separation joints between RC buildings and older structures created pounding effects. The single-storey RC structure heavily damaged the adjacent masonry building in Pompegnino, as shown in Figure 4.24.

Figure 4.24. Pounding of adjacent structures in Pompegnino
