# 2007 August 15 Magnitude 7.9 Earthquake near the Coast of Central Peru

Earthquake Field Investigation Team (EEFIT) Field Mission, 5-12 SEPTEMBER 2007 / Final Report

**Fabio TAUCER, Joint Research Centre (Editor and Team Leader)**  
**Dr John ALARCON, Arup**  
**Emily SO, University of Cambridge**

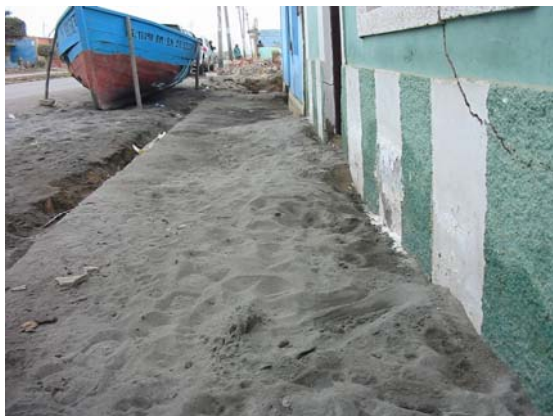
The western area of the town of Tambo de Mora (site number 2 in Figure 2.1) was severely affected by liquefaction. Even though the total area in which liquefaction occurred covers an area of approximately 2 km<sup>2</sup>, the zone of housing affected covered an area of only 200x350 m, where the liquefied sand was observed inside houses and on the sides of the streets (Figure 3.1). Most of the structures affected correspond to 1 to 2 storeys high reinforced concrete (RC) confined masonry (Figure 3.2), which suffered settlements from 0.2 to 1.0 m relative to street level (Figure 3.3 and Figure 3.5). The paved road serving these houses was in good condition, with no evidence of severe damage (Figure 3.1), which lead to the conclusion that the liquefied stratum corresponds to a shallow layer removed/replaced during the construction of the streets, but left for the foundation of the houses. The street lamps toppled at the base to angles of up to 50° with respect to the horizontal plane (Figure 3.4). There were 5 deaths in the area and many people were able to escape from their homes as they exited after the first half of the ground motion (see Section 12.1). People commented that if they had not done so, they would have been trapped, since the second part of the ground motion was stronger, making the houses to settle dramatically. Liquefaction was also observed at the town jail, 2 km north of the housing zone severely affected (photos were not allowed to be taken for security reasons).

Figure 3.1 Liquefied uniform medium/fine size sand (note undamaged street to the left of the boat)

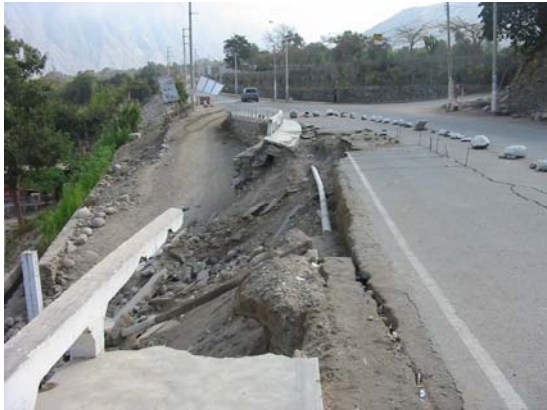
A 4 metre high stone retaining wall that supported a 20 m stretch of the road between Lunahuaná and Imperial failed at approximately 2 km from Lunahuaná (Figure 3.7); tension cracks were evident on the road, which led to closure of one traffic lane.

Figure 3.10 Stone retaining wall failure close to Lunahuaná

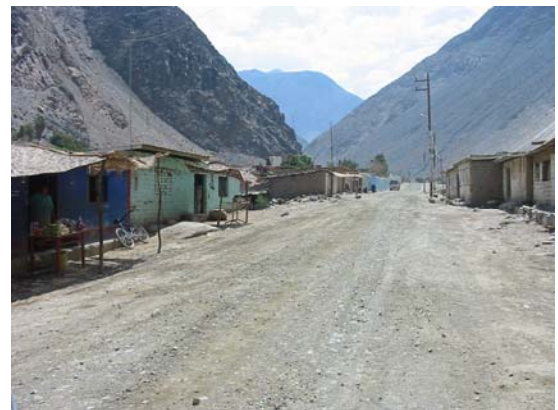
Figure 3.13 Debris fall in the mountain area along the Cañete river valley

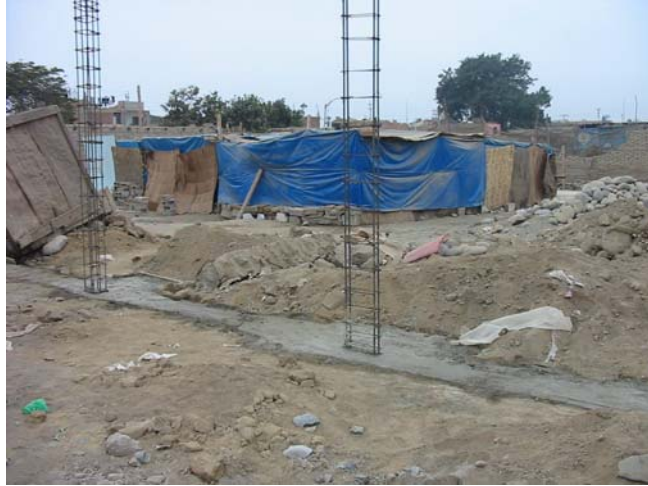
Figure 3.14 Reconstruction of a house in Chincha Alta; individual footings are joined using poorly detailed reinforced concrete

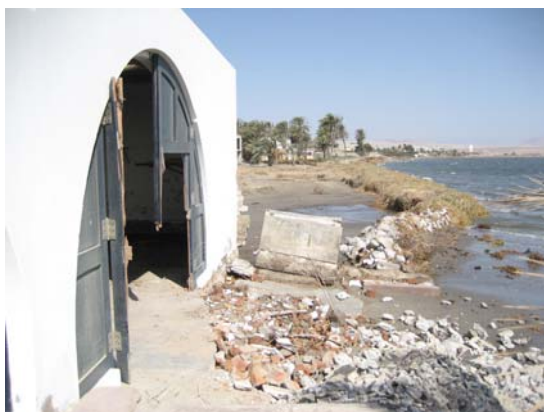
Figure 4.3 Tsunami damage at shore in front of holiday villas in Paracas

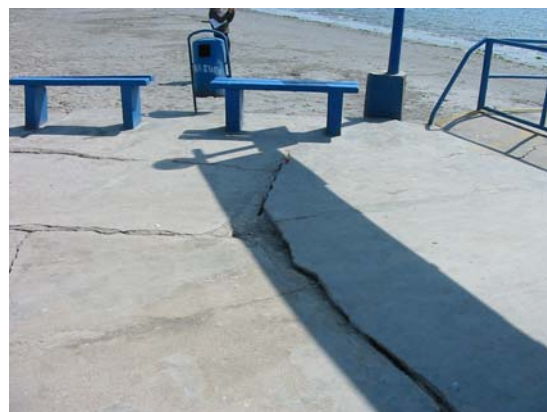
Figure 4.4 Tsunami damage at Paracas waterfront

Structural damage in Paracas included a jetty (larger than the one found at the yacht club) and cracking of the concrete pavement of the waterfront promenade (Figure 4.4 and Figure 4.5), including localised cracks in adjacent columns, while the building stock, composed mainly of 1-2 storey RC confined brick masonry houses showed only minor damage, with a few adobe houses suffering moderate damage. No deaths, collapses or heavy damage was reported to have occurred as a consequence of the tsunami.

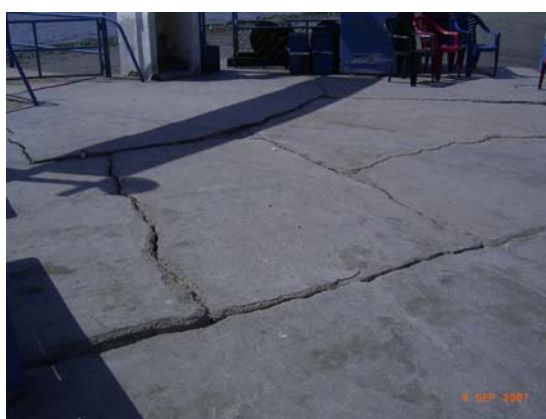
Figure 4.5 Cracking of RC pavement/slab at Paracas waterfront

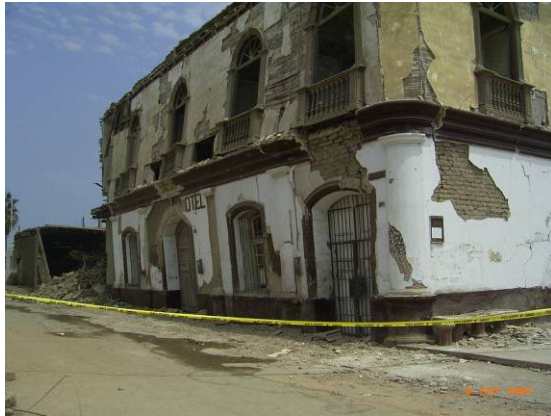
Figure 5.1 Pisco historic waterfront: damaged adobe building with *quincha* at second storey

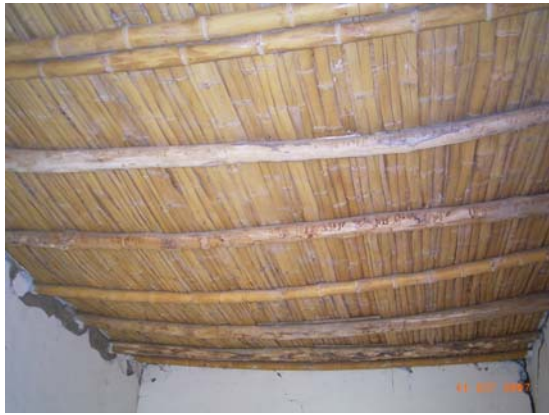
Figure 5.6 Flexible roof offers restraint in only one direction

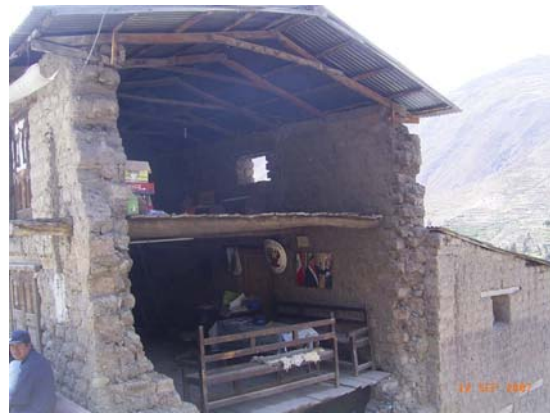
Figure 5.9 Two storey adobe house damaged in Huangáscar

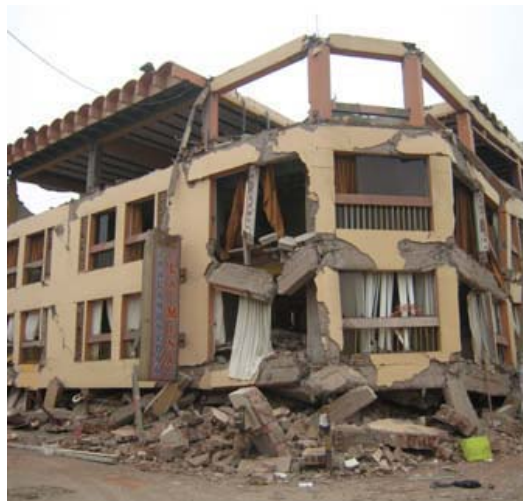
Figure 5.26 Collapsed Embassy Hotel in Pisco (Photo Prof. M. Blondet, PUCP, [www.eeri.org/lfe/images/peru\\_coast\\_photos](http://www.eeri.org/lfe/images/peru_coast_photos))

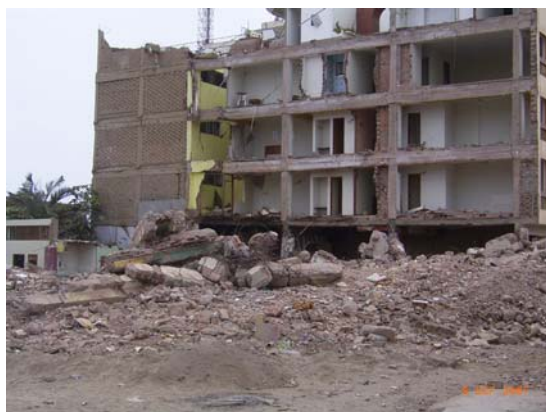
Figure 5.27 Severely damaged RC infilled frame next to the collapsed Embassy Hotel

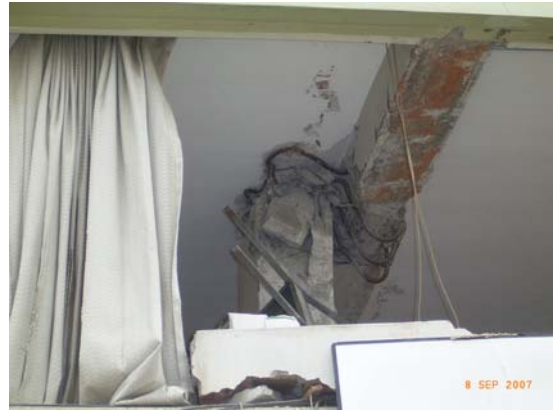
Figure 5.30 Detail of column failure from the building shown in Figure 5.29

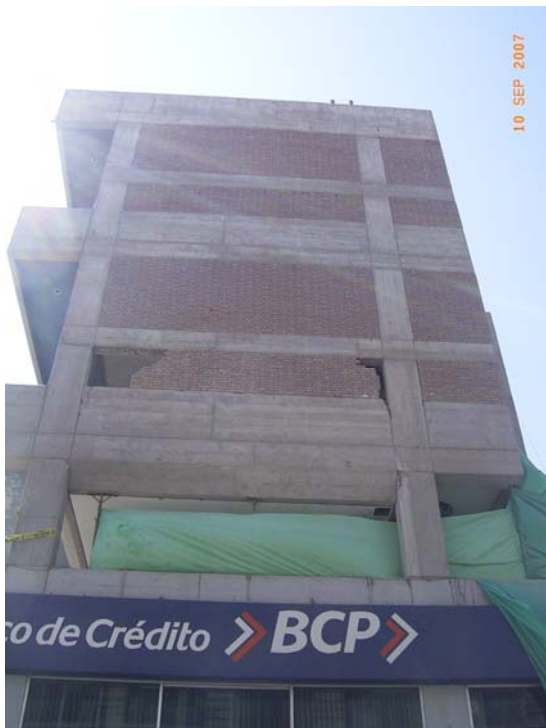
Figure 5.31 Six-storey RC infilled frame in Pisco with vertical irregular geometry showing soft storey damage

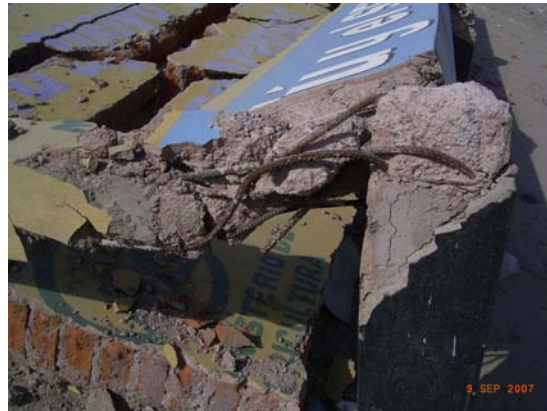
Figure 5.36 Detail of the RC columns of the Pozo Santo billboard, showing 12 mm diameter steel rebars with practically no confinement

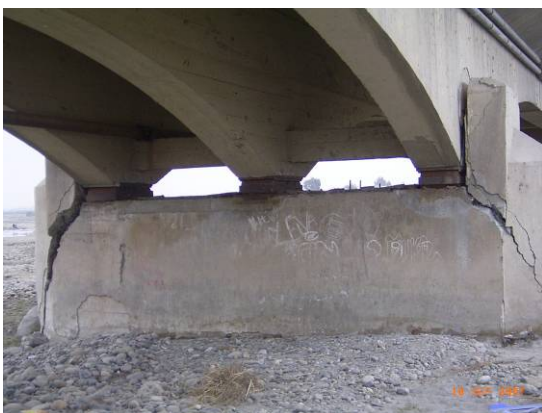
Figure 6.8 Huamaní Bridge: damage of parapets at the second northernmost pier.

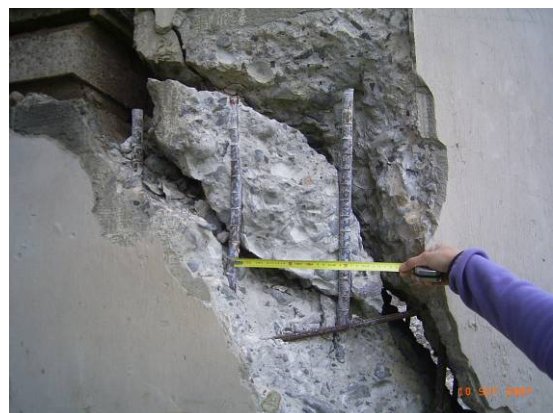
Figure 6.9 Huamaní Bridge: parapet reinforcement detailing at the pier.

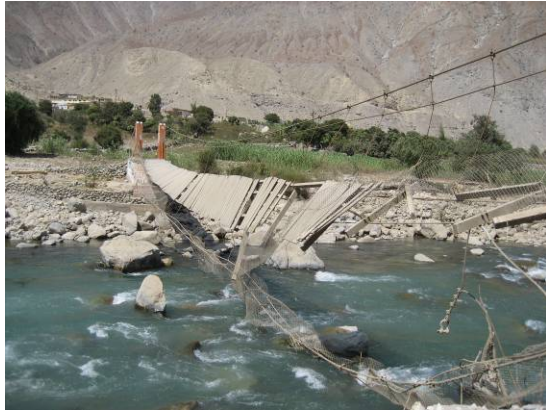
Figure 6.10 Pedestrian bridge crossing the Cañete river damaged by rock fall.

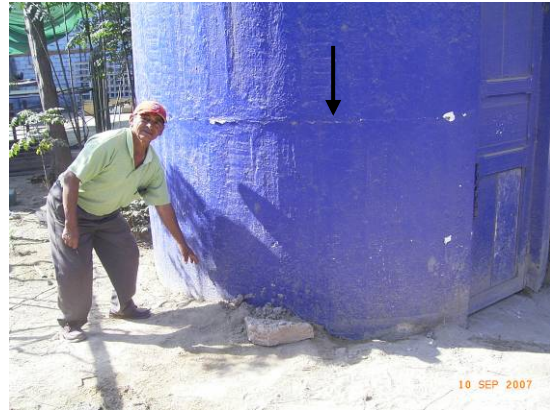
Figure 8.2 Flexural crack running around the perimeter at the base.

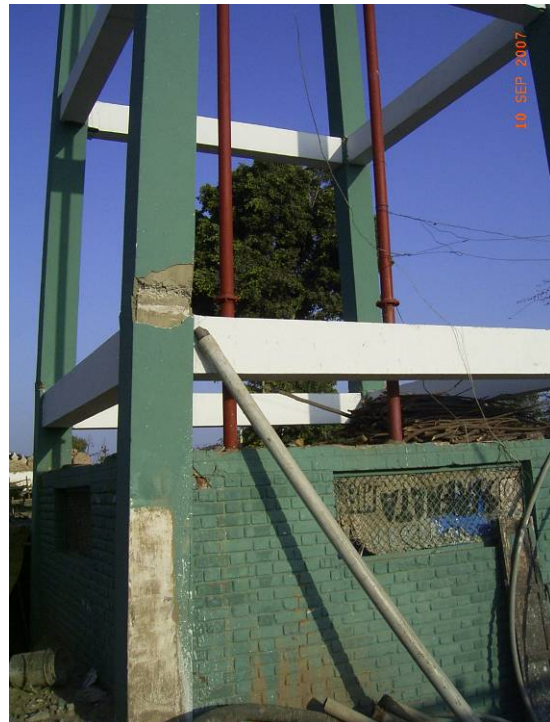
Figure 8.4 Damaged column next to infill wall, joint showing insufficient reinforcement.

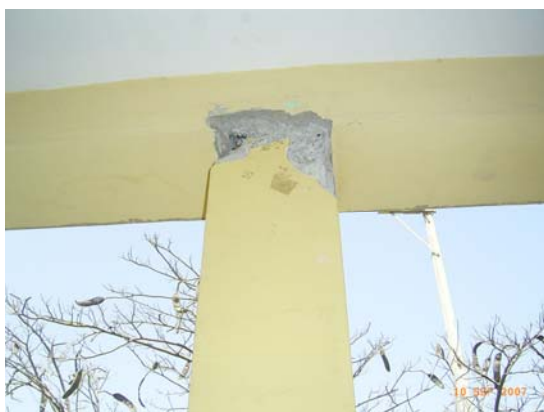
Figure 10.3 *Gran Unidad Escolar San Luís Gonzaga*: column failure at top end

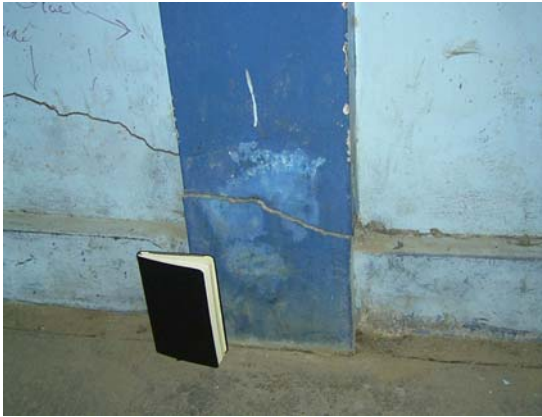
Figure 10.5 Shear failure at the base of a column in a school in Ica

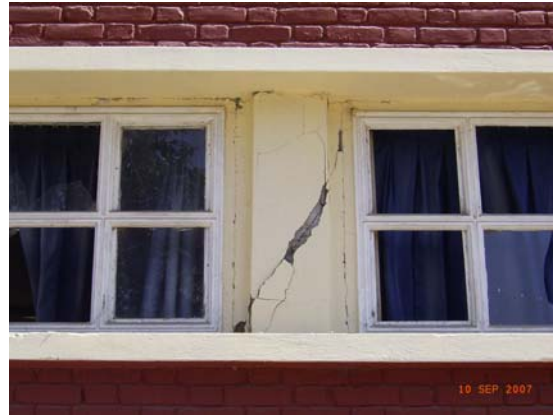
Figure 10.6 *Gran Unidad Escolar San Luís Gonzaga*: short column shear failure

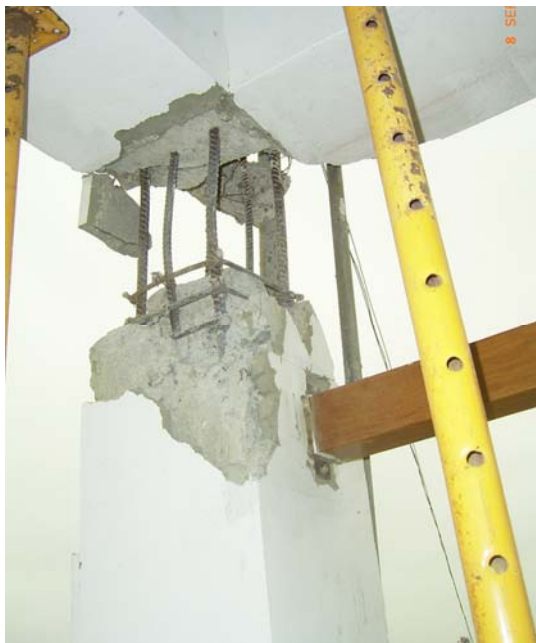
Figure 10.7 Pisco: School building showing failure of column at top end at the second storey, due to insufficient shear reinforcement and activation of a strong-beam-weak-column mechanism

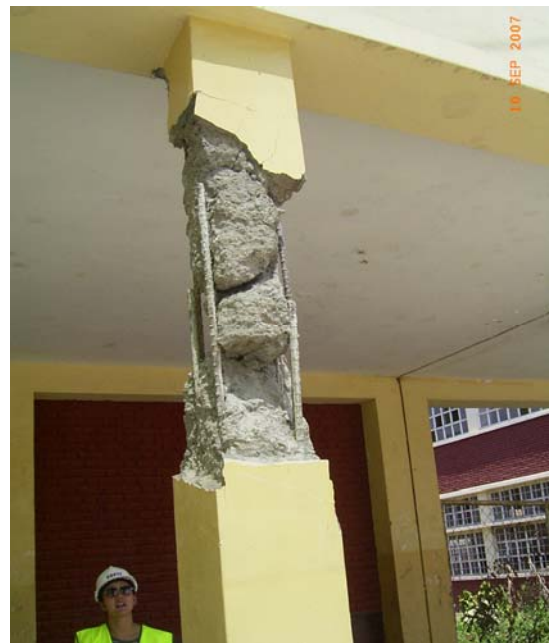
Figure 10.8 *Gran Unidad Escolar San Luis Gonzaga*: column failure in shear due to insufficient shear reinforcement and low quality of concrete

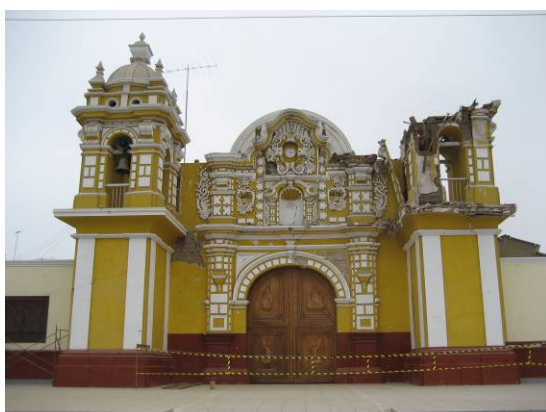
Figure 12.9 XVII century chapel in Hacienda San José near El Carmen with damaged bell tower.
