DISTURBANCES IN THE EUROPEAN NUCLEAR POWER PLANT SAFETY RELATED ELECTRICAL SYSTEMS

Alexander Duchac — Marc Noël *

Key words: Forsmark event, nuclear power plant, disturbances in the plant electrical systems

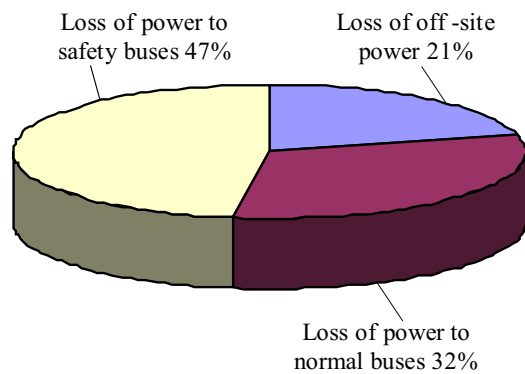
Fig. 1. Major failure mode distribution in (%)

Disturbances reported in the plant electrical systems concerned the following major failure modes (see Fig. 1): Loss of off-site power (21%), Loss of power to normal electrical buses (32%); and Loss of power to safety buses (47%). Although the 24-year time interval during which all of these events were reported is considered as relatively long, the number of events that involved failures of electrical supply — in particular to the plant safety buses — appears nevertheless to be quite high. Even the number of reported events that caused Loss of off-site power at the plant seems to be significant.

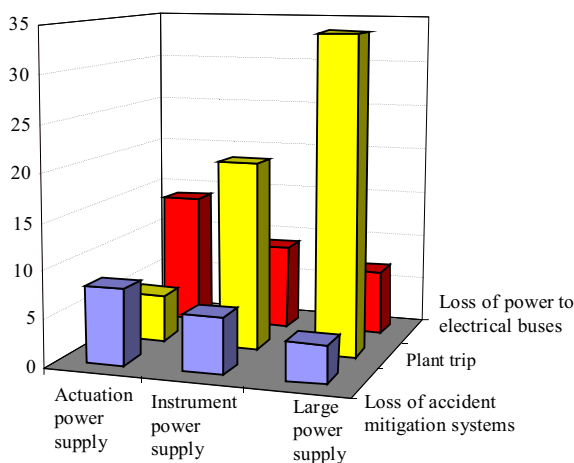
Fig. 2. Dominant failure modes on loss of power supply

Another category that requires attention is the dominant failure mode for loss of specific power supply. Figure 2 shows the distribution of dominant failure modes for loss of instrument channel supply, large power supply, and actuation power supply. In terms of analytical needs, the loss of instrument channel represents a failure or spurious actuation of any measurement (I&C) component; the loss of large power supply represents an internal or external event that has led to the loss of main power lines, malfunction of major electrical equipment (generator, transformer, switchyard, *etc*) or human error (operational or maintenance); the actuation power supply represents failures of electrical components (circuit breakers, transformers, *etc*).

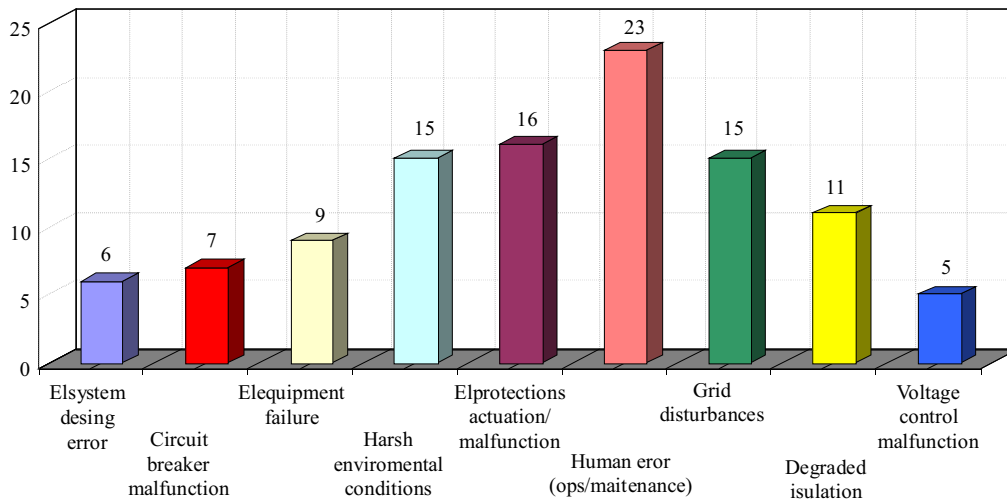
Fig. 3. Contributing factors identified in the selected events

certain groups of events, a number of representative contributing factors have been identified. Figure 3 shows the distribution of these contributing factors by category.

As can be seen, human error is the biggest contributor to the initiators of the reported events. Human error includes errors of both plant and contractor personnel (misalignment of electrical systems, tasks performed in a sequence different from that which is required, omission of an operation/incorrect operation performed in a sequence, switching error, maintenance error, *etc*).
