Living Shoreline Sea Level Resiliency: Performance and Adaptive Management of Existing Breakwater Sites, Year 2 Summary Report

Living Shoreline Sea-Level Resiliency: Performance and Adaptive Management of Existing Breakwater Sites

Year 2 Summary Report

**Shoreline Studies Program
Virginia Institute of Marine Science
William & Mary**

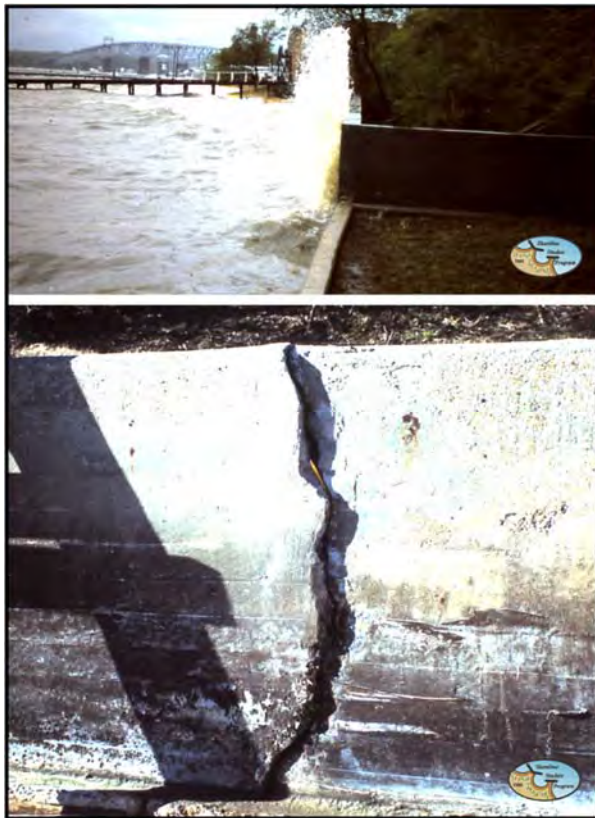
Figure 4-1-5. Top: During the April 1978 northeast storm, waves directly impacted the seawall because VIMS had no sandy beach in front. Bottom: The storm damaged the seawall.

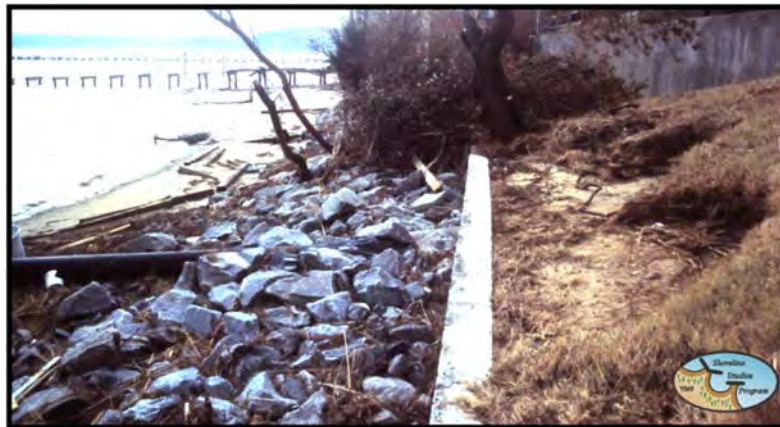
Figure 4-1-7. In 2003, Hurricane Isabel greatly damaged many areas along the VIMS shoreline. Wave action overtopped the seawall and revetment cutting into the bank.

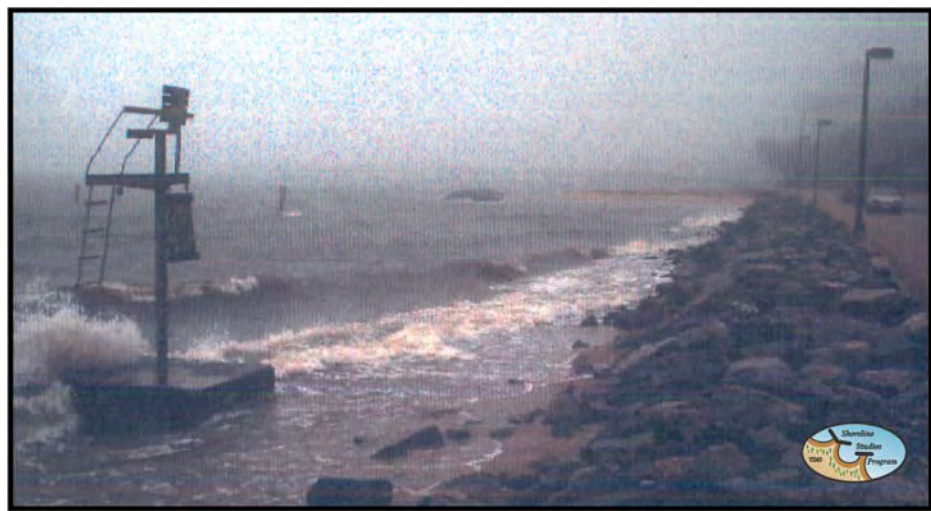
Figure 4-2-2. Yorktown Beach shoreline on 4 March 1993 during a northeast storm.

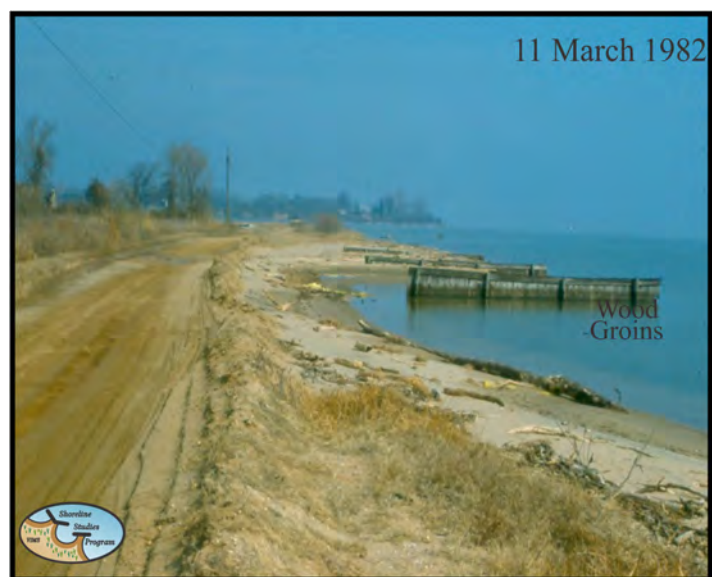
Figure 4-3-2. Aquia Landing shoreline on 11 March 1982 prior to the breakwater installation. Timber groins were becoming detached from the shoreline and were no longer effective shore protection.

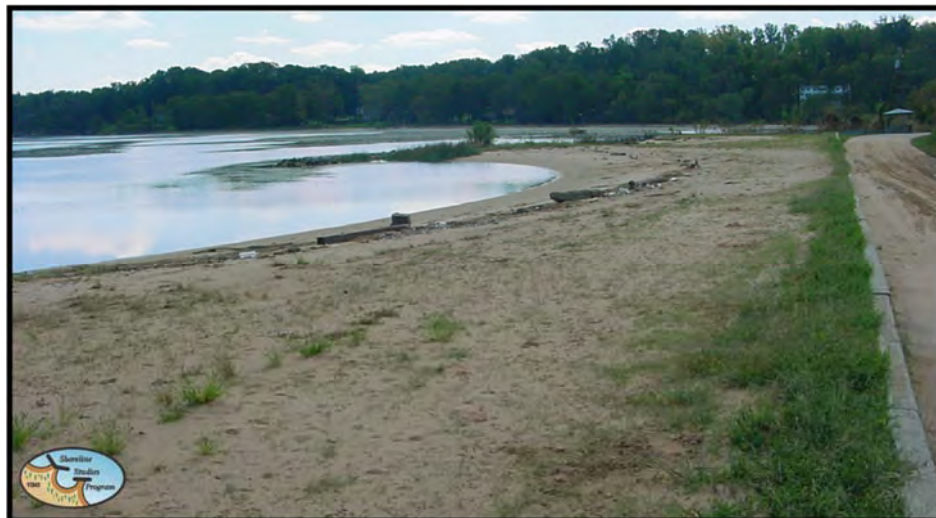
Though the storm surge topped the system during Hurricane Isabel and sand washed over the jersey wall onto the road (Figure 4-3-3), no extreme changes in topography were measured indicating that overall, the breakwater system remained stable during the storm (Hardaway *et al.*, 2006). The beach along Aquia Landing has been relatively unchanged since Hurricane Isabel. The shore planform has remained relatively stable since Isabel except for the thinning of tombolo attachments which have not impacted the beach and backshore (Figure 4-3-4). A wide recreational beach occurs at the site. The tombolos are heavily vegetated and a great deal of SAV occurs in the nearshore. Some variation has occurred in the position of MHW over time (Figure 4-3-5), but it has been relatively minor. The position of the embayments post-Hurricane Isabel shoreline on October 30, 2003, were slightly shifted due to wind and wave action during the storm. The 2013 and 2019 high water shorelines are similar although the 2019 tends to be riverward of the 2013. The tombolo at breakwater 4 has lost its attachment over time as the structure itself sank. Though heavily vegetated, the breakwater 4 tombolo is lower than the others (4-3-6).

Figure 4-3-3. Aquia Landing shoreline on 30 September 2003 post Hurricane Isabel. Though sand washed over the jersey wall, overall the system is intact.

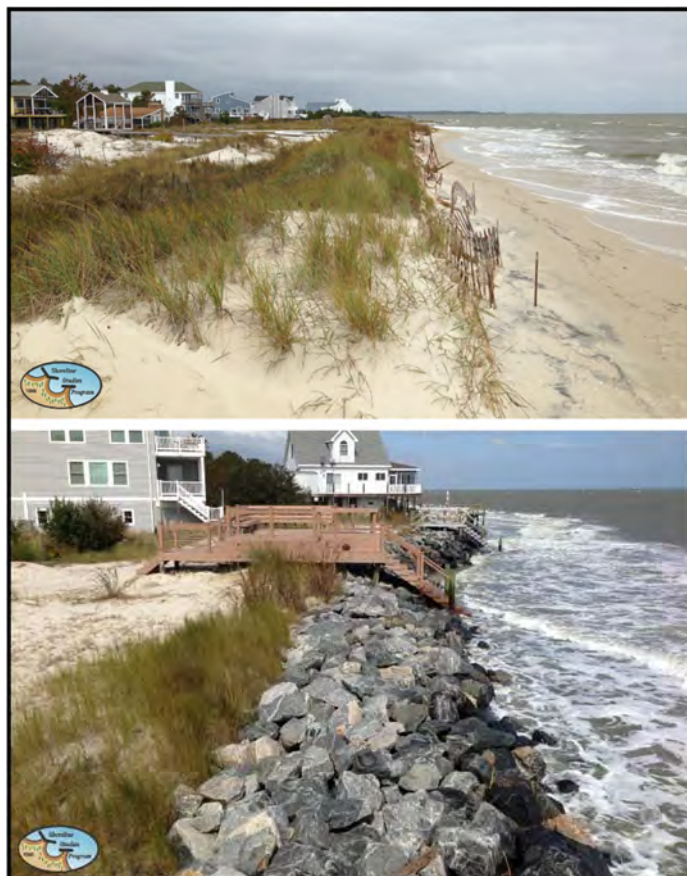
Figure 4-5-4. Top: Northern section of the Bavon reach during a high water event on 5 October 2015. The wide dunes protect the houses. Bottom: a revetment was constructed because the dunes had eroded along the southern section of the reach but no beach

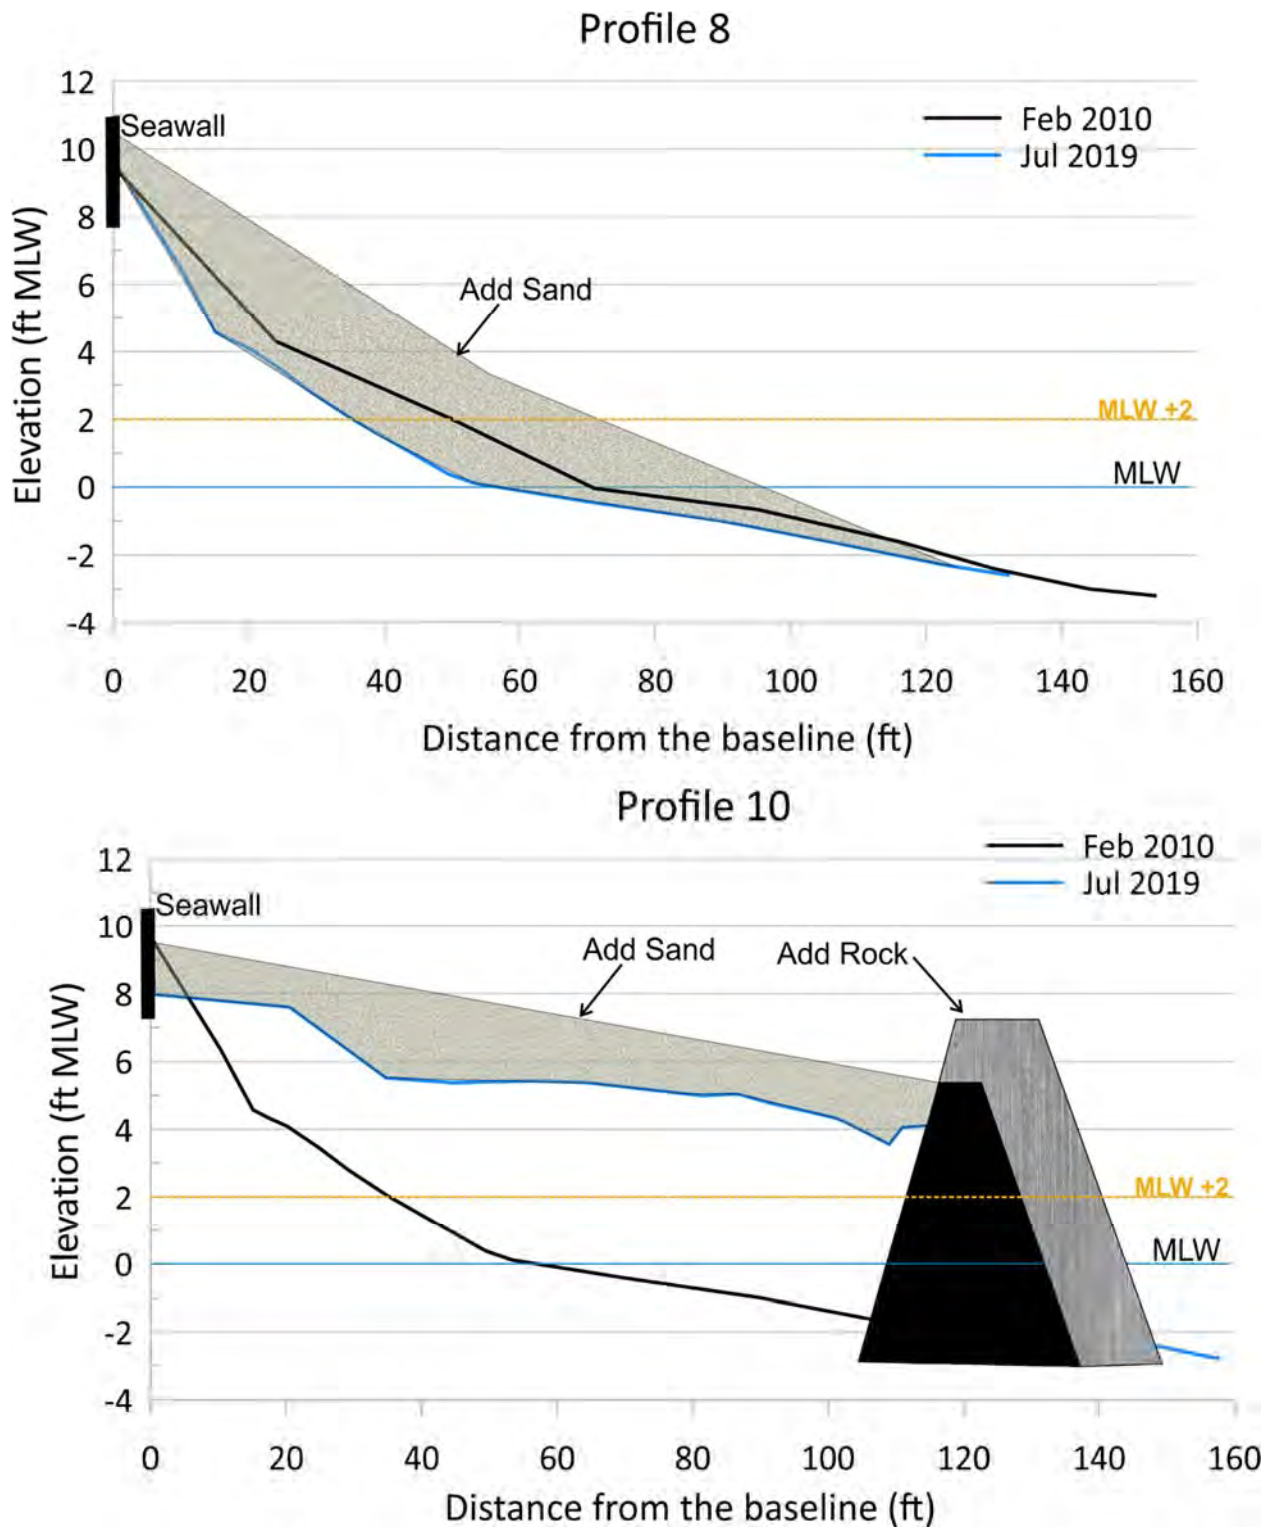
Figure 5-1. Selected cross-sectional profiles of survey data taken at VIMS in 2010, pre-project installation and 2019. The +2 ft MLW depicts the SLR scenario. Rock and sand can be added to the system to adapt to rising sea level to ensure resiliency of the overall system. The 2010 survey data provided by VHB, Inc.

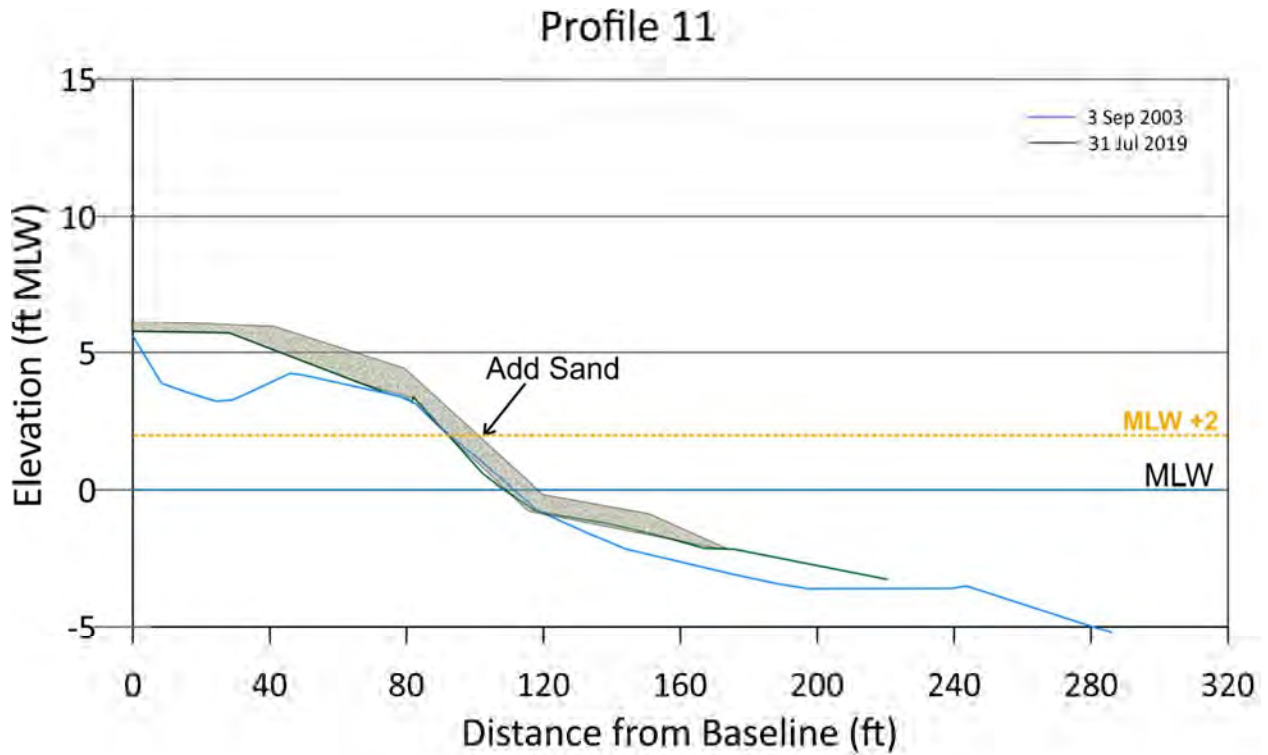
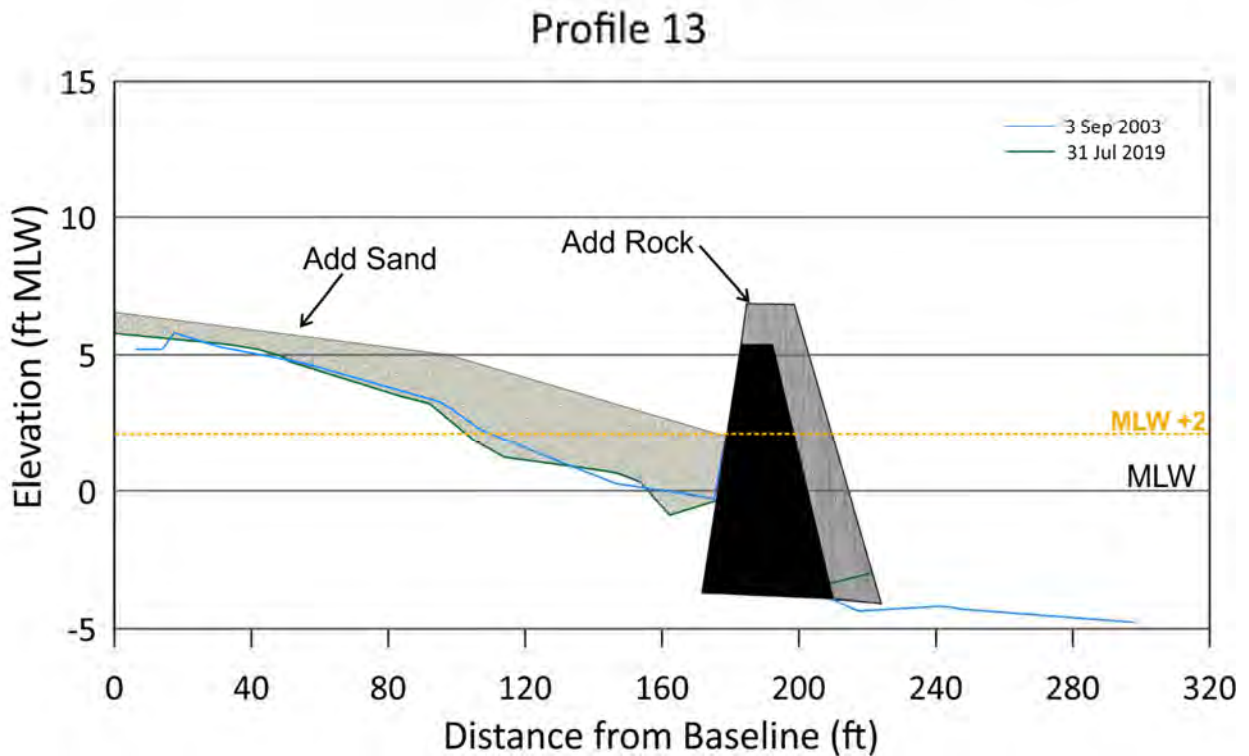
Figure 5-2. Selected cross-sectional profiles of survey data taken at Yorktown in 2003, Post Hurricane Isabel and 2019. The +2 ft MLW depicts the SLR scenario. Rock and sand can be added to the system to adapt to rising sea level to ensure resiliency of the overall system.

At Yorktown, in addition to raising the backshore barrier, to address the 1 and 2 foot SLR by 2050, an increase in breakwater height is recommended (Figure 5-2). The new armor should be at least 2-3 feet higher to accommodate the required rock size which is 1 to 2-ton armor. Perhaps a more reasonable approach to raising breakwaters is to add rock blocks/rectangles along the crest. As an example, these would be on the order of 3x3x8 ft concrete structures that can weigh about 6 tons. Dimensions placement could vary. These would simply be placed along the top of each unit, and, although expensive to fabricate, it might be cheaper than adding and constructing additional armor layers. More sand will be required for the system as well. The shore planform can only adjust vertically with SLR unless the system is moved offshore. Moving the breakwaters offshore and adding much more sand might be cost prohibitive as the breakwater rock volume would increase and additional rock would be required. The high value of infrastructure behind Yorktown Beach as well as the economic value of beach usage make maintaining the beach important.

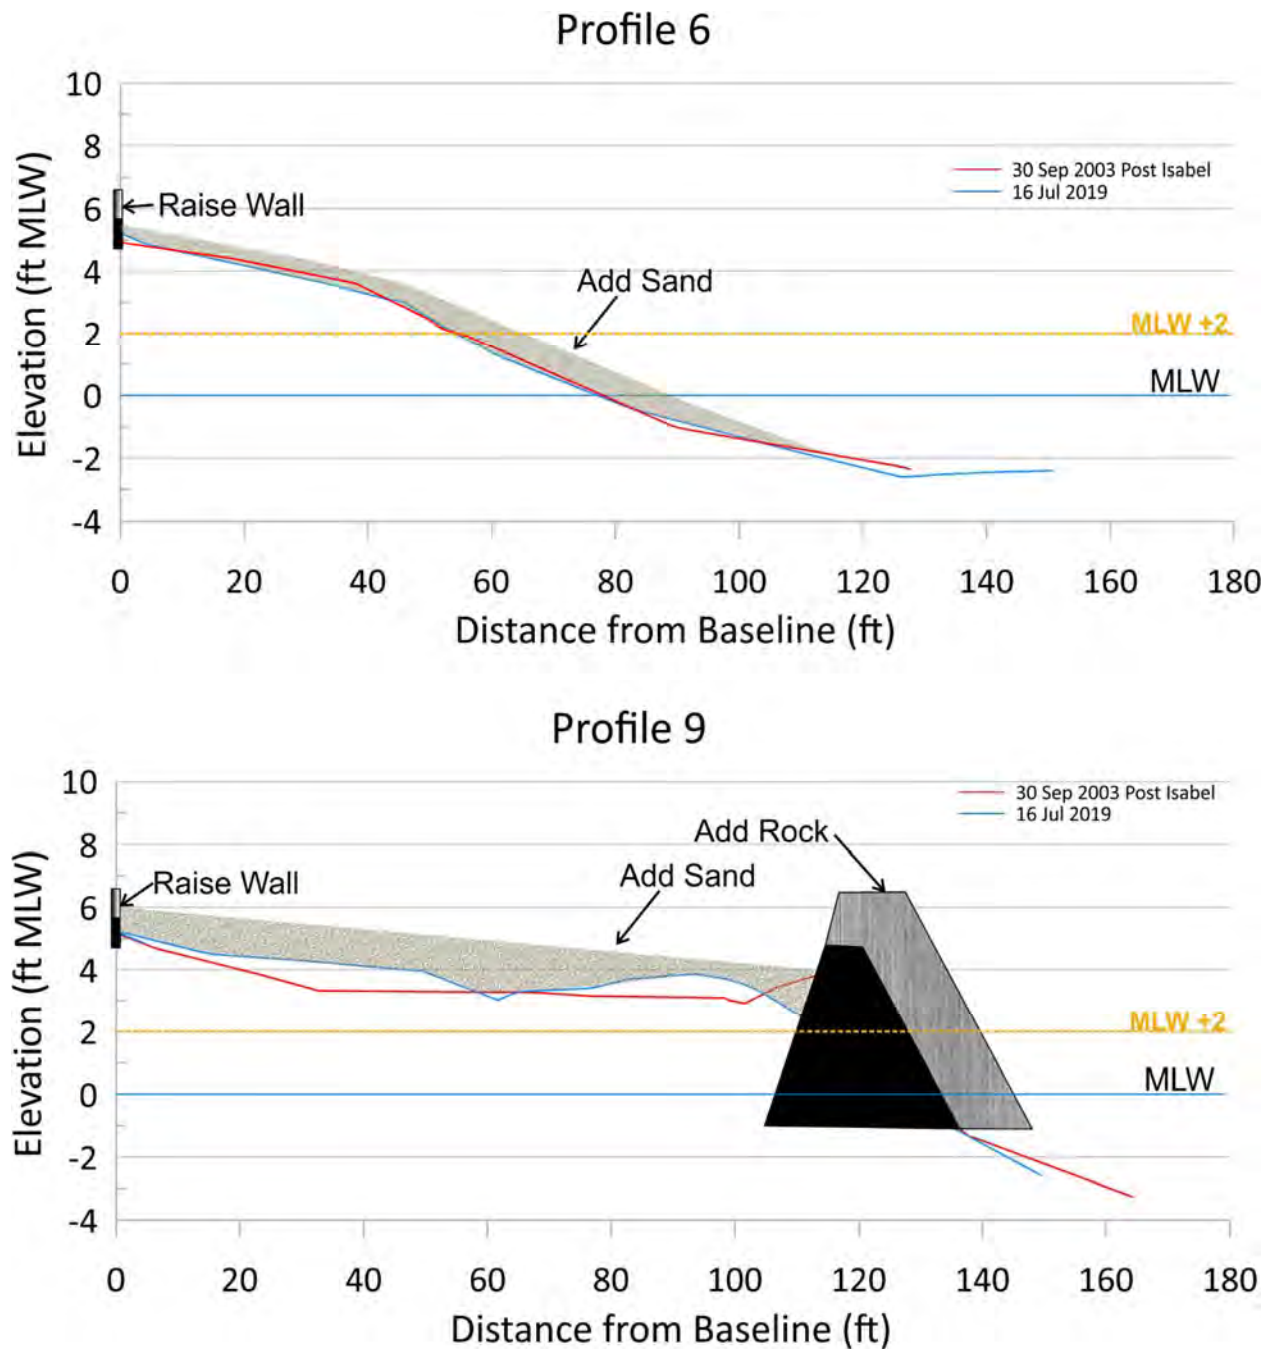
Figure 5-3. Selected cross-sectional profiles of survey data taken at Aquia Landing in 2003, Post Hurricane Isabel and 2019. The +2 ft MLW depicts the SLR scenario. Rock and sand can be added to the system to adapt to rising sea level to ensure resiliency of the overall system.

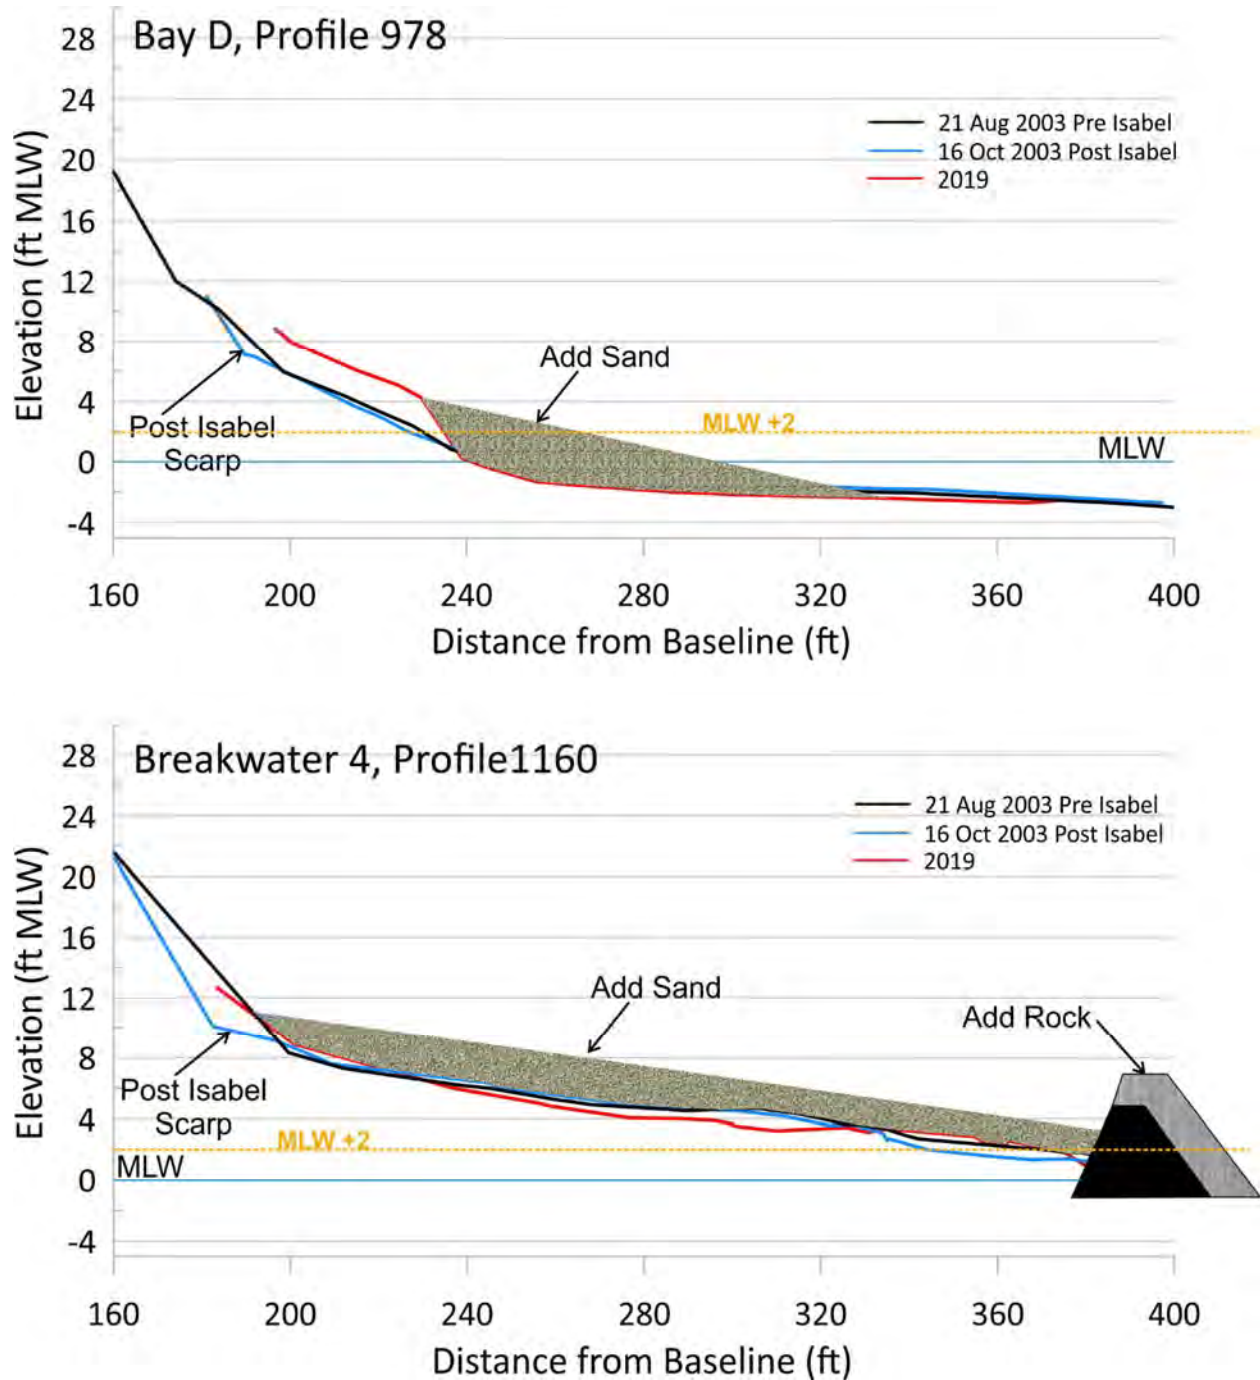
Figure 5-4. Selected cross-sectional profiles of survey data taken at Kingsmill in 2003, pre and post Hurricane Isabel and 2019. The +2 ft MLW depicts the SLR scenario. Rock and sand can be added to the system to adapt to rising sea level to ensure resiliency of the overall system.

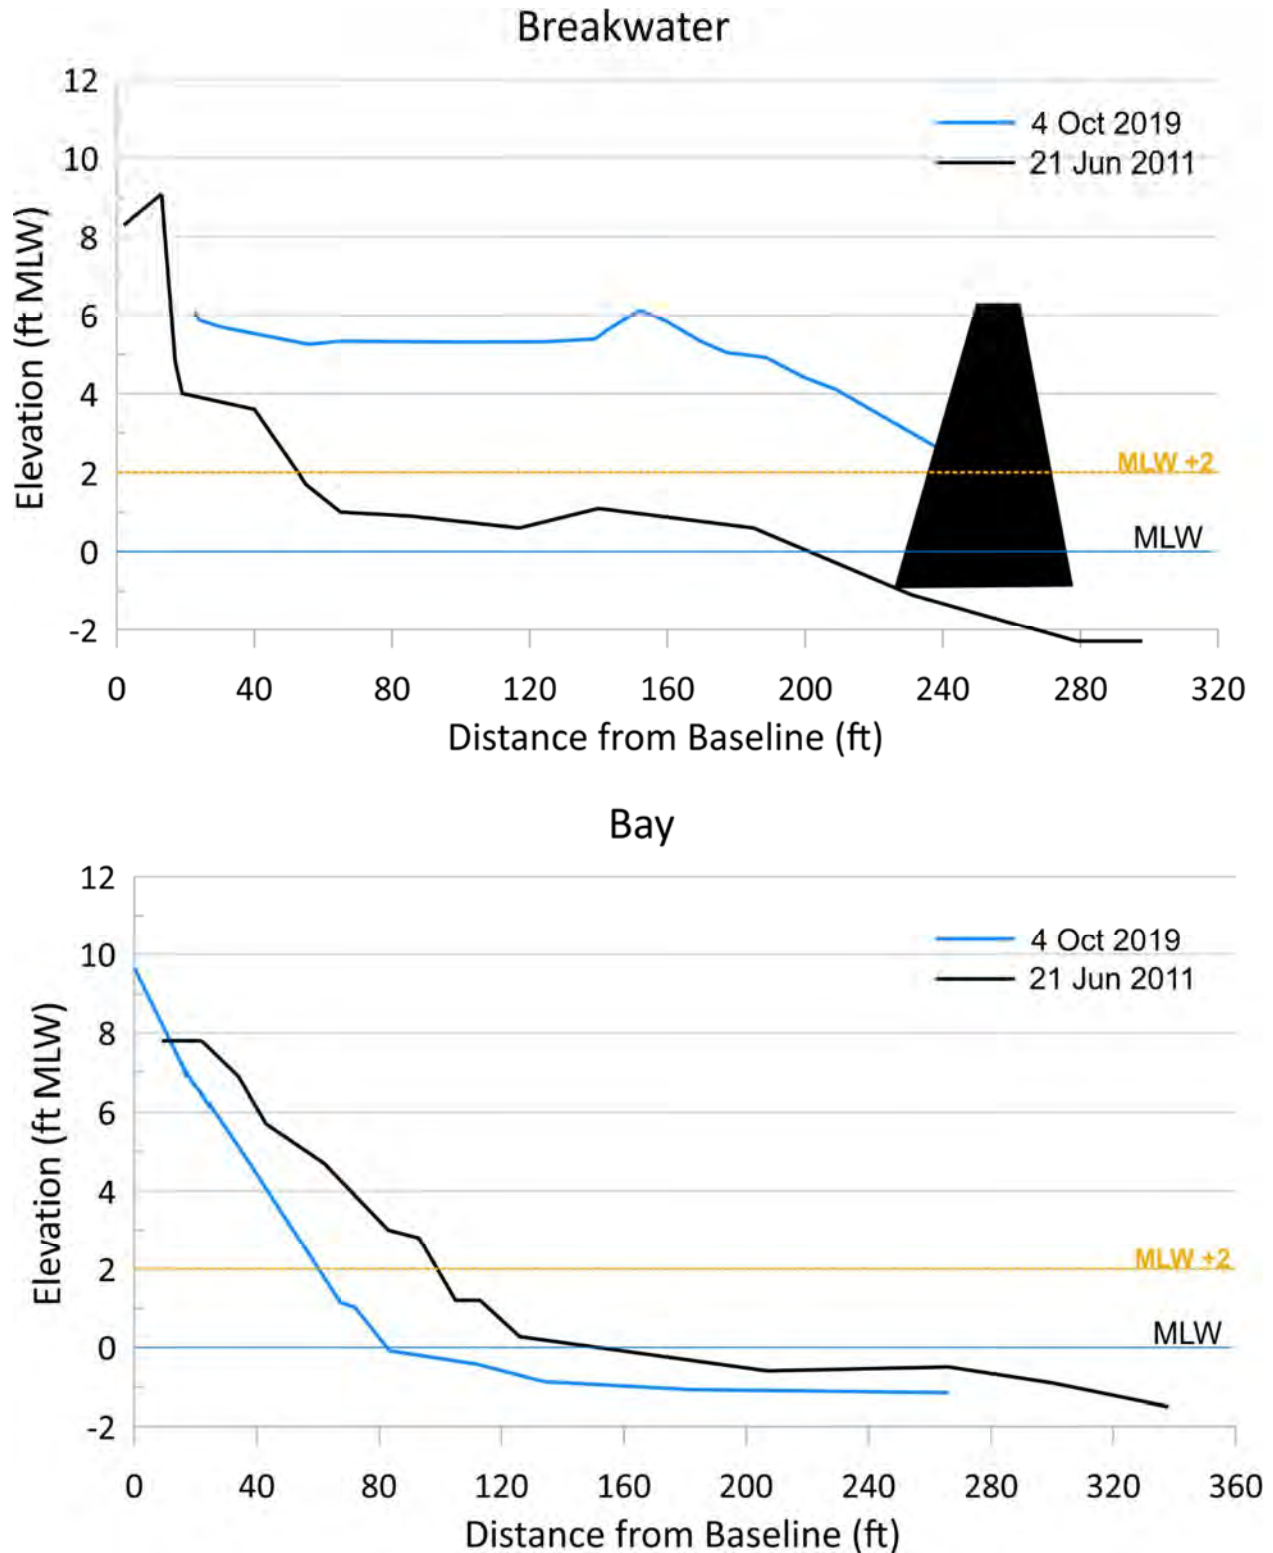
At this stage, the Bavon Beach breakwater system is still evolving (Figure 5-5). Access to Bavon will be an issue in the future as sea level rises, because the road to the subdivision now frequently floods during spring tides. Unless the access issue is resolved any adaptive management options may not be available. Though not modeled, rock and sand could be added to adapt to SLR. As noted earlier, the bay profile shows erosion between 2011 and 2019 even though sand was placed along the shoreline in 2016. The shoreline eroded significantly between 2011 and 2016. As shown in Figure 4-5-3, the southern section of the Bavon reach has had a great deal of beach and dune loss since monitoring of the site began in 2001. With the placement of the structures, the sand has evolved to a dynamic equilibrium and should maintain its shape.

Figure 5-5. Selected cross-sectional profiles of survey data taken at Bavon in 2011 and 2019. The +2 ft MLW depicts the SLR scenario. 2011 survey data provided by VHB, Inc.
