LANDSLIDE MONITORING IN A BUILT-UP AREA

ABSTRACT.

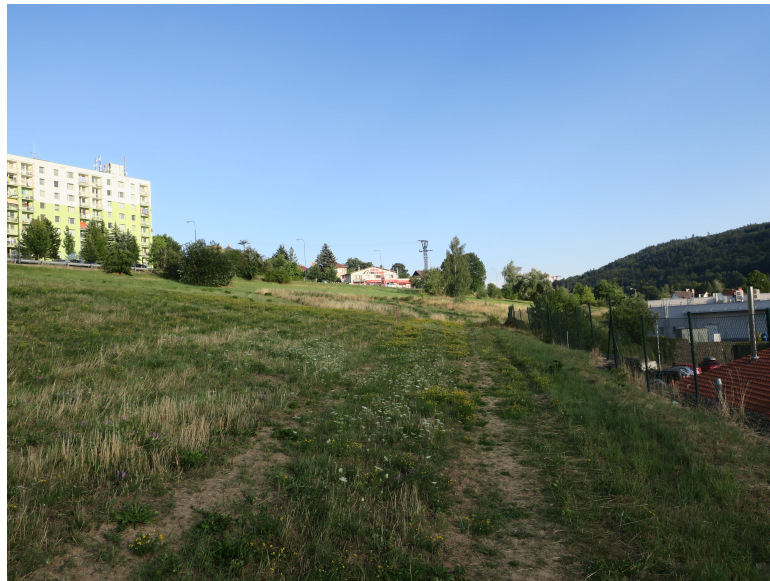
The slope above the store that was monitored, and stabilized by a gabion wall, is situated near the centre of the town Turnov in a commercial zone near the I/35 road. The gradient of the slope that was monitored is approximately 20° towards the gabion wall. The gabion wall overcomes the height difference between the slope and the store car park (Fig. 1) and ensures the stability of the slope.

FIGURE 1. The slope above the gabion support wall, a car park with a shop (right)

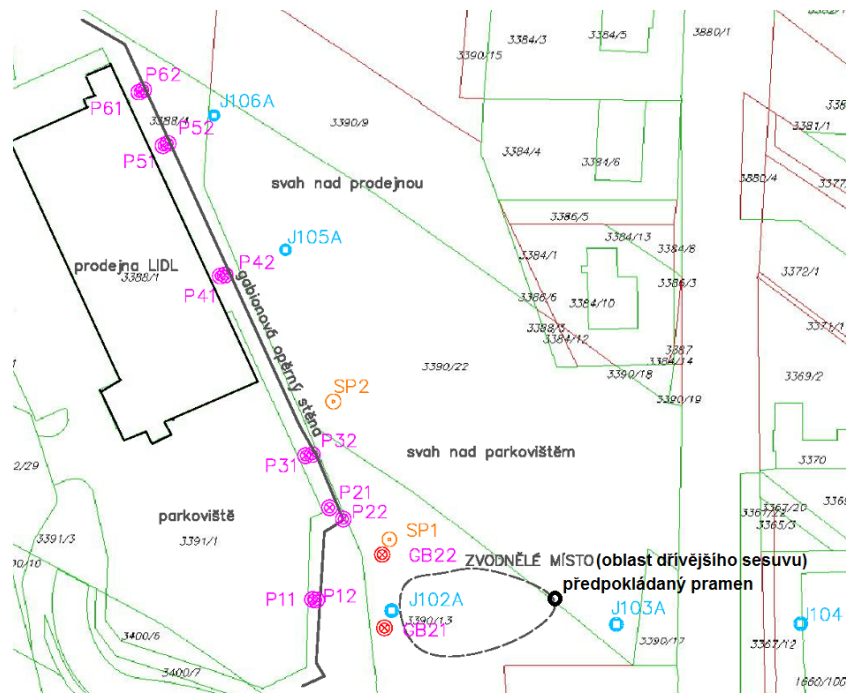
the construction of the gabion wall in 2005, a landslide was initiated on the slope above the car park, and which was subsequently reclaimed. Because of this extraordinary event, the monitoring system of the store under construction and the gabion wall were completed with some elements, the measurement of which was intended to verify and control the stabilization of the reclaimed landslide area (Fig. 2).

FIGURE 2. Monitoring system situation. P11-62: geodetic points, J102A-106A: IK boreholes, SP1 2: observation piezometers.

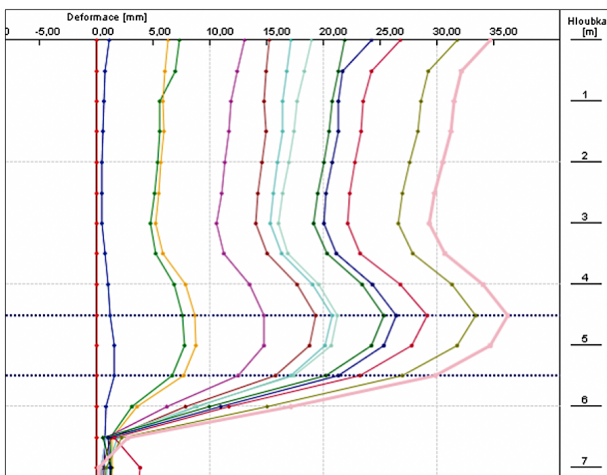
Two inclinometric boreholes (located in the line of the historical landslide in a row) caught accelerating horizontal deformations documenting the formation of a sliding surface at a depth of 6 m below the ground (Fig. 3) with a shift along the slope line by up to 5

FIGURE 3. Development of inclinometric measurements over the years 2014-2018 at the borehole J102A

mm on a quarterly basis, with an initial increase in speed. The observed deformations (shifting in the direction of the store) on the gabion wall were on the scale of millimetres.

The slope mass movements probably re-occurred as a result of an increase in the groundwater level in the area of probe SP1 (the area of the former landslide and a permanently water-saturated site) which led to increased pore pressures on the previously formed sliding surfaces. The landslide processes were linked to areas of weakened zones with a residual soil strength, which were very susceptible to changes in load conditions and hydraulic conditions [3]. The movements that were detected probably did not indicate the depletion of the stability capacity in the supporting structure but functioned as a sufficient warning for the timely completion of the reclamation and stabilization measures adopted in the slope and the gabion wall.

formation of a landslide endangering the stability of the gabion wall, the monitoring supplier recommended adopting adequate measures to lower the groundwater level. The objective of the GWL reduction was to "arrest" it below the level of the sliding surface which was identified at a depth of 6 metres below the ground in the vicinity of the borehole J102A and approx. 3 metres below the ground in the vicinity of J103A.

As part of the building conversions – a remodelling of the store and an increase in the parking capacity – the investor proceeded to enhance the gabion wall with horizontal drainage boreholes to drain groundwater from the more permeable soils and to put in place a drainage groove in the area of the slope movements for effective drainage of surface water in the adjacent slope to the existing drainage system of the store and the car park [4]. The conversions were further supplemented with six-strand ground anchors driven through the gabion wall, extending beyond the localized sliding surface in order to increase the stability of the gabion wall.
