## CHANGE OF A HIGHWAY ROUTE CAUSED BY A ROCKSLIDE

During the spring of 2013, a relatively large rockslide with a total area of 96,952 m<sup>2</sup> occurred in the eastern part of the Malá Fatra mountains. The anticipated depth of the slip surfaces was from 30 to 40 metres and the volume of moving mass was estimated to be 2,000,000 m<sup>3</sup>. The maximum movement of the rockslide on the first day in March 2013 was estimated to be 43 m. The front of the rockslide interfered with the projected D1 highway route. The paper presented here offers an analysis of the causes of the rockslide and its activity in association with the potential threat to the proposed highway.

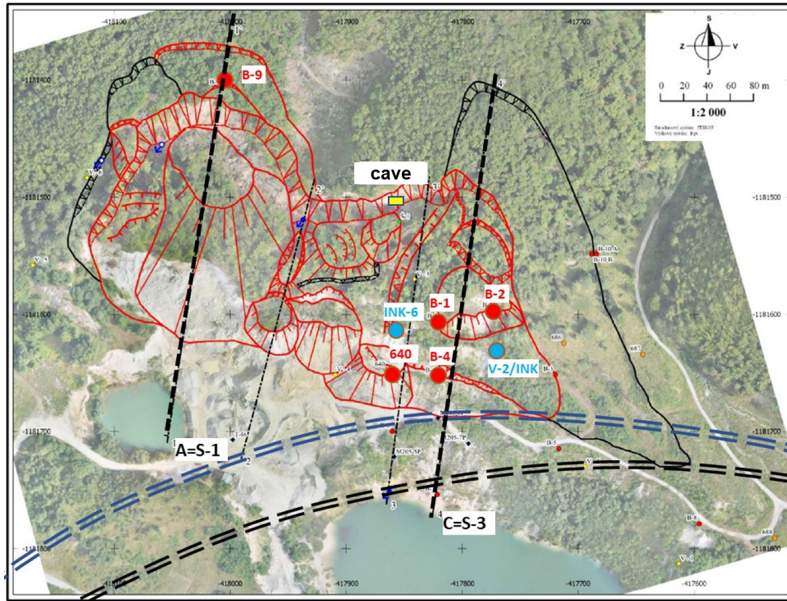
The cause of the slope movement was the extreme climatic conditions over winter and the spring of 2013. Repeated warming caused multiple melting of the snow cover and saturation of the dolomite rocks with water. The trigger of the rockslide was the melting of the thick snow cover in March and infiltration of the melted water into the open cracks in the crown of the rockslide ("Rozsadlina" cave Fig. 1).

FIGURE 1. Rock and rockslide with two alternative routes of the highway, before (blue line) and after the rockslide (black line - variant V1)

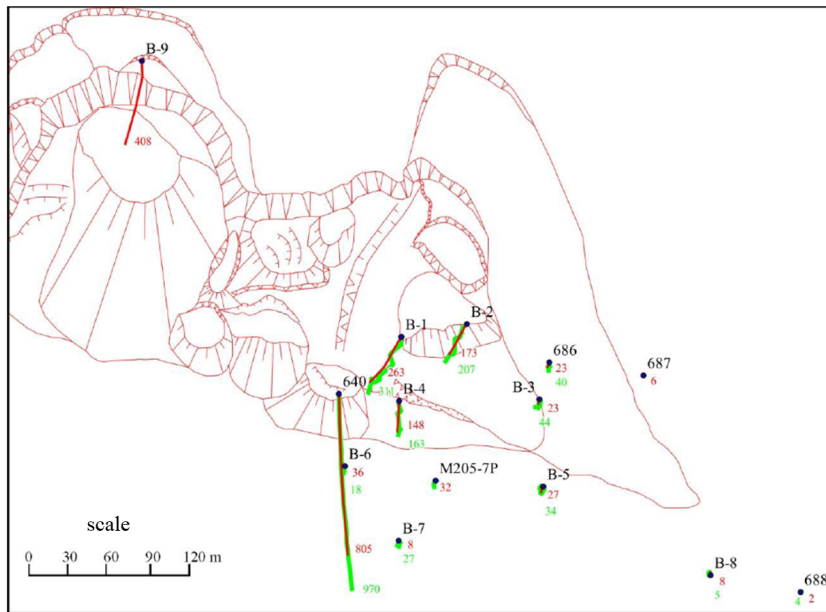
FIGURE 2. Vectors and absolute values of motions (in mm) of geodetic points. Red color – geodetic terrestrial method (14.5. till 14.8.2013), green color GNSS measurements (14.5. till 19.9.2013)

cracks into the granite massif. The active character of this part of the rockslide was indicated by the measurement at point B9 (Fig 2). For the period May 2013 - May 2014, the movement of the geodetic point in the direction of the slope was 1.2 m and its decrease was 0.76 m. Also, at the foot of the rockslide, the pressing of the toe of the rockslide was confirmed by laser scanning (Fig. 3). A simplified mathematical model of this part of the rockslide is shown in Fig. 4.

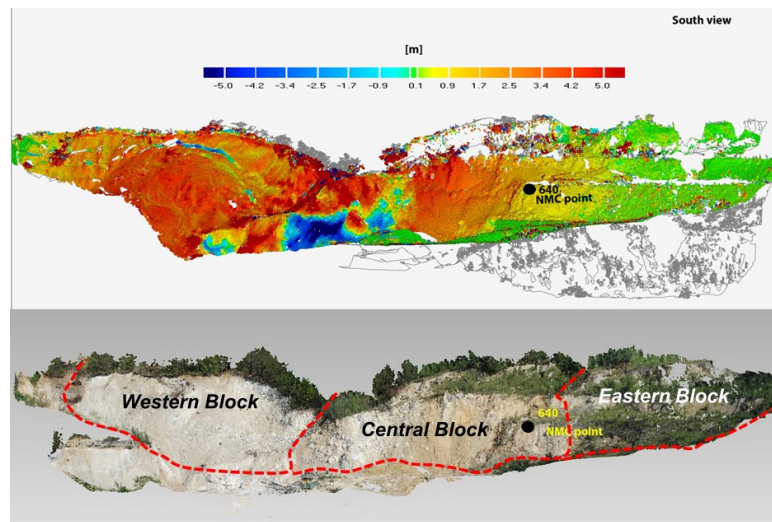
FIGURE 3. Sliding motion activity based on changes in the surface of the rockslide body detected by laser scanning (29.5. and 22.8.2013)

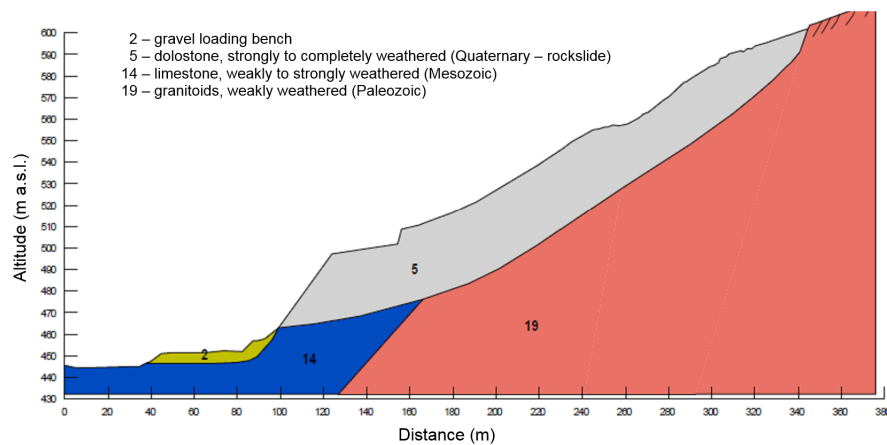
FIGURE 4. Computational model of the slope in profile S-1 (Fig. 1) out of contact with the highway

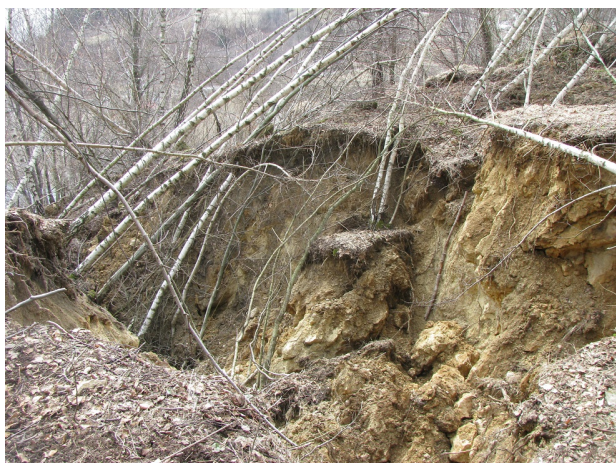
blocks of tectonically disturbed dolostones (Fig. 5). The blocks show, in the upper part, motion vectors towards SW and SSW and in the lower accumulation part, the direction of motion turns in a N – S direction, which is documented by the motion vector of point NDS 640 (Fig. 2). The central part of the rockslide also has a significantly developed main scarp with height about 20 m (Fig. 6). There is a movement of the dolostone blocks along the mylonite zone. This was verified by an inclinometric borehole INK-6 at a depth of about 25.0 m [5]. Rockslide activity was confirmed mainly by geodetic measurements for the period 14.5.2013 to 14.8.2013. A shift 804 mm was recorded at point NDS 640 (Fig. 2) [6]. The average displacement speed of the point 640 in the observed time period reached 9 mm per day. The activity of the front part of the rockslide was documented by laser scanning (Fig. 3). Cracks above the rockslide front were also visually well observable (Fig. 7).

FIGURE 5. Significant radial cracks between two blocks of the central part of the rockslide

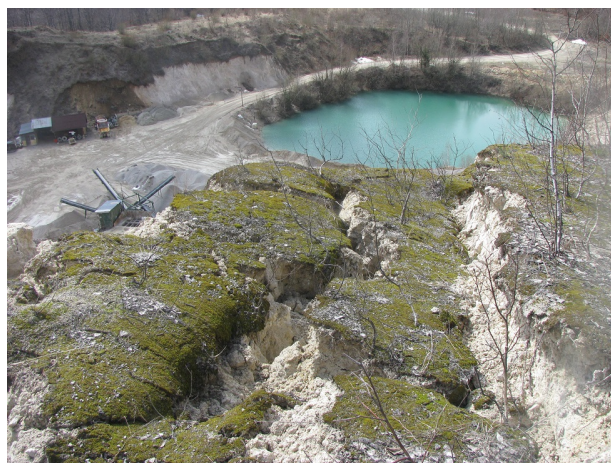
FIGURE 7. Cracks above the front of the rockslide in the central part near the point 640

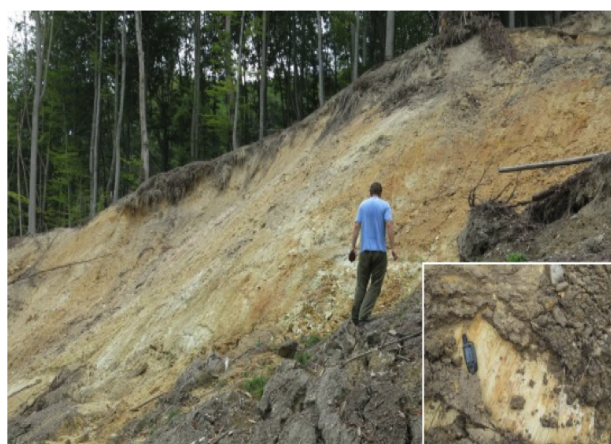
The thrust fault between granites and dolostones has a steep dipping toward the south to southwest and represents the main scarp area of the entire rockslide. Granites in the area of the thrust fault have the character of mylonites (clays with medium to high plasticity). The presence of the mylonites enabled the movement of dolostones along the layer with significantly low share strength. As a second cause of the rockslide we consider the more than 50 years duration of mining activities in the quarry, which has significantly weakened the heel of the slope. These facts created permissive conditions for formation of a large rockslide.

FIGURE 6. Crown of the rockslide with the sliding surface in the central part of the rockslide (detail of sliding surface in mylonites)

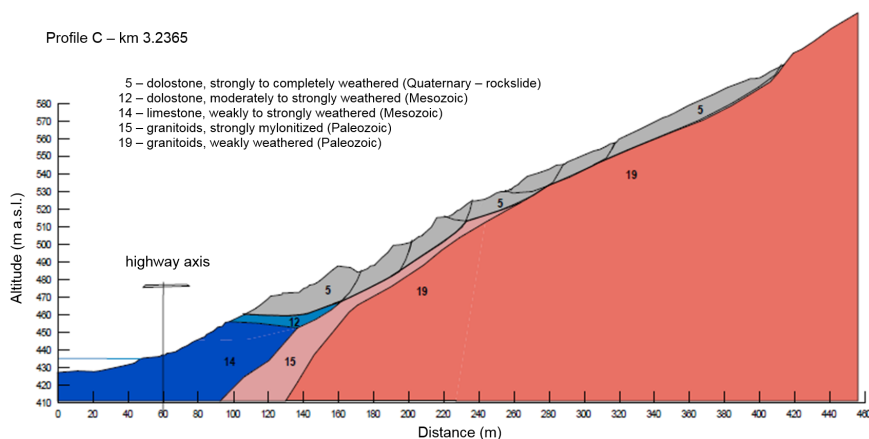
FIGURE 8. Computational model of the slope in the profile C = S-3 (Fig.1) in contact with the highway. The active character of the rockslide in the vicinity of V-2 / INK is also confirmed by the results of inclinometric measurements, which for the period from 18 March 2014 to 21 May 2014 showed movement of the casing by 10 mm

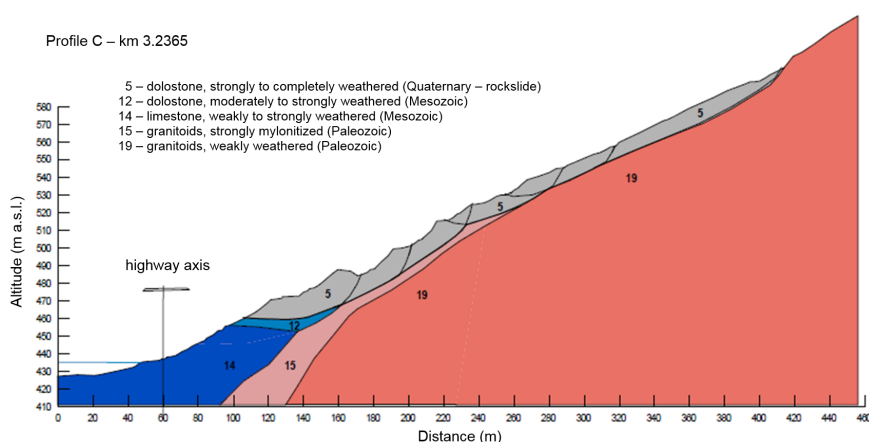
FIGURE 9. Computational model of the slope in the profile C = S-3 (Fig. 1) with a loading bench

On the other hand, a solution using massive loading benches seemed to be potentially a possible method of remediation. The loading benches themselves were designed from a stony material, permeable enough

even after compaction to ensure trouble-free drainage of water from the rockslide and to prevent a rise of the groundwater level at the contact between the rockslide and the loading bench. The stony material used for the construction of the load benches must meet the condition of long-term stability of the fragments. They should not soften after their incorporation into the structure, as this would cause undesired deformations of the bench and closure of macro pores, and as a result of which creep and undesired reduction of permeability could occur. The method of remediation using massive loading benches must be supplemented by remediation measures ensuring both surface and deep drainage of the rockslide.

One of the several considered alternatives of the slope stability remediation with a loading bench is shown in Fig. 9.
