Dorra ABID, Ahmed KTARI, Dhouha MELLOULI, Nedia GAFSI, Nader HADDAR - Failure analysis of shot-sleeves used in brass high pressure die-casting process - Engineering Failure Analysis - Vol. 104, p.177-188 - 2019

Failure analysis of shot–sleeves used in brass high pressure die–casting process

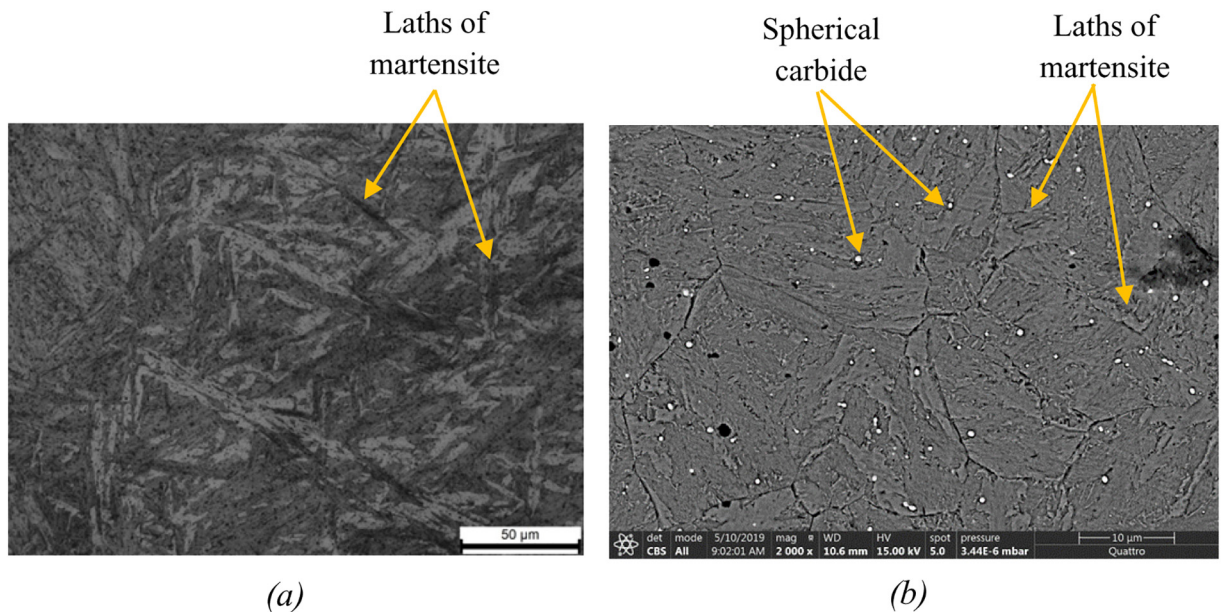
Fig. 2. Microstructure of the shot-sleeve: (a) Light Optical Microscopy (LOM), (b) The SEM microanalysis.

Our studied material is H10, a metallographic observations were realized by means of an optical microscope (Leica[®]) on the same taken sample polished until mirror state then attacked by Nital (5% of nitric acid diluted in methanol). These observations show the presence of a martensitic structure ([Fig. 2](#)).

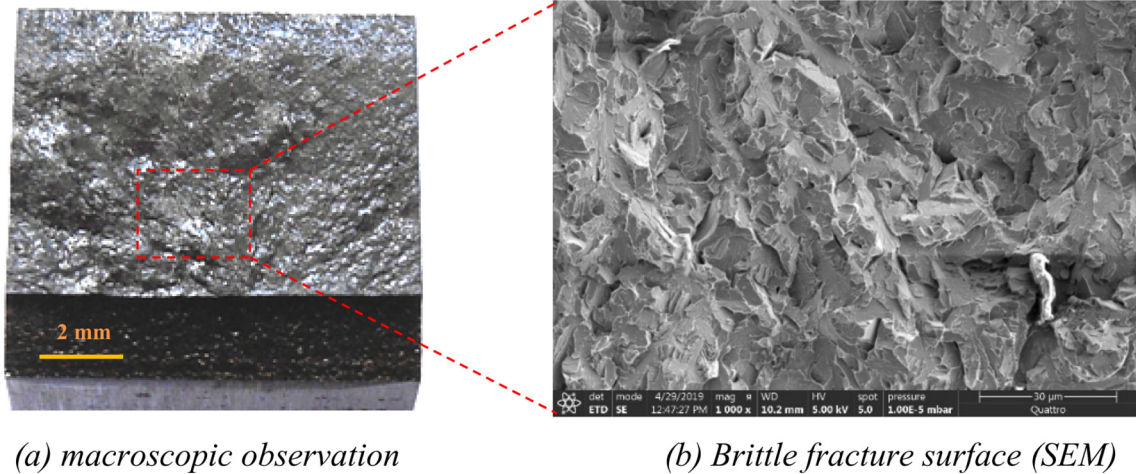
Fig. 5. Fracture surface of Charpy specimen. (a) macroscopic observation, (b) binocular microscope observation.

Standard Charpy V-notched specimens were machined from the failed shot-sleeve by a wire EDM machine (Fig. 4). Then, three tests were conducted at room temperatures to determine the material toughness. The average of the measured CVN energy (CVN = 3.4 ± 0.1 J) and the feature of the fractured surface prove the brittle nature of the specimen material (Fig. 5).

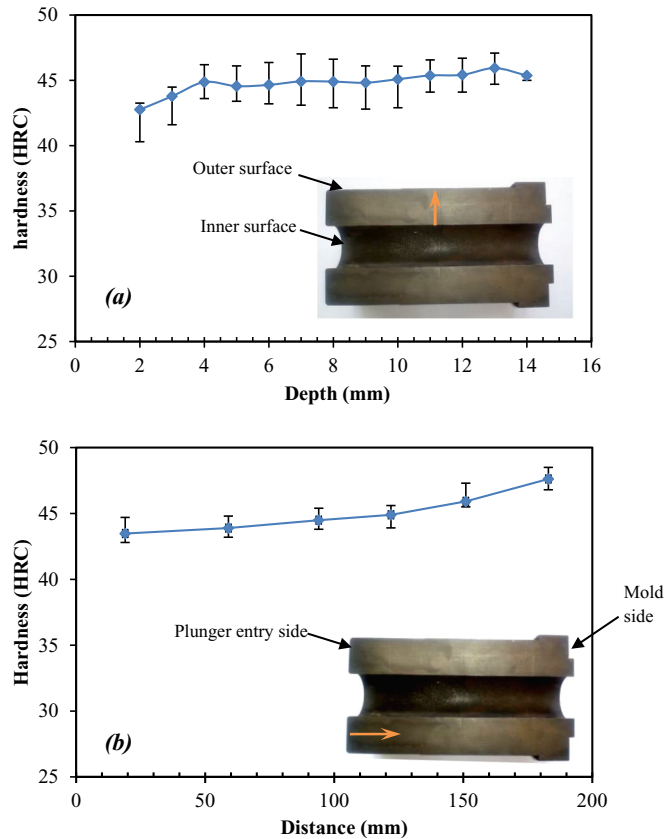
Fig. 7. Hardness shot-sleeve profiles, (a) from the entry to the mold zones, (b) from inner to the outer surfaces.

The hardness profiles were measured, on a shot-sleeve longitudinal section (Fig. 6 (b)) polished until mirror state, from the entry plunger zone to the mold side and from the inner to the outer surface (Fig. 7). These profiles are performed with a Vickers hardness machine using a load of 15 kg. The measured profiles reveal that the hardness appears to be constant for all tested samples.

average of measured hardness is about of $44.8_{-2.4}^{+3.8}$ HRC. This shows that the hardness was remained quasi-constant even after a few thousands of thermal heating and cooling phases (more than 74,000 cycles) and which indicate that the mechanical behaviour of the material is stable (i.e. absence of significant cyclic hardening or softening) under service conditions. Furthermore, micro-hardness measurements were performed with a Wilson hardness machine 402MVD using a load of 1 kg at a distance of approximately $400 \mu\text{m}$ from the inner surface. The average of measured micro-hardness is about $49.8_{-6.4}^{+5.5}$ HRC. This result proves that is no significant increase of the hardness from the heart to the inner surface of the shot-sleeve.

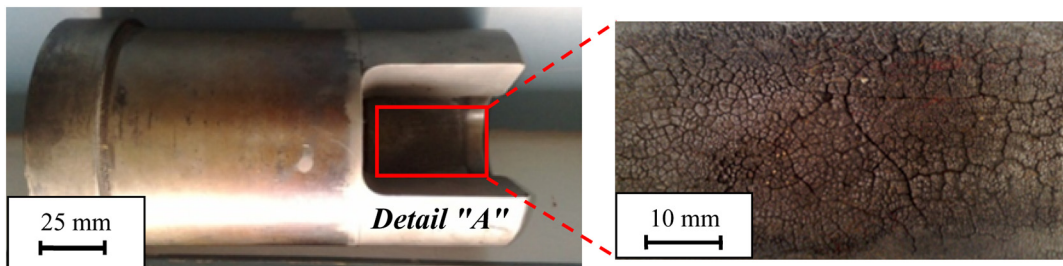
Fig. 8. Cracks network observed on the inner surface of the damaged shot-sleeve.

The second shot-sleeve was cut with a wire EDM machine according to their longitudinal direction to examine the integrity of the damaged surface (Fig. 8). After that, the cut-out parts are subjected to a surface cleaning operations: A chemical pickling with an alkaline solution using a dilute nitric acid was performed, at room temperature, to eliminate all traces of oxides. Then, the damaged shot-sleeve surfaces were subjected to a preliminary assessment with a naked eye to identify their major damage features. The examined surfaces (Fig. 9) clearly show the presence of a cracks network on the inner shot-sleeve surfaces.

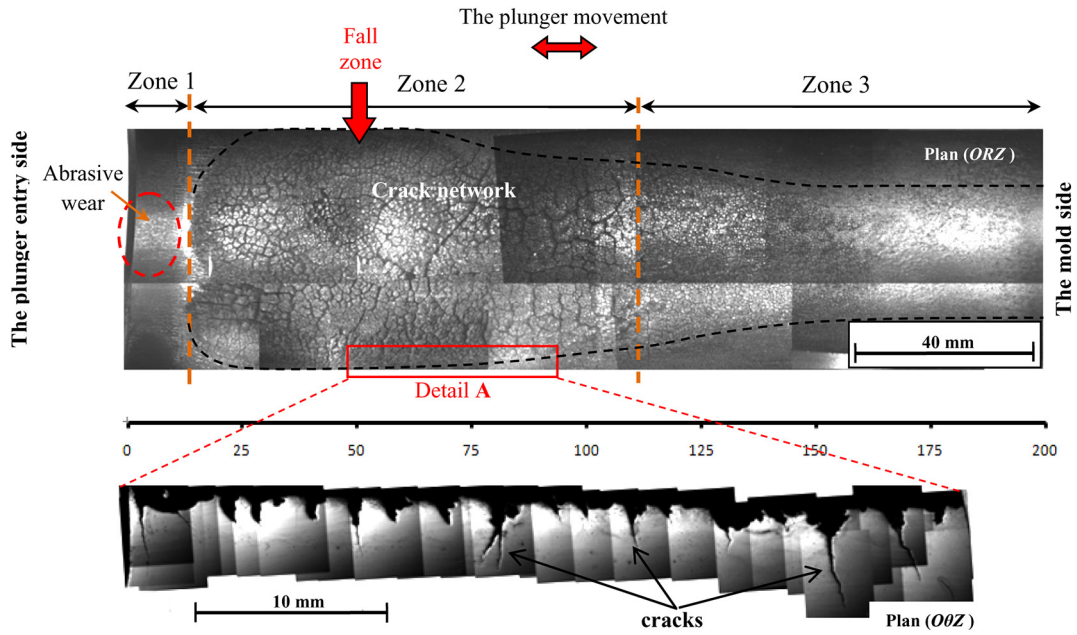
Fig. 9. Shot-sleeve inner surface damage observed with a digital camera.

A finer observations of the shot-sleeve inner side were carried out after a longitudinal cut (Fig. 6 (b)). The examination of the damaged surfaces was made using an experimental device equipped with a digital *Baumer*[®] camera *GIG*E (8 bits). This camera is equipped with a CCD sensor allowing to have a resolution of 1624×1236 pixels. Several photos are taken and then assembled by means of Photoshop[®] software to obtain a large image that cover the entire shot-sleeve examined surface (Fig. 9). This surface reveals the presence of three different zones. The first one is located in the plunger entrance side. It presents a number of scratch according the longitudinal direction which corresponds to abrasive wear caused by the friction between the plunger and the shot-sleeve. The second one corresponds to the first zone which enter in contact with the molten metal ($T = 950^\circ\text{C}$). It undergo cyclic thermal shocks. This zone appears to be the most damaged surface in the shot-sleeve. It presents a dense crack network sign of the thermal fatigue. In addition, the investigation of this zone according to the $O\theta Z$ plan shows that some cracks, after initiation, were propagated in depth along the radial direction (Detail A). The last zone reveals also the presence of a crack network however it is less dense compared to this observed in the 2nd zone (Fig. 9).

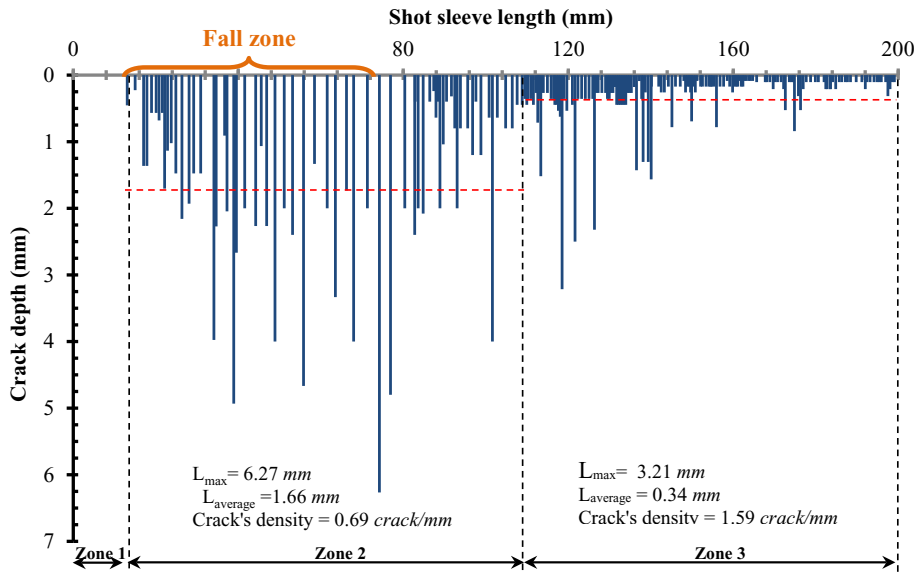
Fig. 10. Crack lengths distribution along the shot sleeve (longitudinal section $\theta = 0$).

In this section, a meticulous investigation on the cracks distribution and density was performed by means of longitudinal and transversal observations (Figs. 10 and 11). The cracks depth according to the axial distance was presented in Fig. 10. It is to be noted that the cracks depth trend along the shot-sleeve follows the Gaussian distribution. Fig. 10 shows that the cracks depth is maximal around the zone 2, which corresponds to the casting zone (fall zone). This zone is characterized by a maximum crack length and average values of 6.23mm and 1.66mm respectively. In zone 3 the cracks deep is less than those observed in zone 2 nevertheless their density is more pronounced (*i.e.* $1.59\text{crack}/\text{mm}$ in zone 3 against $0.69\text{crack}/\text{mm}$ in zone 2). The presence of the shielding effect between neighbouring cracks existing in zone 2 cause the propagation slows down of the smaller cracks and only a few of the biggest ones continue to propagate. Such a phenomenon was observed in many applications in which the thermal fatigue was the main cause of damage [19–20,28].

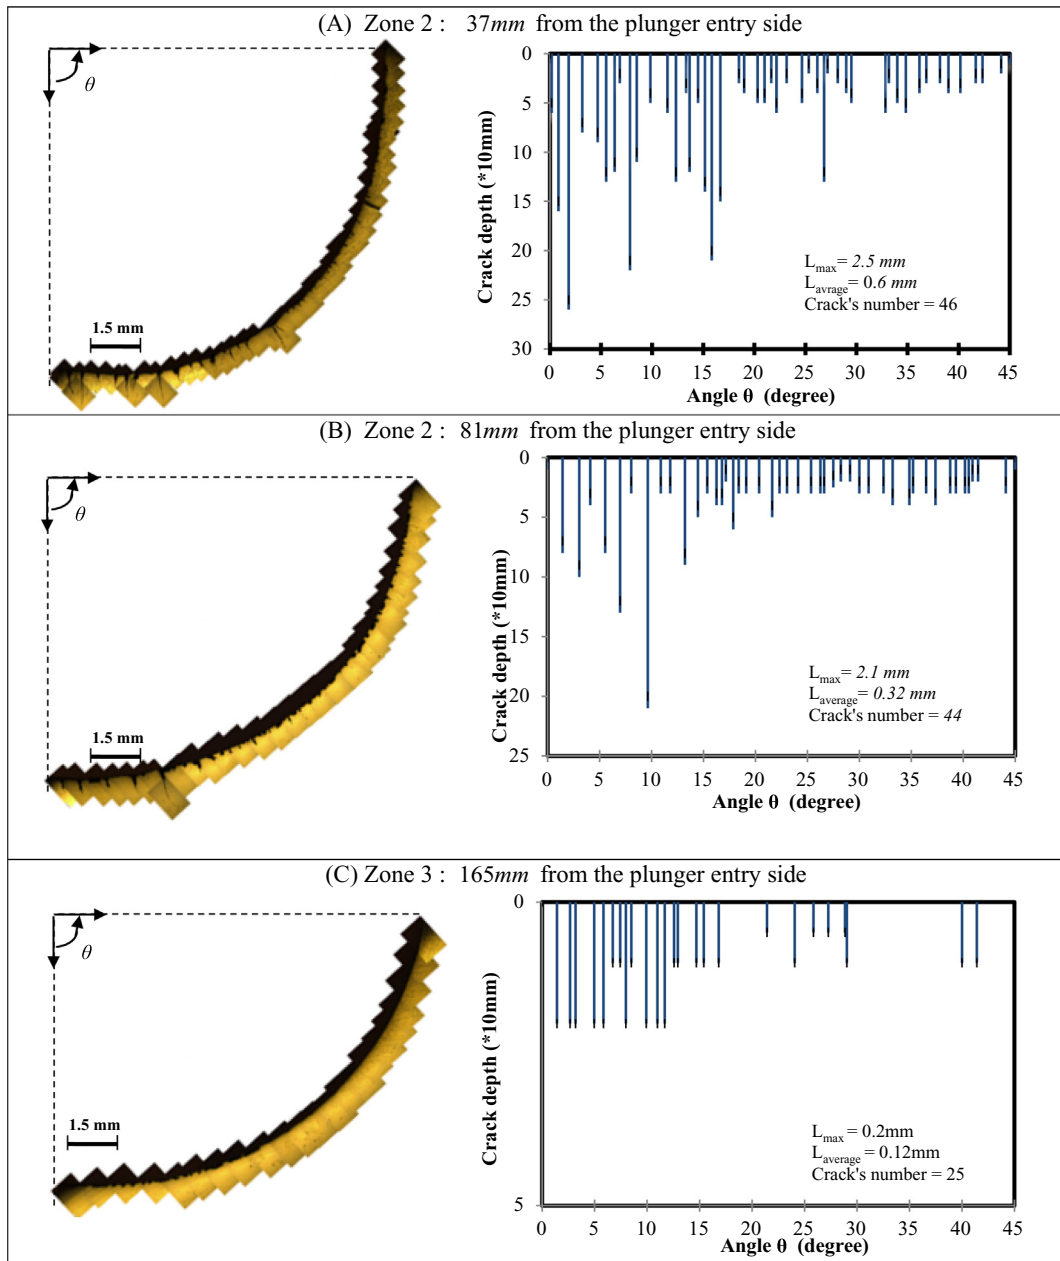
Fig. 11. Crack distribution of damaged shot-sleeve in cross-sections A, B and C.

The cracks depth investigation from the centre of shot-sleeve ($\theta = 0^\circ$) to the shot-sleeve horizontal plane ($\theta = 45^\circ$) for every shot-sleeve cross-sections A, B and C (Fig. 11). It is obvious that the maximal depths are sited at the level of the zone of casting. This result can be explained by thermal fatigue, oxidation and erosion by the molten brass flow which results in removal of superficial layer.

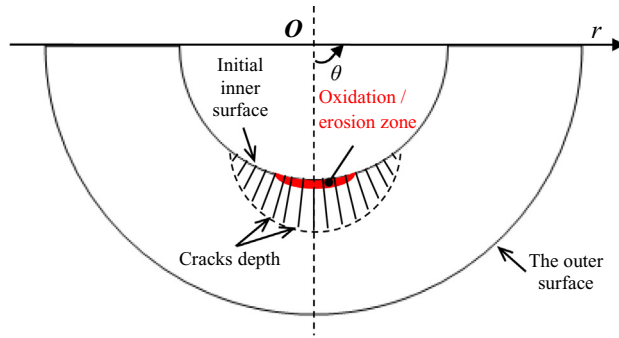
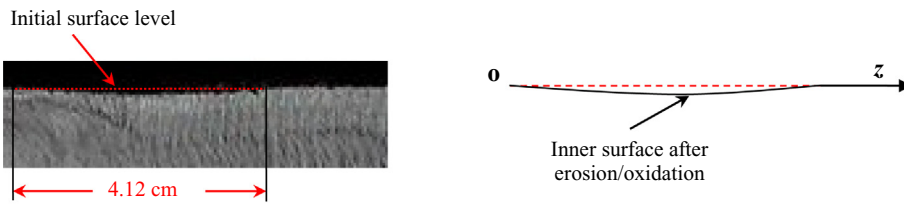
Fig. 12. Oxidation / erosion effect in the fall zone (Zone 2) of the shot-sleeve.

The initial level of the shot–sleeve casting zone (cited in zone 2) was decreased probably due to oxidation and erosion effects as shown in Fig. 12. The cracks situated surroundings the shot–sleeve centre (near $\theta = 0^\circ$) are in reality longer compared to their effective length due to the small decrease of the shot sleeve inner surface level produced after the oxidation / erosion effect. Others micro cracks are totally removed what favoured the propagation of persistent cracks because the motive force was located in them, is confirmed by previous research [1,29].

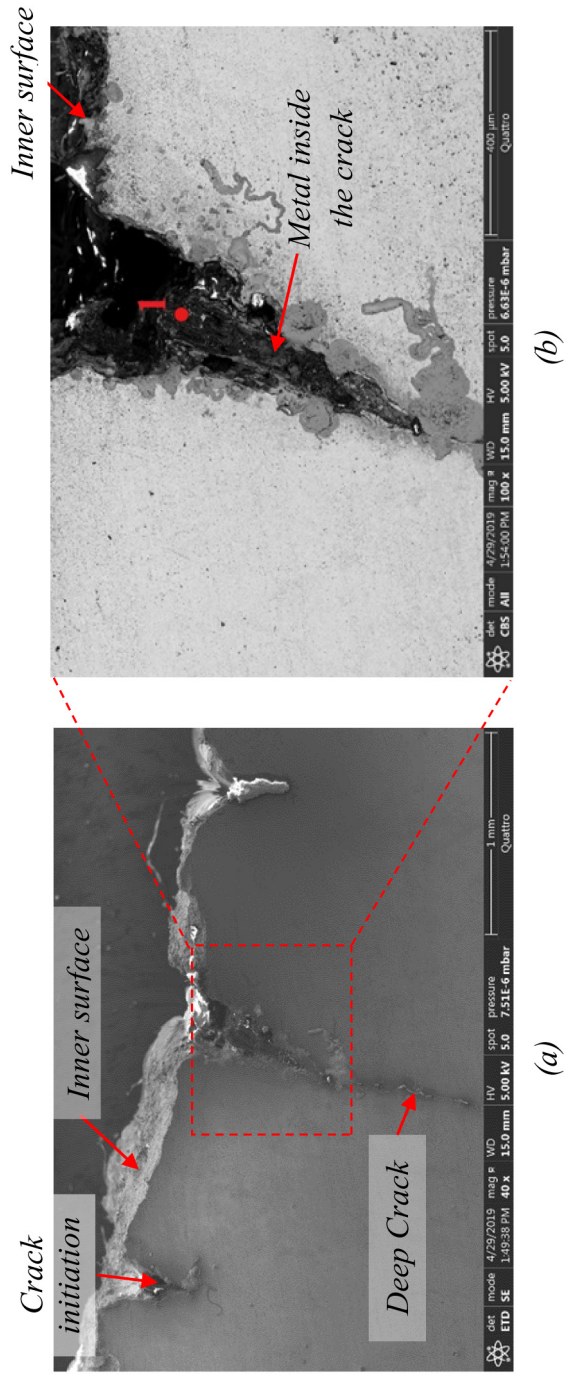
Fig. 13. SEM observation of a damaged shot sleeve cross-section: (a) Short (initiation) and deep crack, (b) Zoom on the examined crack with EDS (point 1).

In addition, in order to more understand the mechanisms leading to the shot sleeve failure, a sample of the cross-section surface was examined using SEM (Fig. 13) and Energy Dispersive X-ray Spectroscopy (EDS) to identify the chemical composition of the metal inside cracks (points 1 in Fig. 13 (b)) (Table 4). According to Fig. 13 (a), the cracks tend to propagate perpendicular to the damaged surface. The initial growth of thermal fatigue cracks is facilitated by an oxidation attack on the crack surface, which forms the Fe, Cu, Zn, Cr, Mo, Si and O rich layer (Table 4). The presence of brass and oxides, in the cracks increases plastic yield ($R_{p0.2}$) and compressive stresses during the heating phase of the thermal cycle [30]. As a result, the tensile stress is further increased during the cooling phase and can leads to the acceleration of the crack growth rate. In addition, the tensile stresses applied on the shot-sleeve inner surface during the cooling phase combined with the erosion phenomenon caused by the molten brass fall in the second zone leads to a local failure, which promote the opening of thermal cracks [13]. These cracks act as channels allowing oxygen to penetrate down to the crack tip area and oxidize both shot sleeve and the filling material. Solidified particles down on the crack act as an obstacle for its closer and the size of the crack openings in the filling material indicates the amount of brass that will fill the crack during the next cycle [20].
