Transformer fault detection based on Raman analysis of the transformer oil (A case study)

M. Kadlečíková¹, J. Breza¹, J. Raditschová¹, E. Vančo², B. Butvinová³

Abstract

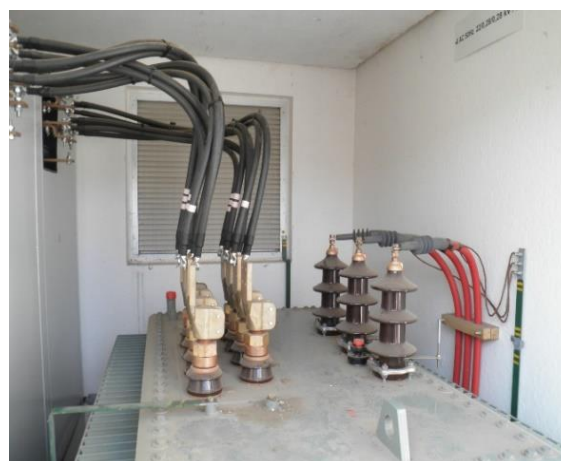
The fault on the transformer was manifested by an alarm from the digital protection system. At the time of the fault, the transformer had been in operation for 3.5 years. When looking at the transformer body from outside, no deformation or destruction of the transformer vessel was visible. There were no signs of oil leakage or other defects (such as bulging) on the welds or other parts of the vessel. There was no visible change in paint color as a manifestation of long-term elevated temperature, oxidation of metal parts due to ambient humidity or melting at the terminal and cable interface, color marks (color patterns) revealing overheating of joints due to assembly errors, and no signs of damage (blackening) of terminals or bushings on the LV and HV sides of the transformer cover (Fig. 1).

Fig. 1: LV and HV terminals and bushings on the oil transformer cover. The transformer was installed in the transformer part of a kiosk transformer station in a photovoltaic power plant. It is a three-phase oil transformer with a rated output of 1250 kVA for a nominal high voltage of 22 kV and 2×280 V low voltage. The three windings are Dyn1yn1 connected (delta connection on the higher voltage side, star connection on the lower voltage side, the clock angle is 1). The system is hermetically sealed in a radiator vessel and filled with a cooling and insulating medium – mineral oil. The container is naturally cooled by air. The winding materials are Cu and Al.

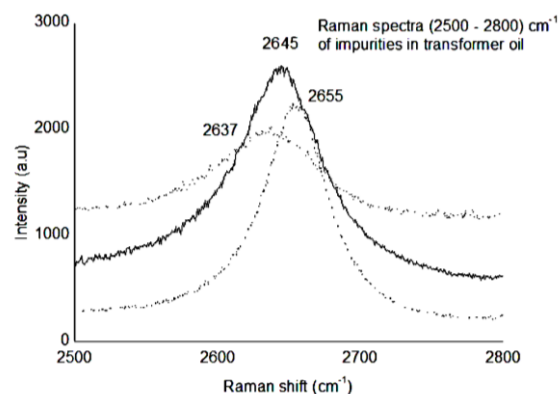
Fig. 3: Raman spectra of soot in wave number range from 2500 to 2800 cm^{-1}

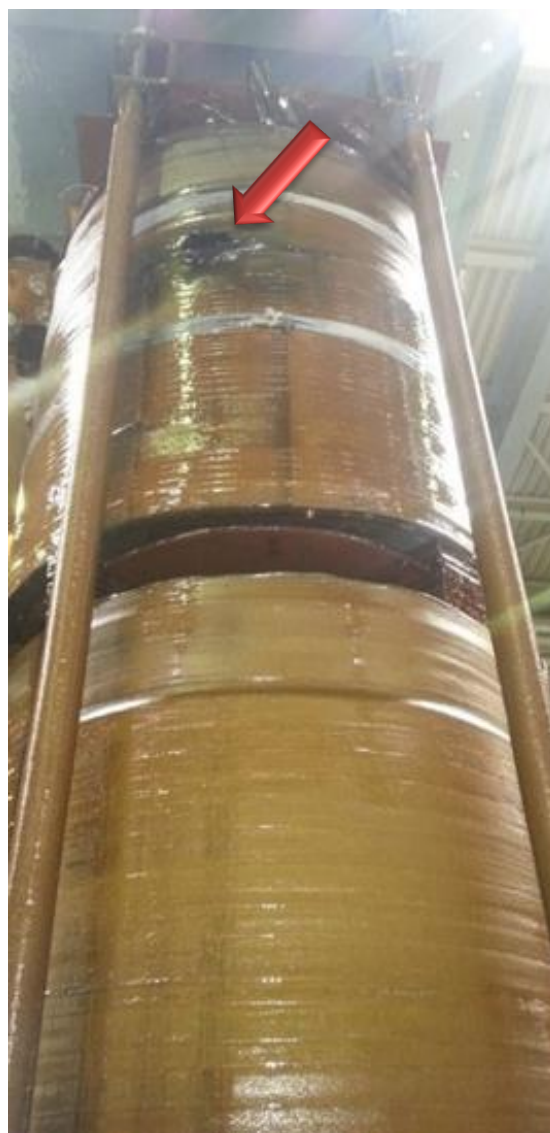
After removing the transformer body from the oil sump (Fig. 4), damage to the high-voltage coil was first observed (Figs. 5 to 7). Figure 7 shows a locally burned HV winding. After complete disassembly of the transformer, damage to the magnetic circuit of the transformer (Fig. 8) and extensive destruction of the low-voltage coil (Figs. 9 to 12) were also found.

Fig. 5: Damaged HV coil visible after removing the transformer from the oil sump. The fault on the HV winding is located approximately in the middle of the column.

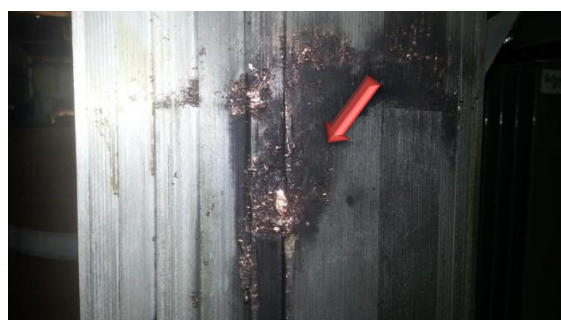
The burning electric arc in the LV coil near the transformer core (Fig. 8) was boosted up by the aluminum present, which reduced iron oxides and gave rise to liquid iron. At temperatures above 768 °C, iron loses its ferromagnetic properties. The melting of a portion of the transformer core is shown in the

photograph. Iron (Fe) has a melting point of 1528 °C and the transformer sheet used does not have a significantly different melting point from pure iron. It is obvious that local and short-term temperature at the level of the melting point of iron was reached in the arc, which damaged the transformer core.

Fig. 8: Arrows indicate the melting of the transformer's magnetic core.

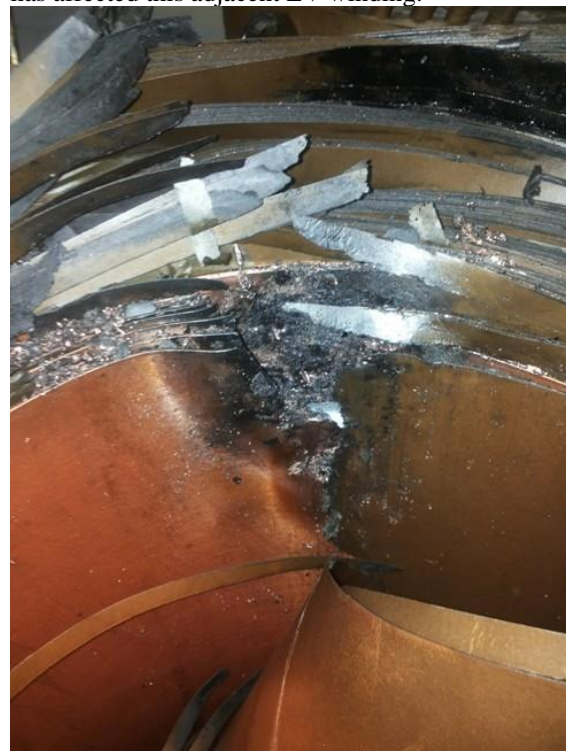
Fig. 10: Detail of the location of the interturn short circuit on the LV coil of the transformer. The interturn short went through 9 layers of the winding.

An interturn short in the transformer winding is dangerous because it results in only a small increase of the current in the winding but in a sharp multiple increase of the current in the short circuit, and locally high temperatures are reached which the cooling

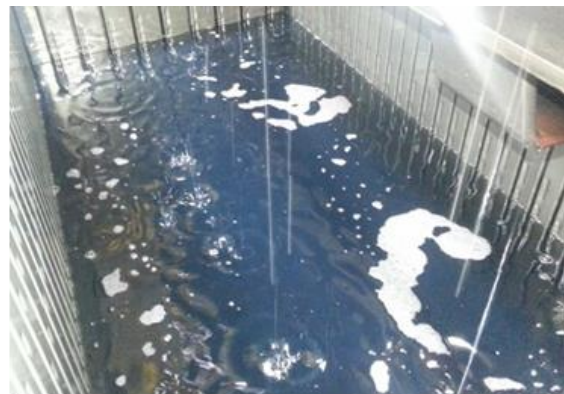
medium is unable to drain the heat. Thermal energy is consumed for local heating (up to the boiling point) and evaporation of the oil, which rises to the surface and, in addition, it is ionized and becomes conductive. In the cooling medium (Fig. 13) there are visible residues after burning, which may be the metal itself, fragments of burnt insulation or oil fraction formed by local boiling of the cooling medium in contact with the molten metal.

Fig. 13: Transformer oil degradation. Fresh oil (according to the manufacturer's characteristics) is pale yellow and transparent.
