Failure Analysis of Brake Panel on Automotive Braking System

Munaji^a, Yoyok Winardi^a,

Abstract

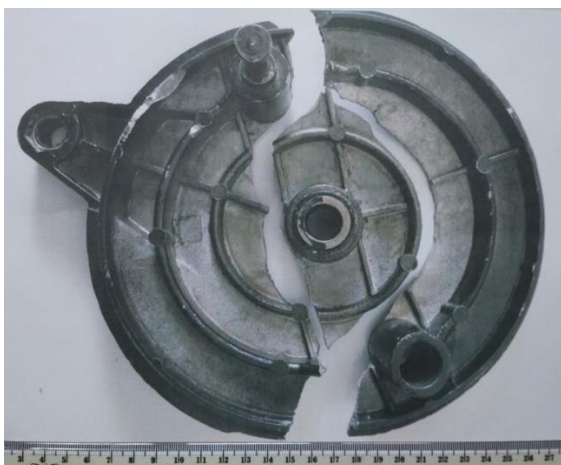
Methods used to determine the occurrence of failed component are macro and micro observation, chemical composition, and testing of mechanical properties (7). Failure analysis of braking panel system of motorcycle are presented. Figure 1 shows the brake system component of a motorcycle. Brake panel/backplate is a failed component. This component has been repaired. After used in 3 months, the brake panel is fractured during braking process. From the result of the observation using digital camera, the obtained shape and fracture location as shown in Figure 2.

Figure 2. Broken component

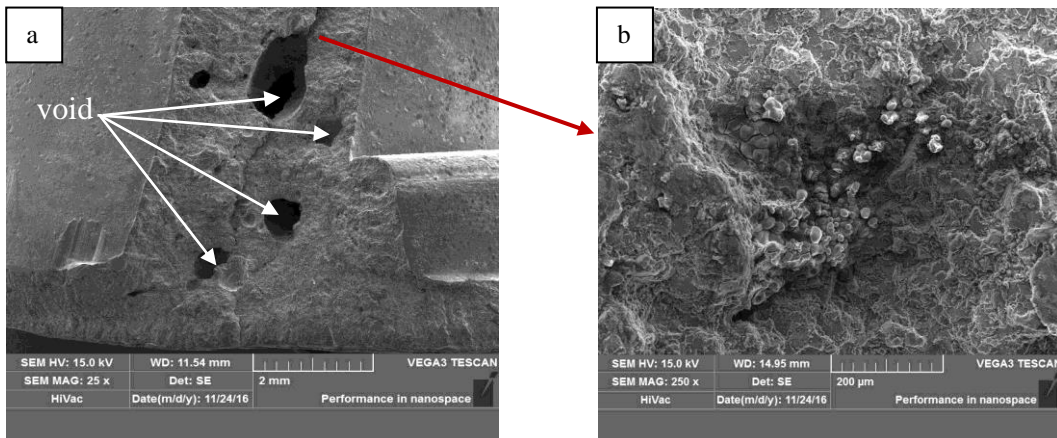
The results of the observation on the fracture surface are shown in Figure 3. and Figure 4. Scanning electron microscopy (SEM) and optical microscope (OM) methods are used to visualize the fracture surface. Based on the result of the observations in the figure 3.a, it can be seen the initial cracks on the surface of test specimen. The crack propagates with big dimensions. These cracks propagate continues in line with the change of the force. Moreover, observations along fracture lines indicate porosity, as shown in Figure 3.a and 3.b. In Figure 3.a, the dimension of blowholes are large. On the other hand the observation result shows that void surface is more smooth, a smoother surface is indicated cause gas trapped in the casting process (9). As the consequence of these void, stress amplification increase at that section (10). It can increase fracture probability at void section.

Figure 3. (a) SEM image of void. (b) Oxide inclusions

Porosity, occur in almost all aluminium alloy castings, can decrease their mechanical properties (11) and increase fatigue live (12). The occurrence of porosity is due to two main aspects, (i) the shrinkage of casting slurry during the solidification; (ii) the solubility of gasses (13), (14). Hydrogen is the main gas of porosity agent in aluminium casting as hydrogen is highly soluble gas (15), (16).

Observations on the fracture surface shows that the fracture occurred between grain boundaries. Fracture surface is rough and brittle with a dark color may indicate that fracture is intergranular fracture types (10).

One of the objectives of good casting product is avoiding porosity in a casting product. This can be achieved by melt degassing. In aluminium cast slurry, the amount of hydrogen can reach 0.3–0.5 cm³/100 g, while the industrial standard requires the concentration of hydrogen before casting close to 0.1 cm³/100 g (17). The control of hydrogen is of major concern in foundries, to control porosity result from trapped gas, several methods are used, either separately or in combination, such as blowing nitrogen or argon into the melt (16), (18), (19), re-melting (20), and rotating impeler degassing (21).

The cause of the failure on motorcycle brake panel has been investigated. Based on the results of the investigation on the brake panel, the failure is caused by stress concentration. Stress concentration is caused by void. The emergence of the void caused by the inability of the fluid of aluminium alloy to form a solid during the casting process. To reduce the occurrence of void in the component, nitrogen gasses can be sprayed during the casting process. So that the trapped oxygen can come out of the casting liquid and minimize the voids, then the strength of the component can be maximized. The casting process can change from disperssion casting to squeeze casting to repair imperfection of casting product.

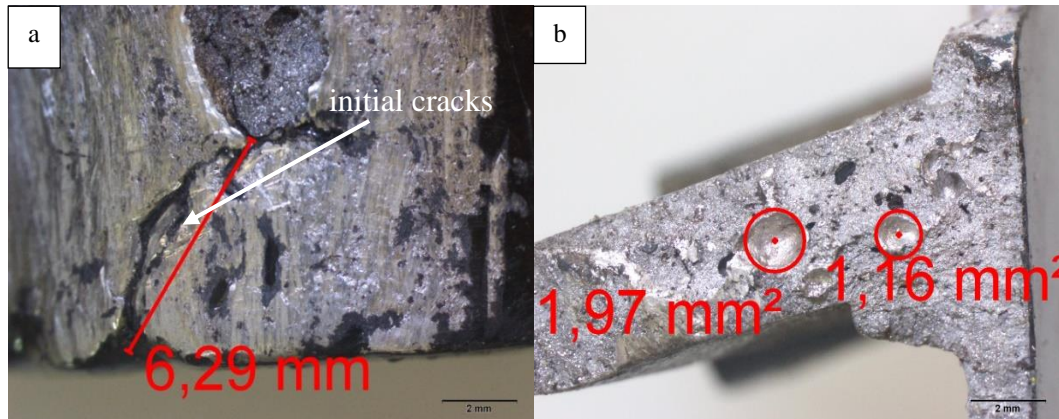
Figure 4. (a) Crack propagation. (b) Dimension of void
