# **Global monitoring of large concrete structures using acoustic emission and ultrasonic techniques: case study.**

Tomoki Shiotani<sup>1</sup>, Dimitrios G. Aggelis<sup>2</sup> and Osamu Makishima<sup>3</sup>

In the specific case presented herein, a 45 m bridge span was inspected. Preliminary visual inspection and testing of excavated cores did not reveal extensive damage. However, cores are

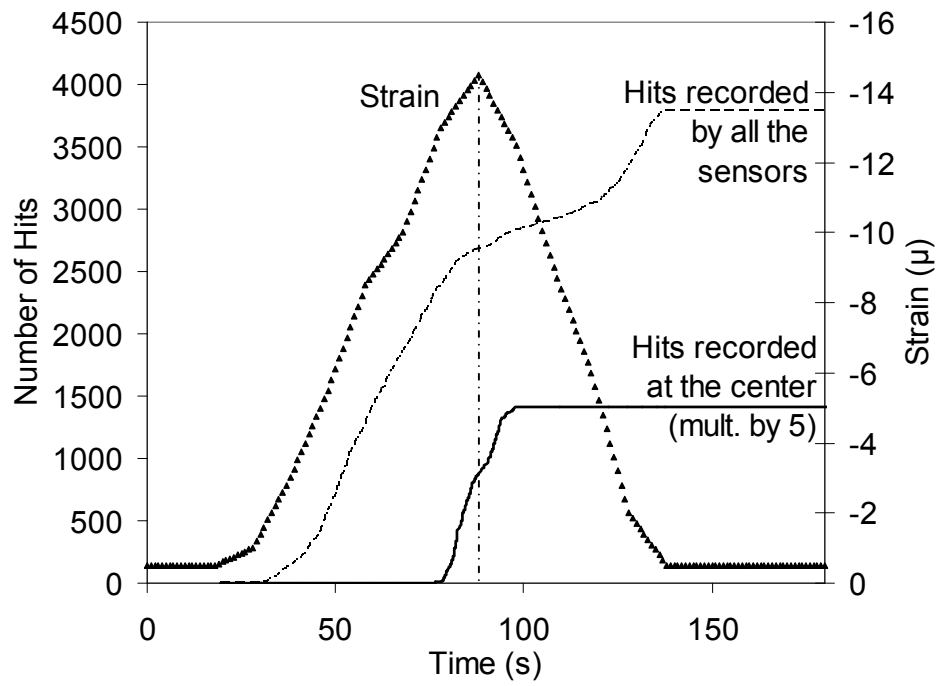
The load for the AE monitoring was supplied by a 20-ton crane, which passed over the bridge with a constant speed of approximately 0.5 m/s (see Fig. 1). As the crane moved over the bridge, the strain on the top surface of the bridge at the mid-span was monitored and can be seen in Fig. 2. The maximum strain was recorded at 88 s, when the truck was in the middle of the span, suggesting the highest tensile stress due to bending at the bottom layer of the structure, where the sensors were attached. In the same figure, the cumulative number of AE hits recorded by all the sensors is depicted for one passage. It can be seen that the rate of AE hits was more intensive before the crane reached the center of the bridge at 88 s. Up to that moment more than 70% of the total number of hits was recorded, implying that more active sources were located in the first half of the bridge. In the same figure, the cumulative number of hits recorded only by the two sensors located close to the center of the bridge is depicted. For clarity reasons they are multiplied by a factor of 5 in the figure. The hits of these sensors started at 14 s before the crane reaches the middle point, and the last hit was recorded 10 s after the crane had passed over that point, showing again higher activity at the first half of the structure.

Fig. 2. Time history of strain at the center and cumulative AE hits during crane passage.

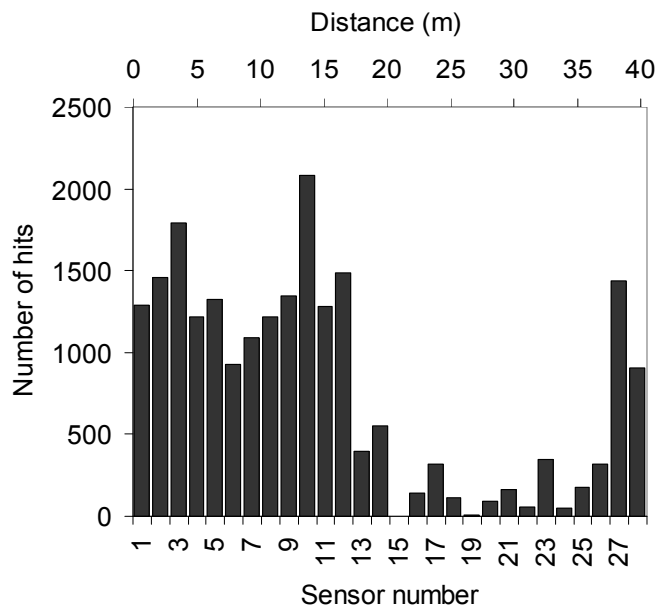
The interpretation of AE information is not always easy. This is the reason why different indices have been introduced. Some of them utilize the relative number of hits during the loading and unloading process, or the load at which the AE activity starts (Ohtsu et al., 2002, Colombo et al., 2005). Others take advantage of the amplitude distribution of AE events (Shiotani et al. 1994, Shiotani et al. 2007). However, in this case just the total number of hits during the crane passage sufficed the requirements of the test. The total number of hits recorded at each sensor during all the passages of the crane is depicted in Fig. 3. The position of each sensor is indicated by the axis on the top of the figure. It is certain that the first part before 20 m, exhibited highest rate of

emissions. Specifically, channel #10 recorded the highest number of hits. This corresponds to the distance of 14 m from the starting point. It is well known that the AE activity is connected to the extent of damage through primary (crack growth) and secondary (frictions) mechanisms. Therefore, the area near the sensor which recorded the highest activity was the most likely to have sustained more serious damage than the rest of the structure examined. Consecutively, this area was selected for the more detailed monitoring using stress waves as described in the next section.

Fig. 3. Number of hits per channel and distance.

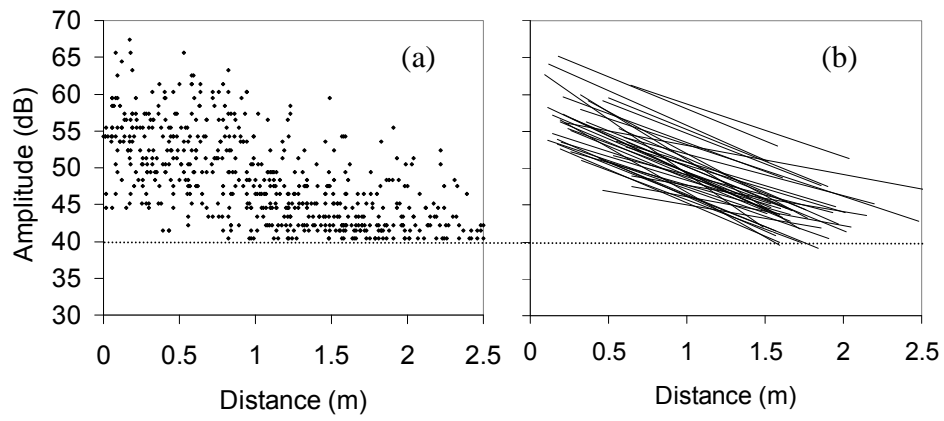
After location of the events, interesting conclusions can be drawn about the attenuation of the structure. In Fig. 4(a) the amplitude of the hits of all events is depicted vs. the distance from the source. The average first hit stands at an amplitude of 54 dB. In Fig. 4(b) the linear fits to the amplitude of each individual event are plotted. Attenuation can be calculated by the slope of each line. Averaging of the slopes of the events recorded from the whole structure results in -7.02 dB/m. It is seen that any "hit" propagates at least 1.5 m before being reduced below the threshold level (40 dB). Therefore, they are recorded by at least 2 sensors. This shows that the separation distance of the sensors is adequate for source location in this case. In any case, attenuation is a crucial parameter that should be seriously taken into consideration since in monitoring of most large structures, compromises must be made between the available number of sensors, time restrictions for measurement preparation and the desirable degree of detail of examination. Attenuation is a key parameter to make an adequate decision.

Fig. 4. (a) Hit amplitude vs. distance from event source, (b) individual attenuation slope for different events.

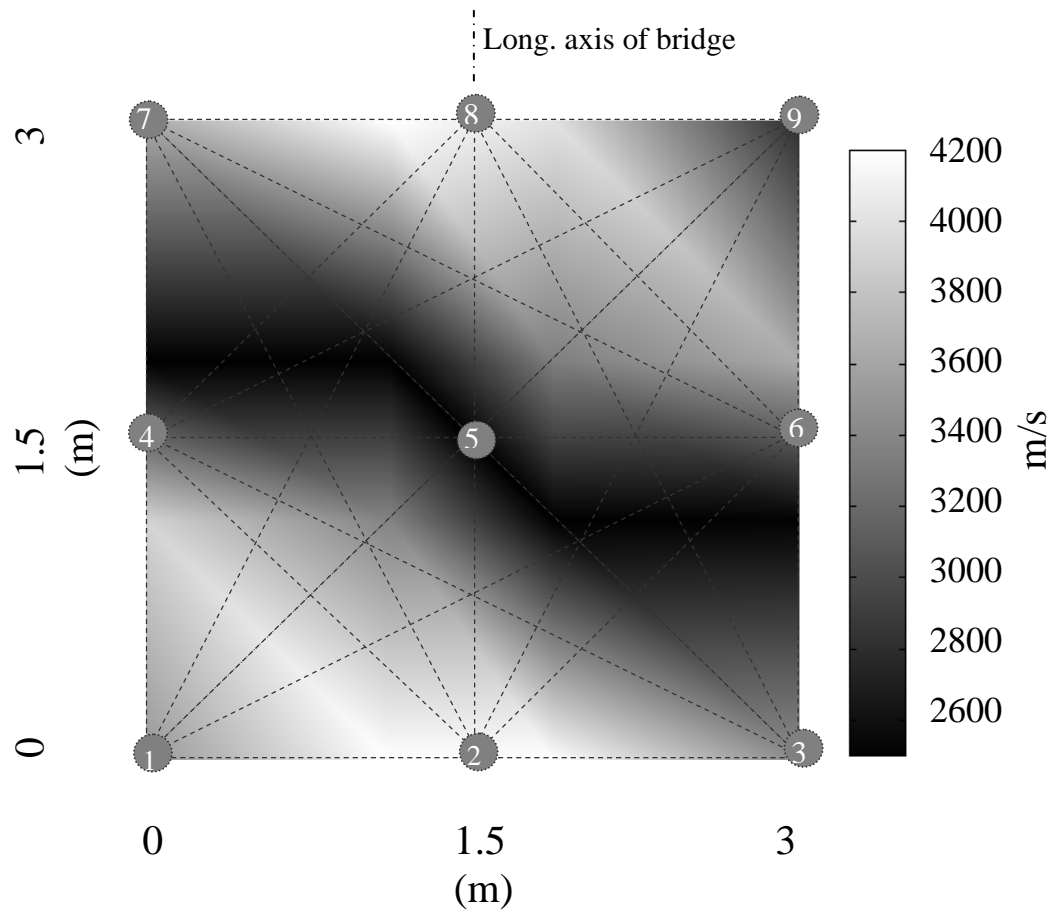
The transit times of the individual paths and the geometry were supplied to suitable tomography program (Kobayashi et al., 2006). This way the visualization of the velocity structure was obtained, as seen in Fig. 6. The tomogram supplies the information of which parts

of the surface area exhibit lower velocity than others. From this figure, it is seen that within the area of 9 m<sup>2</sup>, considerable discrepancies of wave velocity emerge. These discrepancies correspond to different degree of inhomogeneity. Specifically, a zone approximately in the center of the selected area exhibited velocity of less than 2500 m/s, indicating poor quality, while other parts exhibited velocity higher than 4000 m/s. As stated above concerning AE activity, the events may propagate through different parts of the structure or reinforcement and their exact source could be concrete cracks, delaminations of different layers (e.g. asphalt on concrete) or friction between the tendon ducts and matrix concrete. As to the velocity measurements though, propagation took place only through the surface layer of concrete. Therefore, the velocity is characteristic of the concrete material itself indicating low quality or extensive damage on that specific area. It is reminded that the general condition of the structure was considered satisfactory after visual observation. Therefore, the low velocity is attributed to a subsurface defect.

The depth cannot be easily determined though. Concerning Rayleigh waves, it is accepted that the penetration depth is approximately similar to the wavelength (Aggelis and Shiotani, 2007). In this case however, the first arrival used to measure velocity corresponds to the longitudinal wave which is in any case faster than Rayleigh or shear waves. Therefore, it is not straightforward how deep is the surface layer characterized by this velocity. Concerning Rayleigh propagation, typical velocities for the bottom part of Fig. 6 were around 2500 m/s, corresponding to longitudinal velocity certainly higher than 4000 m/s (assuming a typical Poisson ratio of 0.2). Although this implies good quality, the determination of Rayleigh velocity was not always possible due to severe attenuation and distortion of the waveform, especially for paths at the top of Fig. 6. This was because there was no characteristic point to use as reference

Fig. 6. Velocity structure visualization of the bottom surface of the bridge concrete. The positions of the transducers are indicated by ●, and the examined wave paths by dashed lines.
