Case Study on Causes and Countermeasures of a Largely Deformed Reinforced Earth Wall with Geotextile in Hyogo, Japan

Satoru Shibuya

ABSTRACT: This study examines causes and countermeasures of large deformation that took place on the reinforced earth wall, a part of the Tottori expressway planned to pass Hyogo, Japan. Since this reinforced earth wall had experienced unexpected deformation of the wall during construction, the wall was re-constructed twice. However, the wall deformation showed no sign to cease even at the final stage of the construction. In this paper, case study was carried out on the interpretation of the mechanical behavior of the severely damaged reinforced earth wall comprising geotextile with the concrete panel facing. At First, the outline of the damaged reinforced earth wall is in detail described. The background and cause of the damage are discussed based on the results of site investigation. The engineering properties of the fill were examined by performing various in-situ and laboratory tests, including the surface wave survey (SWS), PS-logging, RI-logging, soaking test, the direct shear box (DSB) test, bender element (BE) test, etc. Consequently, the bac

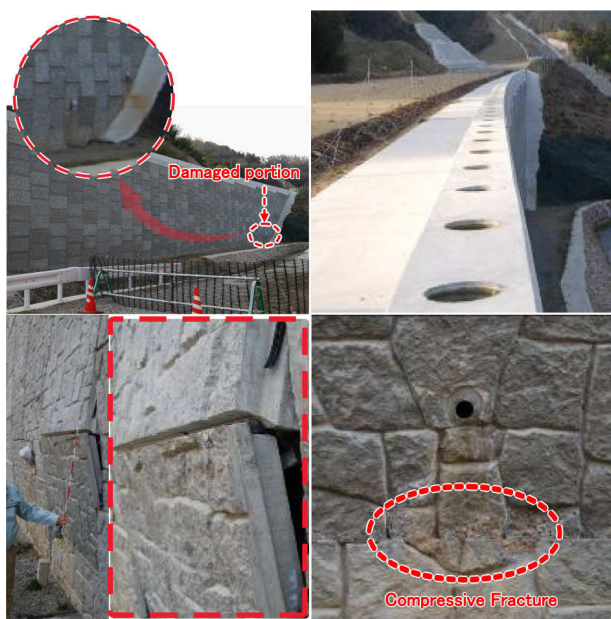
Fig. 4 Severely damaged portion.

The wall height at the severely damaged portion was approximately 15m. As described earlier, the parts of the fill for the first and second remedies had been improved by cement injection using the dry weight of Portland cement of 50kg/m^3 .

The drainage layer was sandwiched between these two cement-mixed layers. Note that the severely damaged portion of the wall is surrounded by the improved soil with a low-permeability and the bedrock. In addition, there is a small valley behind it.

The construction of the wall was finally completed in November, 2007. However, the field observation clearly indicated that the deformation of the wall showed no tendency to stabilize with time. Case study was hence commissioned in order to manifest the cause of the wall damage, and also to examine effective counter-measures to re-stabilize the wall. Fig. 4 shows some pictures of the reinforced earth wall cited, including the severely damaged portion. The outwards deformation at the damaged portion on the wall was on-going by showing the horizontal displacement to reach the value as large as 166mm. The concrete panel wall had been constructed by using a high-density poly-

thene geo-textile sheet. Based on the observation, a type of wall damage due to the existence of a poorly compacted soil layer was strongly suspected (refer to Fig. 1).

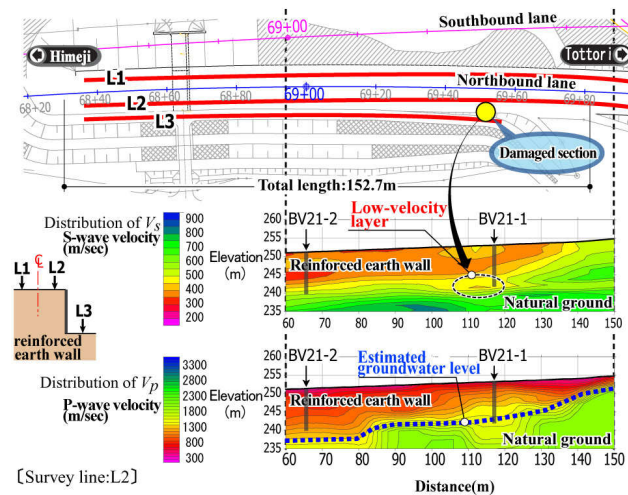
Fig. 5 Results of HR-SW survey.

The HR-SW survey was carried out to figure out the 2D profile of the elastic wave velocities, i.e., S-wave and P-wave velocities (V_s and V_p) of the fill, together with the foundation. Fig. 5 shows the profiles of V_s and V_p with depth for the 160m long survey line L1. In general, the V_s increases with depth involved with increase in in-situ stresses.

However, a low-velocity layer was observed for V_s near the severely damaged section at BV21-1 (n.b., elevation: approximately 240m, distance: 110~115m). The decrease in V_s strongly suggests some reduction of the magnitude of stresses at the deformed section.

On the other hand, the dashed curve in the profile of V_p represents the boundary associated with $V_p = 1500\text{m/s}$, noting that the specific condition of $V_p = 1500\text{m/s}$ is applicable to saturated condition. Accordingly, it may be surmised that the state of soil behind the damaged panels is close to saturation.

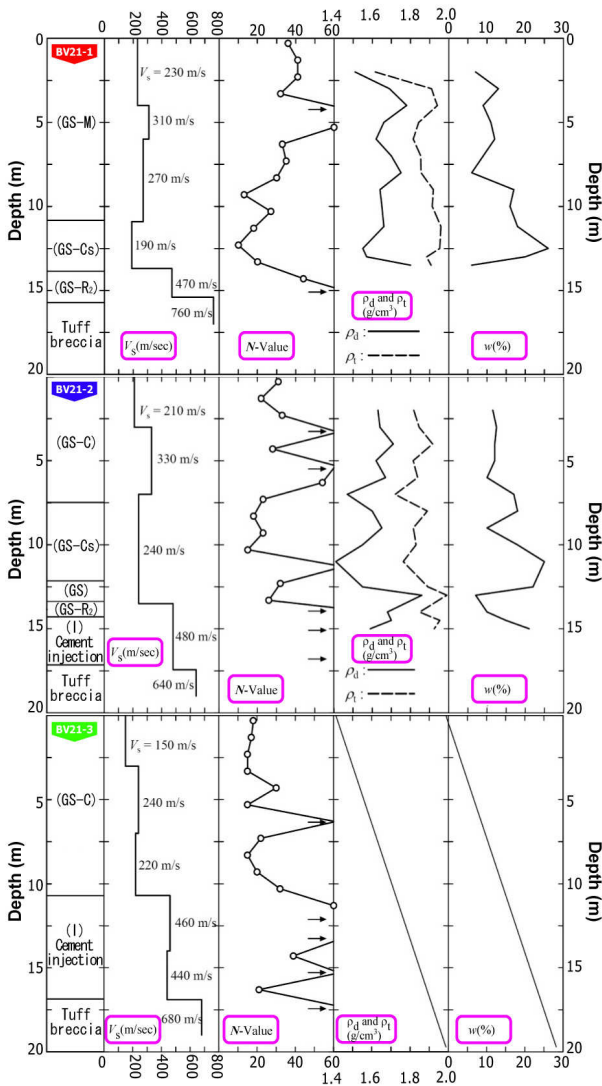
Fig. 6 Profile of physical properties of the fill.

Fig. 6 shows the profiles of V_s , N-value, ρ_p , ρ_d and w_n at three locations of BV21-1, BV21-2 and BV21-3, respectively (see Fig.3). As seen in Fig. 3-18, the horizontal layer over the depths roughly from 10m to 13m for the length between BV21-1 and BV21-2 is seemingly soft by showing higher

water content with the relatively low values of V_s , N -value, and ρ_d . The supposed soft soil layer corresponds to the portion characterized by the low-velocity from surface wave survey.

In addition, the controlled value for the density was set to $0.9\rho_{d \max}$ based on the compaction curve similar to that of the sample at point A. It is now almost certain that the soft soil layer with larger amount of fines, and having lower values of V_s , N -

value and ρ_d is responsible for the damage of the wall as shown in Fig. 6. The profile of $V_{s,f}$ with depth is shown in Fig. 9, in which the result of the BE test is also shown for comparison.

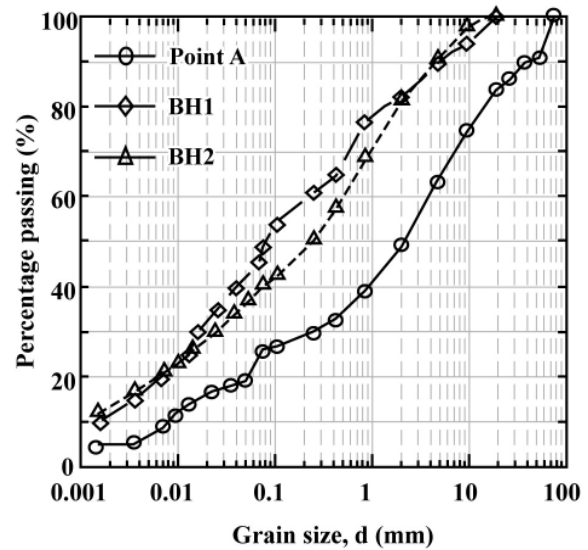
Fig. 7 Grain-size distribution curves.

On the other hand, the soil at point A may well be regarded as a representative sourcing for the fill material. Fig. 7 shows the grain size distribution of these three samples. It is obvious that the soils

from BH1 and BH2 are much finer in grain size by showing the fines content, $F_c = 49.0\%$ and 40.2% for BH1 and BH2, respectively, whereas $F_c = 25.2\%$ at point A.

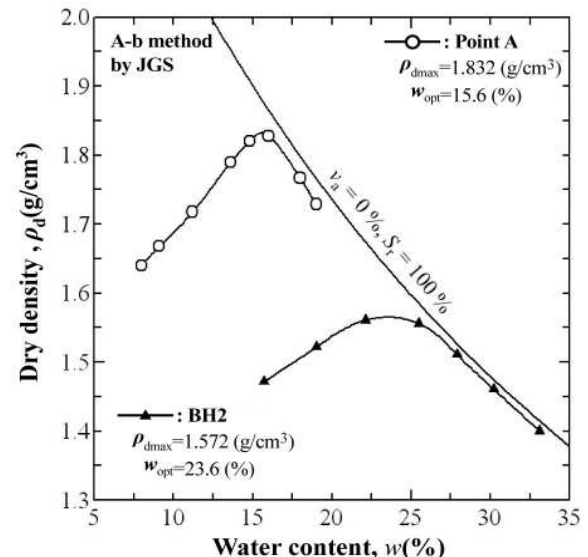
Fig. 8 Compaction curves.

Fig. 8 shows the compaction curves of two samples at point A and BH2. The maximum dry density, $\rho_{d \max}$, of the BH2 sample was far smaller than the other sample (n.b., $\rho_{d \max} = 1.572 \text{ g/cm}^3$ for the BH2 sample and $\rho_{d \max} = 1.832 \text{ g/cm}^3$ for the other), whereas the optimum water content was higher (n.b., $w_{\text{opt}} = 23.6\%$ for the BH2 sample and $w_{\text{opt}} = 15.6\%$ for the other).

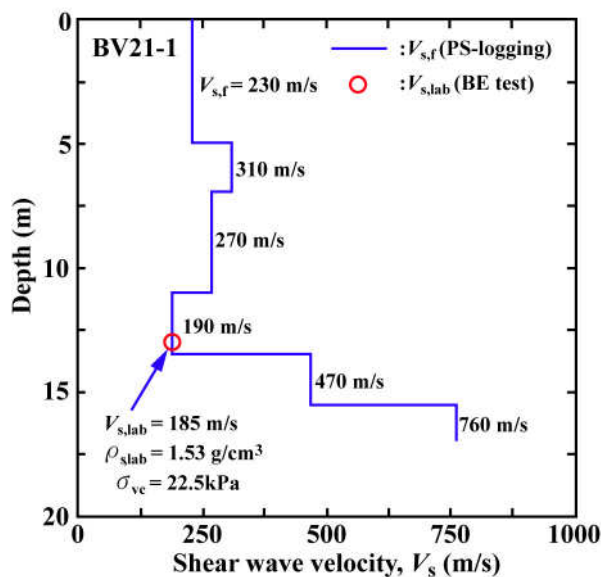
Fig. 9 Results of PS-logging and BE test.

The $V_{s,lab}$ from the BE test almost coincided with $V_{s,f}$ at the relevant depth when the sustained σ_v of the laboratory sample was 22.5 kPa, noting that the σ_v of 22.5 kPa accounts for merely one-tenth of in-situ overburden pressure at the prescribed depth.

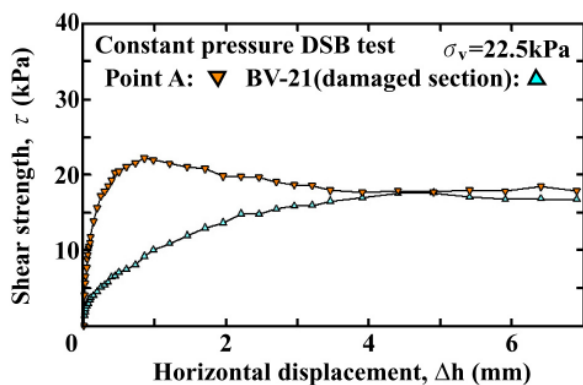
Fig. 10 τ - Δh relationships in constant pressure DST.

In an attempt to obtain the shear strength at the damaged section, the constant-pressure DST (for the details of apparatus, see Shibuya et al., 2005) was performed. The relationship between the shear stress and the horizontal displacement is shown in Fig. 10, in which similar result of the sample from point A is also shown for comparison.

The maximum shear stress, τ_{max} , of 17 kPa was very small for the sample at the damaged section, bearing the overburden height of the embankment of about 10m in mind. The stress-displacement curve exhibited no peak for the sample, whereas it showed a higher strength involved with a distinct peak for the other sample comprising fewer fines.

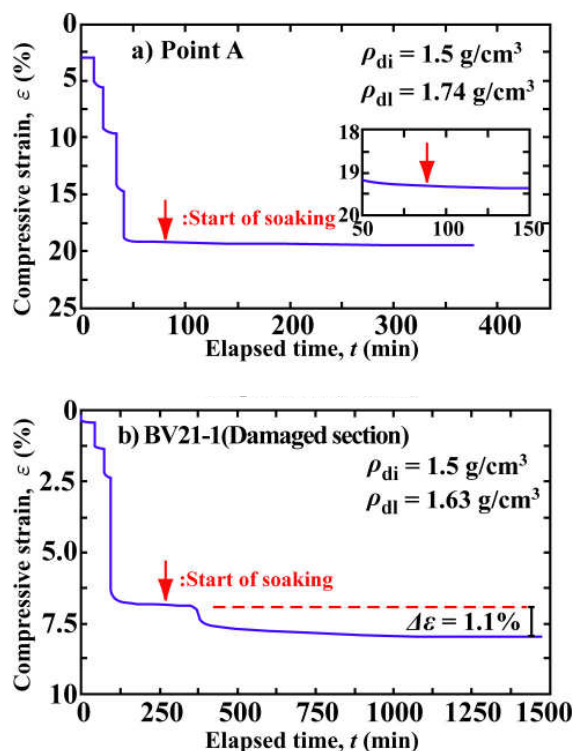
Fig. 11 Results of Soaking test at $\sigma_v = 200$ kPa.

The results of soaking test are shown in Fig.11. In the event of soaking, the sample at the deformed section exhibited a considerable amount of settlement with time to reach the compressive strain of 1.1 % over a period of one day. Conversely, no volume change was observed for the other sample.

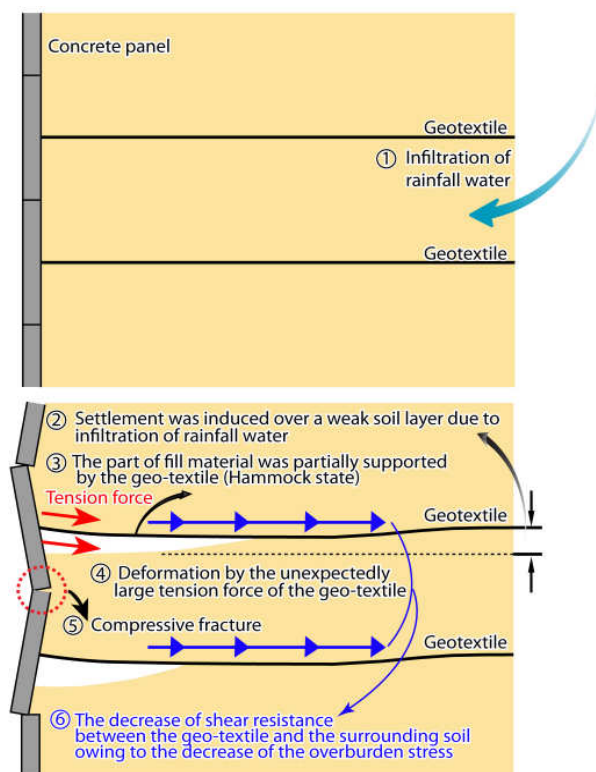
Fig. 13 Mechanical behaviour of a largely-deformed reinforced earth wall with geo-textile.

Based on this observation, the background as well as the mechanical interpretation for the damage of the wall can be postulated as an image shown in Fig.13, it may be described such that;

- i) a considerable amount of subsidence took place over the weak soil layer in the lower part of the reinforced earth due to seepage of rainfall water,
- ii) the weight of the upper fill was partially supported by the geo-textile hooked on the concrete panels, and
- iii) the concrete panels associated with the hammock state were severely damaged by the unexpectedly large downwards compression force triggered by the tension force of the geo-textile.

Once the “hammock state” was reached inside the wall, the overburden stress corresponding to the hammock state in the fill will be dramatically reduced, which in turn would bring about decrease of the shear resistance between the geo-textile and the surrounding soil.

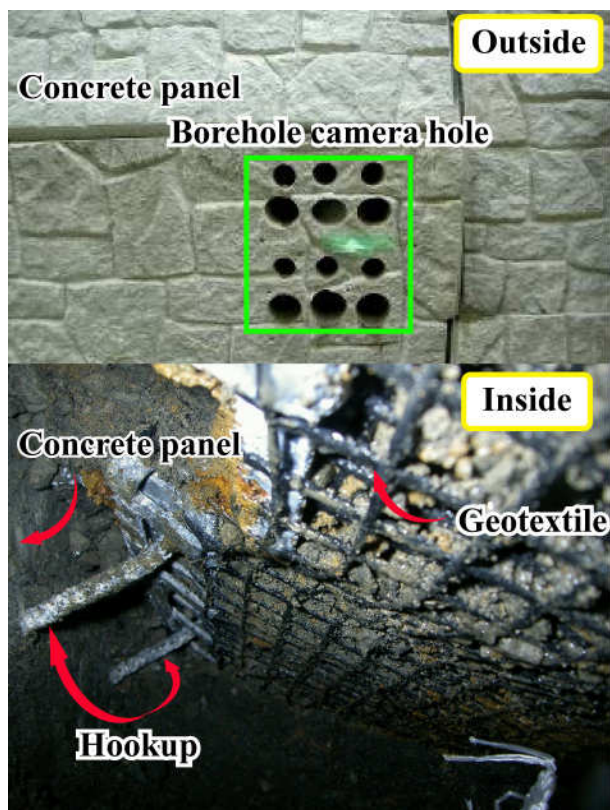
Fig. 12 Pictures inside reinforced earth wall.

The results of site investigation have revealed the fact that a 3m-thick weak soil layer extends behind the damaged section of the wall. The weak soil layer may be characterized with unexpectedly low values of V_s , ρ_d and the SPT N-value. In addition, the soil properties can be characterized by the occurrence of a considerable amount of settlement on soaking. Fig.12 shows the pictures inside the wall at the deformed section.

A space was found underneath the geotextile, suggesting that the weight of the fill above the geotextile was partially supported by the geotextile. In this paper, the new wording of “hammock state” is conveniently used for describing it.

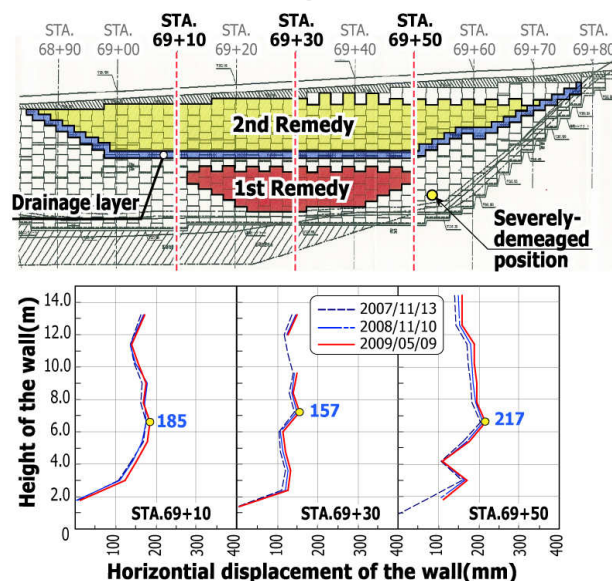
Fig. 14 Observed deformations of the wall facing.

As seen in Fig.14, the range for the maximum value of horizontal deformation was 150 to 200mm. This corresponds to deformation rates of 1.0 to 1.5% against the height of the wall.

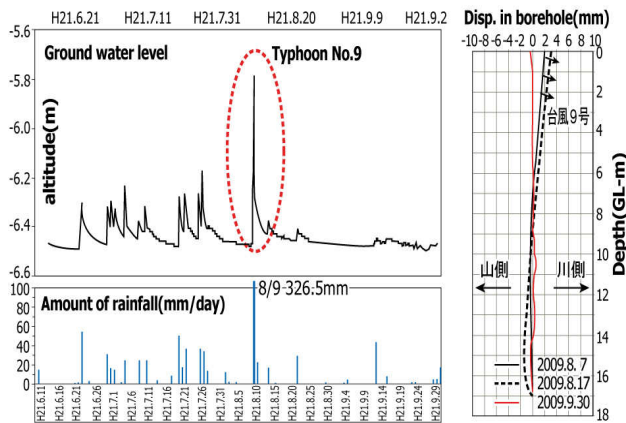
Fig. 16 Record of rainfalls at the site

Fig. 16 shows the record of rainfall at the site. It shows that the measured displacement increased after raining. This result may be interpreted due to the effects of infiltration water caused by heavy rains, which remained inside the embankment, despite that the drainage layer was made at the time of the second remedy construction.

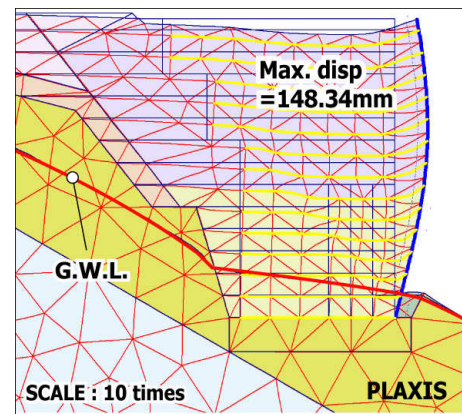
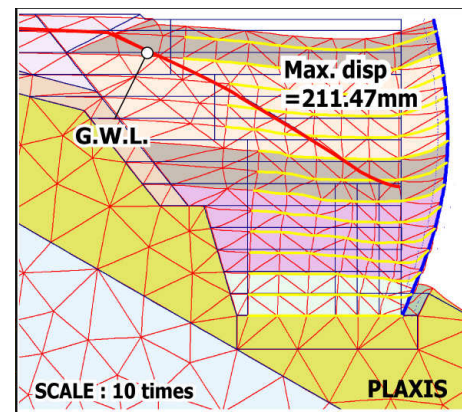
Fig. 18 Deformed meshes due to increase in water level.

Fig. 18 shows how the reinforced earth wall deforms according to the increase in the ground water level. The maximum amount of displacement with and without raining is 211.5mm and 148.3mm, respectively. This simulation demonstrates that the infiltration water permeating the reinforced earth wall has a strong influence on the movement of the wall.

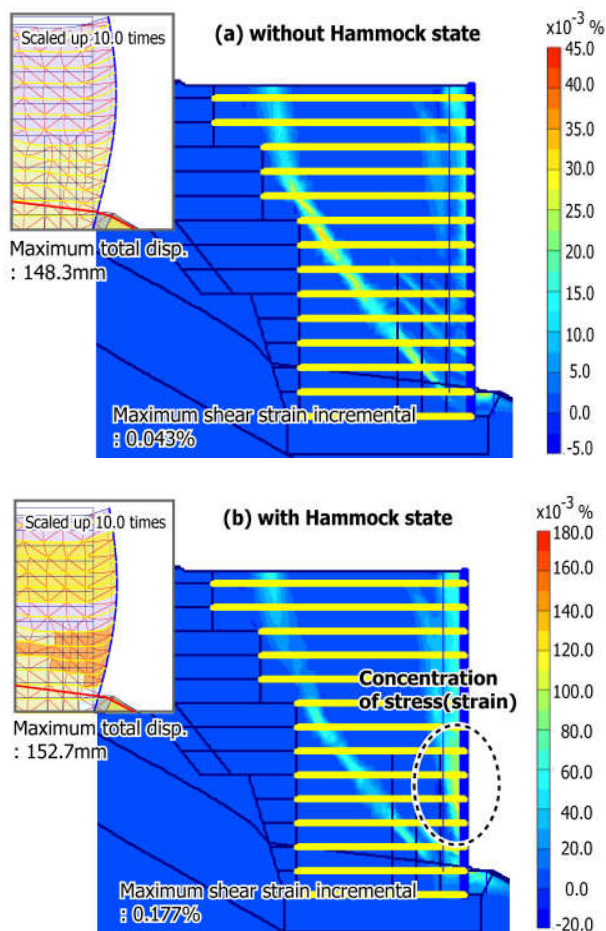
Fig. 19 Incremental shear strains in the fill, together with the deformed meshes near the wall facing.

Fig. 19 shows the results of analysis performed for two cases, i.e., the case of normal geogrid and the other case of geogrid subjected to the condition of “hammock”. Based on the observation, the hammock condition was assumed over the lower part of the wall comprising the soft soil layer. The effect of hammock was significant in that large deformation was observed near the wall by showing the maximum shear strain increment almost ten times the normal condition.

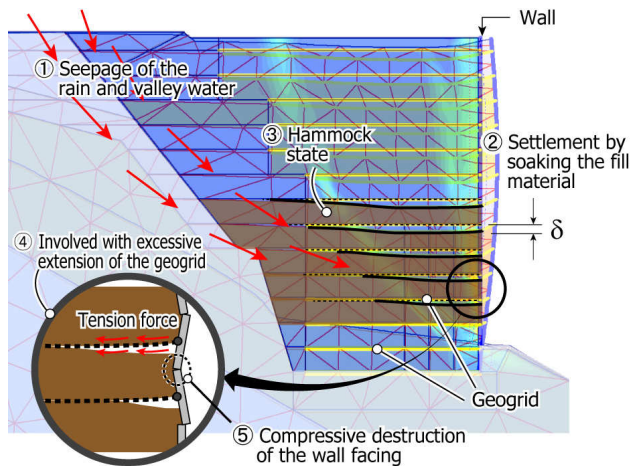
Fig. 20 Sequence for the development of wall.

As depicted in Fig.20, the large deformation of the wall may be induced with the sequence of events in the following. First, highly compressive filling materials existed inside the backfill. Second, rainwater and the water in a valley infiltrated into the layers, which in turn induced deformation in compression.

As a result of the generation of settlement in the weak soil layer, so-called ‘hammock state’, in which the weight of the upper filling was partially supported by the geogrids, was gradually formed.

This condition generated high tensile force to the geogrids, which in turn induced stress concentration on the concrete panel connected to the high-tensioned geogrids. As a consequence, a type of compression failure took place on the concrete panels.
