## Collapse of Braced Excavation in Singapore

K. Ishihara

**ABSTRACT:** After the collapse of the subway excavation in the Nicoll Highway, extensive in-situ investigations were carried out to identify causes of the accident. The results of detailed studies disclosed that lack of toe-in depth of the diaphragm wall into the stiff competent strata could be one of the causes of the incident. This aspect of the studies is highlighted in this paper.

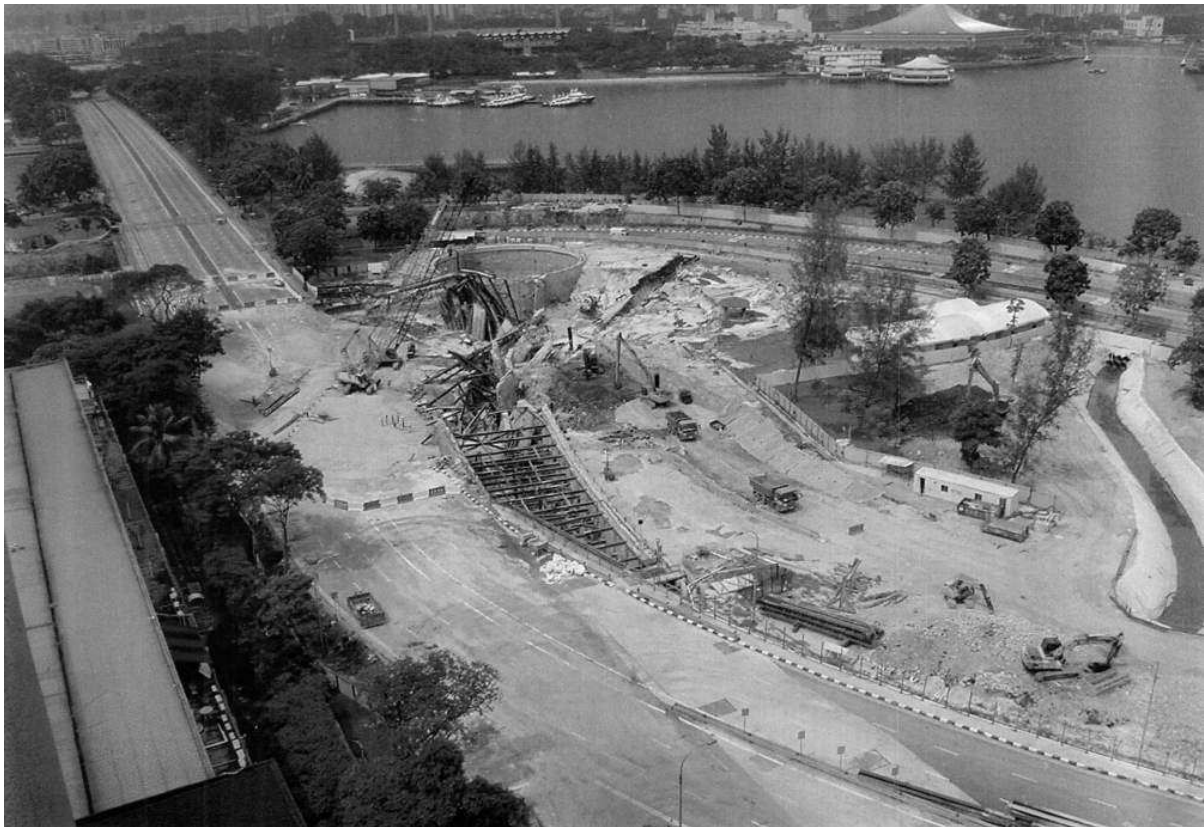
Fig. 3 Oblique view of the site to the east after the collapse.

A section of temporary retaining wall structure adjacent to Nicoll Highway collapsed almost suddenly within a matter of a few minutes at 3:30 p.m. on April 20, 2004. An overview of the site of failure is shown in Fig. 3. This is located at the seaward side of the land reclaimed around 1970. The features of the braced excavation and collapse are roughly shown in the plane view of Fig. 4 where it is noted that a large tunnel access shaft (TSA) 17m in radius had been constructed to facilitate transport of structure elements and materials down to the floor of the excavation.

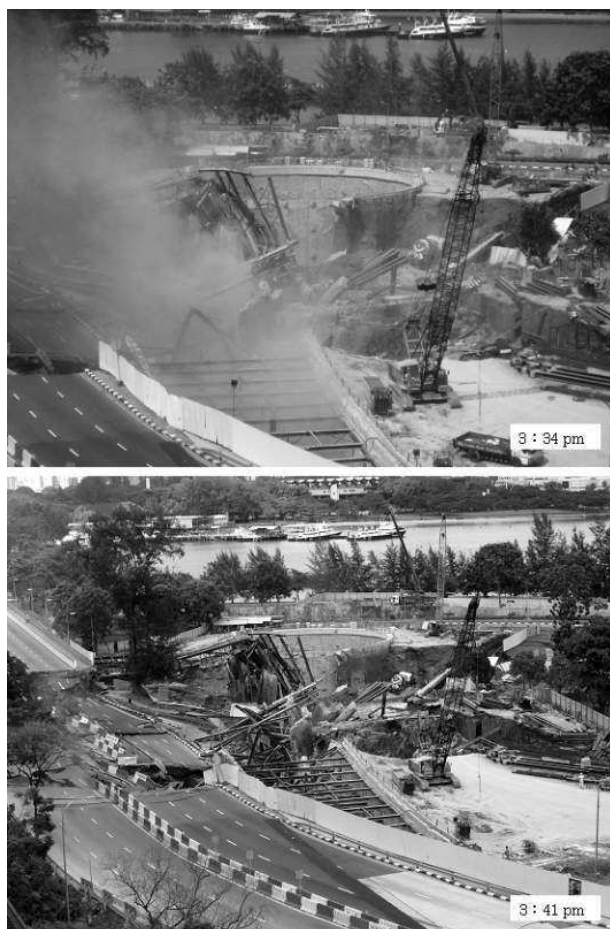
Fig. 7 Photos showing the incident at 3:34 p.m. and 3:41 p.m.

In the morning of April 20, from 9:00 a.m. to 10:00 a.m. engineers on the spot is said to have heard sounds of metallic collision near the north side of the strut S338 and observed the inner flange of H-beam waler at the 9th strut having buckled and shifted about 5 to 6cm downward. This shift aggravated to about 20cm by 2:30 to 2:45 p.m. It was also witnessed around this time that the inner flange of the waler at the 9th strut S335 on the south side had also buckled. Between 2:00 p.m. and 3:00 p.m. the sounds of metallic collision were heard more frequently and eventually the collapse took place at 3:33 p.m.

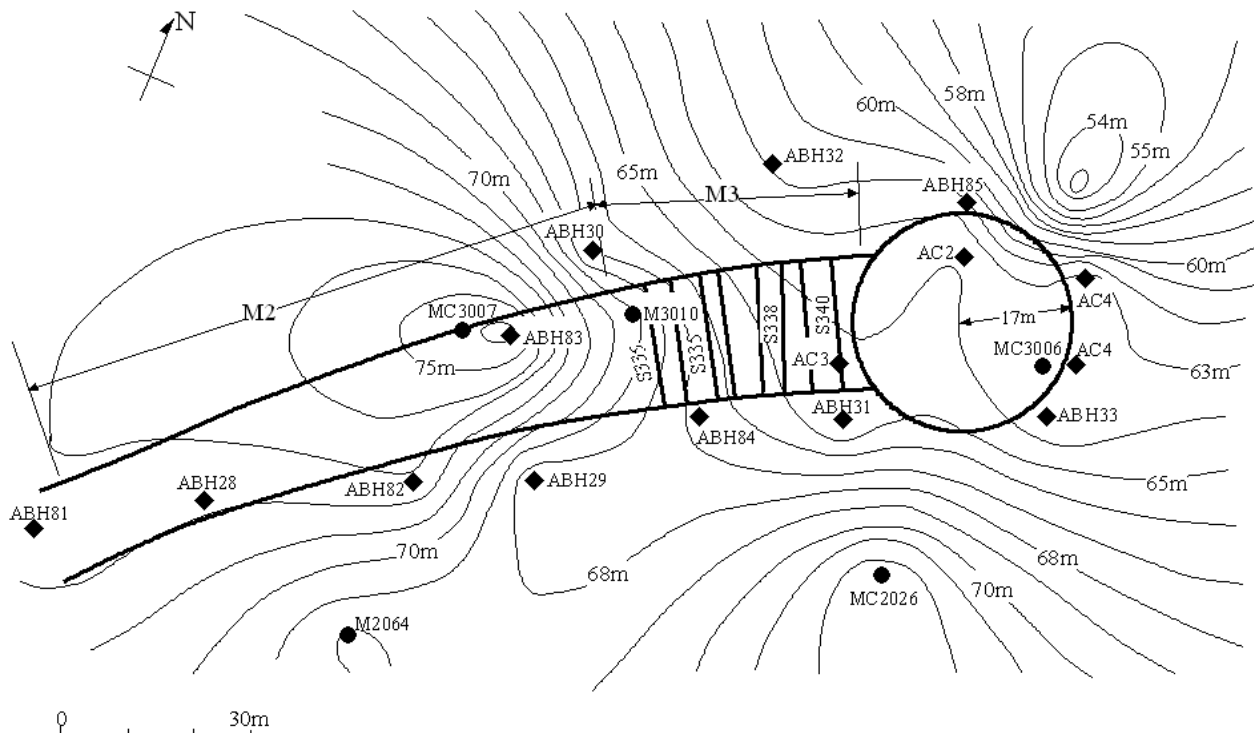
Fig. 8. Contours of elevation at the top of the old alluvium (OA-layer) based on boring data at the design stage.

In view of its importance, the contour lines indicating equal elevations of the top of the OA layer were also drawn in Fig. 8, on the basis of the information available at the design stage. It is noted in Fig. 8 that the distance between two adjacent boring logs was no shorter than about 20m and consequently the buried valley near the southern wall close to the access shaft was not identified. This fact turned out to be vital for creating the worst situations to occur afterwards.

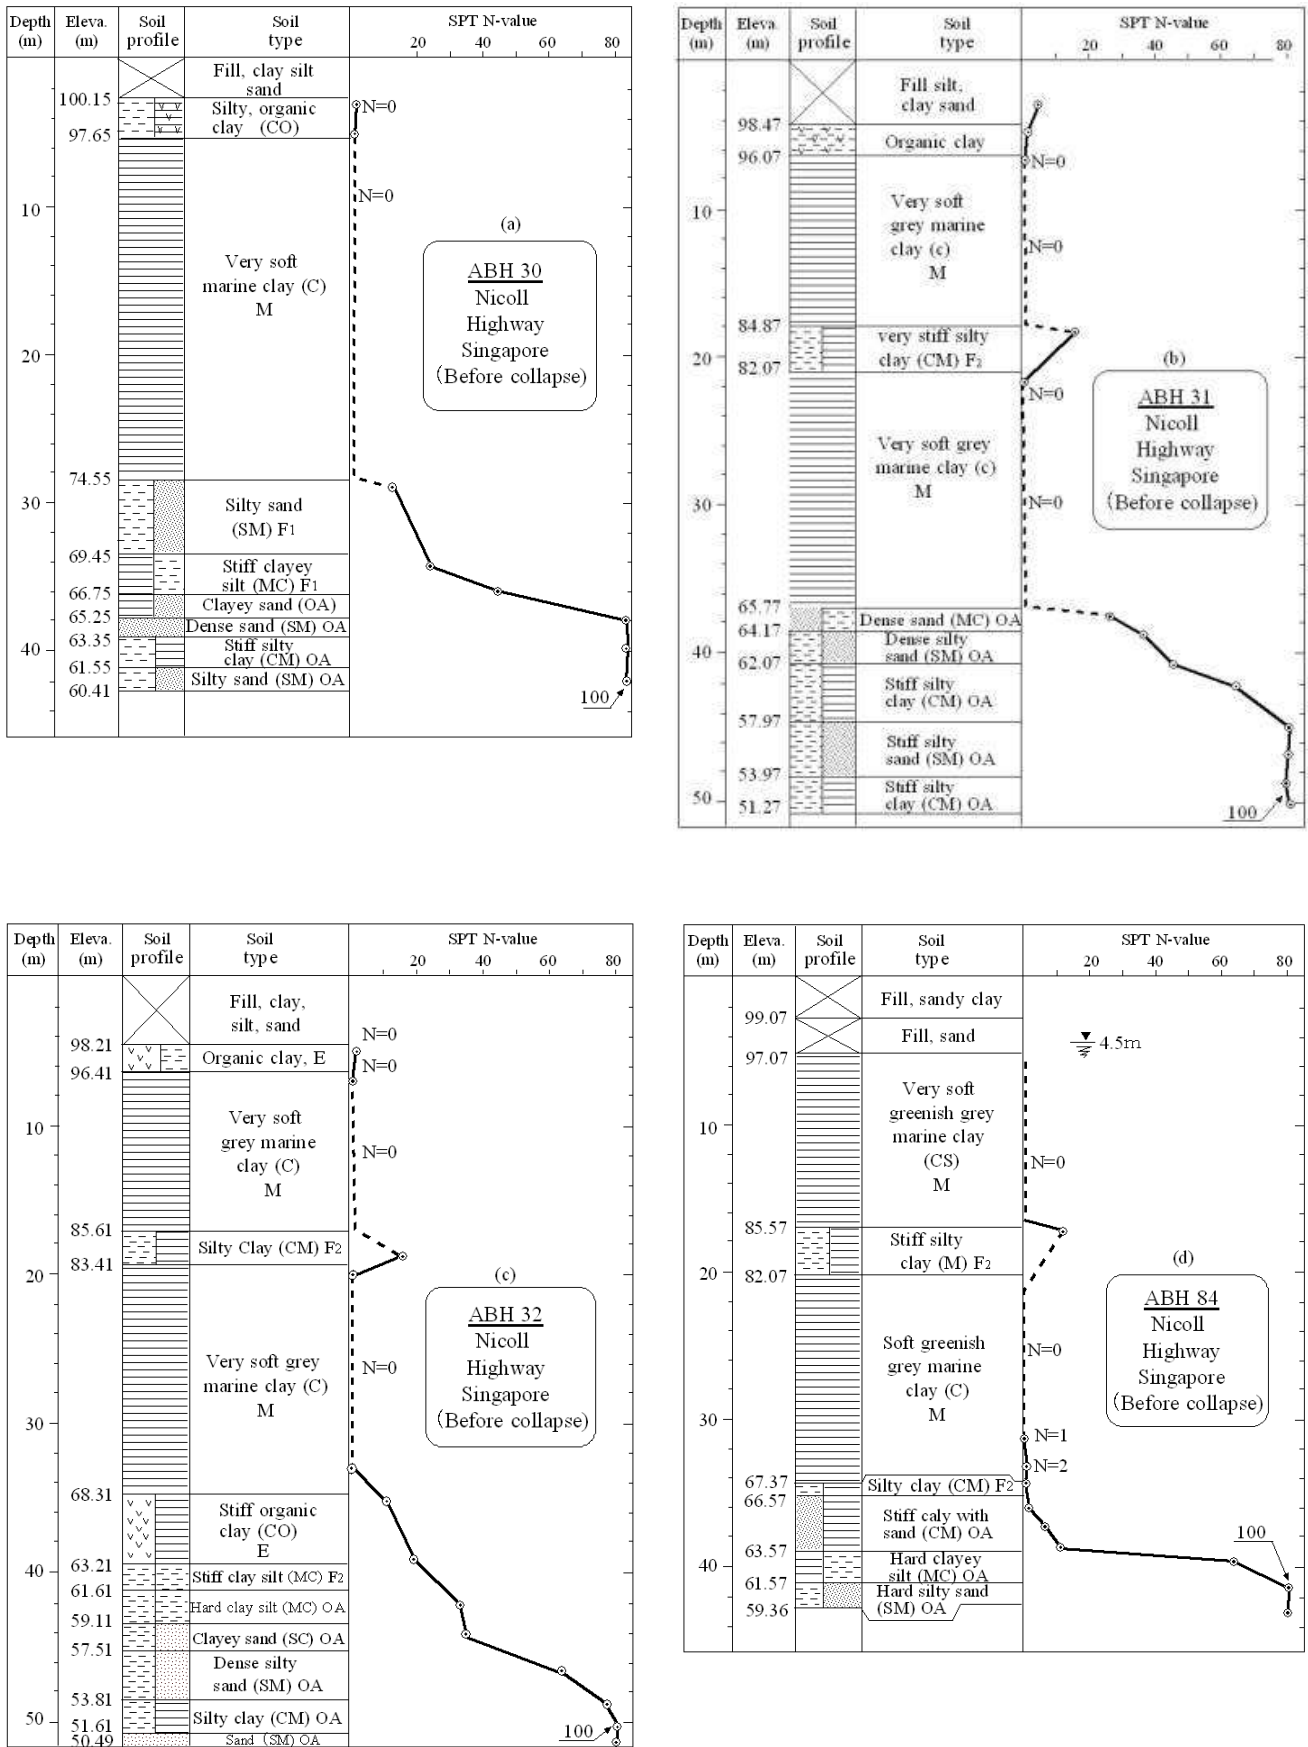
Fig. 9 Soil profiles at the sites near the excavation obtained before the collapse.

The results of the boring and SPT N-values at the site ABH30, 31, 32 and 84 are shown in Fig. 9. It may be seen that the recent fills exist to a depth of 3 to 5m underlaid by a thick deposit of soft marine clay, M, having a SPT N-value of zero. In the middle of this clay deposit, there exists a stiff silty clay layer of fluvial origin about 3m thick at the depth of 18 to 20m. This layer has a SPT N-value of 10 to 15 and denoted by F<sub>2</sub>.

The deposits M and F<sub>2</sub> are called Kallang Formation. Under the Kallang Formation, there exists a stiff silty sand layer having variable SPT N-value from 10 to greater than 100. This layer is an old alluvium and denoted by OA. Between the marine clay M and the OA layer, there exists occasionally the estuarine deposit, E, consisting of organic soil and also the fluvial layer F<sub>2</sub>.

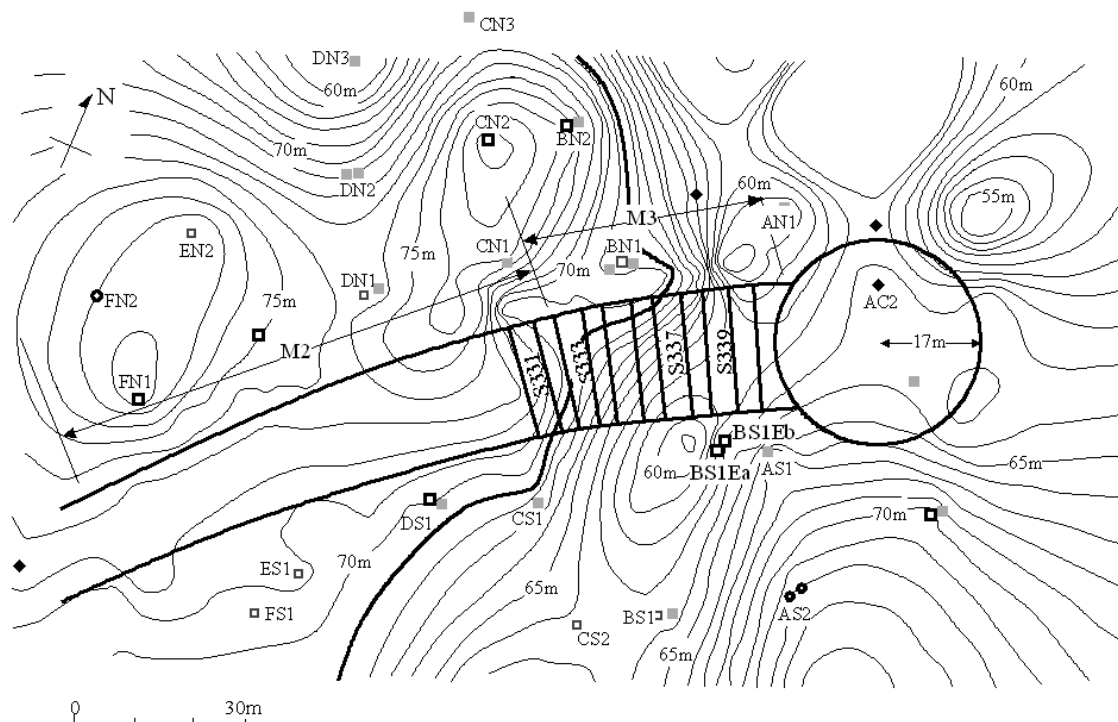
Fig. 10 Counter of elevation at the top of the old alluvium (OA-layer) based on boring data after the collapse.

By compiling all the data made available after the collapse, the contour lines of the top of the OA layer were established as demonstrated in Fig. 10 with a higher level of accuracy as compared to that shown in Fig. 8 which was made up with the boring data at the time of the feasibility study and the design. The contour lines in Fig. 10 unveil some important features as follows which had not been identified in the previous map in Fig. 8.

- (1) There exists a steeply depressed buried valley at the location on the south side a few meters south of the strut S336 and S337. The bottom of the buried valley has an elevation of about 59m RL. The buried valley dips steeply towards the east from the south end of struts S331.

- (2) The buried valley extends towards the north-east running on the west side of the tunnel access shaft (TSA).
- (3) As typically observed in the soil profiles at BS1Ea and BS1Eb in Fig. 11, the SPT N-value tends to increase at the elevation of 67m RL upon hitting the base layer OA. The SPT N-values corresponding to the transition zone below the OA layer were collected from other borings and shown together in Fig. 16 by choosing the nominally identified top of the OA layer as zero point. It may be seen that the property of soils is not so competent with a SPT N-value less than about 30 to a depth of about 3m from the top of the OA layer.

In the area of complicated geological setting, existence of buried valleys should be suspected at the stage when projects are put forward. In such a case soil investigations need to be carried out at a spacing closer than that normally adopted. In addition, properties of soil materials within the buried valley should be investigated in details, if it is discovered. The outcome of these studies should be meticulously reflected on the grand planning as well as on detailed design of the soil-structure system considering each phase of construction processes.

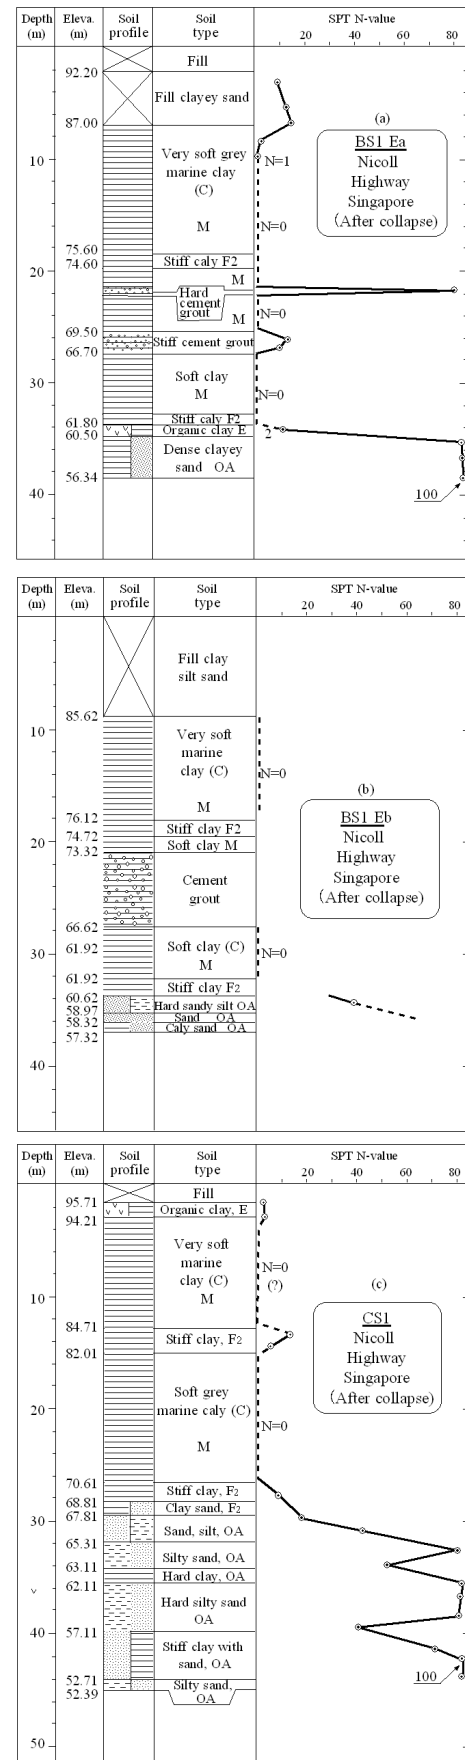
Fig. 11 Soil profiles just south of the collapsed diaphragm wall panels.

Some of the results of the borings conducted at points BS1Ea and BS1Eb about 7m south of the collapsed wall is displayed in Figs. 11(a) and (b) where it can be seen that remains of the grouted cement were encountered at an elevation of 73m and 67m RL. In another boring at CS1 shown in Fig. 11(c), the soil stratification was found to be about the same as that before the failure event.

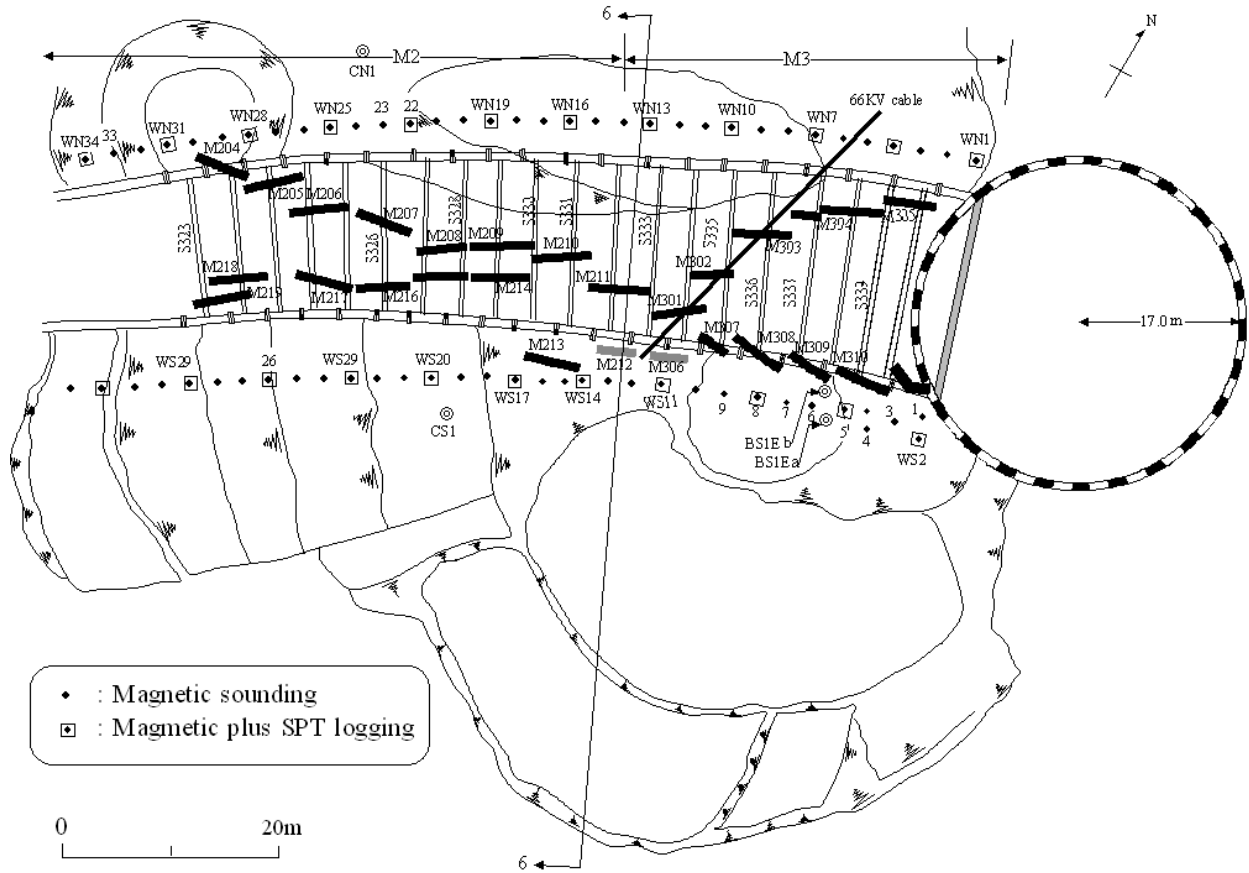
Fig.12 Locations of the magnetic sounding and boring conducted after the collapse.

The magnetic logging was conducted at a spacing of about 2m along the alignment 3m behind the northern diaphragm wall. These are denoted by WN1 southward to WN34 as shown in Fig. 12. Similarly, along the alignment 3 to 5m behind the south diaphragm wall, the magnetic logging was performed. These are indicated by WS1 to WS33 in Fig. 12. When the boring hits some obstructions, the drilling was made once again nearby. In the area between WS10 and WS14, it was not possible for the boring to reach the targeted depths because of obstructions encountered midway. Thus, several more borings were carried out until they reached the OA base deposit.

After investigating the location of the exposed top of the diaphragm wall panels, it became possible to approximately figure out the scenario of the failure. Exact locations of the panel top in plan view are shown in Fig. 12. Based on the features shown in this figure it may be mentioned that the collapse mechanism at panels M213, M212 and M306 were different from that elsewhere and almost certainly it involved the toe of the diaphragm wall panels kicking in, and flow of the soil underneath the diaphragm wall panels. This form of the failure will have allowed the maximum southward movement of the opposite north wall panels, namely M211 and M301.

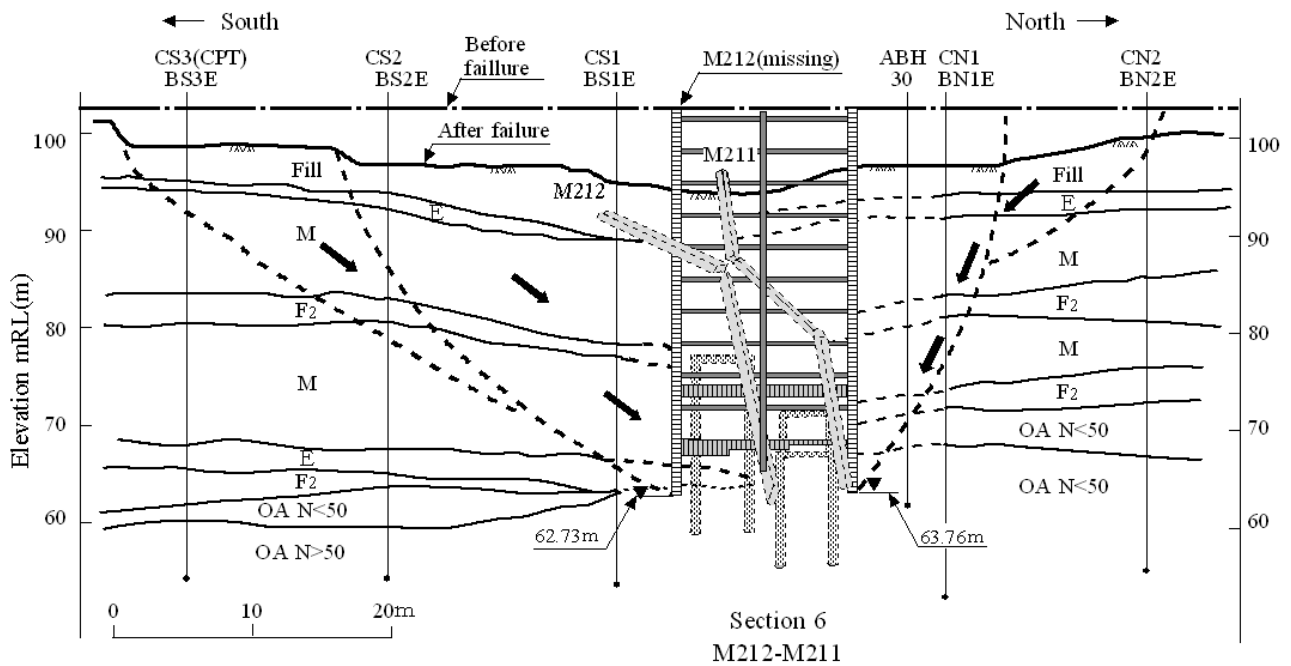
Fig.13. Features of the ground movements towards the excavated space accompanies by the subsidence.

huge amount of soil mass moved into the excavated space. In fact, a subsidence of the ground surface as much as 10m was observed on the south side in proximity to the wall and the settlement extended about 50m southward, as seen in Figs. 4 and 12. The area of the ground settlement extended also north towards the Nicoll Highway but to a lesser extent as can be seen in Fig. 4. Thus, it was considered certain that the failure was initially triggered by the breakage of the diaphragm walls on the southern side, thereby involving a landslide towards the excavated space. As a result of losing the horizontal support, the northern walls moved also towards the excavation, inducing sliding of soil mass towards the south but to a lesser extent.

This scenario of the event was substantiated by the borings conducted after the failure in which the elevation of the intermediate layer  $F_2$  was found to be located almost 10m lower than that found by the borings before the failure. Note that prior to the collapse, the elevation of the base of intermediate  $F_2$  layer was remarkably consistent across the collapse area, and so provides a good marker for identifying the vertical displacement of the soil deposit. The location of the  $F_2$  layers after the collapse is shown in the cross-section in Fig. 11. It was then possible to depict the mode of soil movement involved in the slides on the south and north sides. The approximate locations of the sliding surfaces are displayed in Fig. 13 for the cross section 6-6 of Fig. 12.

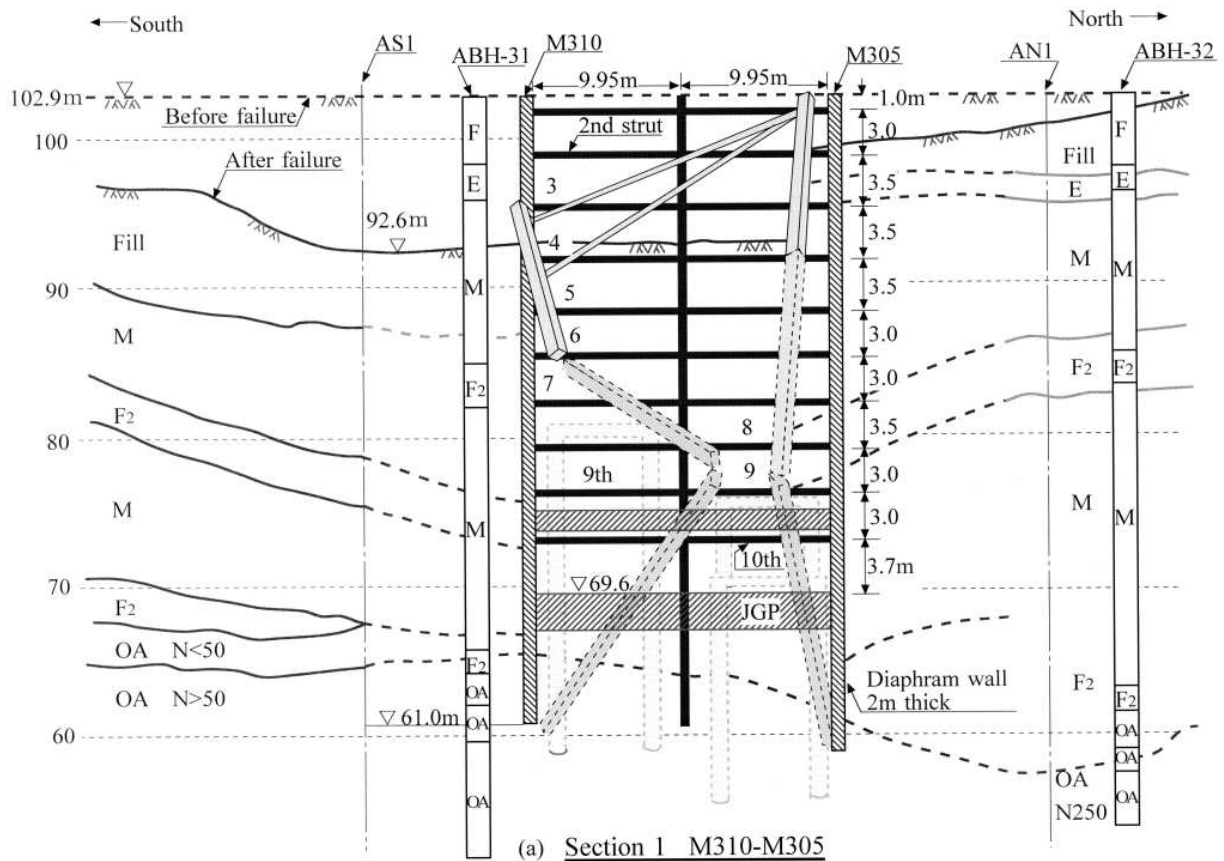
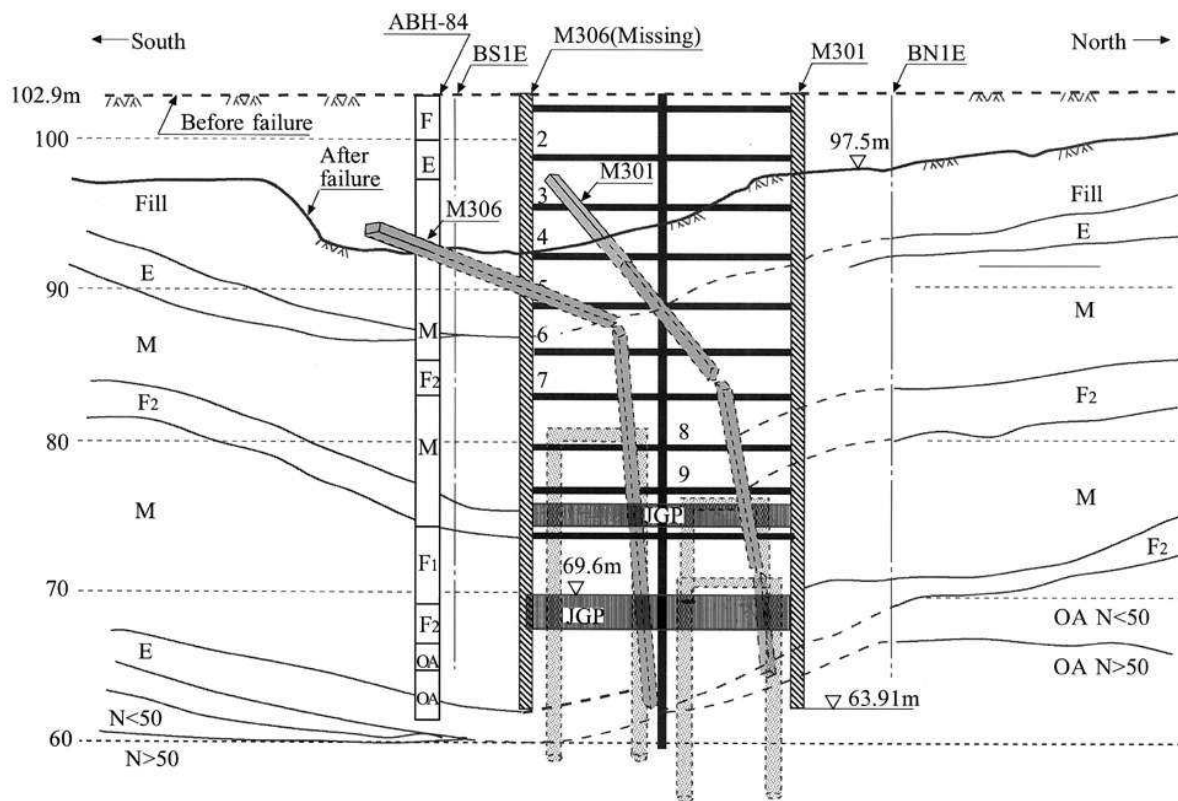
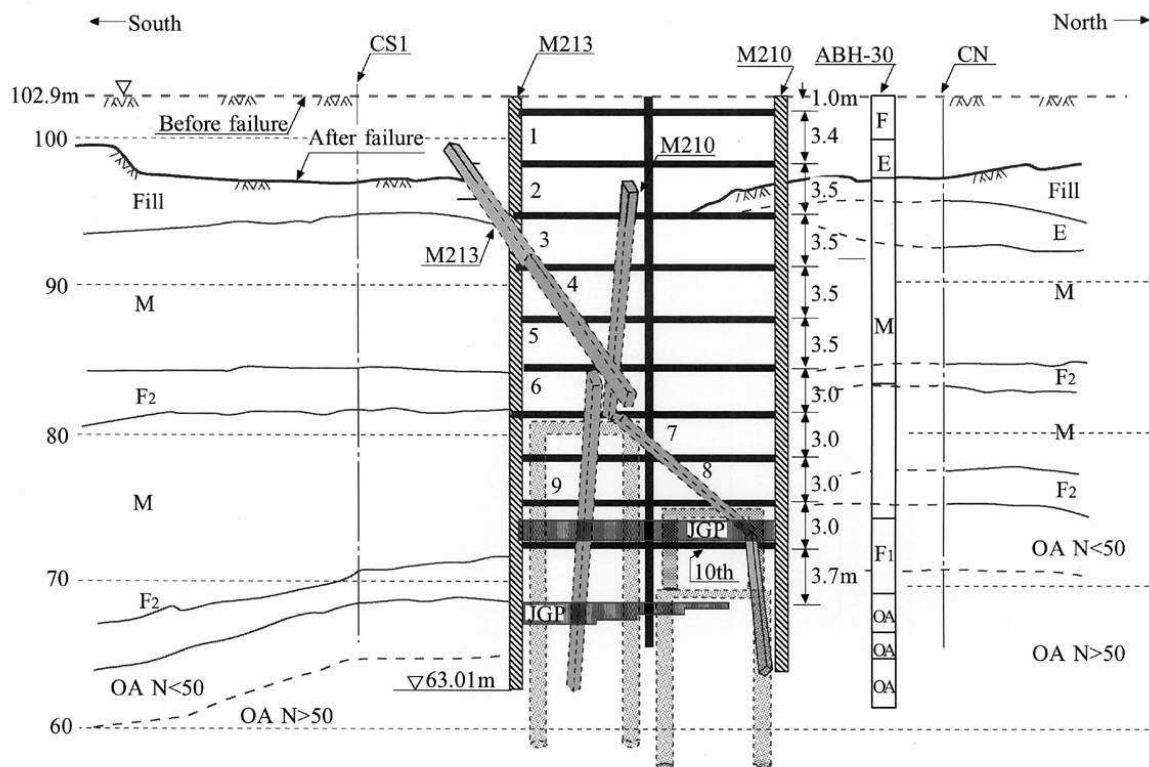
Fig.15 Cross sections showing the mode of collapse in the zone of failure.

As a result of the post-incident in-situ investigations as above, it became possible to figure out approximately the states of collapse for each of the cross sections indicated in Fig. 14. Shown in Fig. 15 are probable features of the collapsed water-strut system buried within the ground which were speculated for the cross section 1, 5 and 7. It is to be noticed that in the cross section 1 and 5, the intermediate layer  $F_2$  is inclined towards the excavation as verified by the boring data at ABH31 and 32 and also at AS1 and AN1 conducted after the failure. This is indicative of the settlement of the even deep-seated soil layer involved in the slide.

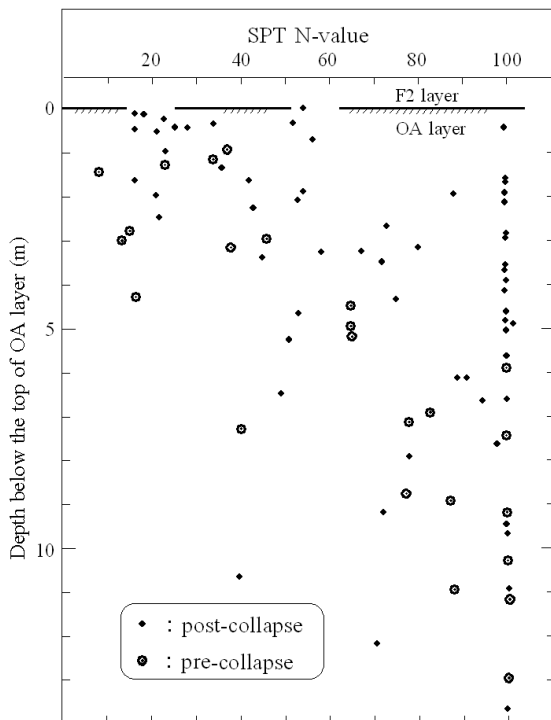
Fig.16. SPT N-values from the top of the OA layer

With regard to the latter suspect, closely-spaced soil investigations revealed that the upper part of the OA layer in the buried valley is comprised of sands, silts and clays sometimes containing organic materials with the SPT N-value not greater than 30 as demonstrated in Fig. 16. This fact indicates that the infill materials were not necessarily as competent as they had been expected at the design stage.

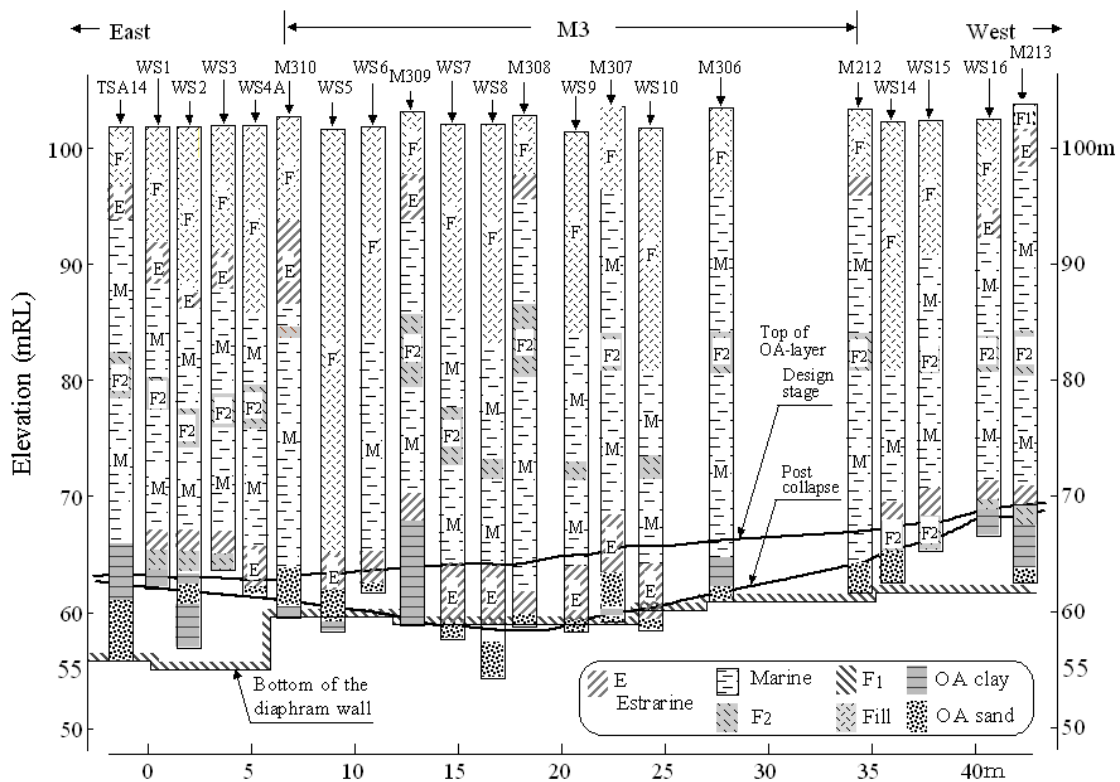
Fig. 17. Soil profile along the south wall and bottom of the diaphragm wall.

To obtain a clear picture of the toe-in depth, the results of the borings at the time of the magnetic logging tests plus some others nearby were compiled and arranged side-by-side so that soil profiles along the alignment south of the diaphragm walls can be visualized. The picture arranged in this way is demonstrated in Fig. 17 where the top of the OA layer considered at the design stage is indicated, together with the similar top line established after the collapse based on the detailed investigation by the magnetic logging. Note that the symbol such as M306 to M310 and M212 indicate the location of the diaphragm wall panel. It is also to be noted that for the section between M212 and M309, the estuarine deposit E and the upper part of the OA layer might have been displaced laterally being involved in the slide.

At the same time, settlements of the order of 5-10m are envisioned to have occurred in the upper part of the OA layer, as inferred from the settlements of the upper lying layer  $F_2$ , as shown in Figs. 13 and 15, which was confirmed by the post collapse boring data. From the records of the diaphragm wall construction, the bottom line of the wall before the collapse is known and it is shown together in Fig. 17.

By comparing the elevations at the top of the OA layer before the collapse with those of the bottom of the diaphragm wall, it can be seen from Fig. 17 that in the eastern zone between WS1 and WS4A, the toe-in of the wall was more than 3m. In the zone of collapse between WS5 and WS16, the toe of the diaphragm wall seems not to be embedded sufficiently deep. However, the depth of embedment into the OA layer may be considered deeper than 3m in consistence with that considered in the design. It is to be pointed out, however, that the quality of the soils at the upper part of the OA layer was less competent in stiffness or strength as compared to that assumed at the time of the design. This point would have a more important bearing from the forensic point of view.

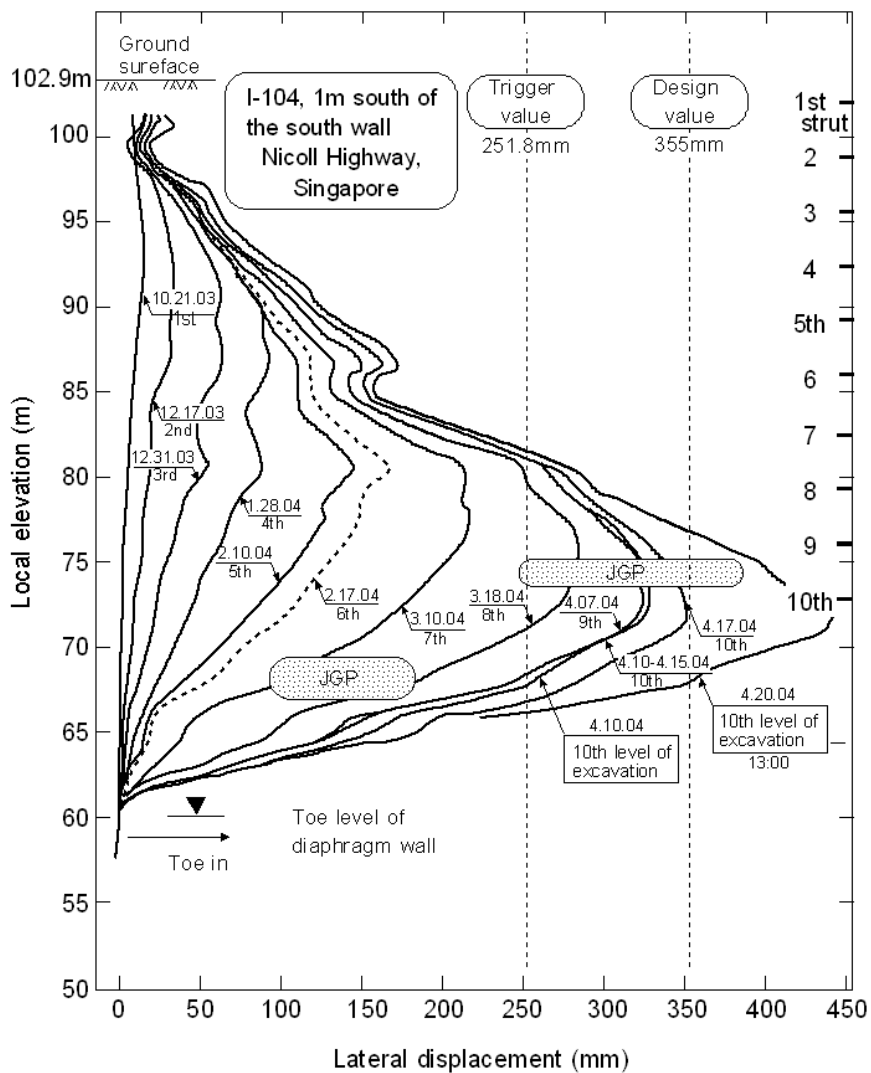
Fig. 19 Time change of depthwise distribution of the wall measured by the inclinometer in the soil deposit 1m apart from the south wall.

In the area which failed there were inclinometers at or just behind the wall at the north and south sides of the excavation. Shown in Fig. 19 is the time change of depthwise distributions of the wall deflection estimated from the inclinometer, I-104, which had been installed in the soils 1.0m apart from the south wall near M212 (Fig. 18).

It is known that the wall deflection started to increase significantly from April 17, 2004 as indicated by a dash line in the figure.

The maximum displacement measured at 13:12 on April 20, 2004 is known to have amounted to 43.5cm at the elevation of 72m. It is to be noticed that actual collapse took place at 15:33. i.e. 2 hours 21 minutes (141 minutes) afterwards. Thus, it is likely that just at the time of collapse, the maximum value of the wall deflection might have been larger than 43.5cm. It should be cautioned that the waler-strut system had sustained the deflection of at least 43.5cm for the period of 141 minutes without causing collapse.

To be noticed, moreover, is the fact that the distribution of the wall deflection shown in Fig. 19 was obtained by integration of tilts at several depths measured by the inclinometer on the assumption that the tilt at the toe was equal to zero. This assumption may not be correct in the present case, because the toe of the diaphragm wall had not been firmly embedded in a stiff base stratum. Thus, the distribution of the wall deflection shown in Fig. 19 should be taken simply as indicating the relative displacement counted from the toe of the diaphragm wall.

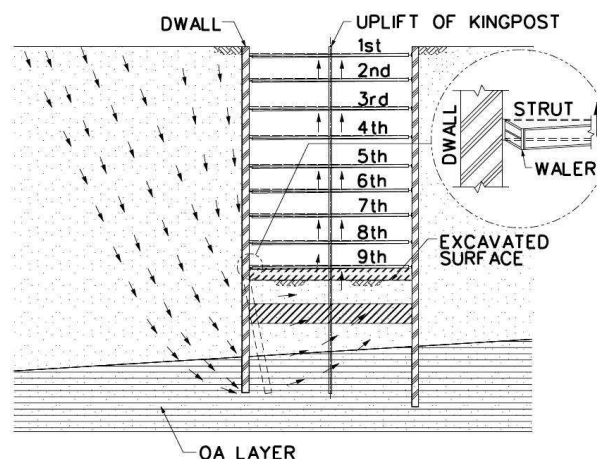
Fig. 19. Probable movements of soils near the toe of the diaphragm wall, and uplifting of the kingpost and sag of the wall leading to buckling and offset between strut and layer.

- (2) The inward movement of the wall panel toe must have caused some uplift of the soil deposits within the excavation, which induced in turn a lift-up of the kingpost in the middle of the struts. In addition, excavation has nullified

friction between the soil deposits inside and the diaphragm wall thereby inducing some sag of the heavy-weight wall. The sag must have caused the offset between the strut and walls.

- (3) This uplift, combined with the sag of the wall must have caused the local buckling or breakage of the flange of the H-beams at connection between the walers and struts, creating as much as 20cm vertical offset as illustrated in Fig. 20. As a result, the net length of the struts was shortened and diaphragm wall must have deformed further inwards.
