# **Dynamic Analysis of Earth Dam Damaged by the 2011 Off the Pacific Coast of Tohoku Earthquake**

This study examines possible failure mechanisms and dynamic behavior of the Fujinuma dam, which failed following the 2011 Off the Pacific Coast of Tohoku Earthquake. The study comprises two parts: an investigation through field and laboratory experiments, and a numerical simulation of the dam. Field measurements and laboratory experiments were conducted to acquire necessary information. Microtremor observations of the surviving portion of the failed dam were performed to extract data on its dynamic characteristics. Triaxial and other laboratory tests provided information required for the analysis. For the seismic analysis, a coupled solid-fluid finite element method was applied and observed and simulated motions of the 2011 Tohoku Earthquake used as input. Mechanical behavior of the dam material was described using the Mohr-Coulomb failure criterion. Frequency and dynamic analyses were performed and dam behavior and possible failure phenomena presented. Furthermore, a comparison between the simulation results and existing facts is discussed.

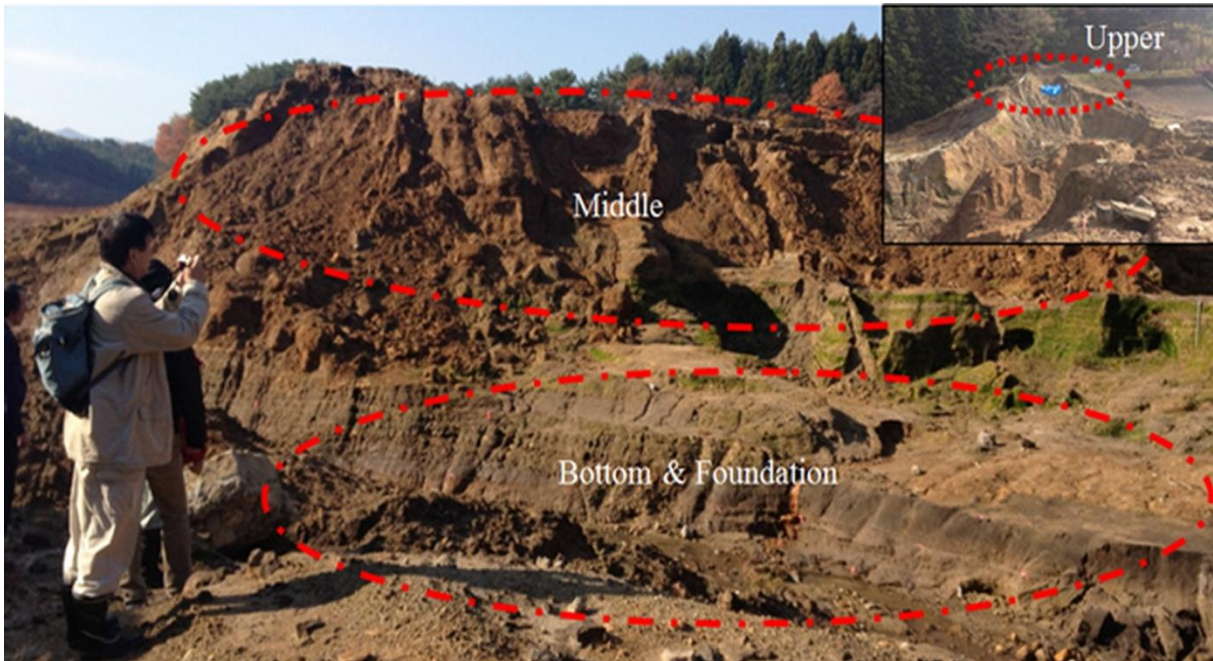
Photo1

Following the dam failure, most of the upper portion of the dam was washed away; the severe damage or breach location can be observed at the maximum cross section near the left abutment from downstream. On the opposite side, the remaining dam body consisted of the compacted fill materials. The foundations of the dam were exposed to ground level on the downstream side. From visual inspection of its properties, the dam body can be classified into three parts: upper, middle, and bottom.

The upper layer comprises the top 6–8 m to the dam crest. Unfortunately, most of the upper layer was flushed away when the dam failed. However, on the left abutment, a portion of the upper embankment remains. Visual observation was performed on this section, which revealed that the fill material consists mainly of coarse sand of light color varying from light brown to gray (Photo. 1).

The middle portion is about 7–9 m thick. This layer can be seen clearly in the remaining portion of the dam. From visual observation of this portion, this layer appears to have been filled with brownish cohesive soil containing yellowish-gray silt, loam-type clay, and humic silty sand (Photo. 1). Moreover, traces of compacted layers can be identified, each approximately 20–30 cm thick.

The bottom layer is between 4 and 6 m thick. This portion consists mainly of layers of loam-type clay and humic silty sand ranging from black to dark gray (Photo. 1). In addition, previous investigators [23,24] have indicated that some parts of the bottom layer consist mainly of dark brown sand and gravel. The black foundation material of the dam consists of organic residuals mixed with clay and silt.

Photo. 1. Remaining portion of the failed dam.

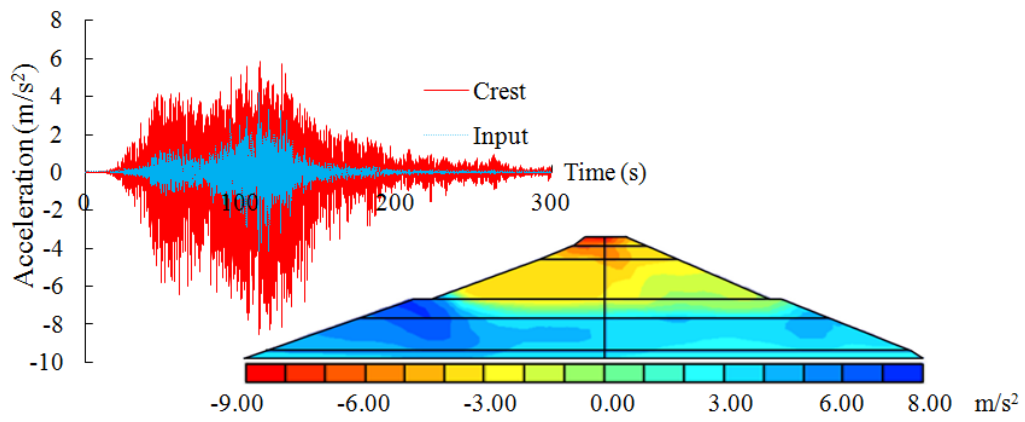
Fig12

Results show that larger maximum crest acceleration can be obtained using inverse phase of the observed and simulated motions. Therefore, the acceleration contours at the time when the maximum acceleration reached the dam crest are shown in Figs. 12 and 13 for inverse phase of the observed and simulated motions, respectively. By using the observed motion, the maximum crest acceleration is determined to be 7.42 m/s<sup>2</sup> and 8.56 m/s<sup>2</sup> accelerating towards the upstream direction at the time of 104.45 s and 111.60 s for normal and inverse phase motion (Fig. 12), respectively. For the simulated earthquake, the maximum crest acceleration is 7.60 m/s<sup>2</sup> acting towards the upstream direction at the time of 72.78 s. Similarly, for its inverse phase, the crest experienced the maximum acceleration moving towards the upstream side with a magnitude of about 7.65 m/s<sup>2</sup> at 71.24 s (Fig. 13).

For both motions, it can be seen that the acceleration at the dam crest is amplified significantly. The maximum amplification ratio taken from the crest to the base is 1.76 and 1.79 for the observed and simulated motions, respectively. To verify the effects of the phase of ground motion, the opposite waveforms were used as input motions and amplification ratios of 2.03 and 1.80 were obtained for the observed and simulated ground motions, respectively. This indicates that the response is very sensitive to input ground motion.

Fig. 12. Acceleration contours (inverse phase of observed motion).

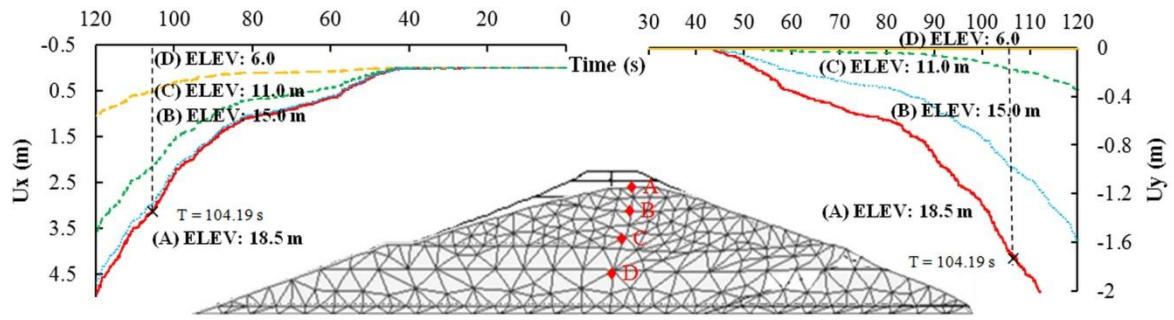
Fig14

Fig. 14 shows the deformed mesh at 104.19 s and its corresponding displacement curves when subjected to the observed motion. It can be seen that the entire dam body was moved in the downstream direction. As time increases, plastic deformations were accumulated. This caused the permanent horizontal displacement  $U_x$  of 2.95 m, and crest settlement  $U_y$  reached 1.80 m at 104.19 s; this is considered as the point of dam failure due to the loss of freeboard. Settlements at other observation points yield a similar tendency, but the settlements were less with decreasing dam height.

According to the facts, the dam experienced overflow and subsequent breach. The one possible cause is that the significant settlement of the dam body led to the loss of freeboard. Thus, the observed motion does reflect the actual failure mechanism of the dam, whereas the simulated motion does not. However, all cases show that settlement is high, especially in the upper portion of the dam owing to its softness. For the changed phase, the observed motions show the significant effect of creating the displacement obtained from the normal and inverse phase, to be in opposite directions.

Fig. 14. Deformed mesh at 104.19 s using observed motion.

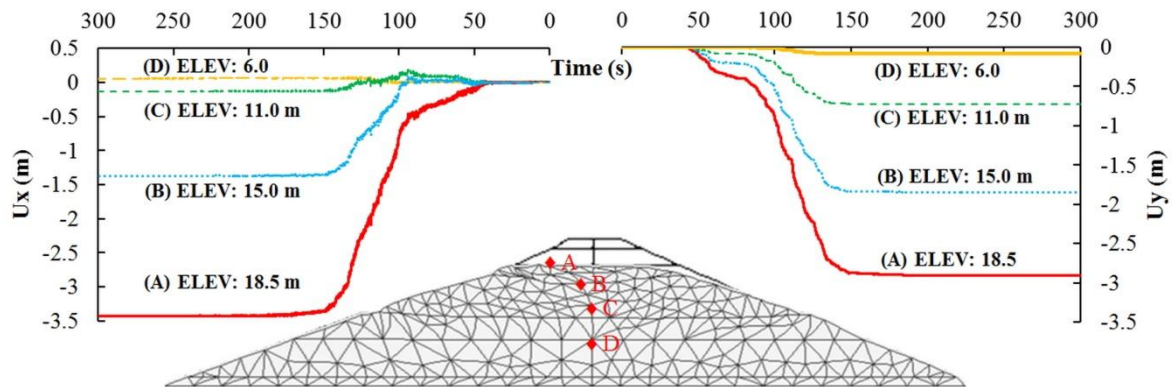
Fig15

In addition, the deformed meshes and deformation curves in both directions, at the end of the shaking using the inverse phase of the observed and simulated ground motion, are shown in Figs. 15 and 16. These indicate that both horizontal and vertical displacements fluctuated during the earthquake and settled continuously at a rapid rate, and then remained constant until the end of the excitation. The permanent horizontal displacement of the dam was 3.40 m (upstream side), 0.30 m, and 0.42 m for the inverse phase of the observed, simulated, and inverse phase of simulated motion, respectively. The vertical displacement at the dam crest reached 2.90 m, 0.63 m, and 0.60 m for the inverse phase of the observed, simulated, and inverse phase of simulated motion, respectively. As a result, by considering overtopping failure, the dam was able to withstand safely the simulated input motion except for the case of using the inverse phase of the observed motion, for which overflow is expected to occur.

Fig. 15. Deformed mesh at end of the analysis using inverse phase of observed motion.

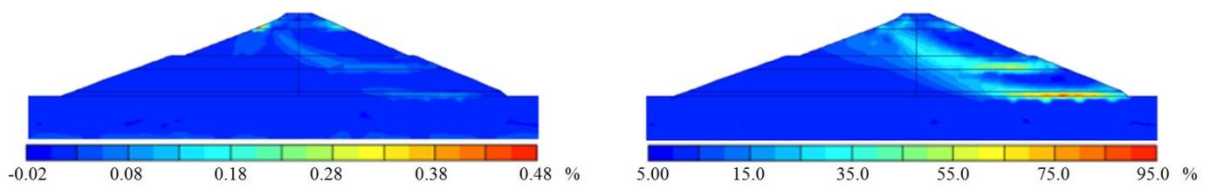
Fig17

Shear strain contours for various times obtained using the observed motion are shown in Fig. 17. Most of the dam body experienced an insignificant rate of shear strain. It can be seen that initially, large shear strains occurred in the upper portion, especially on the upstream side. Thereafter, the occurrences of large shear strain can be observed clearly on both sides of the dam in the middle and bottom portions of the downstream slope. This excessive level of shear strain may indicate a possible cause for the dam failure. Similarly, shear strain contours obtained from the remaining motions, yield almost the same pattern as the previous motion (Figs. 18 and 19). However, the exception is when using an inverse phase of the observed motion, for which large shear strains can be seen on the upstream slope instead of on the downstream slope.

The sequence of dam failure has been reported by previous researchers. Initially, the dam experienced excessive deformation or a slide on the upper portion of the upstream slope. This, together with a subsequent large slide that occurred on the downstream face, yielded a loss of freeboard and triggered the overflow that resulted in the breaching of the dam. Most numerical results show good agreement with this scenario, except for the case of using the inverse of the observed motion, which exhibited large strain appearing mainly on the upstream slope. The simulated motions also yield good agreement, but only with a smaller value of shear strain.

Fig. 17. Shear strain contours at 40 s and at 104.19 s using observed motion.

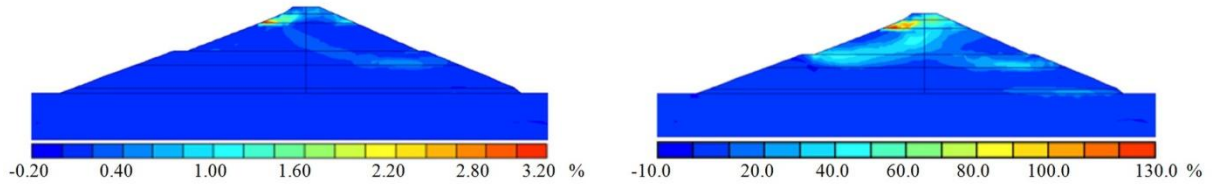
Fig18

Fig. 18. Shear strain contours at 40 s and at the end of motion using observed motion (inverse phase).

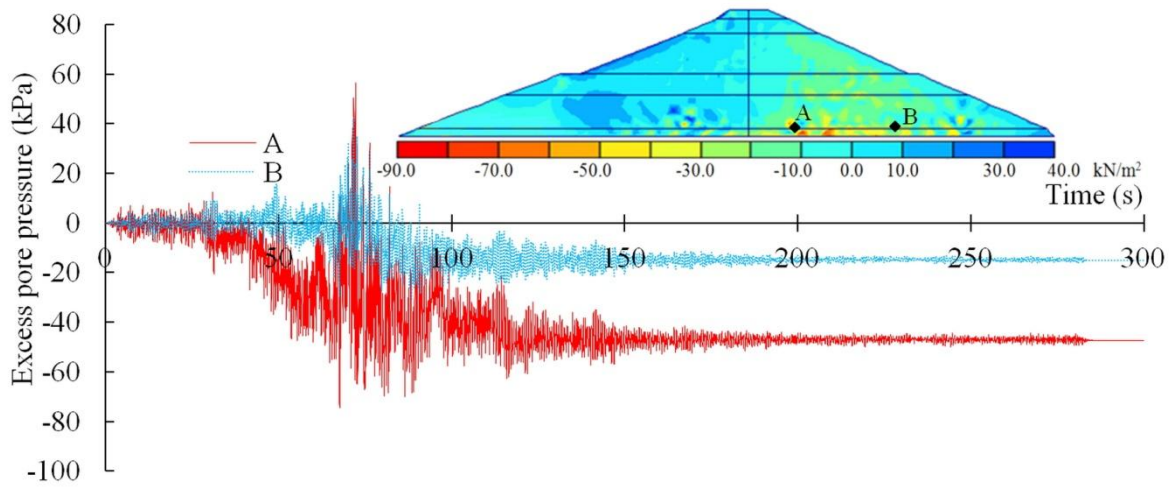
Fig20

The distribution of the excess pore pressure within the dam body and the records of the observation point A and B at 104.19 s using the observed motion are shown in Fig. 20. It can be seen that the excess pore pressure developed mostly at the downstream side. The maximum excess pore pressure was about 90 kPa and it can be found near the dam's base close to the dam center line. Besides, the suction or the positive excess pore pressure can be found on the upstream face and within dam's body on the upstream side. It can be seen that from the time history curves of the excess pore pressure at the

The results show that most of the dam body experienced the build-up pore pressure that was not high enough to equal the effective stress and trigger the total loss of the soil strength. However, in particular locations such as on the downstream side where the effective stress found to be small, the reduction of shear strength can be fairly high and led to significant permanent deformation on those areas. However, it must be noted that the Mohr-Coulomb model can only capture the excess pore pressure due to volumetric stress. Although, the excess pore pressure due to earthquake excitation was presented here, the actual phenomenon of cyclic mobility and liquefaction cannot be modeled and captured in this study.

Fig. 20. Excess pore pressure.

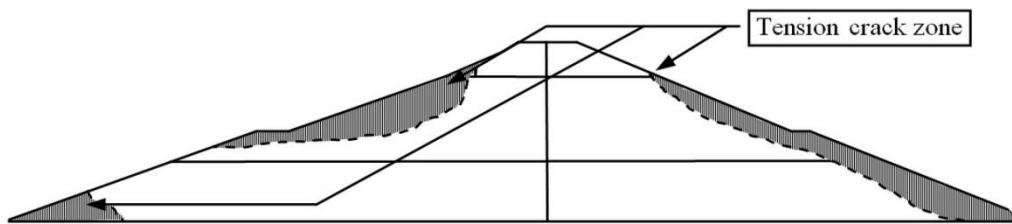
Fig21

In the analysis, it is possible to capture the tension crack during the shaking duration by illustrating the location in which the tensile stress does exceed the tensile strength. Fig. 21 summarizes the zone of the tension crack that occurred throughout the time of the analysis for both the observed and the simulated motion. It can be seen from both cases that the tension crack occurred similarly within the same location. This crack appeared clearly in the middle portion and at the toe for both sides. However, the tension crack on the upstream slope seems to penetrate deeper into the dam body. From this evidence, it would appear that sliding and internal erosion could be triggered, thereafter causing the failure of the dam.

Fig. 21. Tension crack zone.
