An Investigation of Traditional Javanese Wooden Houses ‘Joglo’ Damaged during the May 2006 Yogyakarta Earthquake, Indonesia.

Yulianto P Prihatmaji^{1,4*}, Akihisa Kitamori², Kohei Komatsu³

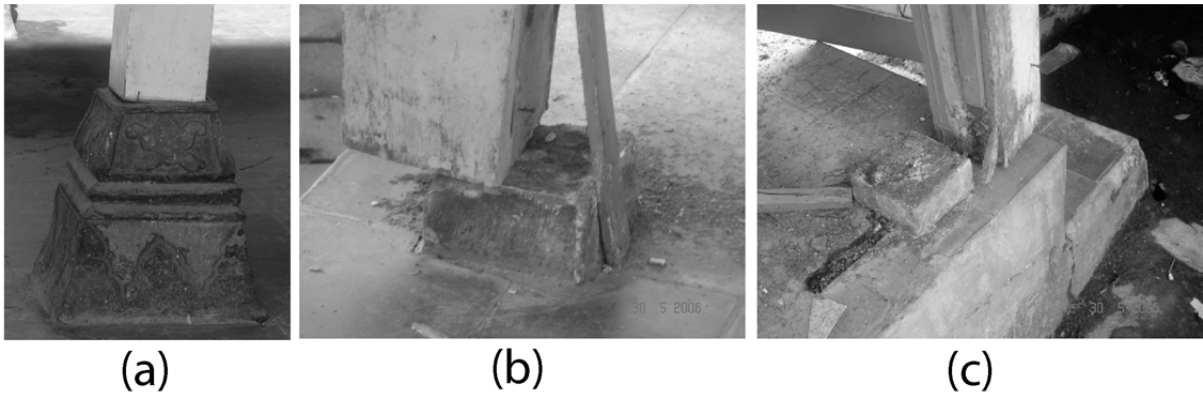
In our research we suggest a number of facts. Tenon of column's end works in securing the position of the columns on the foundation. It makes the structural system able to resist against seismic lateral forces even if columns are inclined (Figure 7a). The fatal damage of the joint between column and foundation occurred when some columns lacked the original tenons (Prihatmaji et al, 2011). This is observed more commonly on side structures rather than core structures (Figure 7b). These columns then easily slipped over the foundation causing total collapse of the structure (Figure 7c). In addition, the joint of column tenon and stone base is seriously damaged when the column's leg has decayed (JHS, 2007; Prihatmaji et al., 2010a). Due to the damage of the column's tenon, the joint failure also represents a critical criterion in terms of building stabilization after a seismic attack.

Figure 7. (a) The declined column, (b) Decaying of the column tenon, (c) The column stand on stone base without tenon.

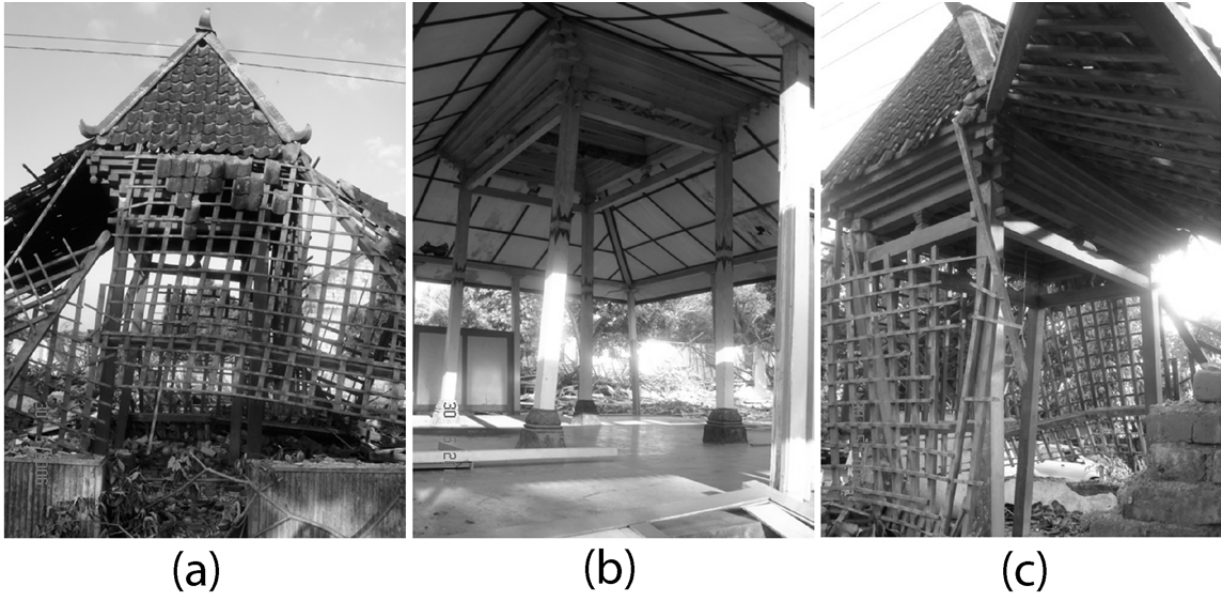
Figure 8a, b and c. State of Joglo's core structure after an earthquake.

Figure 8a-c, shows four columns that are severely inclined but still standing and securing human life. Hence, the role of joints is very important and significant. The most crucial damage between column and beam is observed at joints at the lower and upper beam. The joint of the long beam with the column gets damaged due to shear force and bending moment inside the mortise (Prihatmaji et al., 2011; Prihatmaji et al., 2010b). Furthermore, mortise of columns, into which a number of beams are inserted, may cause a fatal damage on the core structure.

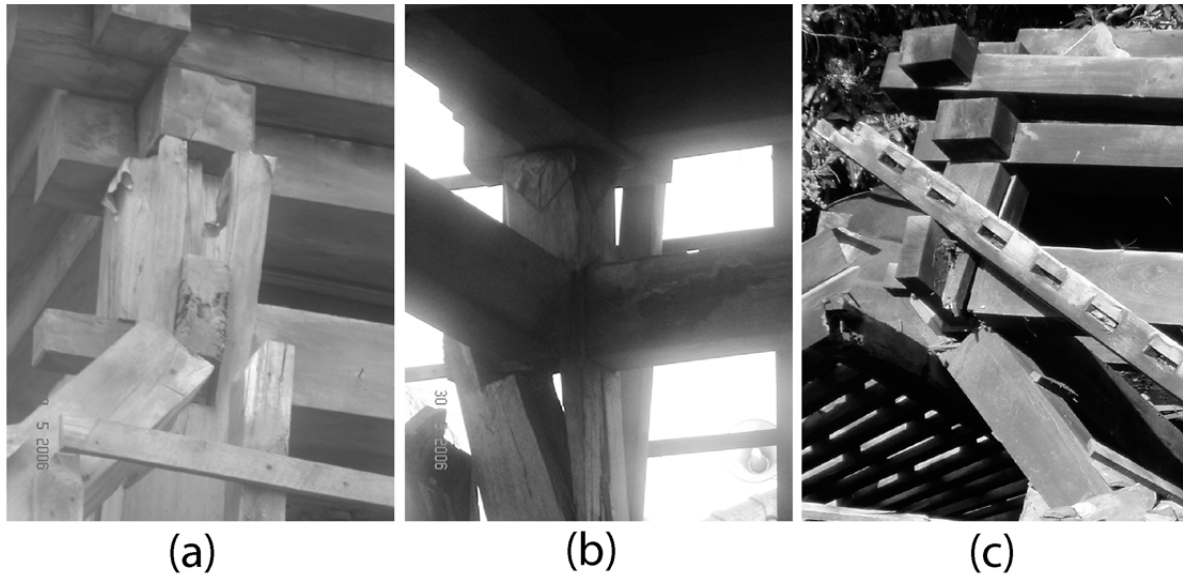
Figure 9a shows that the lower beam transmits lateral forces to the column, causing shear failure between lower and upper beam, resulting in the damage of both the column and the beam. When the strength of the column is weaker than that of the joints, (e.g. due to dimension loss by decay or carving), the column failed to bend, without the beams being damaged (Figure 9b). This may result in a total collapse of the structure, as seen in Figure 9c.

Figure 9. (a) Collapsed column-to-beam joint, (b) Broken joint, (c) Collapse of the core structure (@ JHS, 2006).

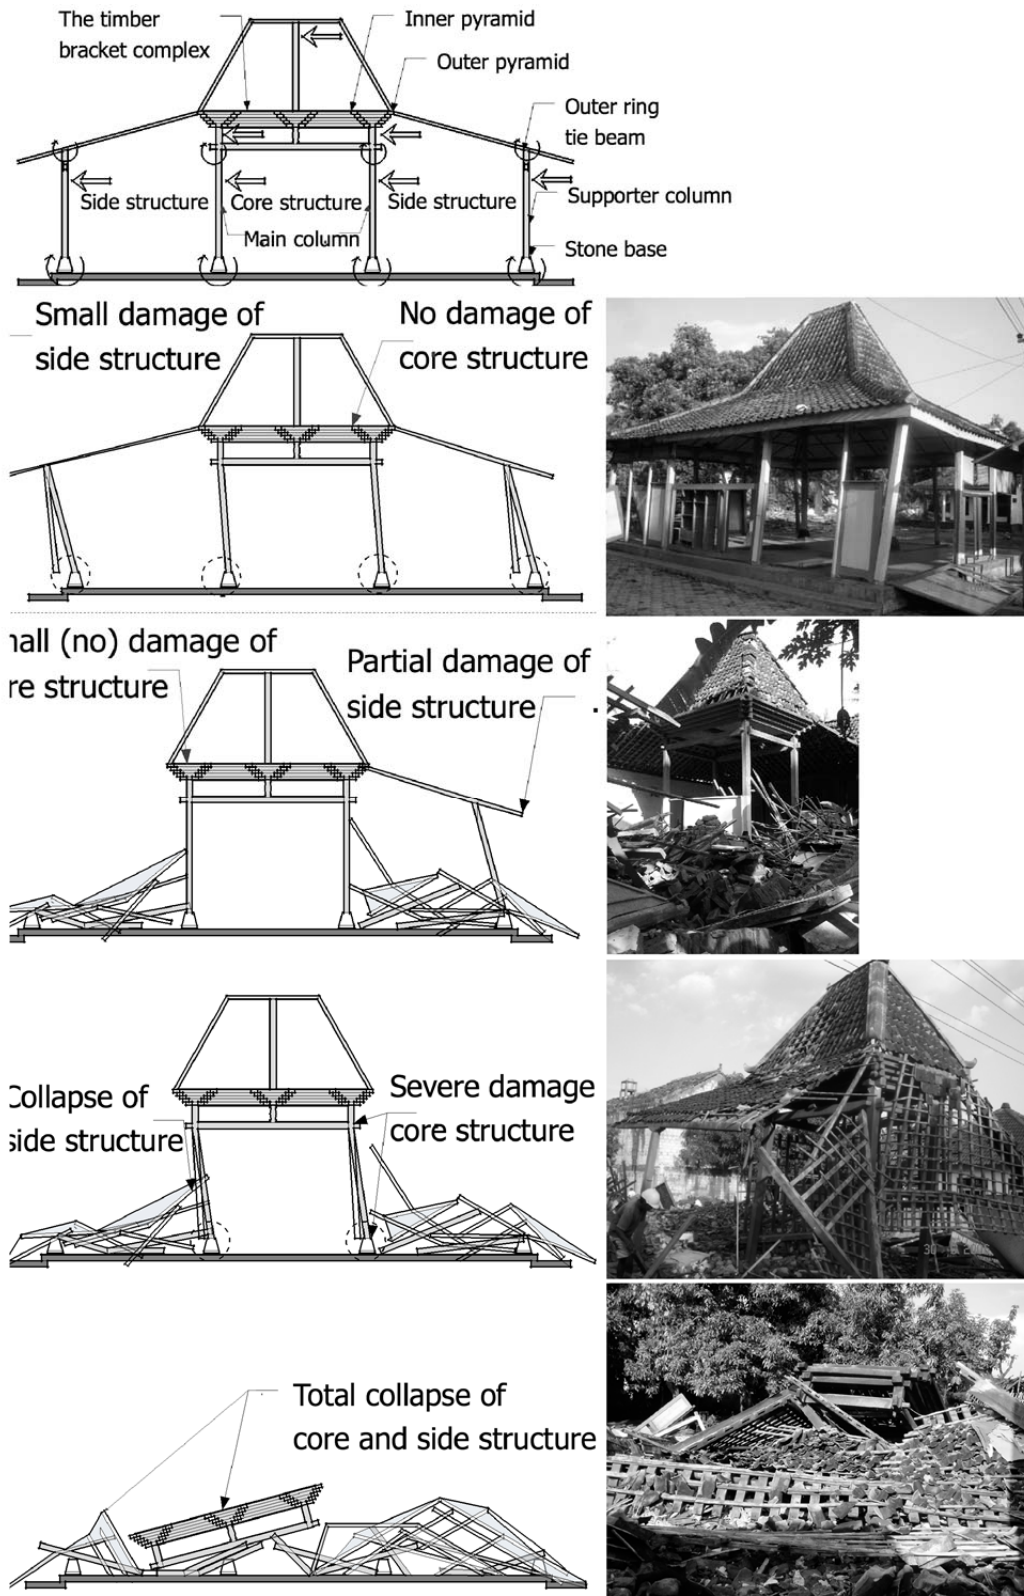
Figures 11a-d show different levels of damage in Joglo-type structures. We categorized them into 4 levels according to the gravity for the structural security and in order of appearance. Firstly, part of the side structure is selectively damaged while the core structure is still standing. This is due to the

difference of strength performance, as shown in Figure 11a. Secondly, the side structure is partially collapsed or damaged while the core structure is slightly or not damaged (Figure 11b).

Figure 11. Levels of damage of the Joglo building (a) First level of damage, (b) Second level of damage (Figure 10b in right courtesy by Wulandari, 2006), (c) Third level of damage, (d) Fourth level of damage (Figure Figure 10a, b and d in left modified from Prihatmaji, 2010b and Ikaputra, 2011. Figure 10d in right modified from JHS, 2007).

Figure 11c shows the third level of damage, which is identified by the collapse of the side structure, with the core structure remaining standing. At this stage, the core structure's columns are inclined but safe. This indicates the importance of the strength performance of the core structure for the security of the residents. At the fourth level of damage, the entire structure falls-down due to the collapse of core and side structure (Figure 11d).

The specific feature of the first level of damage involves broken mortise of columns, and slip between columns and stone foundations at the side structure, decline of column of side structure, and damage of outer ring joint. In the secondary level, joints between outer ring's beam and column are deformed or broken, and joints between inner ring beam at core structure and rafters broke, due to the rafter end connection being pulled out. In the third level, severe damages on the core structure are observed besides second level of damage. Severe damage on core structure is due to the main column's declining and breaking of the joint at lower beam of core structure. The main structures are totally collapsed including roof structures in the fourth level.
