Cleaning Procedures for Small Dental Instruments Prior to Sterilization

K. S. Lester

Westmead Hospital Dental Clinical School

Lester, K. S. and Mitchell, P. (1987) "Cleaning Procedures for Small Dental Instruments Prior to Sterilization," *Scanning Microscopy*: Vol. 2 : No. 1 , Article 20.

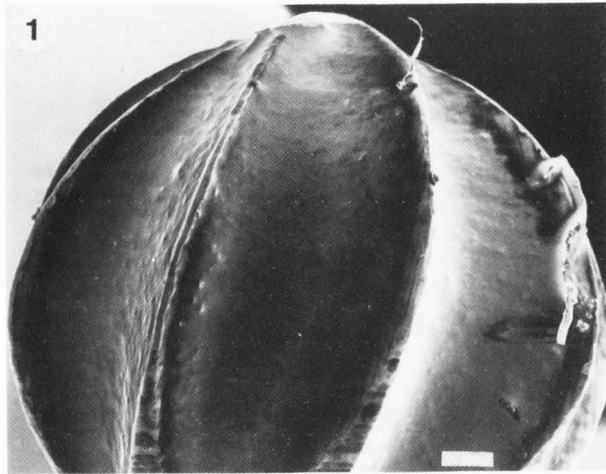
Fig. 1. An unused carbon steel round bur (i) covered with a film of grease and oil with several non-metallic filaments attached. Bar = 100 μm .

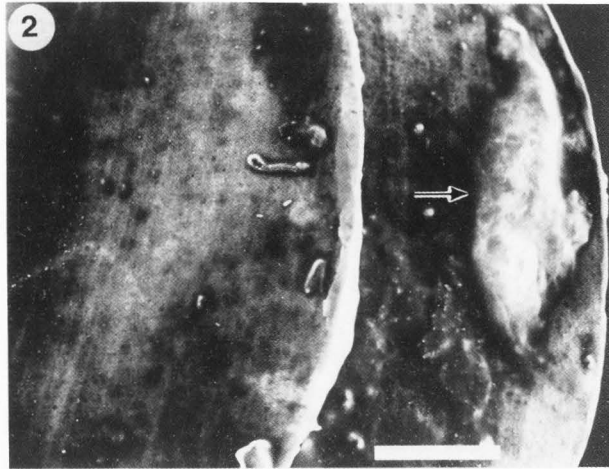
Fig. 2. Higher magnification of a similar bur (i) to Fig. 1 showing bubble formation in the film coating (at arrow). Bar = 100 μm .

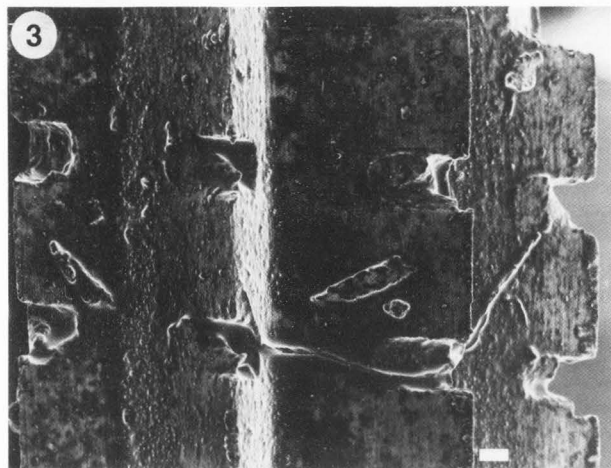
Fig. 3. An unused flat fissure carbon steel bur (ii) showing film over surface and attached thread. Bar = 100 μm .

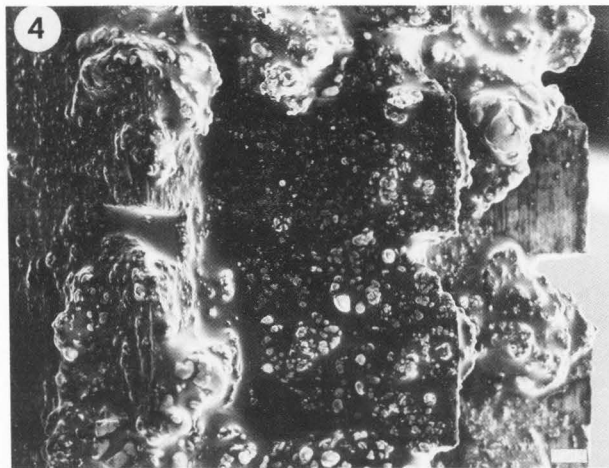
Fig. 4. Higher magnification of a similar bur (ii) to Fig. 3 showing accumulated particulate matter embedded in the film coating. Bar = 100 μm .

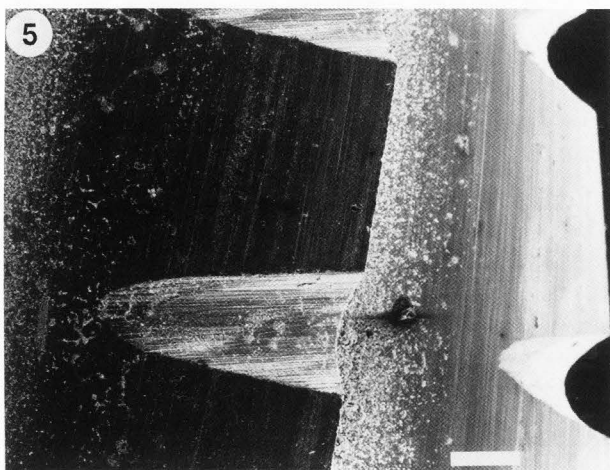
Fig. 5. An unused tungsten carbide fissure bur (iii) with fine debris accumulated along the longitudinal flutes. Bar = 100 μm .

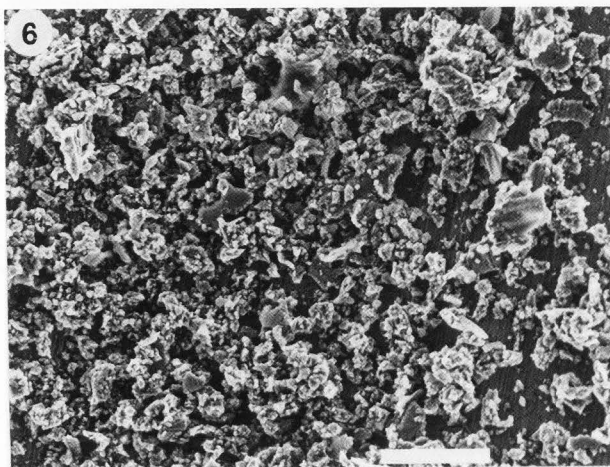
Fig. 6. Higher magnification of the same bur (iii) as in Fig. 5 showing the crystalline debris along the flute. Bar = 10 μm .

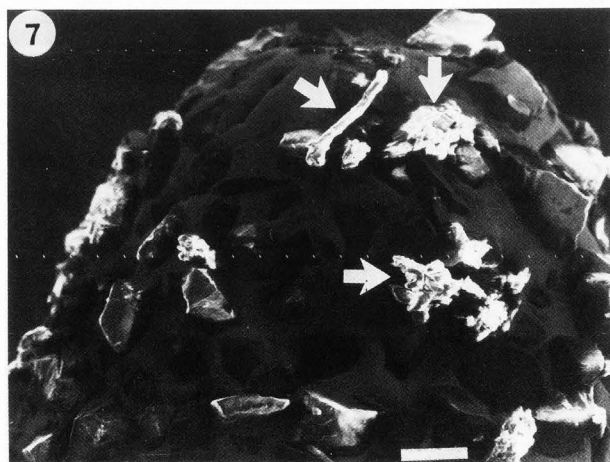
Fig. 7. An unused diamond bur (iv) showing non-conductive fibrous debris (at arrows) between the diamond particles (the print is purposefully at a low contrast level to compensate). Bar = 100 μm .

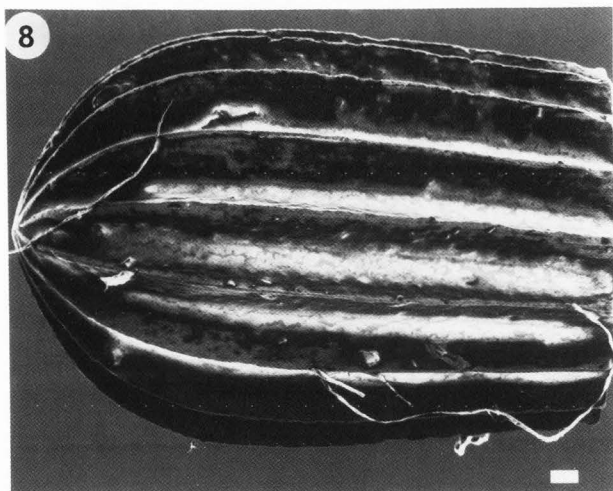
Fig. 8. Bur (v) as unpackaged. Note the film over the surface and the usual adherent thread-like material. Bar = 100 μm .

Fig. 8 shows the typical appearance of a bur - (v) - as unpackaged with associated organic film and adherent threads. The organic film and some of the debris are removed after the first cleaning in 70% ethanol (Fig. 9). Fig. 10 shows the degree of accumulation of debris on the flutes after a normal single use in the preparation of a single amalgam restoration for polishing. The level of cleaning resulting from the standard protocol of that time (see Table 1 - Procedure 2) is quite

Our recommendation for a cleaning procedure for new unused burs is: i) ultra-sonicate for 4 mins in 70% ethanol (made up with distilled water); and ii) hot air dry. Our recommendation for a cleaning procedure for used burs is: i) place in a 1/20 dilution of a 16.5% sulphamic acid based detergent and tap water; ii) ultrasonicate for 4 mins; iii) wash generously in distilled water; and iv) hot air dry. If there is concern for the especial de-greasing of a used bur, a 70% ethanol (in distilled water) rinse can be added before drying. For grossly contaminated burs, the prior use of a bur brush, although not evaluated in this study, makes good sense.

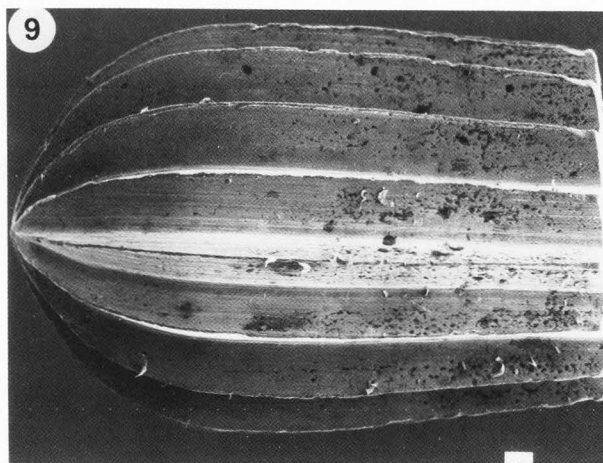
Fig. 9. Same bur after initial cleaning in 70% ethanol with ultrasonication for 4 min. Note the loss of the film, the relatively poor quality of metal finish and the small particles still adherent to the bur surface. Bar = 100 μm .

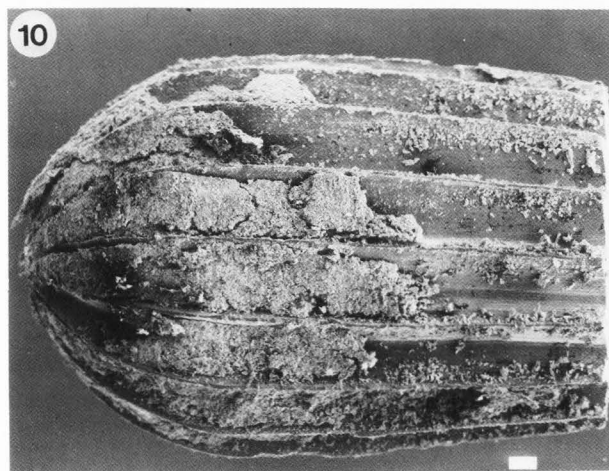
Fig. 10. Same bur after use in the initial preparation of the surface of a carved amalgam for polishing. Macerated amalgam clogs the flutes of the bur. Bar = 100 μm .

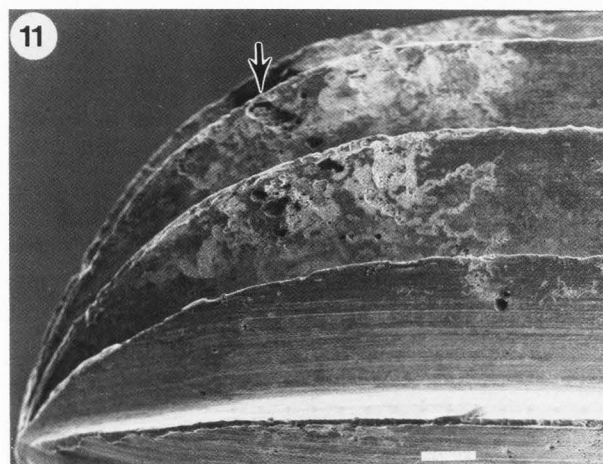
Fig. 11. Same bur after second cleaning although first in PA based detergent. The level of cleaning is high (see flutes at bottom of picture) but there is obvious deterioration of the metal surface (at arrow). Bar = 100 μm .

acceptable (Fig. 11), but the apparent damage to the bur in certain locations by way of severe erosion of the flutes (Fig. 12) led us to be concerned about the possible role of the phosphoric acid component of this detergent in the observed deterioration.

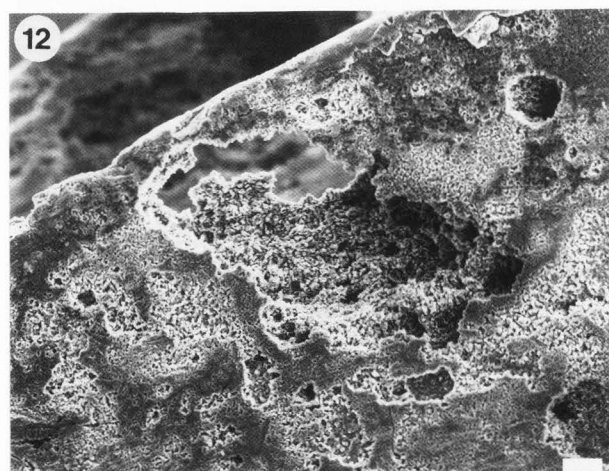
Fig. 12. Higher magnification of the area arrowed in Fig. 11. The metal of the cutting edge of this particular flute has been eroded through completely. Bar = 10 μm .

The most significant finding from this series of observations is the corrosive action on carbon steel burs of a phosphoric acid based cleaning solution (Fig. 12) which was in routine use for bur decontamination in the sterile supply unit of our Dental School. The original basis for our use of the agent was its known effectiveness on stainless steel instruments. This was the natural result of a predominant experience by the sterilizing staff in, and concern for, instruments

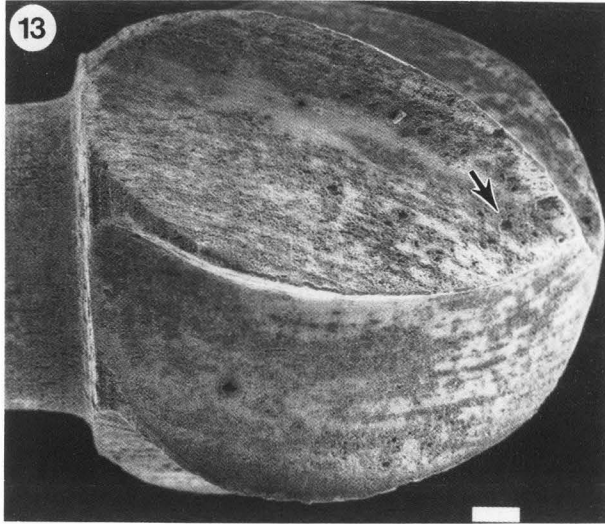
Fig. 13. Unused carbon steel round bur (i) after the extreme of 1 h ultrasonication in the recommended dilution (1/20) of PA based detergent. Although clean, the surface is obviously pitted even at this low magnification. The arrow locates the corrosion pit for Fig. 14. Bar = 100 μm .

All exposures of the burs to the PA detergent resulted in detectable damage to the metal surface. There are four parts to this result (a) to (d). a) The exaggerated effect of 1 h ultrasonication in the PA detergent on bur (i) is shown in Figs. 13, 14. A severe honeycombing of the entire surface of the head of the bur has occurred. b) The lessened erosive effect of a reduction both in concentration (1/40 dilution) and in time of ultrasonication (4 mins) is clear (Figs. 15, 16) by comparison with Figs. 13, 14. The colony-like precipitates give the appearance of being related to the accelerated drying process, particularly the use of 70% ethanol (see below). c) The influence of ultrasonication was further explored by simply soaking the bur in a 1/20 dilution for 4 mins without sonication (Fig. 17a). Etching is still apparent (although a higher magnification is required to assess it) indicating that the essential causative agent is the PA

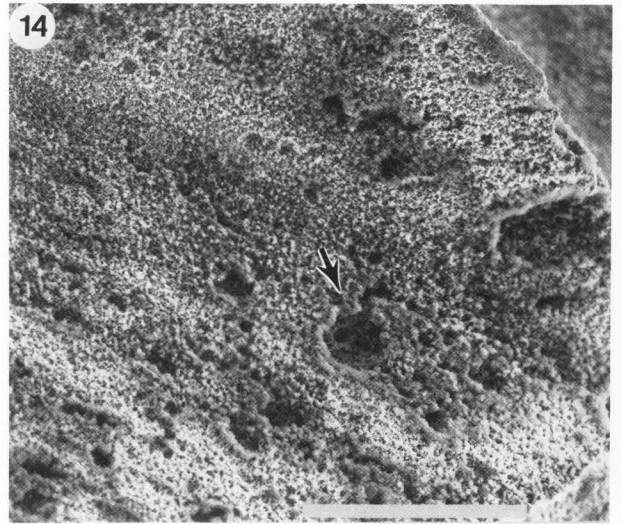
Fig. 14. High magnification view of area arrowed in Fig. 13 to show the extensively corroded surface. Bar = 100 μm .

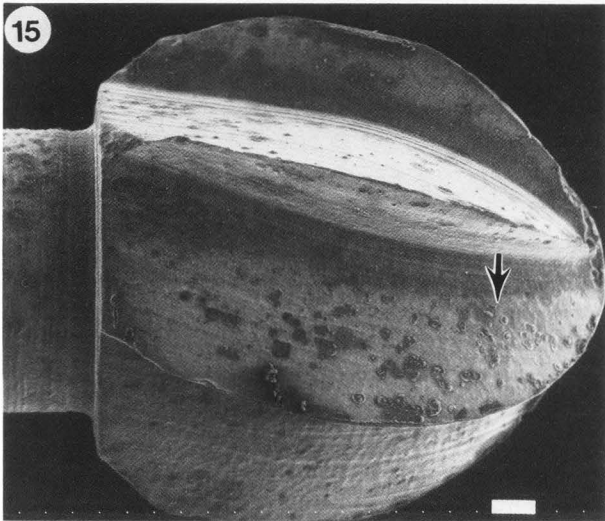
Fig. 15. Unused carbon steel bur (i) after 4 min ultrasonication in a 1/40 dilution of PA based detergent, rinsing in 70% ethanol and hot air drying. The bur is clean and less pitted but has plaque accumulations on its surface. Arrow locates Fig. 16. Bar = 100 μm .

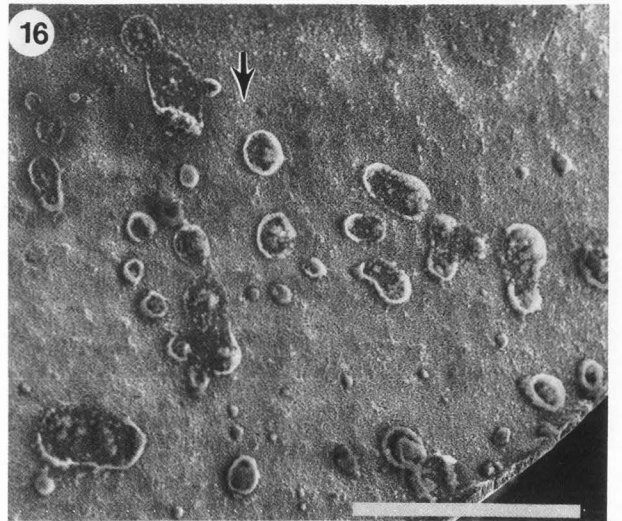
Fig. 16. Higher magnification of Fig. 15 (arrow to same relative location). Surface is pitted at this magnification although obviously much less than for higher concentration and extended ultrasonication time. The colony-like clusters are, we feel, related to the ethanol in tap water rinsing. Bar = 100 μm .

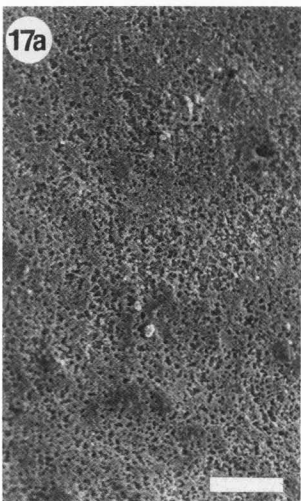
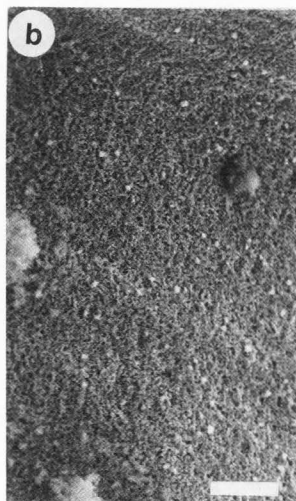
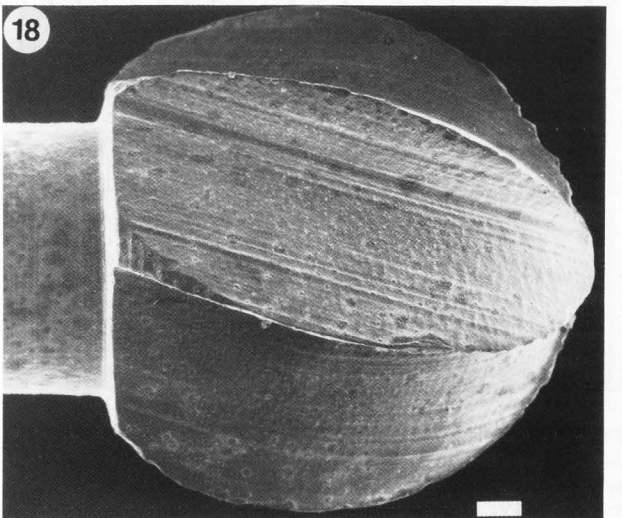
Fig. 17. Higher magnification views of bur surfaces (unused bur (i)) subjected to different concentrations and times of ultrasonication in PA based detergent. 17 (a). normal dilution (1/20) and no ultrasonication. Bar = 10 μm . 17 (b). extreme dilution (1/400) and 4 min ultrasonication. Bar = 10 μm . Pitting of the bur surface occurred for both regimes although less for the extreme dilution of PA detergent.

detergent. d) An attempt to minimise the adverse effect of the PA detergent on the metal surface involved a dilution to (w/w) 1%; the etching effect still occurred (Fig. 17b).

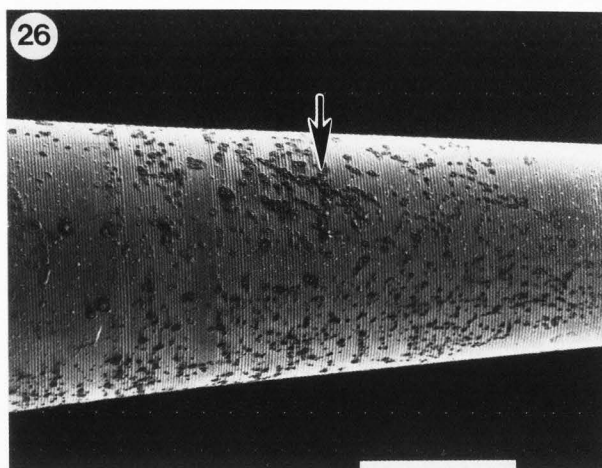
Fig. 26. Survey view of shank of unused carbon steel bur (i) washed in tap water and air dried after ultrasonication in SA based detergent and storage for 18 days. There are accumulated precipitates (? Fe (OH)₂) over the surface. Arrow locates field for Fig. 27. Bar = 1 mm.

Tap water rinsed burs showed continued surface deterioration with time compared to a distilled water rinse: a) where cleaned burs stand for 18 days after tap water washing, progressive surface changes occur (Figs. 26, 27) - the crystallite clusters are surrounded by a smooth-surfaced ring; b) similarly stored burs washed in distilled water do not show the same surface deterioration (Fig. 28). By naked eye examination, burs washed in tap water are obviously discoloured ("rusty") and those washed in distilled water retain their original surface lustre.

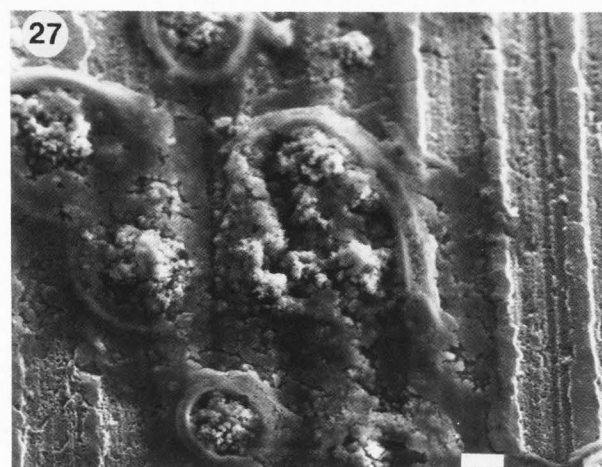
Fig. 27. Higher magnification of arrowed area in Fig. 26 showing detail of precipitated cluster. Bar = 10 μ m.

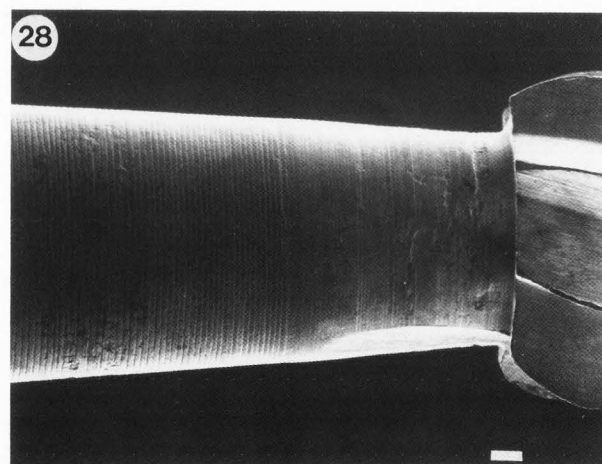
Fig. 28. Unused carbon steel bur (i) washed in distilled water and air dried after ultrasonication in SA based detergent and storage for 18 days. There is no surface precipitation of the kind seen when washing is with tap water. Bar = 100 μ m.
