Reported by ACI Committee 133, Disaster Reconnaissance

The Institute's Team for Damage Investigations

Lessons learned from field deployments

by Lucas A. Laughery, Aishwarya Y. Puranam, Christopher L. Segura Jr., and Anahid A. Behrouzi

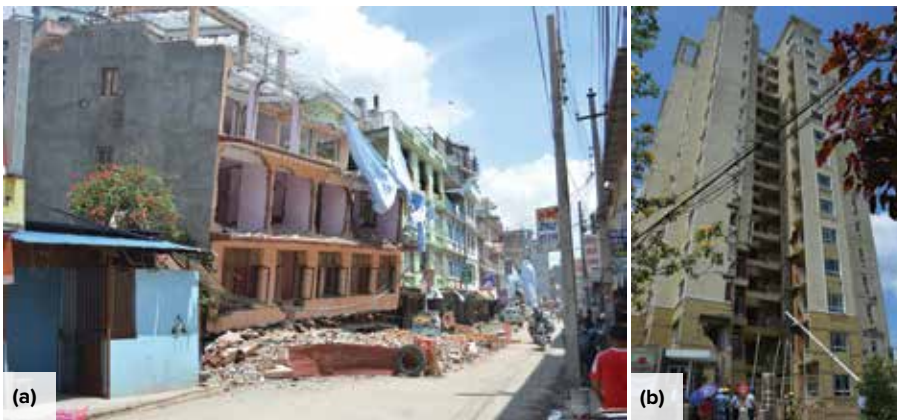
partition walls. Figure 3 shows severe damage to unreinforced masonry infill in low-rise and high-rise buildings.^{18,19} Collapse of the first story in the low-rise building (left) demonstrates the soft-story vulnerability. More information about the reconnaissance can be found in Shah et al.²⁰

Fig. 3: Buildings damaged in the 2015 Nepal Earthquake: (a) low-rise building (after Reference 18, licensed under CC BY-SA 3.0); and (b) high-rise building (after Reference 19, licensed under CC BY-SA 3.0)

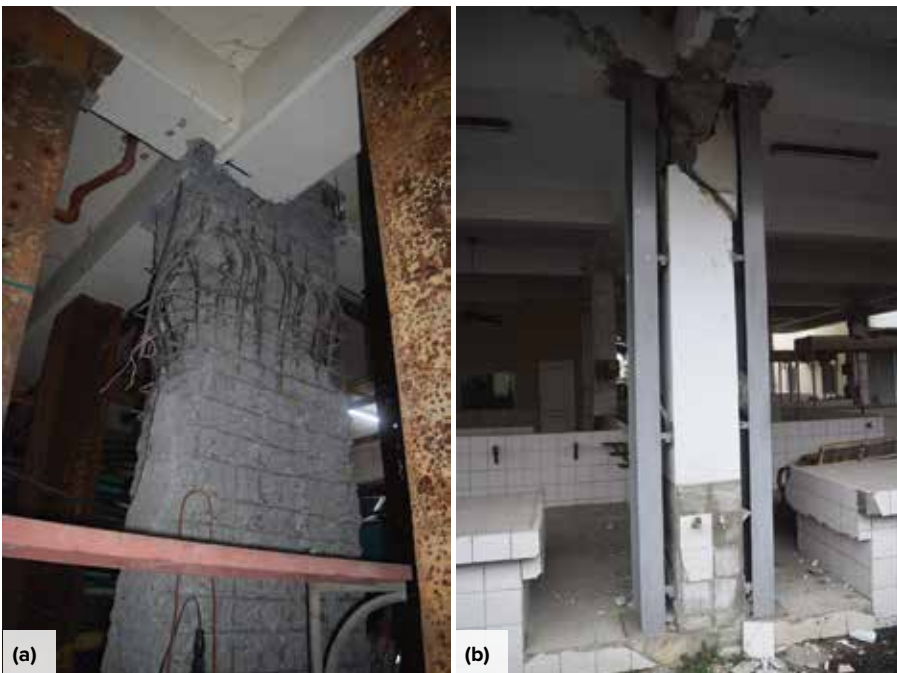
Much damage was observed in Tainan City, approximately 40 km (25 miles) from the epicenter. Reports suggested that most fatalities resulted from the collapse of a 14-story residential building. ACI Committee 133 deployed a team in March 2016, supported in part by the National Science Foundation (NSF), to join researchers from the Taiwanese National Center for Research on Earthquake Engineering (NCREE) to investigate the effects of the earthquake on RC structures. Over 12 days, 119 low-rise school, residential, and government buildings and 11 structures between eight and 23 stories tall were surveyed around Tainan City. In addition to conventional techniques, teams used aerial drones to collect videos of structures. Members of the ACI team investigated the failure of a corner column in a 14-story building in Tainan City, and they concluded that the failure was the result of axial demands imposed from discontinuous RC walls intended to function as partitions.²¹ The team also conducted an evaluation of four different seismic vulnerability screening indices, including that proposed by Hassan and Sozen¹⁶ and another then used in Taiwan. Figure 4 shows damage that was observed in columns in two different buildings.²²

Fig. 4: Damage to columns in the 2016 Taiwan Earthquake: (a) axial compression failure; and (b) shear failure (after Reference 22, licensed under CC BY-NC-SA 4.0)

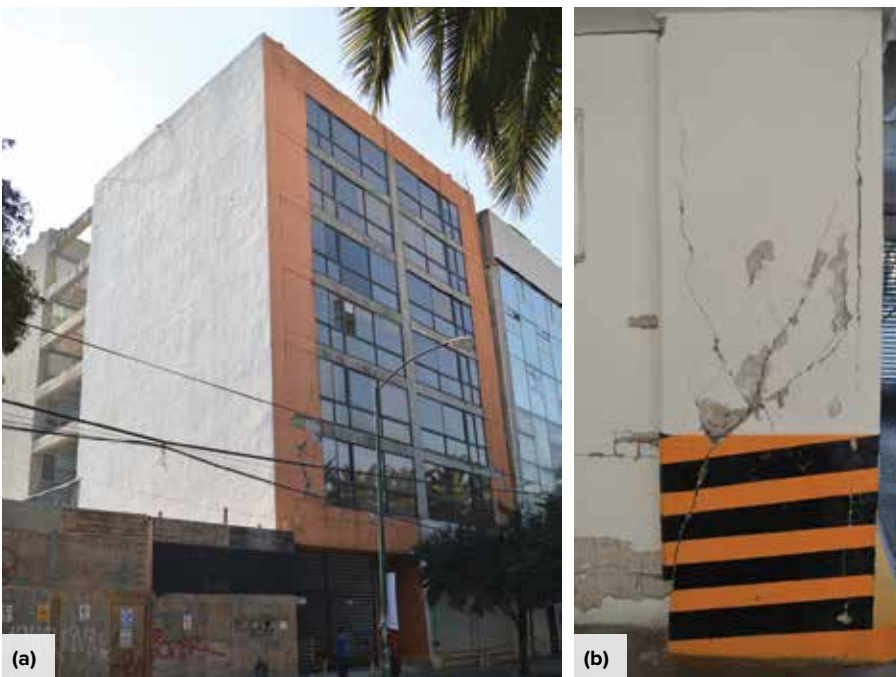
Two major earthquakes occurred in Mexico during September 2017: a M_w 8.1 on September 7 off the southern coast of Chiapas and a M_w 7.1 on September 19 about 55 km (34 miles) south of the city of Puebla. The second event caused significant loss of life and damage in Mexico City, including the collapse of more than 40 buildings.²⁵ In mid-October 2017, ACI Committee 133 deployed a team with funding support from the NSF. With the assistance of faculty from Universidad Nacional Autónoma de México (UNAM) and Colegio de Ingenieros Civiles de México (CICM), the team surveyed RC buildings located in Mexico City. Most of the buildings surveyed were constructed prior to 1985, were five to 10 stories, and were comprised of RC framing with masonry infill. The most salient observation was that the affected structures were too flexible. Flexible RC frames without adequate transverse reinforcement lack the deformability to cope with large lateral drift demands. Continuous grade-to-roof infill walls were observed to increase stiffness and reduce drift, but these walls were seldom distributed in two directions on the floor plan. In most cases, continuous infill was present only along floor plan edges perpendicular to the street. In this direction, damage to the frame was infrequent and relatively minor. Continuous infill walls were rarely present parallel to the street, and in this direction building damage tended to be much more severe (Fig. 6).

Fig. 6: A typical residential building affected by the 2017 Puebla Earthquake: (a) edge frames oriented perpendicular to the street had continuous infill walls and exhibited no significant damage; and (b) edge frames oriented parallel to the street had infill walls and fenestration and exhibited shear failure in first-story columns (after Reference 26, licensed under CC BY-NC-SA 4.0)

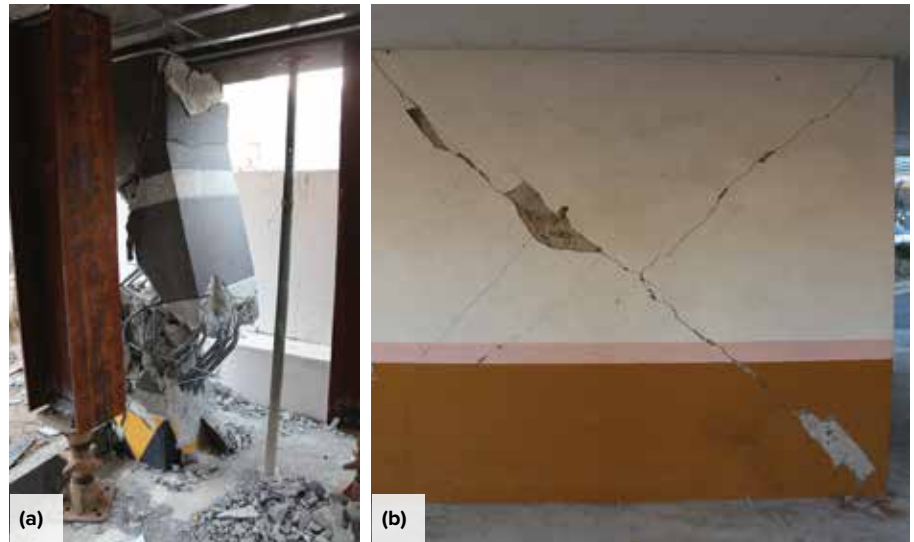
South Korean universities and engineering firms (Chang Minwoo Structural Consultants and faculty/students from Seoul National University, Ulsan National Institute of Science and Technology, Kyungpook National University, Daegu University, and Gyeongnam National University of Science and Technology), the team documented both damaged and undamaged buildings over the course of 6 days. The team collected dimensions of structural elements to evaluate the Hassan Index as well as stiffness irregularities.¹⁶ Of the 43 buildings with severe or moderate structural damage, 36 were “piloti” structures, residential buildings with three to four stories and an open first story for parking. The first-story structure comprised exposed RC columns with a single stairwell/elevator shaft of RC walls. Above the open first story, the structures included infill walls between residences. Architecturally, this configuration offered ample covered parking and sound-dampening between dwellings, but structurally it led to soft-story conditions that proved to be vulnerable to earthquake shaking as the first story sustained large drift demands. Security cameras captured dramatic video of the sudden failures of RC columns in such an apartment building.²⁷ Figure 7 shows the damage observed in two buildings.²⁸

Fig. 7: Observed damage to RC structures in the 2017 Pohang Earthquake: (a) a first-story column; and (b) a structural wall in another building (after Reference 28, licensed under CC BY 3.0)

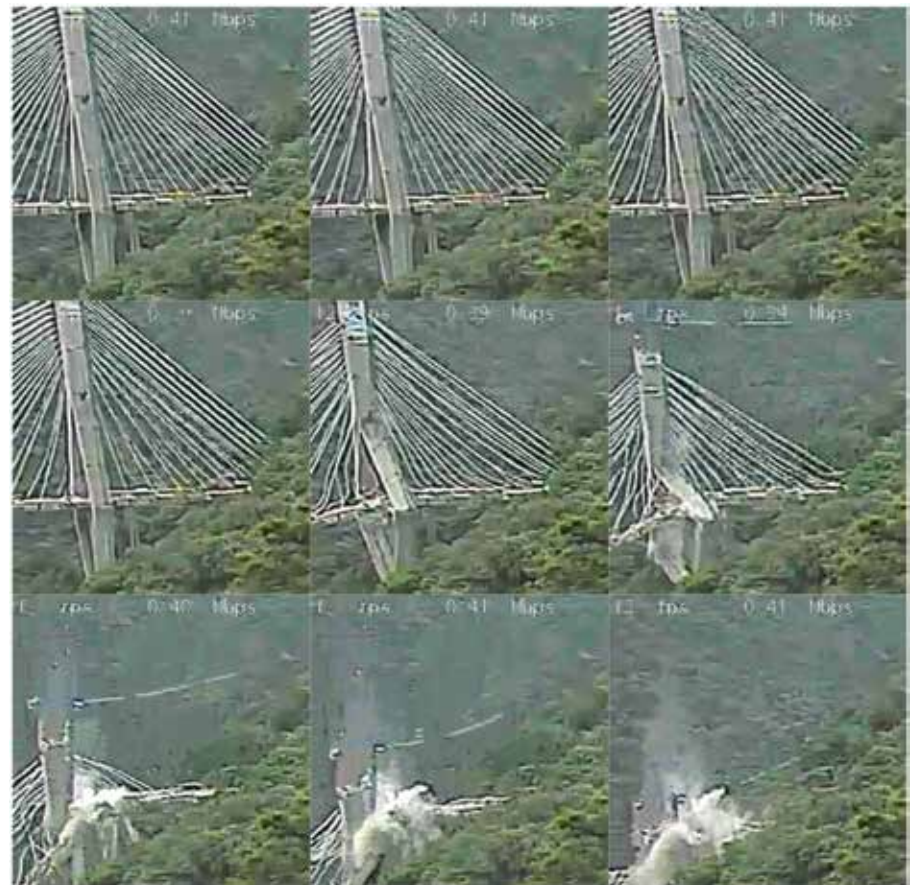
On January 15, 2018, construction of the Chirajara Bridge, one of 47 bridges in a Colombian project to expand the Agencia Nacional de Infraestructura (ANI) highway from Bogotá to Villavicencio, was nearing completion when its west tower collapsed, claiming the lives of nine construction workers. With the approval of ANI, members of ACI Committee 133 visited the site on January 25-26 to collect information that could assist in the development of improvements in design recommendations for bridge structures. The team evaluated footage of the collapse (Fig. 8) and conducted on-site inspections using a spotting scope, cameras, and unmanned aircraft systems

(UAS). A review of the design drawings revealed that the tower slab, which was apparently intended to act as a tie midway up the diamond-shape support

towers, had insufficient longitudinal reinforcement to support the gravity loading condition estimated on the tower at the time of the collapse. Findings

Fig. 8: Chirajara Bridge west tower failure sequence (after Reference 29)

from the ACI Committee 133 team's investigation illustrate the importance of: 1) exceeding Code minimum reinforcement ratios in critical members to allow spread of inelastic deformations, thus avoiding brittle behavior as a result of strain concentrations; and 2) the peer-review process, specifically for complex structures. Details of the investigation can be found in Pujol et al.²⁹

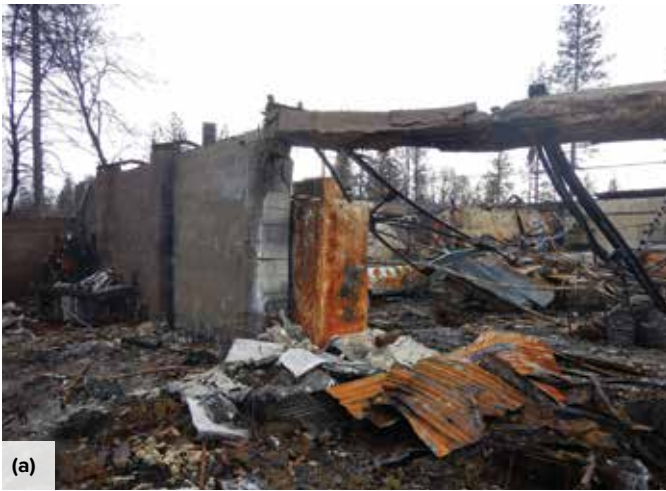
Typical commercial facilities consisted of RC or masonry wall structures with light-gauge steel joist roofs. One example was the Stratton Market, which collapsed due to the fire

Fig. 9: Remains of buildings destroyed in the Camp Fire: (a) Stratton Market; and (b) Paradise Elementary School (photos courtesy of Erica Fischer)

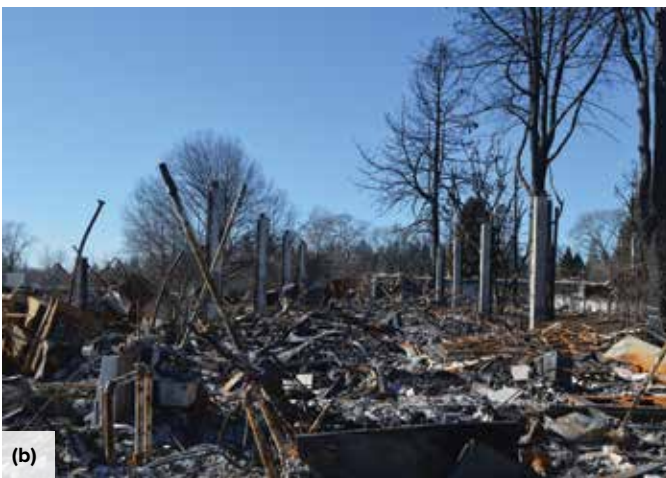
(Fig. 9(a)). One school building, Paradise Elementary School, had RC columns and timber framing. It also completely collapsed due to the fire (Fig. 9(b)). The ACI team also documented damage to a three-story residential building with RC framing. The fire caused buckling of the building's corrugated metal roof, cracking and spalling around flexural reinforcement in RC roof beams, and vertical splitting and spalling of third-story columns.
