## **Belleza Desnuda: A Conservation Assessment of the Exterior Concrete Surfaces of Henry Klumb's Parroquia Nuestra Señora del Carmen in Cataño, Puerto Rico**

# Belleza Desnuda: A Conservation Assessment of the Exterior Concrete Surfaces of Henry Klumb's Parroquia Nuestra Señora del Carmen in Cataño, Puerto Rico

BELLEZA DESNUDA: A CONSERVATION ASSESSMENT OF THE EXTERIOR  
CONCRETE SURFACES OF HENRY KLUMB'S PARROQUIA NUESTRA  
SEÑORA DEL CARMEN IN CATAÑO, PUERTO RICO

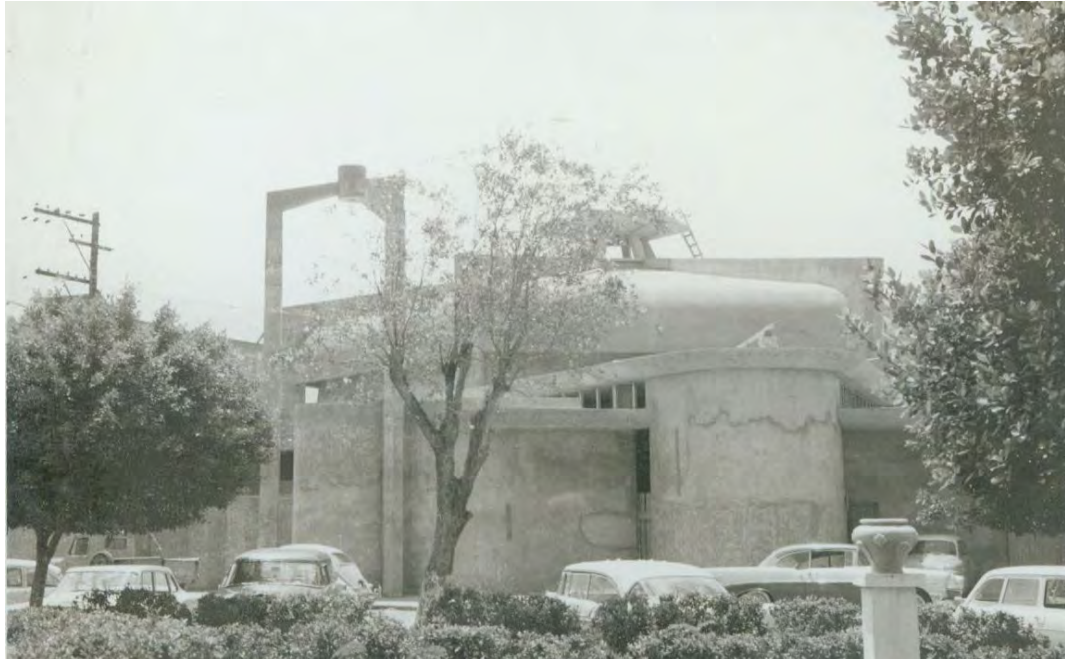
*Fig. 4.17* – Del Carmen Church during construction in 1962. The variations on the stuccoed surfaces can be seen since the construction phase. Source: Henry Klumb Collection, AACUPR.

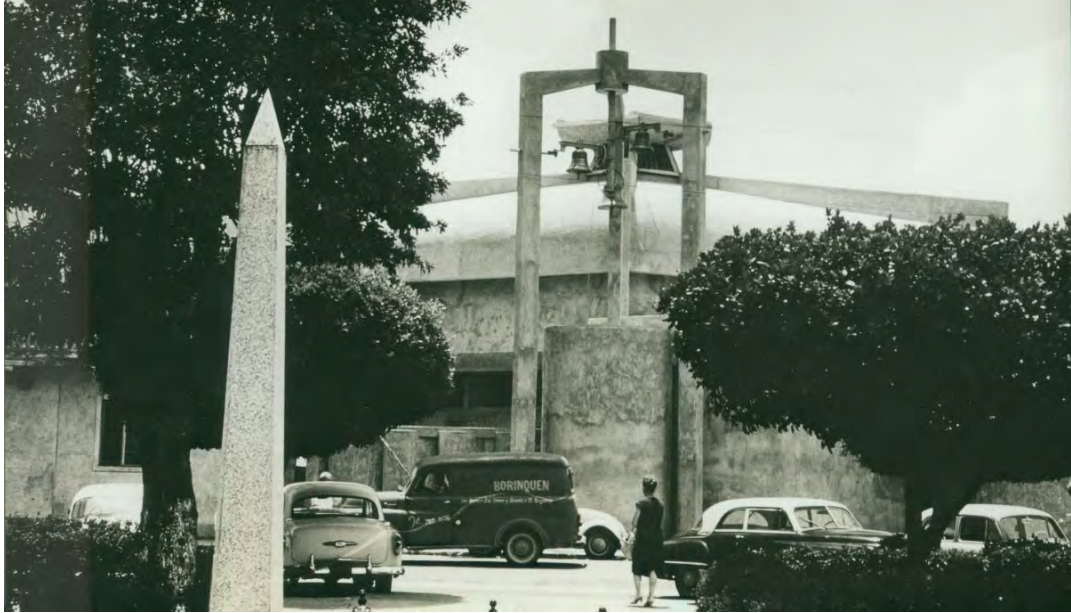
*Fig. 4.19* – Del Carmen Church before inauguration in 1963. The differences in stuccoed surfaces can be seen also in the bell tower. Source: Henry Klumb Collection, AACUPR.

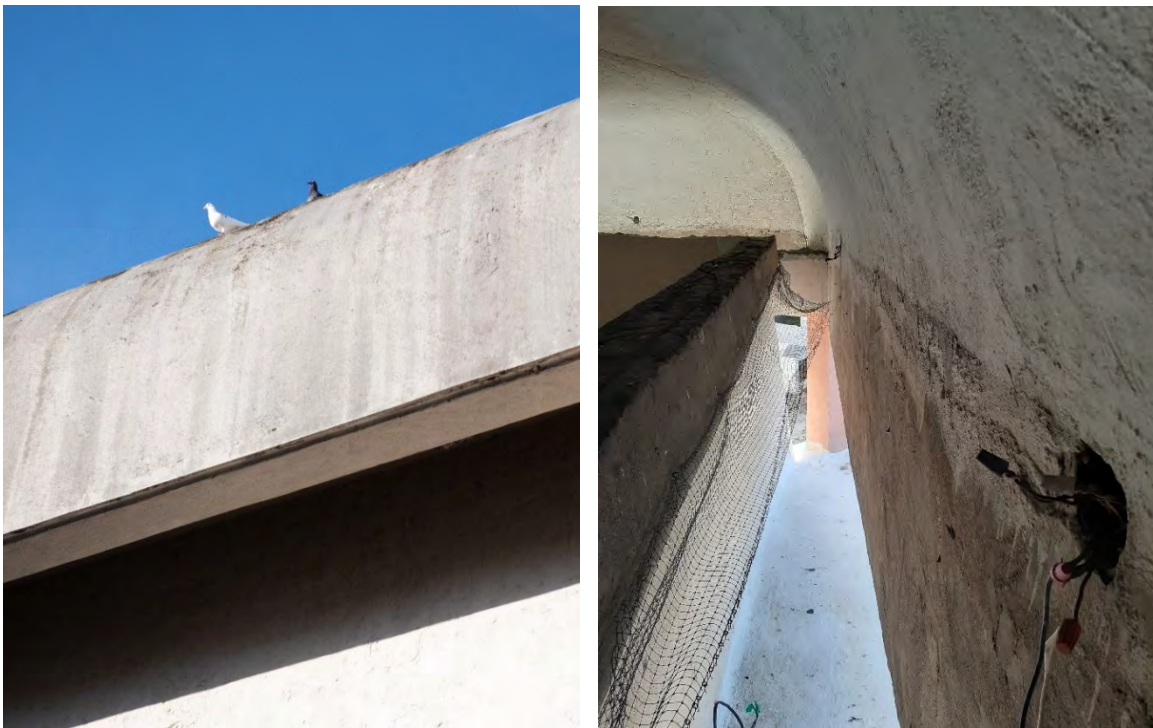
*Figs. 4.26 & 4.27* – In the early 2010s the Church’s administration installed a pigeon netting along the dome. These nets are currently deteriorated. Photos by Javier Freytes, 2019 & Author, 2020.

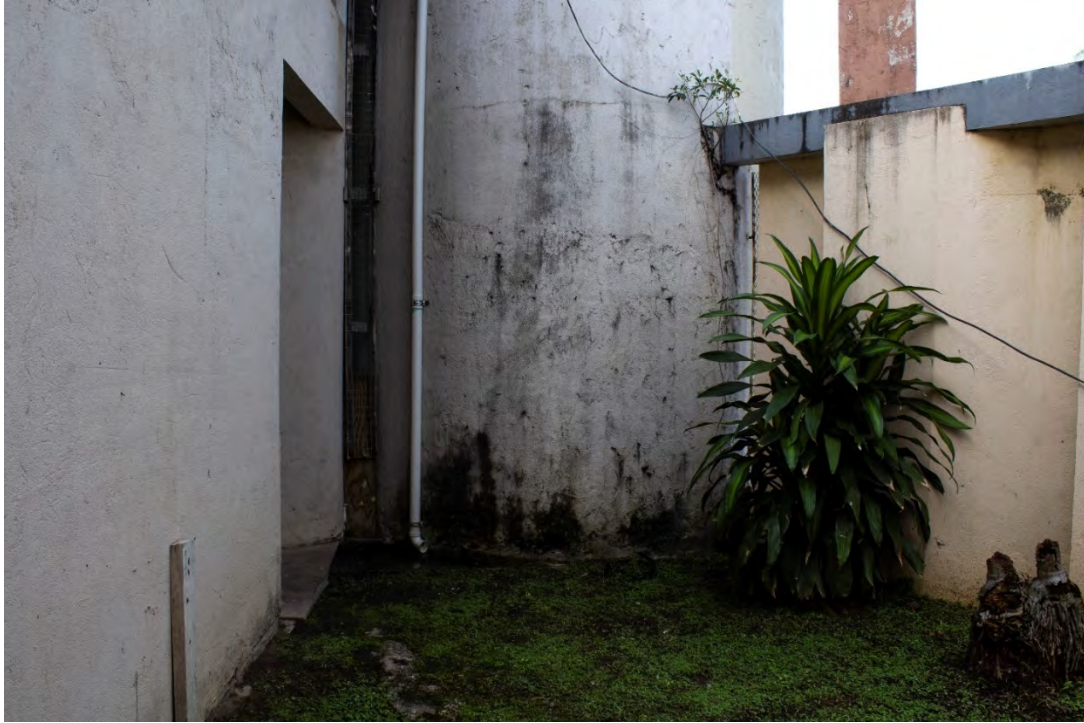
*Figs. A2.10, A2.11 & A2.12 - Water ponding due to the new drainage along poor water management issues have increased the chance of development of micro and macro biogrowth on Side B of Elevation 3. These include mold growth, leafy plants and insects living on scaled stucco. Photos by Author, 2020.*

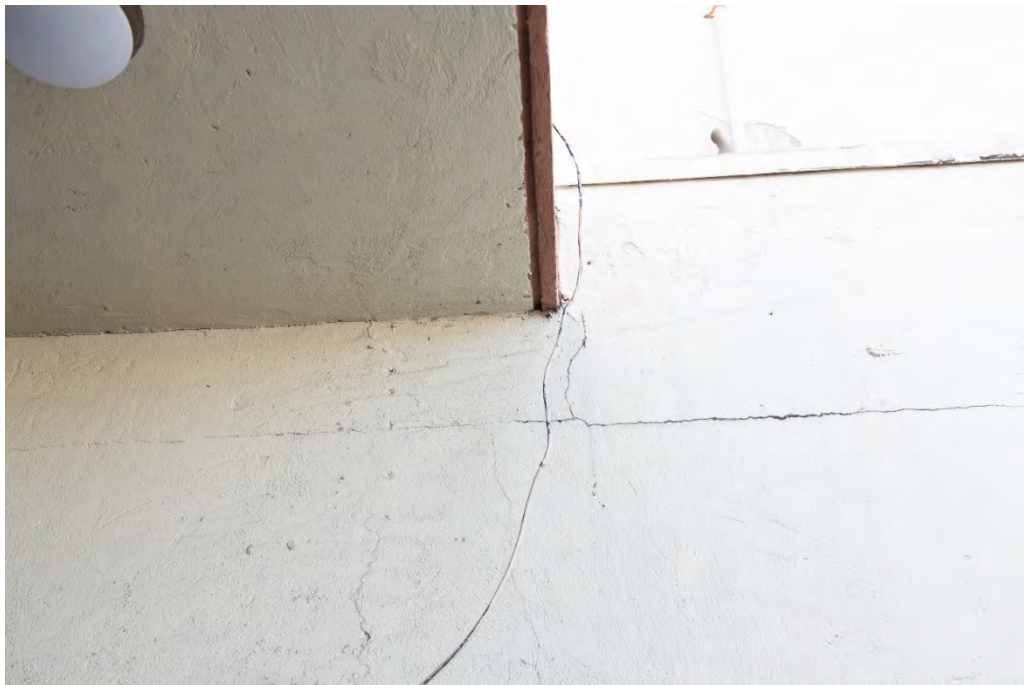
*Figs. A2.15, A2.16 & A2.17- Scaling along detachment/debonding and discoloration of stucco near the entrance in Elevation 4 (top left photo). Macro biogrowth and development of vertical and horizontal slight/hairline as sign of reinforced corrosion on Elevation 5 (top right and bottom photos). Photos by Author, 2020.*

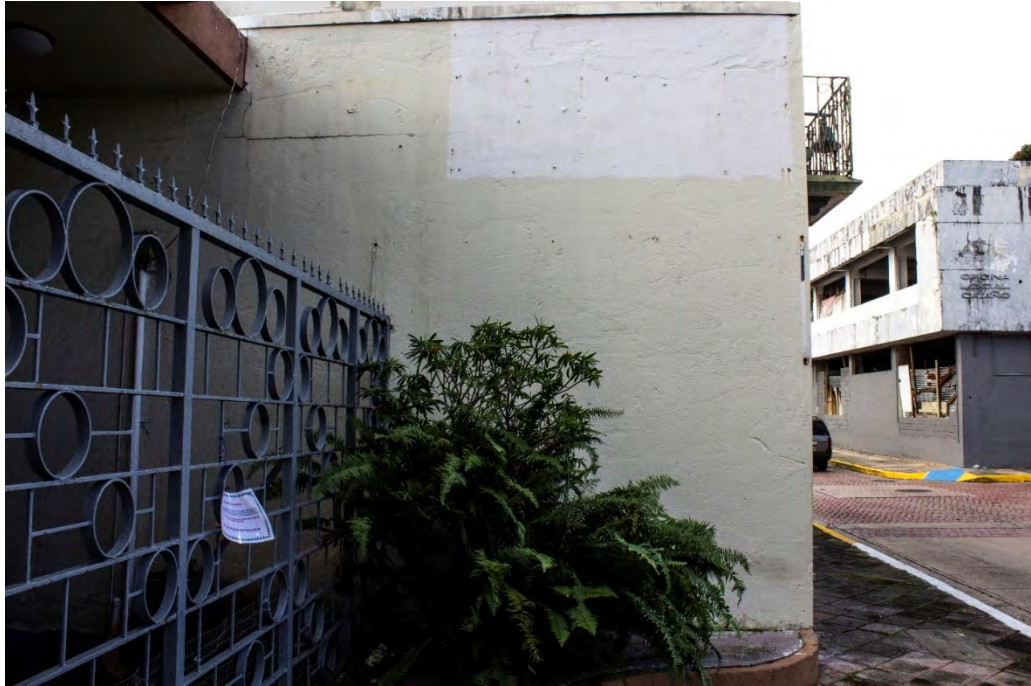
*Fig. A2.18, A2.19 & A2.20 – Two different paint coatings can be found on Elevation 5 along corroding nails and screws from an earlier sign (top photo). The original sign on the wall was installed in 2012 (bottom left photo) & removed c.2015 (bottom right photo). The original entrance signs are present in the 2015 photo. Photos by Author, 2020; Andrés Rivera, 2012 & Luis E. Carraza, 2015.*

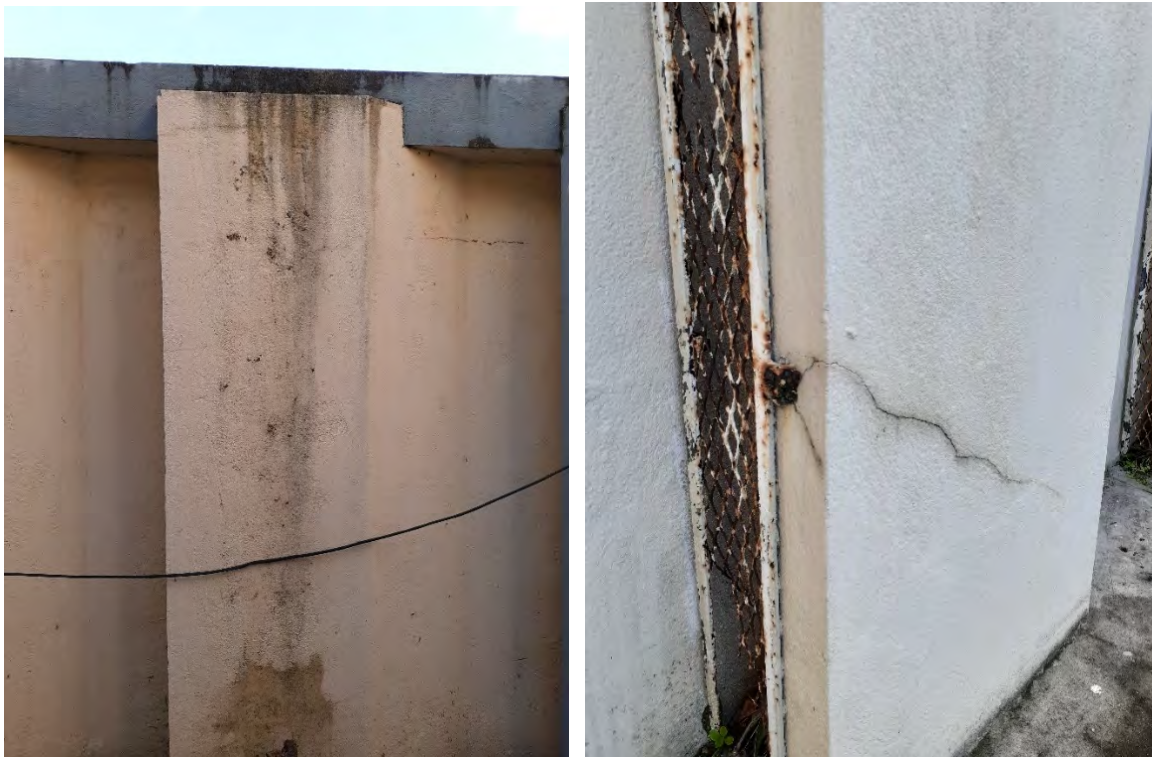
*Fig. A2.24 & A2.25 –Soiling and mold issues on the surfaces of the precast panels on Side B (left photo). Diagonal slight cracking due to steel corrosion on Side A of the precast panels (right photo). Photos by Author, 2020.*

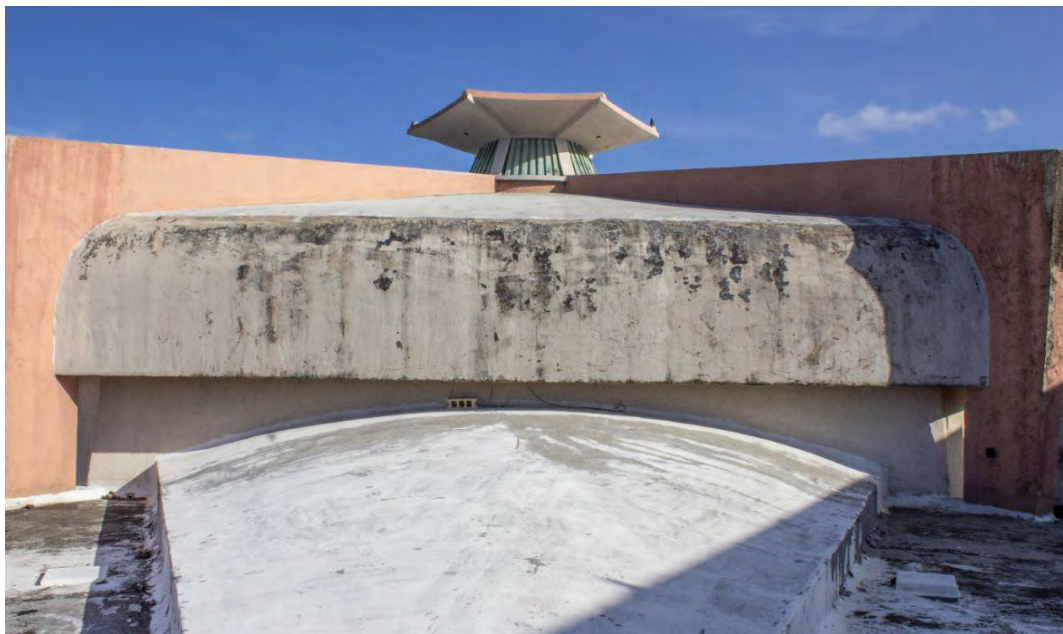
*Fig. A2.33 – Surface fouling and paint peeling/deterioration on Elevation 8 (top photo). Photo by Author, 2020.*

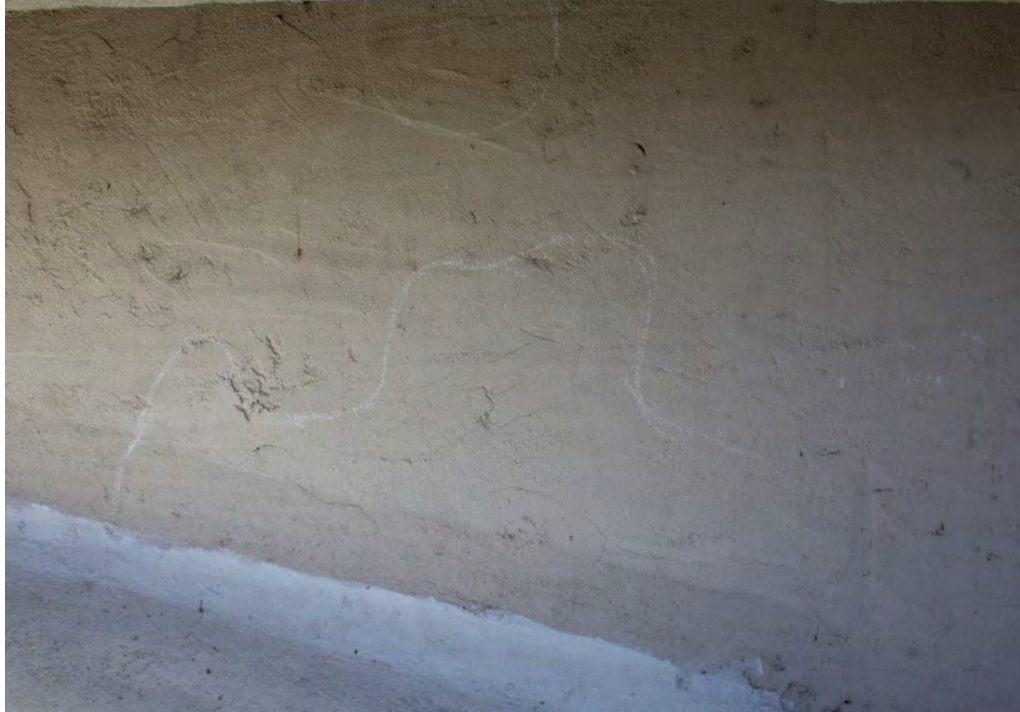
*Fig. A2.34* –Detaching/debonding areas with small hairline diagonal cracks on the stuccoed tilted wall on Elevation 8. Photos by Author, 2020.

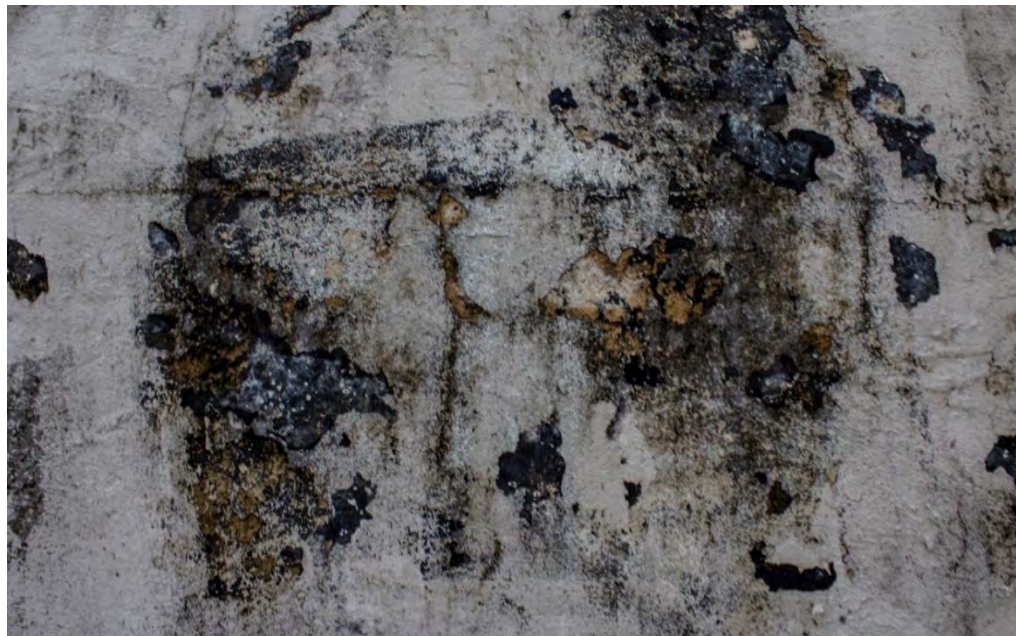
*Fig. A2.35* – Vertical and horizontal microcracking, paint peeling and moisture issues on the surfaces of the dome on Elevation 8. Photo by Author, 2020.

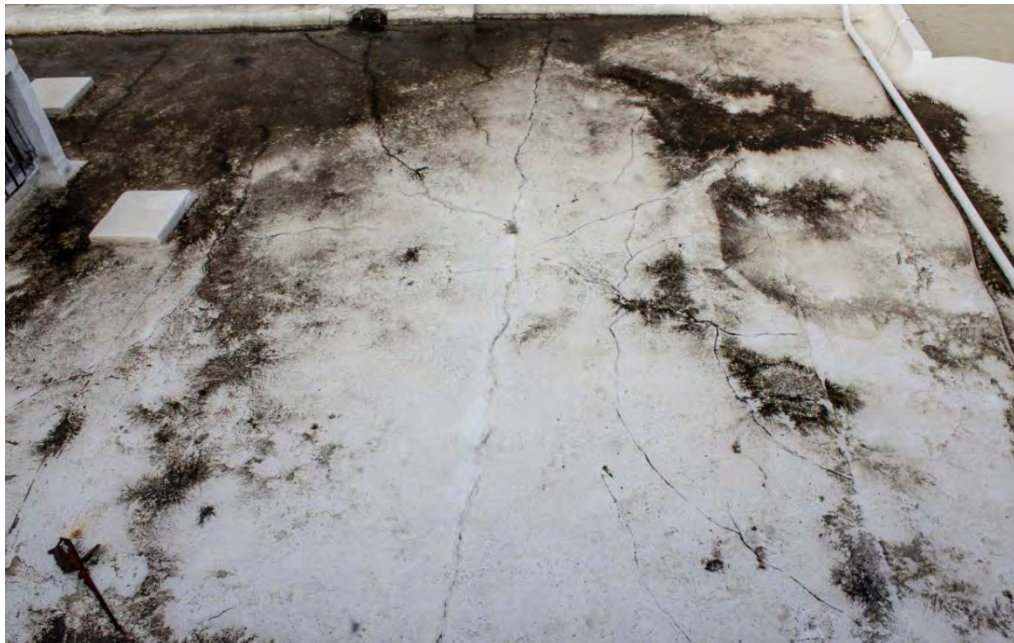
Fig. A2.37 – Current condition of the roof slabs on the west side of the church - Elevation 9. Photo by Author, 2020.

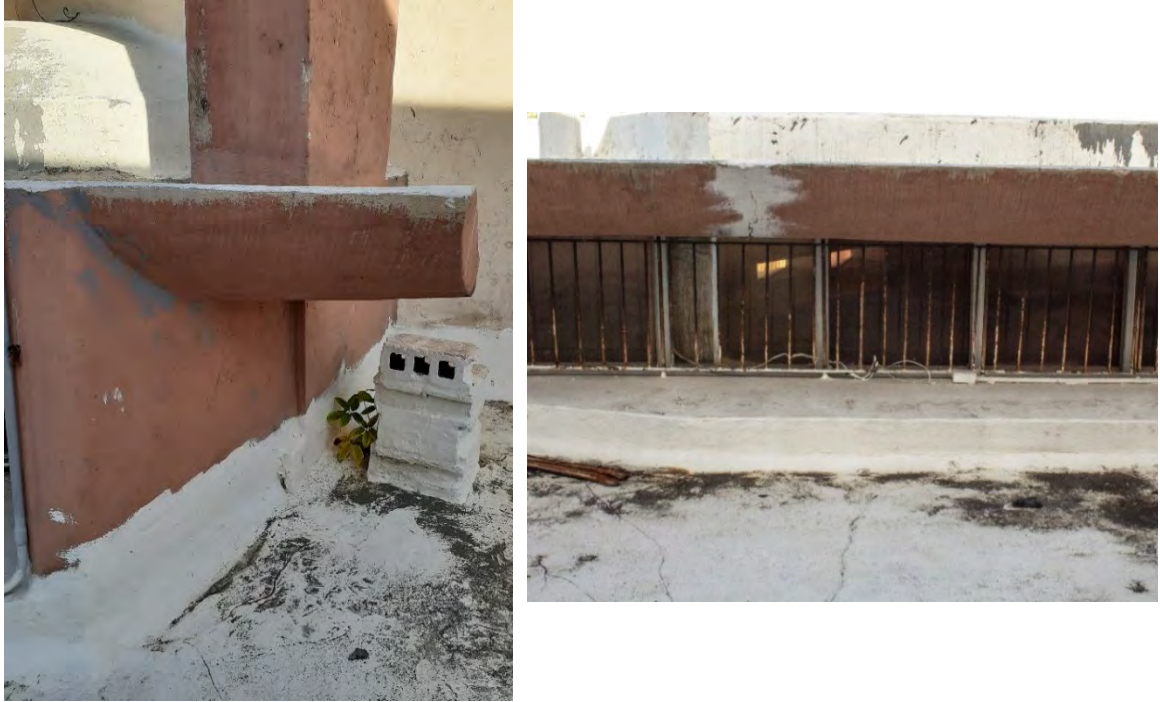
*Figs. A2.44 & A2.45 – Major paint peeling, cracking and improper repairs in Elevation 10B. The sealing grey coating has also been applied to these concrete elements with a new paint coating of painting. Photos by Author, 2020.*

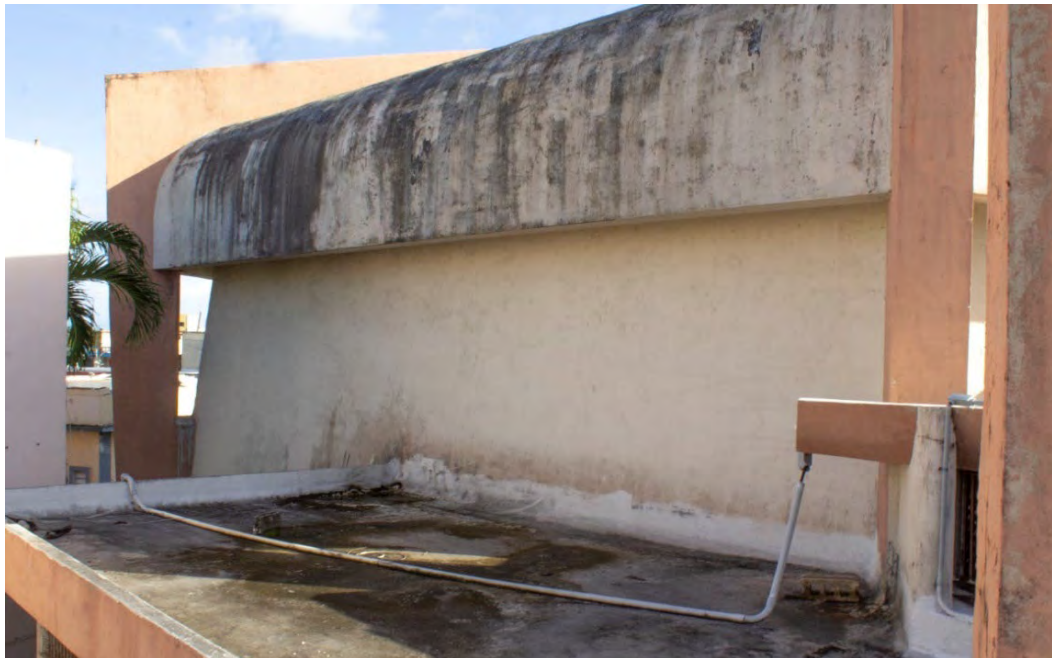
*Fig. A2.52* – The application of a sealing coating to the stuccoed wall is causing moisture, bio-fouling and discoloration issues. Photos by Author, 2020.

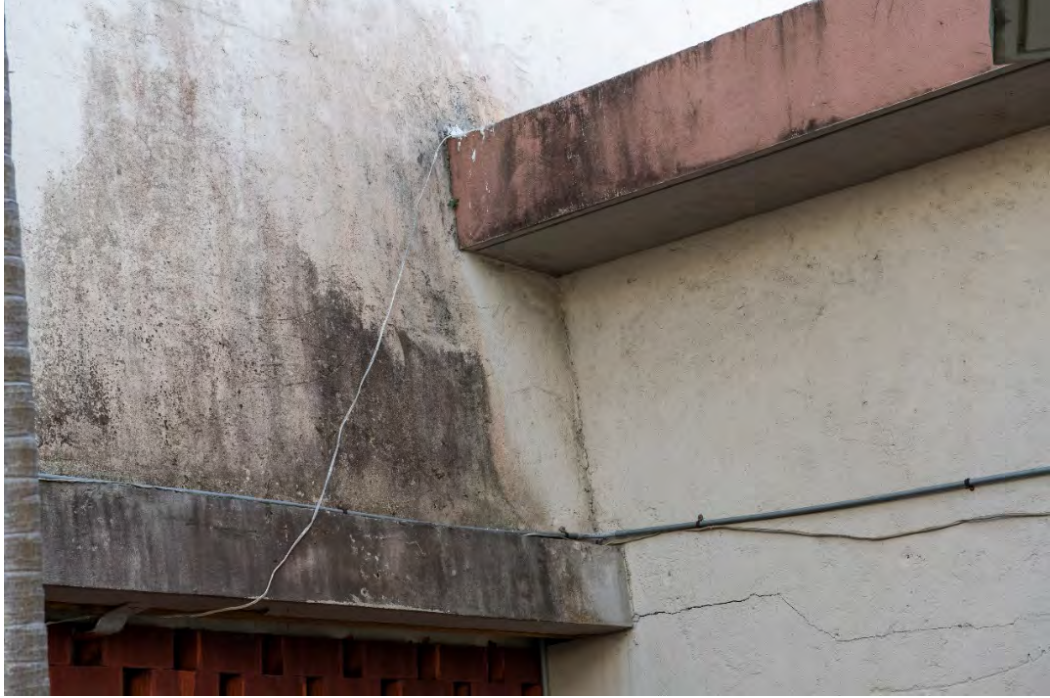
*Fig. A2.53* – Bio-fouling growth and atmospheric soiling issues on the lower side of Elevation 12. Photos by Author, 2020.

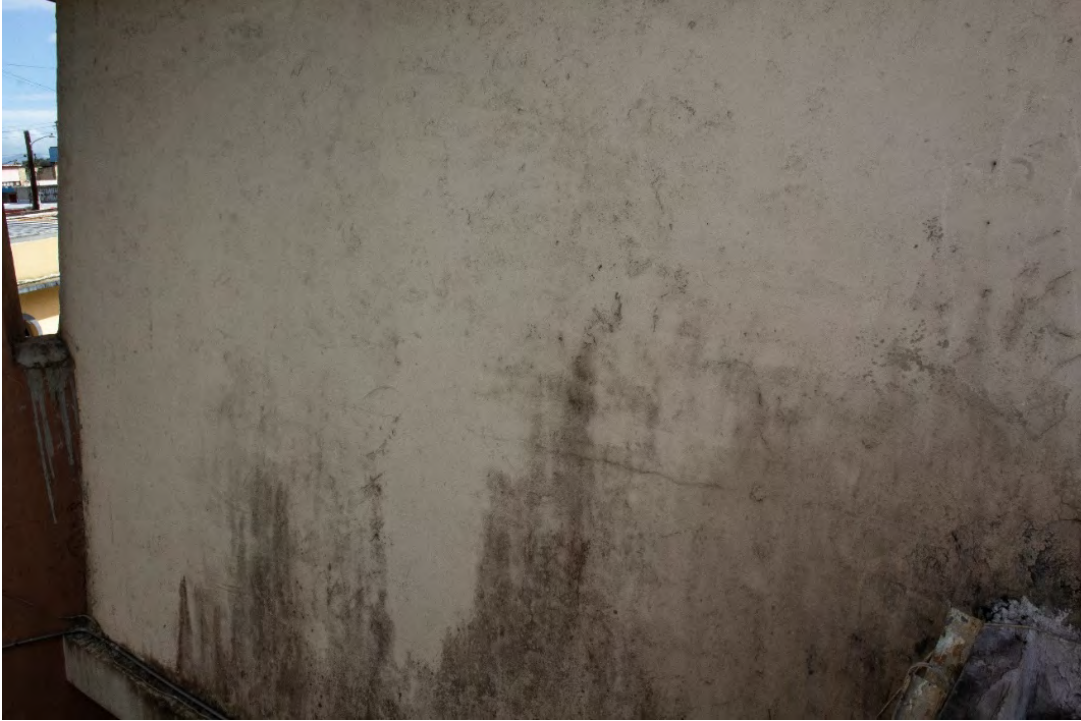
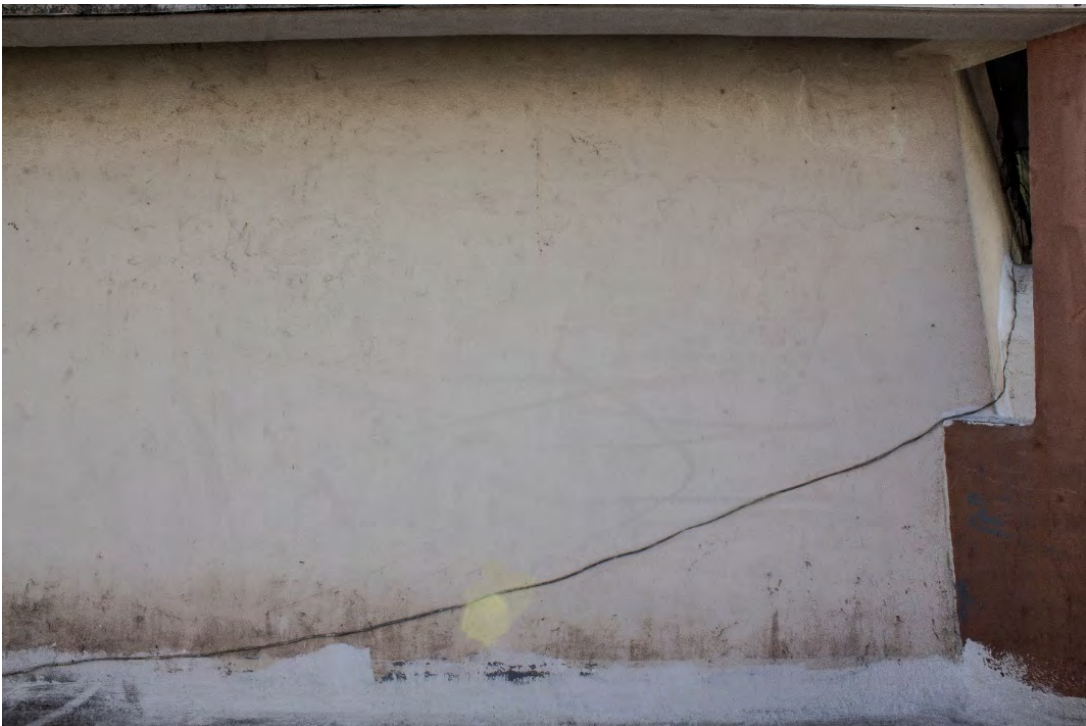
*Figs. A2.54 & A2.55 – Horizontal and vertical highline cracks, minor detachment/debonding sections and scaling along the surfaces. Photos by Author, 2020*

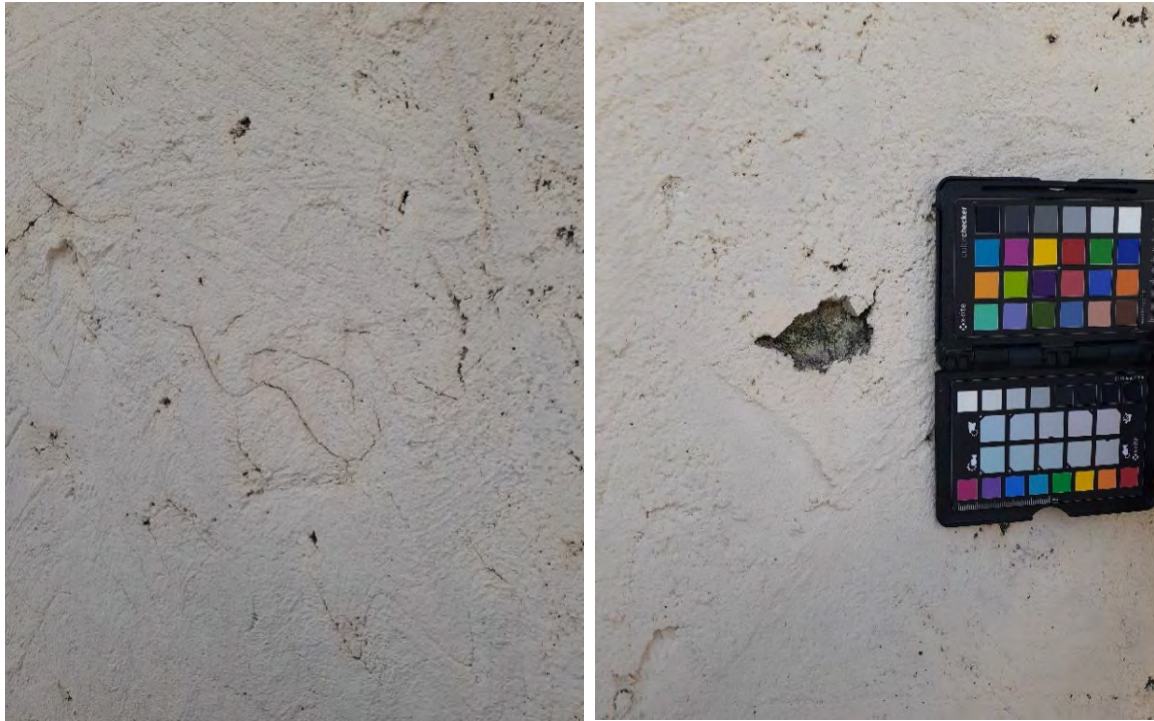
*Figs. A2.57, A2.58 & A2.59 – Highline cracks along discoloration sections and scaled portions of the stucco in Elevation 13 (top photos). Original stucco patches -now covered- show the uneven workmanship over the exposed surfaces. Photos by Author, 2020.*

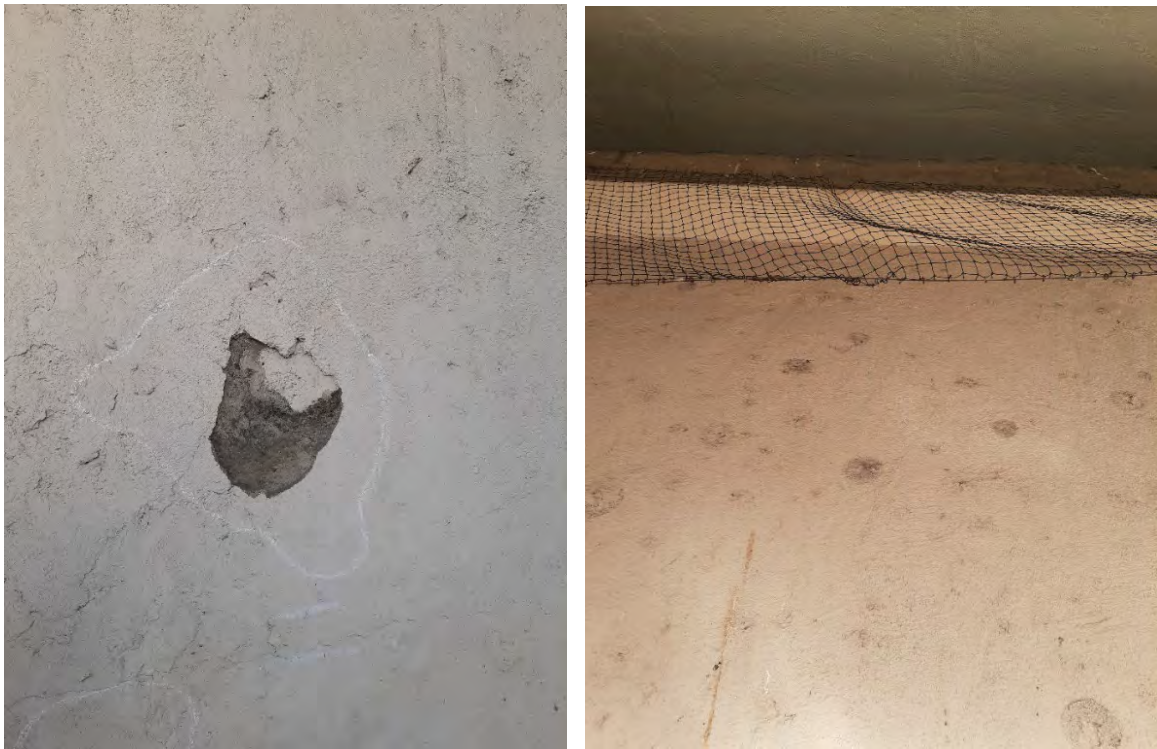
Fig. A2.66 & A2.67 – Elevation 16 showed some scaling and detachment/debonding conditions. Fouling and deterioration under the stucco layer is particularly visible in this section of the Elevation (left photo). Guano and soiling issues on the wall and a broken pigeon netting (right photo). Photo by Author, 2020.

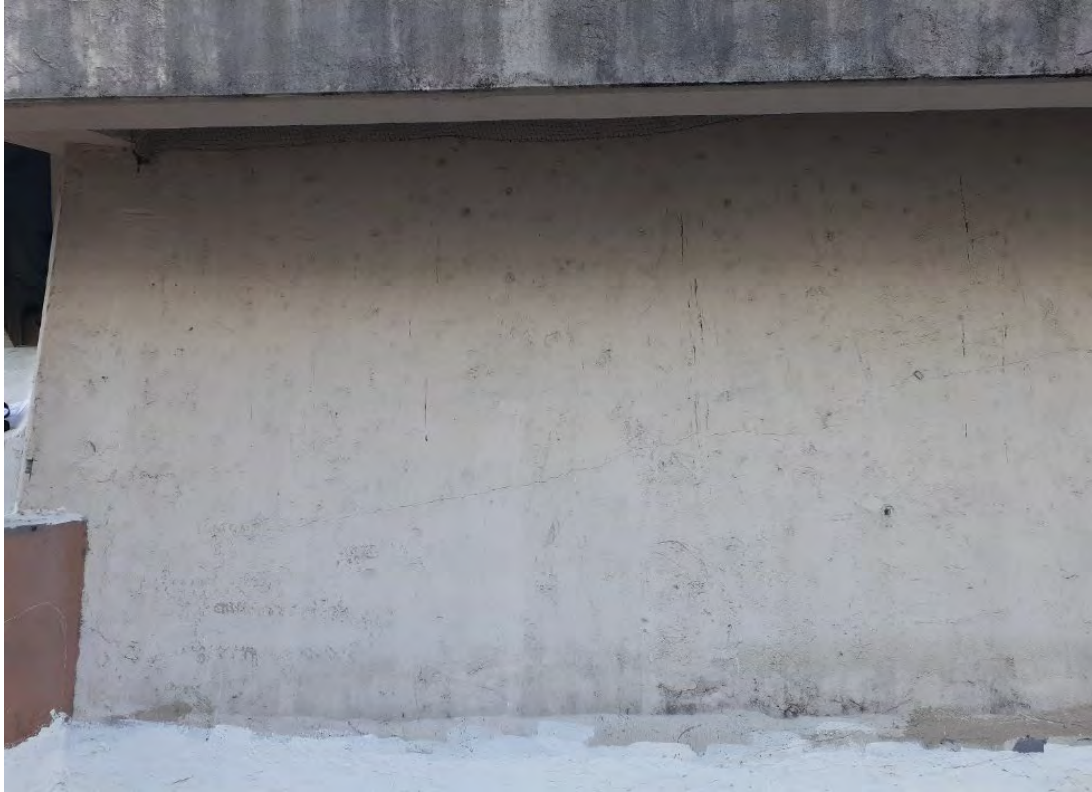
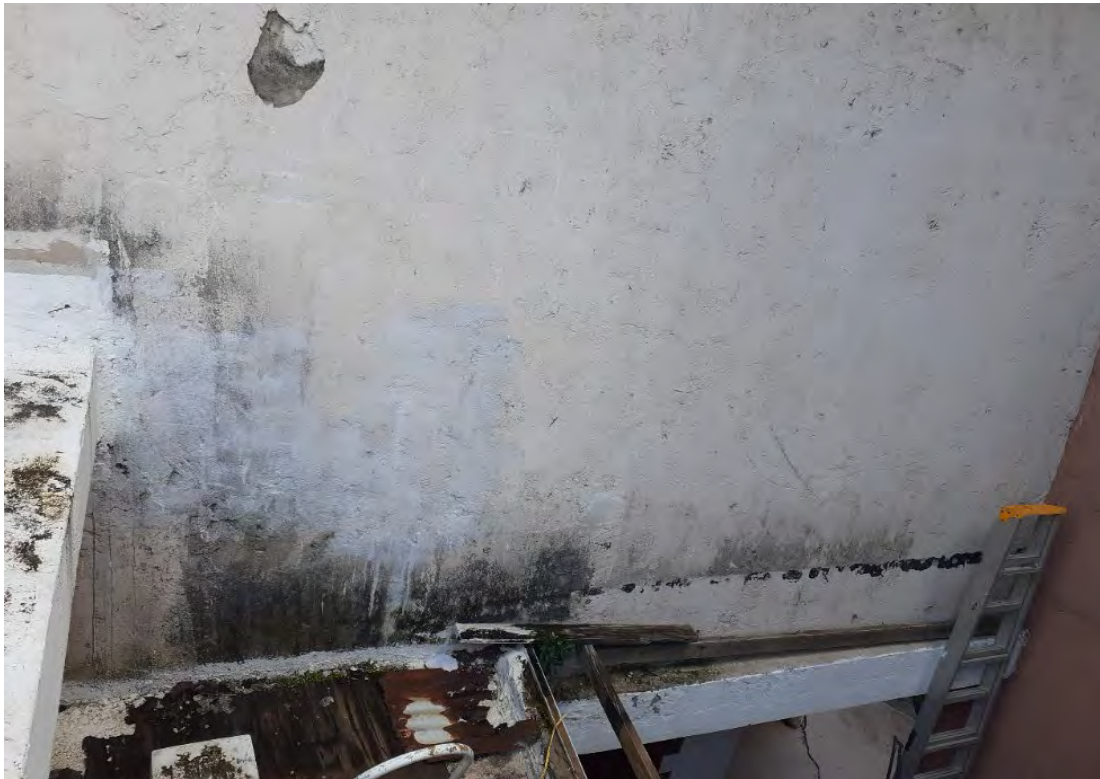
*Figs. A2.68 & A2.69 – Cracking, scaling, guano, mold growth, fouling and moisture issues on Elevation 16. The roof sealing and waterproof coating was also applied to the base of the wall. Photo by Author, 2020.*

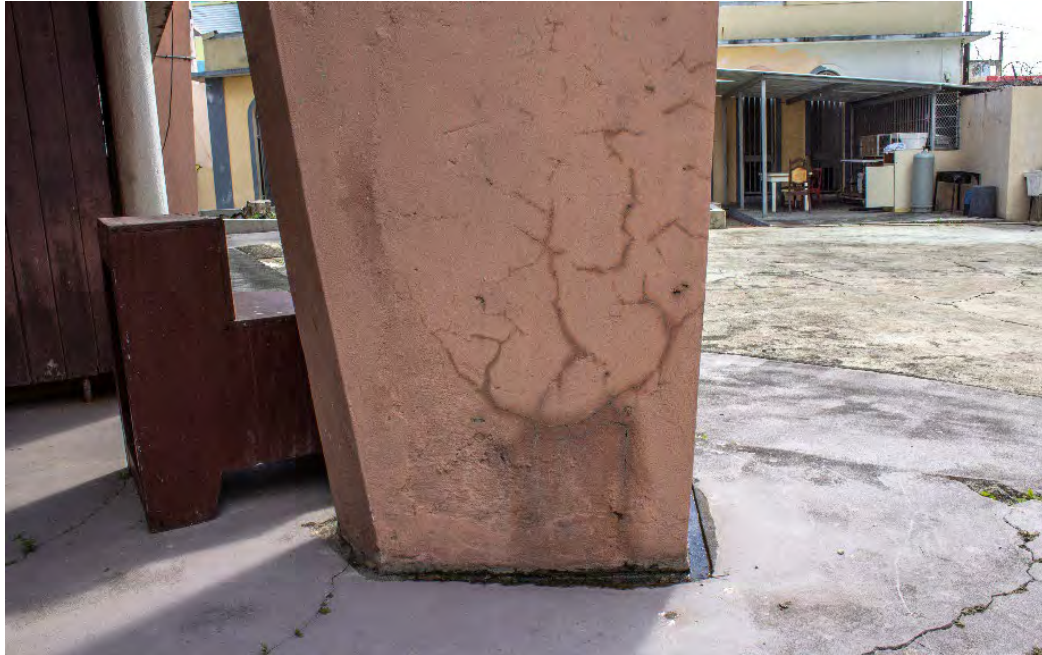
*Fig. A2.84* – Possible alkali-aggregate reaction (AAR) on stucco (as defined by Poole & Sims, 2016) at the base of Column D. Common visual identification of this condition includes crazing surrounded by moisture and discoloration patterns, and efflorescence. Photo by Author, 2020.

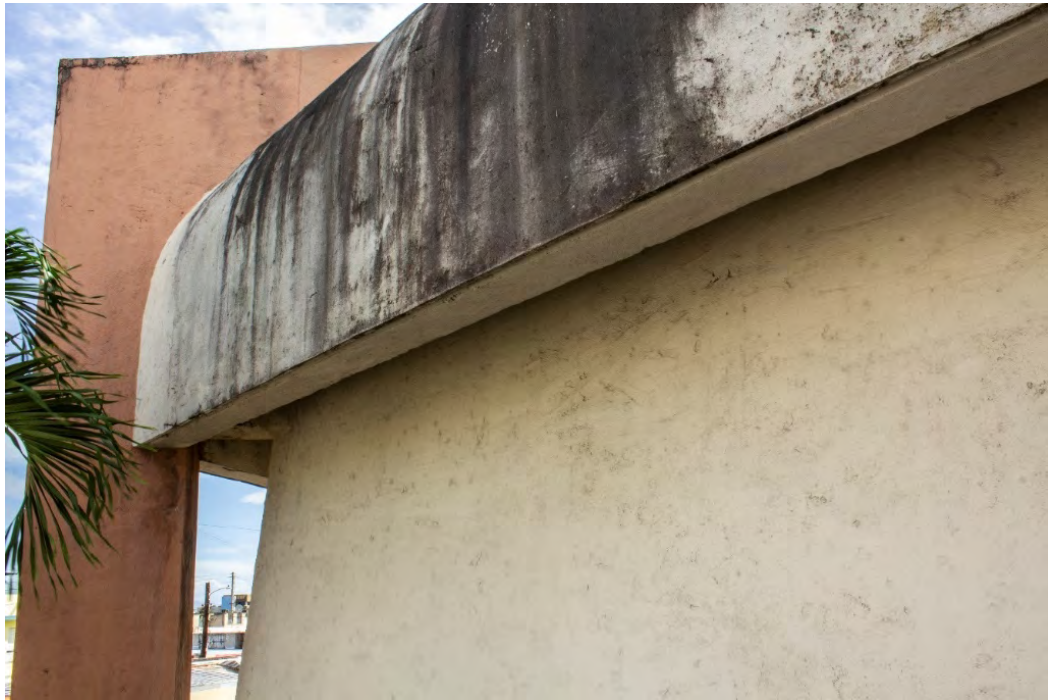
*Fig. A2.95, A2.96 & A2.97 – A failing previous repair behind Column F (top left photo). Fouling, scaling and vertical/horizontal cracking issues on the top of Column F (top right and bottom photos). Photos by Author, 2020.*
