## Load-deformation analysis on a slope at Gunung Pulai water treatment plant, Sultan Ibrahim Reservoir

To cite this article: K Azman *et al* 2019 *IOP Conf. Ser.: Mater. Sci. Eng.* **527** 012031

K Azman\*, M Mushairry<sup>1</sup>, A R Ahmad Safuan<sup>1</sup>, O Mohd Hanim<sup>1</sup>, I Izni Syahrizal<sup>1</sup>, V Mohammadreza<sup>1</sup>, C A Sophia<sup>1</sup>, M A Mohd Azreen<sup>1</sup>, A Rini Asnida<sup>1</sup>, S Radzuan<sup>1</sup>, H Muhammad Azril<sup>1</sup>, A Mohd Nur Asmawisham<sup>1</sup>, M A Mohd For<sup>1</sup>, T Sahrul Nizam<sup>1</sup>, A R Afif<sup>1</sup>, K Kamrul Zaman<sup>1</sup>, H Hairul Hairi<sup>1</sup>, A W Zulkifly<sup>1</sup>, D S A Ismail<sup>1</sup> and M A R Muhammad Fateh<sup>1</sup>

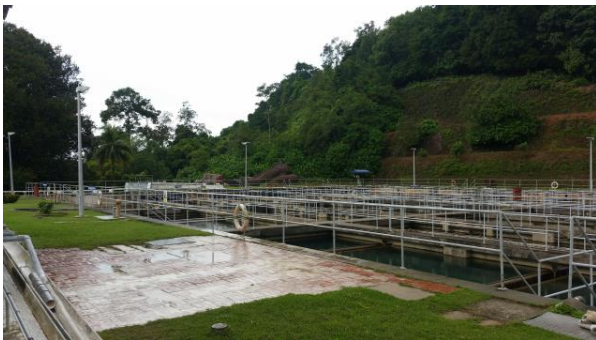
State government under new management of the Syarikat Air Johor (SAJ). However, the integrity of the water treatment structure should be checked due to the structure was built over more than 90 years, and moreover after a several cracks was recently observed at Water Sedimentation Plant as shown in Figure 1 and Figure 2.

**Figure 1.** Water sedimentation plant.

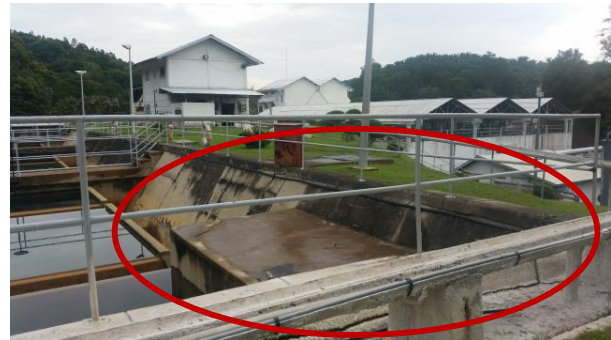
Two (2) possibilities could have contributed to the cracks which are the effect from vibration due to blasting activities from the nearby quarry and/or the movement of present retaining wall or sloping area nearby the treatment plant. To measure and quantify the vibration, real time monitoring is conducted in order to understand on the vibration effect toward the treatment plant structure. The implementation of slope monitoring program and installation of vibration monitoring devices at Gunung Pulai Water Treatment Plant (GPWTP) that include designing, setting-up and installing multiple monitoring systems with the aim of identifying contributed factors to the problem of crack on water treatment structures, i.e. Water Sedimentation Plant (Kassim *et. al.*, 2018a).

**Figure 2.** A structural crack was observed on the Water Sedimentation Plant storage tanks.

Therefore, it is strongly recommended that slope remedial works (designing and constructing stable slope) together with in depth investigation on crack of sedimentation concrete structure (repairing and monitoring of crack propagation) should be carried out in very near future. The most importantly, the slope at corner area should be reinstated to strengthen gabion wall before the cracks on that particular location of Water Sedimentation Plant are repaired.

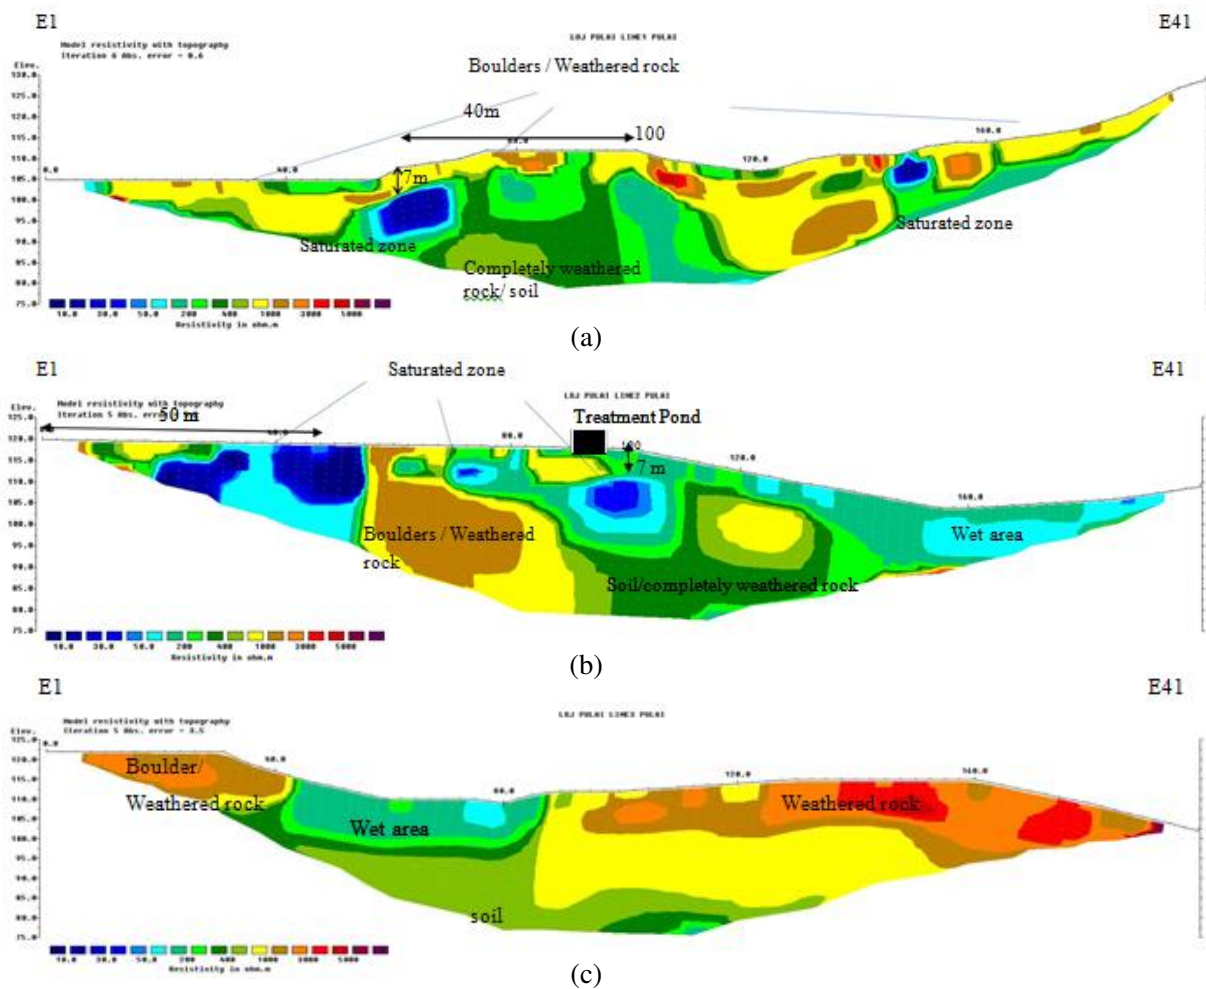
The resistivity images in Figure 4 show a subsurface profile along 200m of resistivity Line 1, Line 2 and Line 3. The images show that the subsurface material of Line 1 is dominantly underlain by resistivity

value less than  $500\Omega\text{m}$  around the centre of the line that can be interpreted as completely weathered rock or soil. Significant low resistivity zone (less than  $50\Omega\text{m}$ ) was identified at 40m (60m from E1) from the center of the Line 1 that interpreted as saturated zone. The depth of saturated zone is estimated 7m from the surface. The image also shows that the subsurface material of resistivity value ranging above  $1000\Omega\text{m}$  can be interpreted as hard layer of weathered rock or boulders. The hard layer is shown overlain the area.

Figure 4. Resistivity image of Line 1 (a), Line 2 (b) and Line 3 (c) (Kassim *et. al.*, 2018b).

Line 2 is dominantly covered by low resistivity value material which is less than 400Ωm interpreted as soil or completely weathered rock. The significant very low resistivity (less than 50Ωm) was found 50m from E1 considered as saturated zone where consider as soil with high water content. The saturated area is believed to be confined by the hard material (boulders). Saturated zone was also detected at the center of survey line which is next to the water treatment pond. And lastly, Line 3 shows that subsurface material is dominantly underlain by high resistivity material (more than 1000Ωm) that can be interpreted as hard and

weathered rocks. It is believed that there is soil layer underlain the boulders. It can be observed at the upper part of subsurface profile at the distance of 45m to 90m from E1 there is a location of low resistivity area which considered as wet area where it is considered high water content in the soil here.

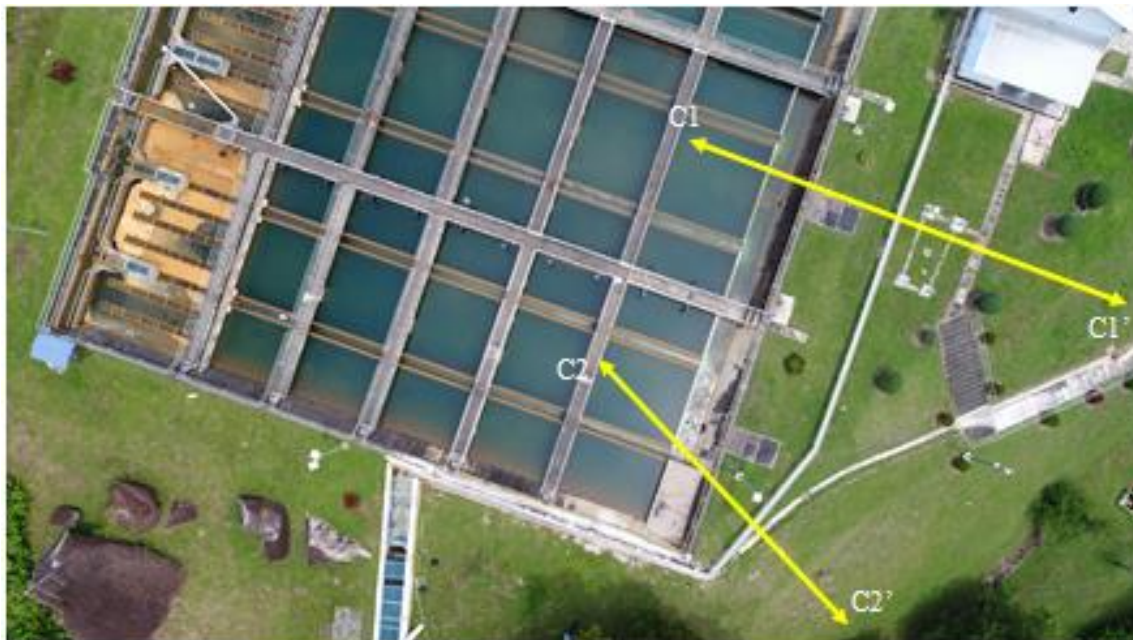
In general, the existing slope in the Water Sedimentation Plant is relatively steep with the average slope angle ranges from  $27^\circ$  to  $30^\circ$ . Since the friction angle,  $\phi$  for top soils – Silty SAND obtained from site investigation works ( $\phi' = 20^\circ$ ) is lower than the average slope angle, the existing slope is expected to be unstable and unsafe, and erosion could occur due to present of loose top soil on slope and high rainfall intensity during monsoon season (Kassim *et al.*, 2012; Lee *et al.*, 2011).

Figure 5 shows two slope cross section, C1 and C2 where the original slope has a slope height of 25m and slope angle of  $27^\circ$ . The original slope profile and soil properties are interpreted from nearby BH1, BH2, BH3 and BH4 as shown in Figure 3 (Kumpulan Ikram, 2018). The geometry and soil profile consist of two main layers of Top Soil firm to stiff Silty SAND (unit weight,  $\gamma = 16\text{kN/m}^3$ , effective friction angle,  $\phi' = 20$ , effective cohesion,  $c' = 5\text{kPa}$ , Young Modulus,  $E = 3000\text{kPa}$  and Poisson's ratio,  $\nu = 0.4$ ) and Bottom Soil stiff to very stiff Weathered Rock ( $\gamma = 24\text{kN/m}^3$ ,  $\phi' = 35$ ,  $c' = 0\text{kPa}$ ,  $E = 30000\text{kPa}$  and  $\nu = 0.3$ ). There are 2 type of analysis carried out on C1 and C2, i.e. Factor of Safety (FOS) distribution analysis via sensitivity on seismic load ( $k_h$ ),  $\gamma$ ,  $\phi'$  and  $c'$  and Load-Deformation analysis on original slope with treatment plant full with water.

**Figure 5.** Slope cross section of C1 and C2.

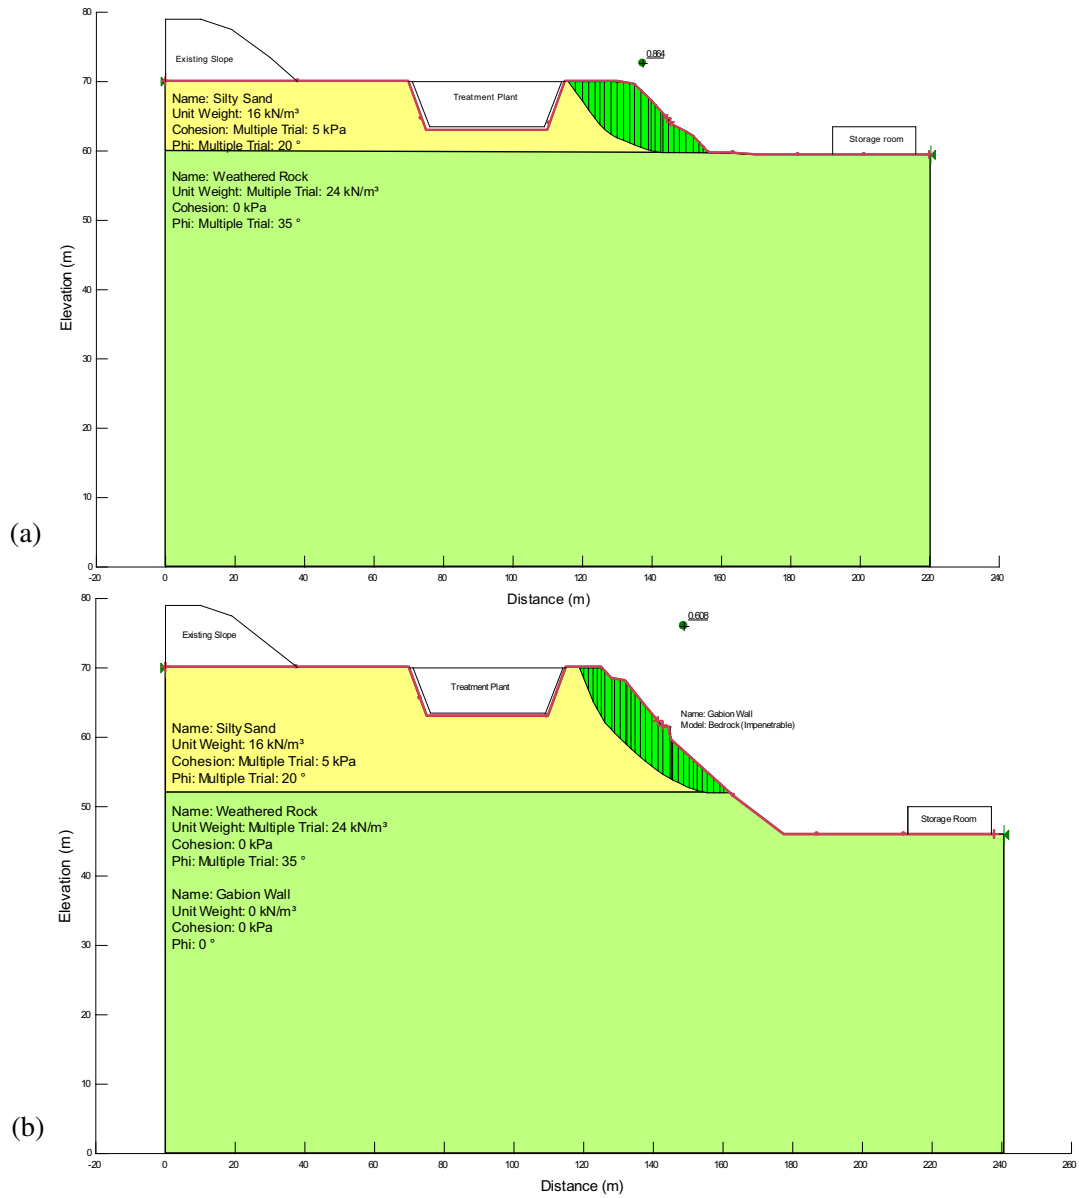
Figure 6(a) and (b) shows the calculated Factor of Safety (FOS) for cross section C1 and C2. The slope stability analysis show the failure feature for cross section C1 is likely global and deep seated with the FOS = 0.864 via sensitivity analysis. The FOS = 1 (stable condition) with sensitivity of  $k_h$ ,  $\phi'$  and  $c'$  at 0.21g, 24° and 10kN/m<sup>3</sup>, respectively on top soil (Silty SAND) but FOS is not sensitive to bottom soil (Weathered Rock) as shown in Figure 7. The results for cross section C1 indicate any decrease in  $\phi'$  and  $c'$  (during wetting/saturated condition) or increase in  $k_h$  will cause instability on slope (FOS is less than 1).

Also, the failure feature for cross section C2 is likely global and deep seated with the FOS = 0.608 via sensitivity analysis. Figure 7 shows the FOS < 1 for all  $k_h$ ,  $\phi'$  and  $c'$  values to show original slope at cross section C2 is unstable. However, the sensitivity trends are similar to cross section C1 where it is sensitive to top soil but FOS is not sensitive to bottom soil. The results indicate the slope at C2 is likely to fail to compare to FOS for C1 = 0.864.

Figure 6. Slope stability analysis on C1(a) and C2(b).

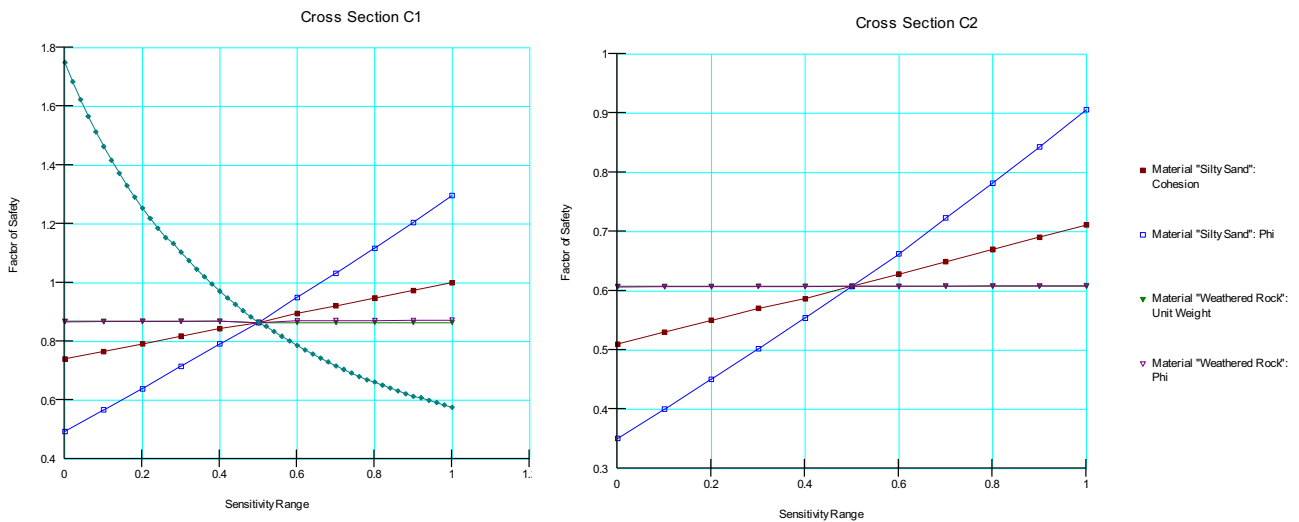
Figure 7. Sensitivity analysis on C1 and C2.

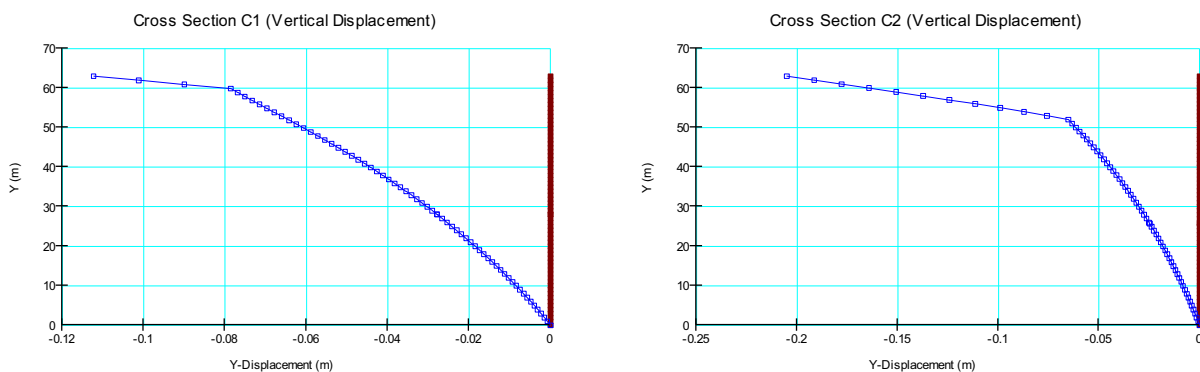
Figure 8 to 10 shows the results of Load-Deformation analysis on cross section C1 and C2. The results of analysis show the vertical displacement on cross section C1 is maximum on the bottom of treatment plant (Y-displacement = 110mm) but decreasing to 0mm at Reference Level of 0m. The horizontal displacement, X-displacement = 10mm to 60mm on cross section C1. The results for cross section C1 indicate applied load significantly affect deformation at both vertical and horizontal directions which could have contributed to FOS < 1 in slope stability analysis. For cross section C2, the maximum vertical displacement (Y-displacement) = 200mm is larger than found on C1 (Y-displacement = 110mm). The horizontal displacement on C2, X-displacement = 60mm to 150mm as shown in Figure 10. The results indicate deformation due to applied load is more critical at cross section C2 to compare to cross section C1.

Figure 8. Vertical displacement on C1 and C2.

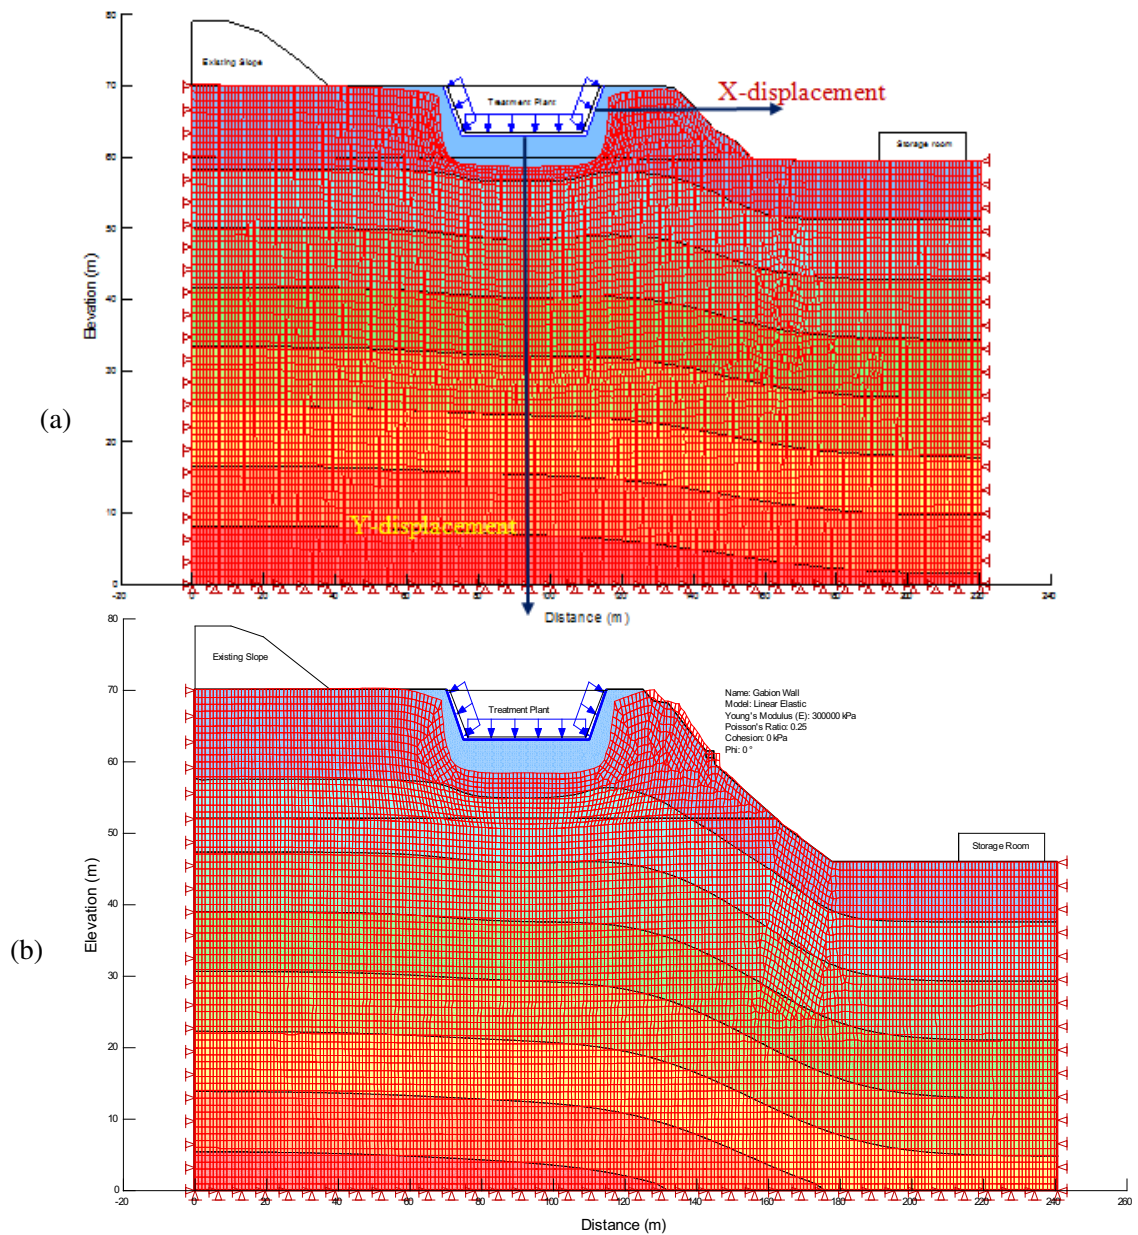
**Figure 9.** Load-Deformation analysis on cross section on C1(a) and C2(b).

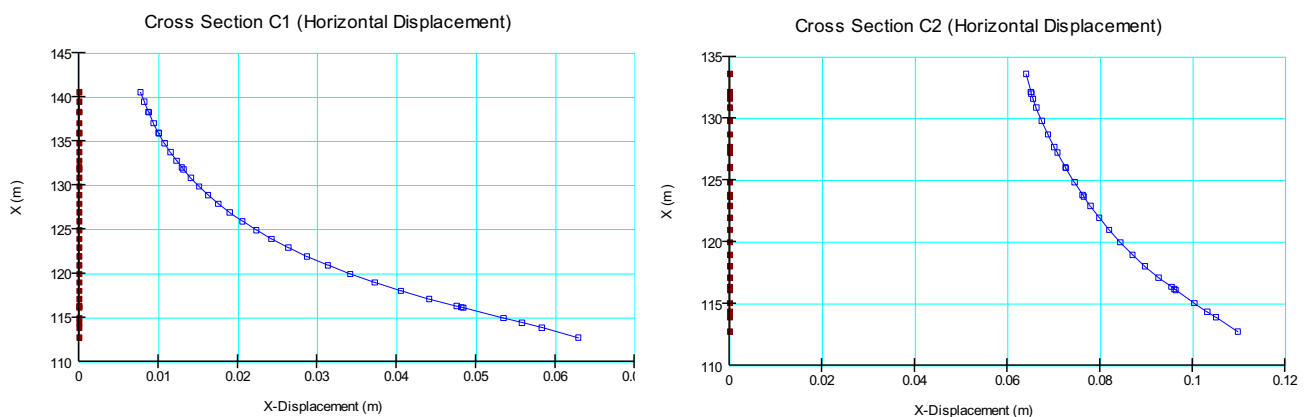
applied structural and water loads significantly affect deformation at both vertical and horizontal directions which could have contributed to  $FOS < 1$  in slope stability analysis. It is also shown that deformation due to applied loads is more critical at cross section C2 (near corner area of Water Sedimentation Plant) to compare to cross section C1.

**Figure 10.** Horizontal displacement on C1 and C2
