# Rapid Bridge Replacement under Emergency Situation: Case Study

Yong Bai, P.E., M.ASCE<sup>1</sup>; William R. Burkett, P.E.<sup>2</sup>; and Phillip T. Nash, P.E.<sup>3</sup>

### I-95 Chester Creek Bridge Incident

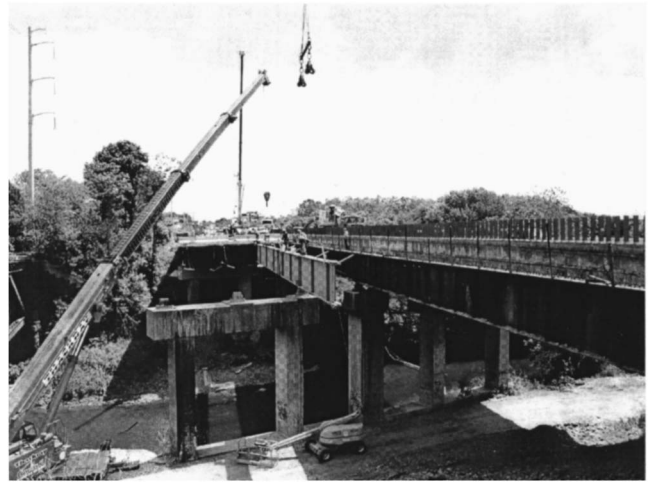
Buckley installed the nine steel girder segments on June 8 and 9. Fig. 2 shows a piece of steel girder being placed on a concrete pier cap. Then, construction crews set 4.3-m-wide (14 ft) steel deck pans between the four rows of girders. Next, reinforcing bars were installed in place for the concrete deck. A total of 38 truckloads of concrete were placed to form the new 254 mm (10 in.) deck on Tuesday, June 16. Fig. 3 presents the new concrete bridge deck. While the concrete cured, construction crews poured new parapet walls on the bridge. The compressive strength of the concrete deck exceeded the required 27,560 kilopascals (4,000 psi) less than a week after the deck pour. On June 25,

Fig. 2. Placing steel girder on concrete pier cap

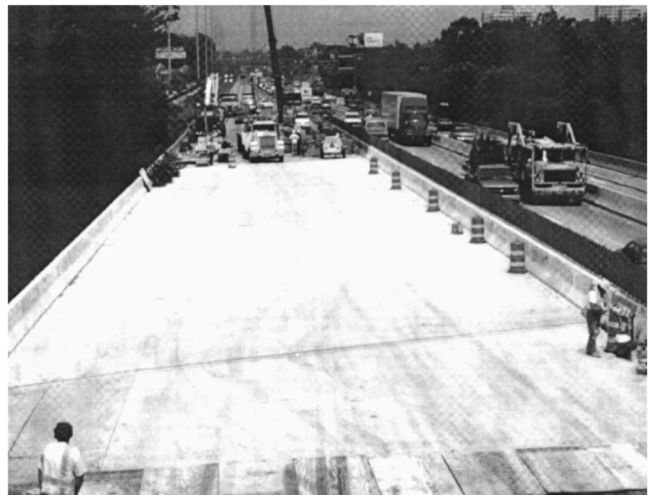
Fig. 3. New concrete deck
