Lessons Learned from an Emergency Bridge Replacement Project

Yong Bai, P.E., M.ASCE¹; William R. Burkett, P.E.²; and Phillip T. Nash, P.E.³

I-40 Webbers Falls Bridge Incident

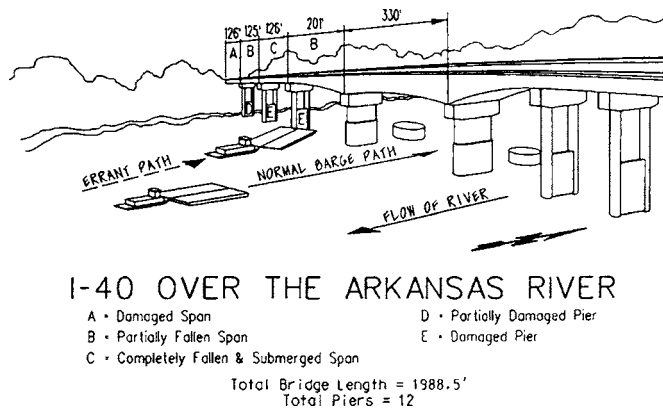
Fig. 1. I-40 bridge incident sketch

piers of the bridge, knocking down two piers (indicated as E piers) and partially damaging another (indicated as the D pier). Four spans totaling approximately 152 m (500 ft) were also damaged. Span 1 [38 m (126 ft), shown as damage type A] was damaged, but did not fall. Span 2 [38 m (125 ft), shown as damage type B] and Span 4 [61 m (201 ft), shown as damage type B] partially fell into the river. Span 3 [38 m (126 ft), shown as damage type C] completely collapsed into the river. Fig. 2 shows the damaged bridge.

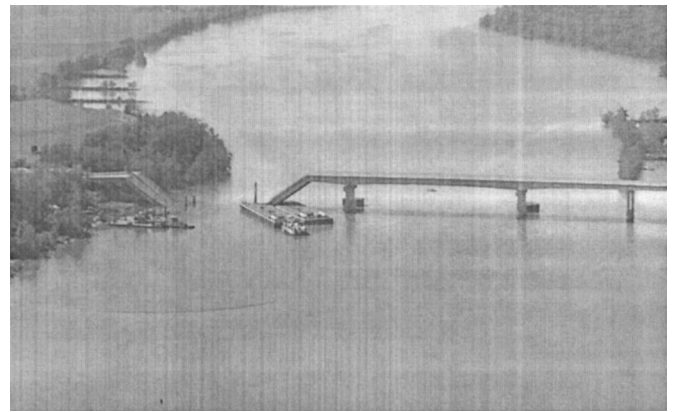
Fig. 2. Overview of damaged bridge

still attached to the undamaged bridge, as shown in Fig. 2. The remainder of the bridge structure could have been further damaged if the crews had not been careful during the demolition. To prevent this from happening, the Magnolia Marine Transport Company stabilized the barges and the crews constantly monitored the movements of the bridge and barges. Combinations of demolition devices including a wrecking ball, explosives, concrete shears, and other cutting devices were used to meet the different needs at the site. The debris removed from the accident site was piled on a 2 ha (5 ac) site on the river's west bank and was trucked or floated away during the demolition.

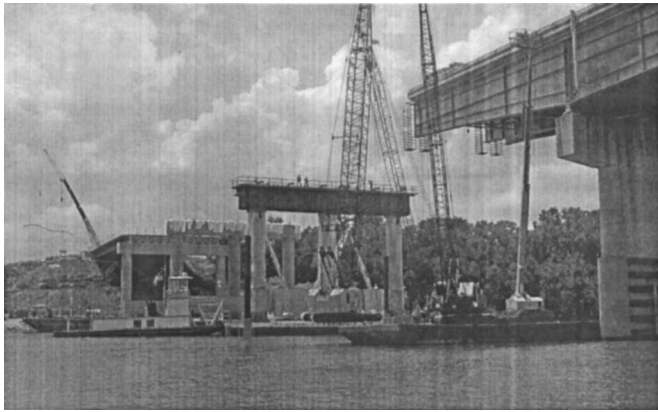
Fig. 4. New pier structures under construction

The old piers had two columns supporting them. The new piers were three column structures supported by drilled shafts. Pier 3 was rebuilt at the original station. Its three columns were spaced to straddle the existing spread footings that were left in place. The new piers were 2.7 m (9 ft) in diameter (under web wall portions), which was 0.6 m (2 ft) larger than the original. Fig. 4 shows the new pier structure under construction. The new piers were constructed with a construction joint at the top of web walls, which were full column width with some chamfering at the ends for ease of forming. Substructure concrete was permitted to be loaded at 75% of design strength.

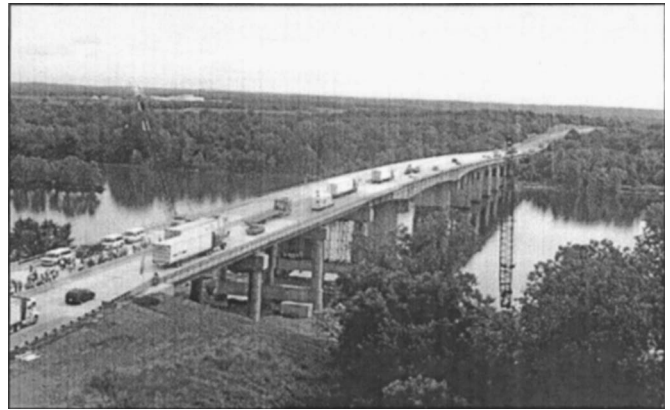
Fig. 5. I-40 bridge reopened to traveling public

streamline the bid review and approval procedures and get the reconstruction contract ready to put out for bid. ODOT also received technical help and cooperation from the U.S. Army Corps of Engineers, the U.S. Coast Guard, and other state DOTs. Fig. 5 shows the bridge as it was reopened to the traveling public on July 29, 2002.
