Micro-CT Scanning in the Investigation of Squat Defects in Rail Steel

Shaun Earl

*Submitted for the degree of Doctor of Engineering in the
Department of Materials Science and Engineering at the
University of Sheffield, UK.*

January 2021

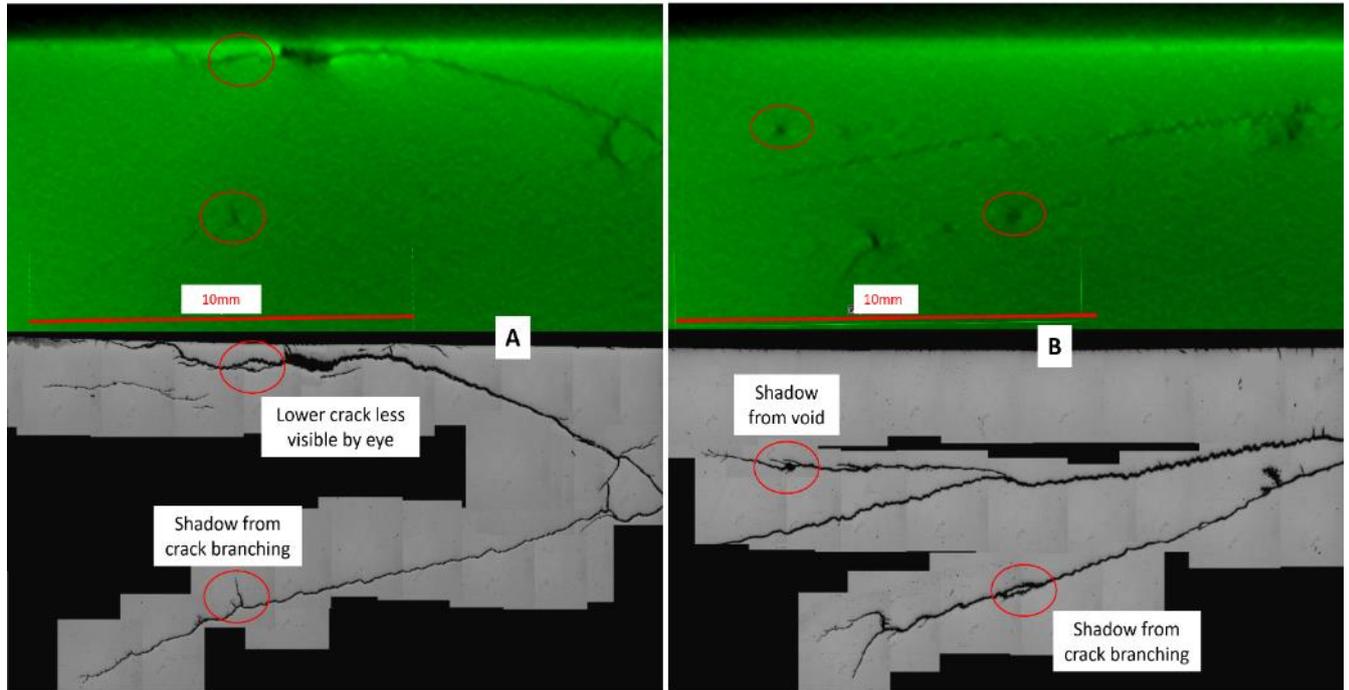
Figure 74: Comparison of longitudinal CT scan orthoslice to longitudinal section in sample 2 a) The surface void visible from the surface scans with a shadow and its cause highlighted b) Branching that shows shadows in the scan and the same cause as (a) in the micrograph.

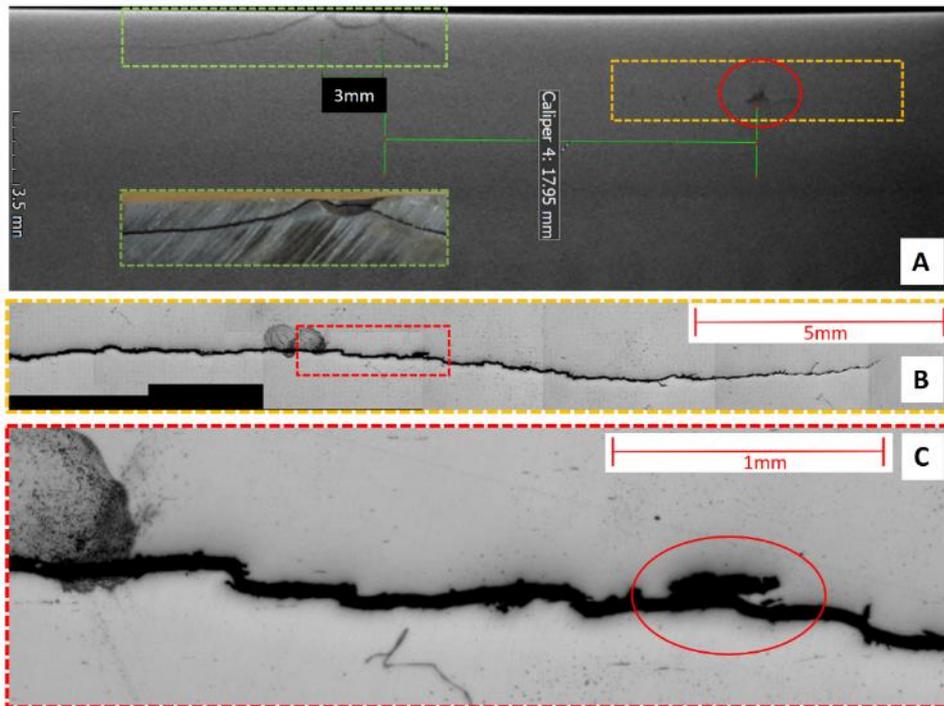
Figure 75: Longitudinal slice through the c-shaped crack in the centre of the surface of sample 4. a) CT scan orthoslice showing the surface breaking crack, highlighted in the green box, with a photo of the sectioned sample inset in the lower green box b) An unetched micrograph of the area highlighted in the orange box c) An expanded view of B, with a red circle showing the cause of the shadow in the CT scan orthoslice (a).

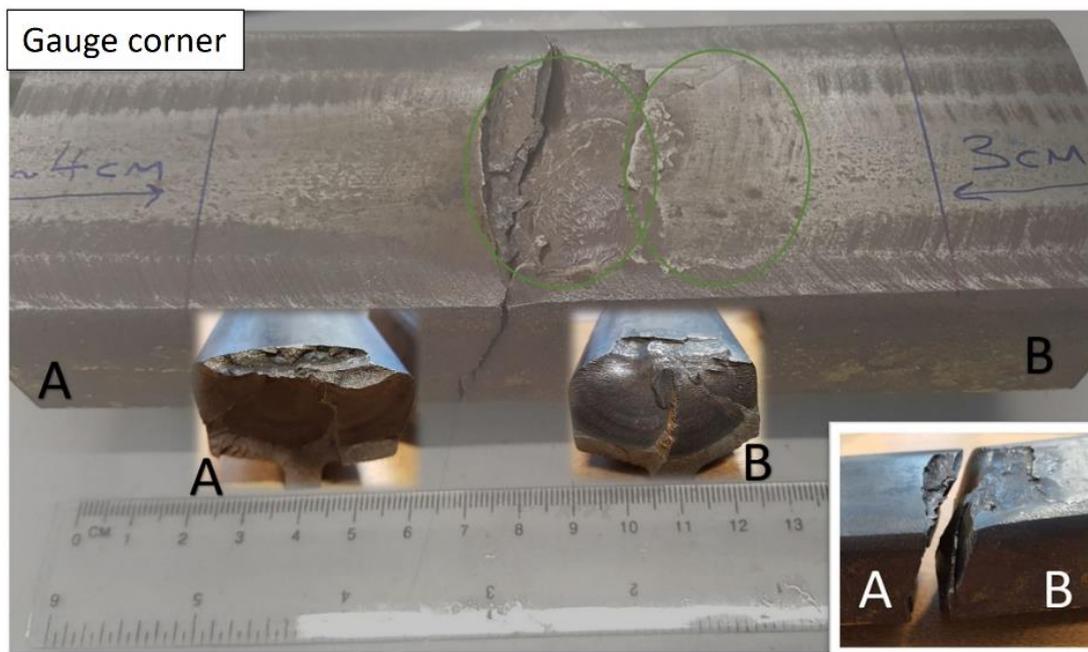
Figure 79: Sample 3 in its entirety split into pieces A and B. The lobes of the Squat are circled. The figure shows how the crack initially grew at a shallow angle (the shelled region) before taking a drastic change of direction and heading down through the rail. Future references to Sample 3 will be to piece B only as it contains the intact lobe of the defect.

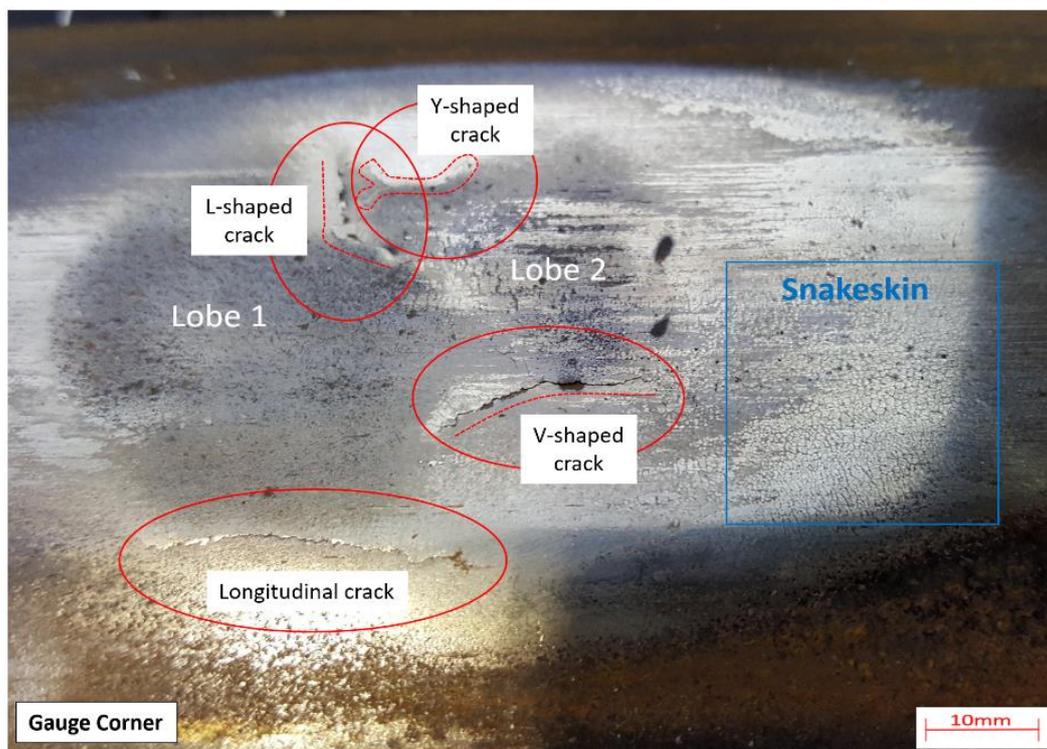
Figure 81: Sample 1 with the cracks circled in red and the snakeskin boxed in blue.

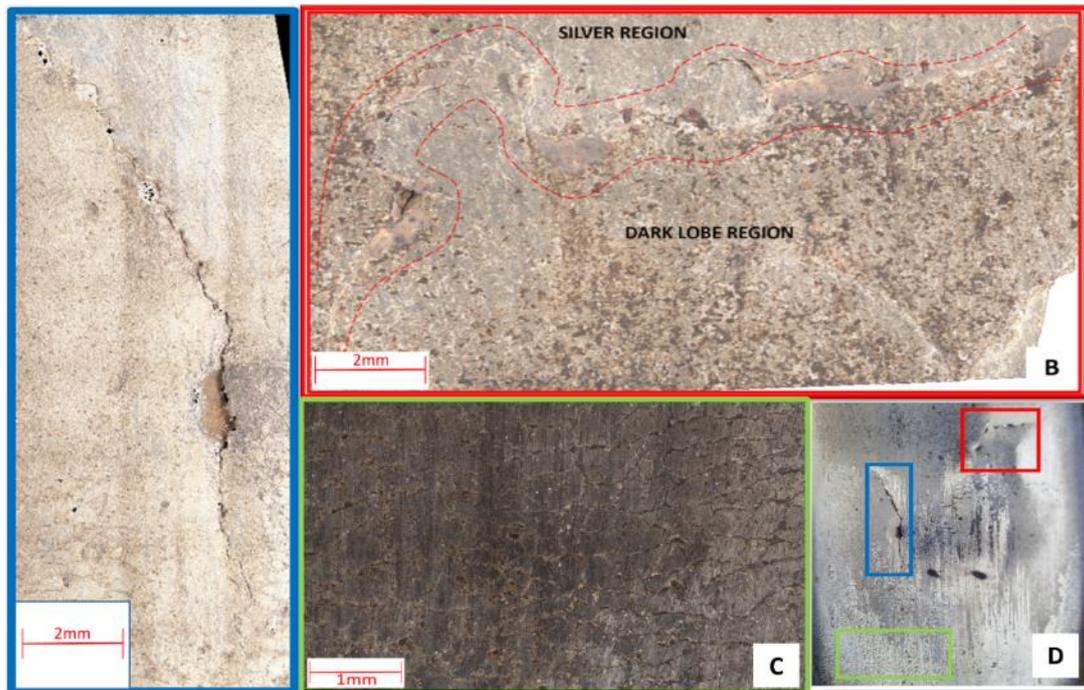
Figure 82: Some of the surface features imaged from Sample 1 a) The L-shaped crack with 'islands' that appear pink in the scan b) The V-shaped crack with a pit that penetrates into the substructure c) 'Snakeskin' microcracks across the surface of the rail just beyond the defect d) A colour coded overview showing where the images are taken from.

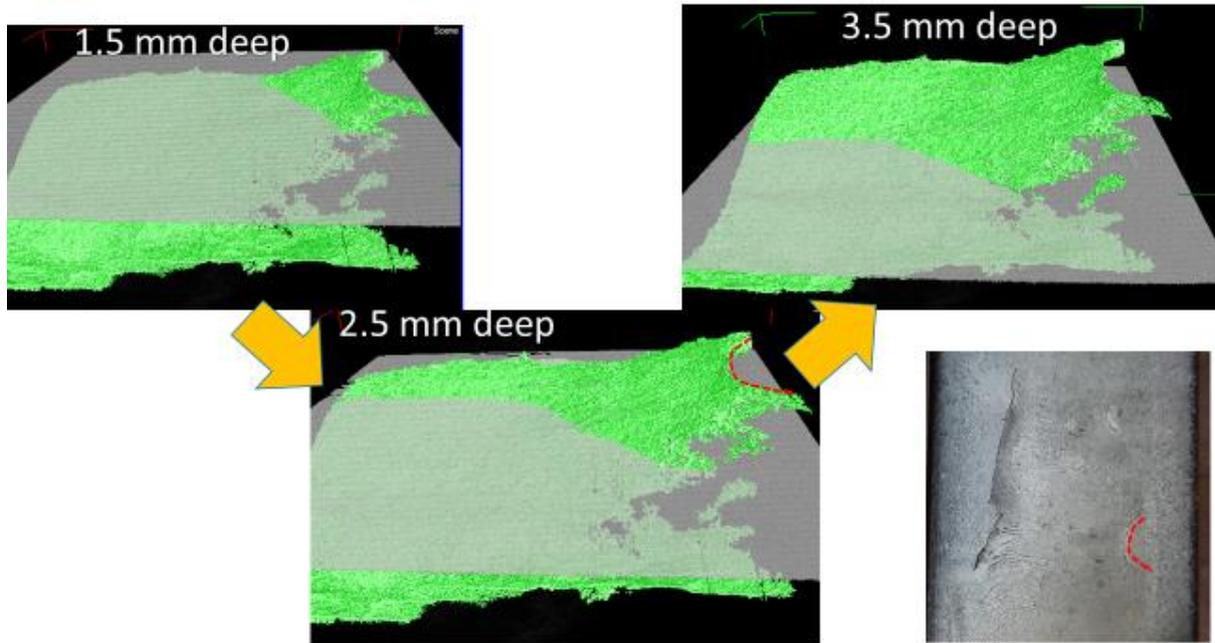
Figure 91: The main crack plane morphology for the high-resolution scan of Sample 2. Measurements are the depth below the highest point of the running surface that the plane is set at. Inset is a photo of the whole defect showing where the defect reaches the surface creating longitudinal cracks.

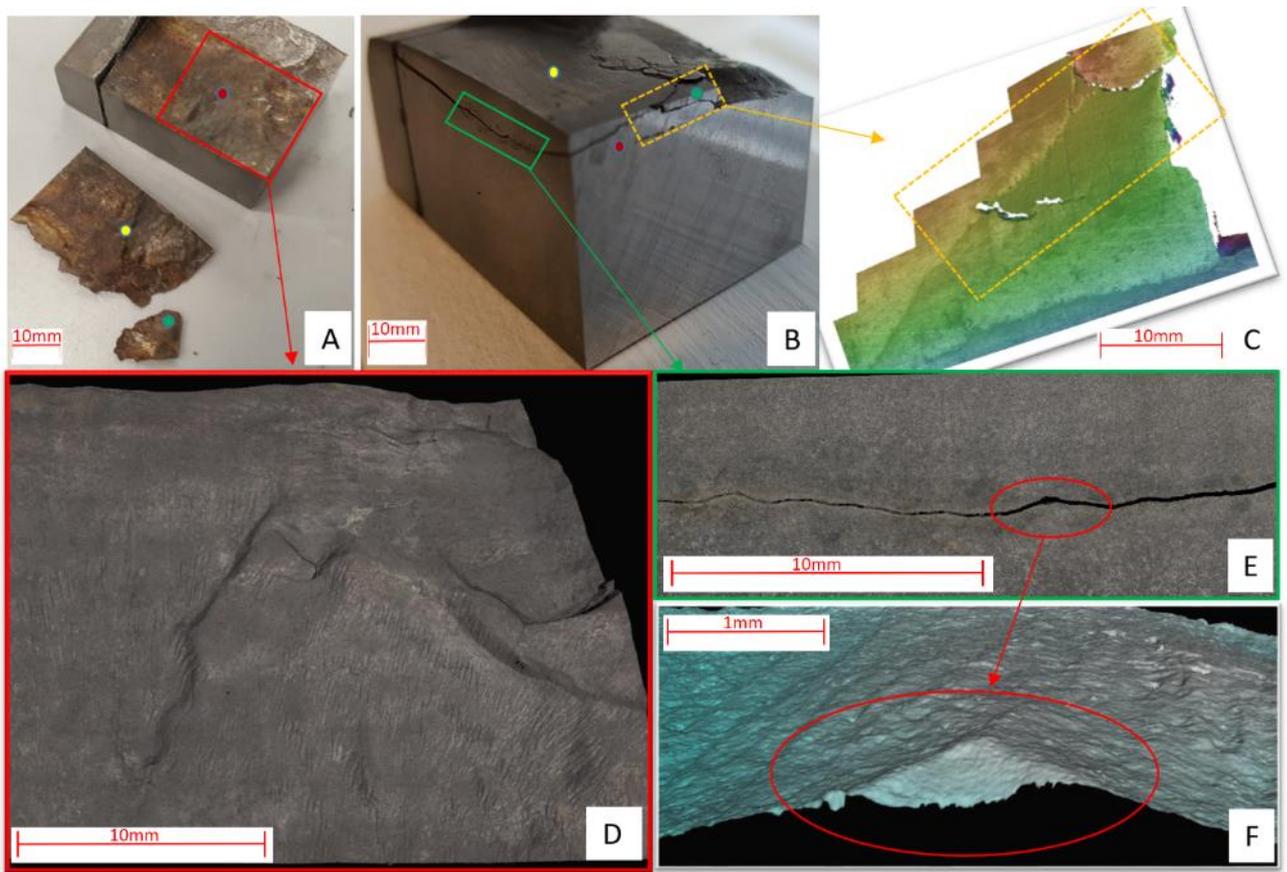
Figure 94: The fracture surface under the remaining second lobe/ spot of the Squat in sample 3. A) The fracture surface immediately after removing the upper surface. B) The sample before the removal of the surface showing the two cracks propagating down into the rail from a possible initiation point. C) The 3D model of the possible initiation area taken before cutting with the orange box showing the common area D) The 3D model of the crack plane shown in A. E) An enlarged view of the green box in B showing where material has spalled away during cutting. F) A 3D model of the 'void' in E.

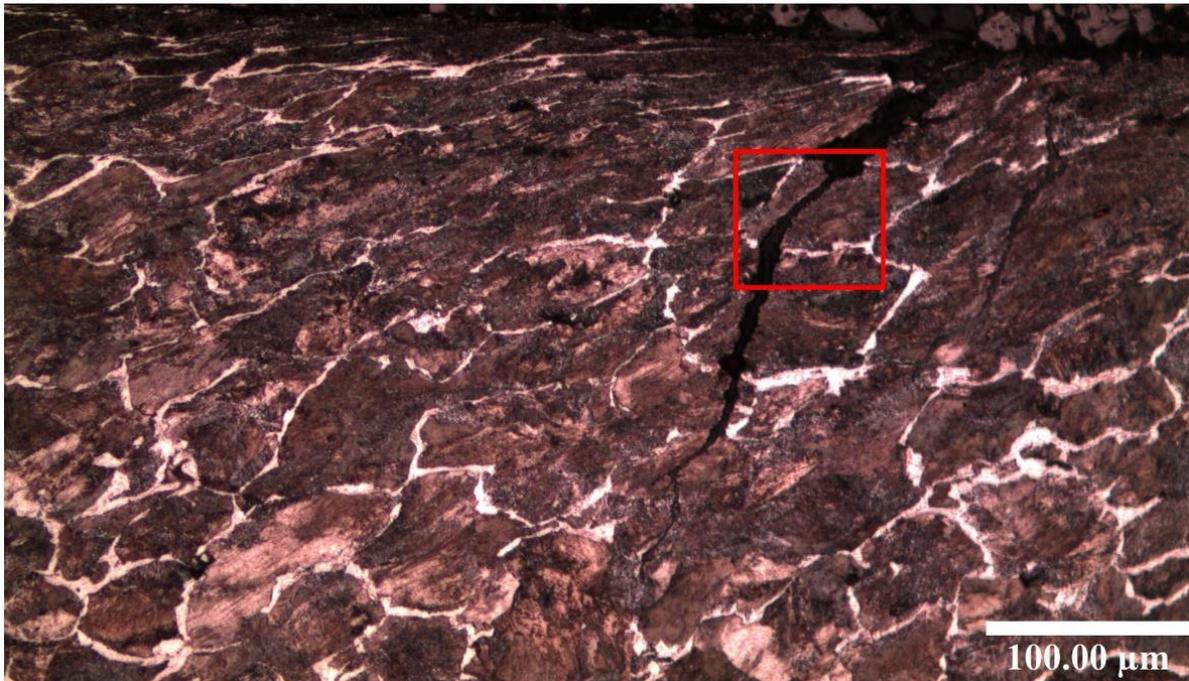
Figure 107: Optical micrograph of sample 2 showing a surface crack with apparent non-sensitivity to microstructure (intragranular fracture). The red box shows where SEM images were taken from (shown in Figure 108).

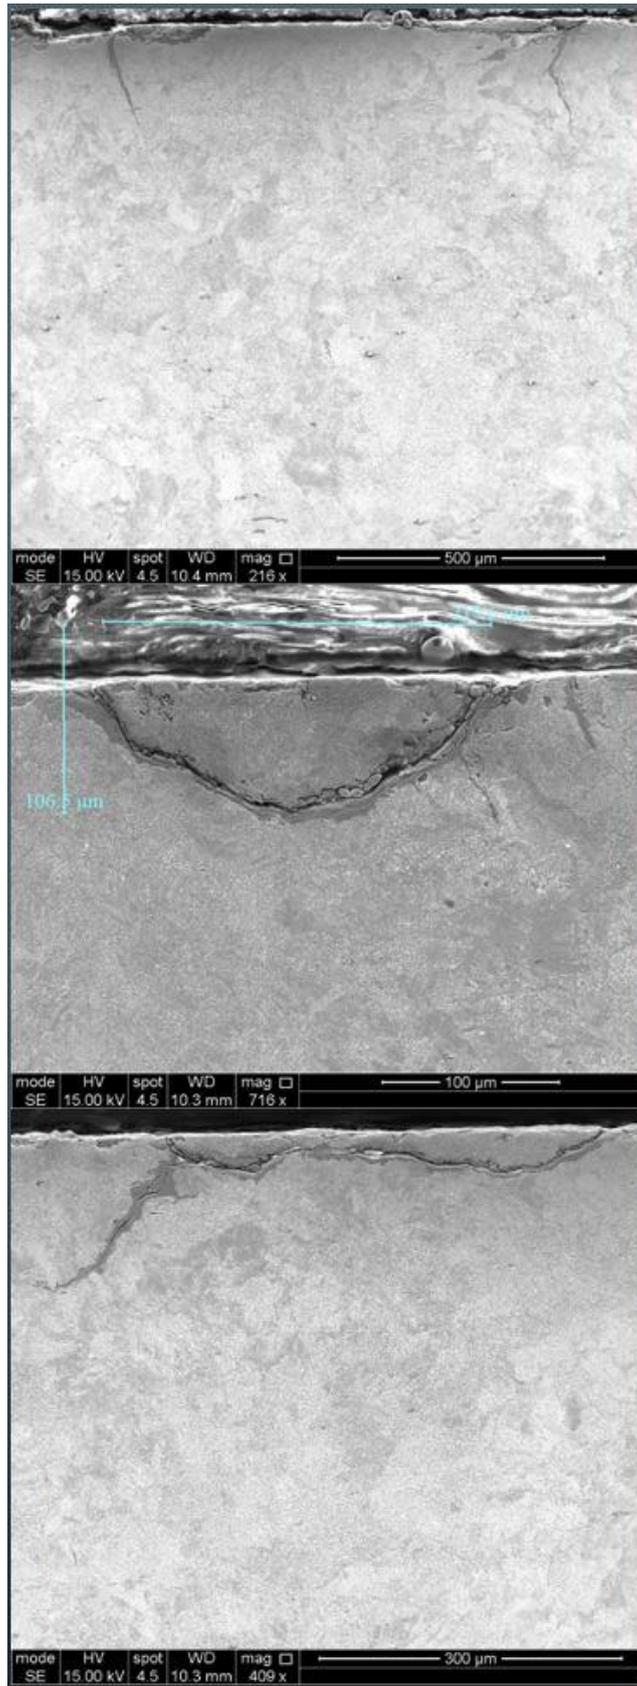
Figure 115: SEM images of pits developing in different locations within Sample 1 due to delamination. Vertical cracks grow from the pit interface.

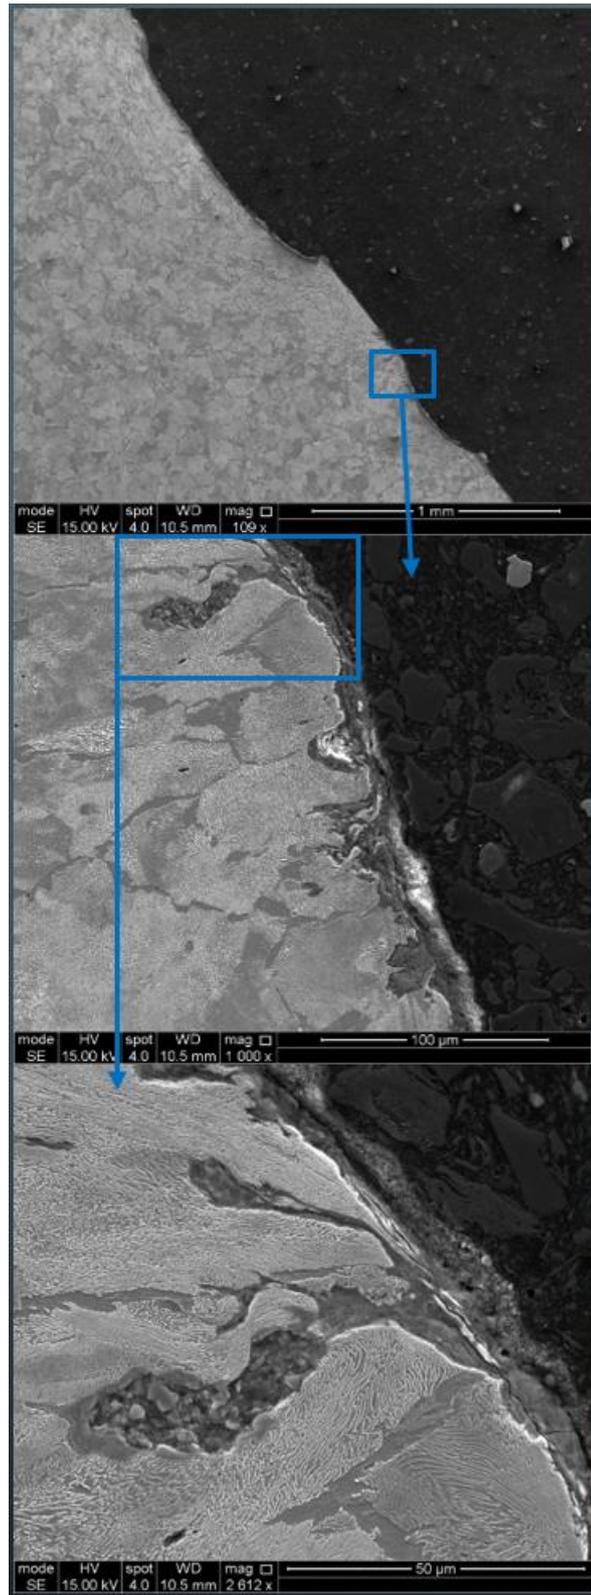
Figure 118: Oxide corroding the ferrite boundary between pits in Sample 5. This oxide would contribute to fretting like that seen creating the voided region in Sample 2. The oxide path back to the surface may be in a different plane to this image.

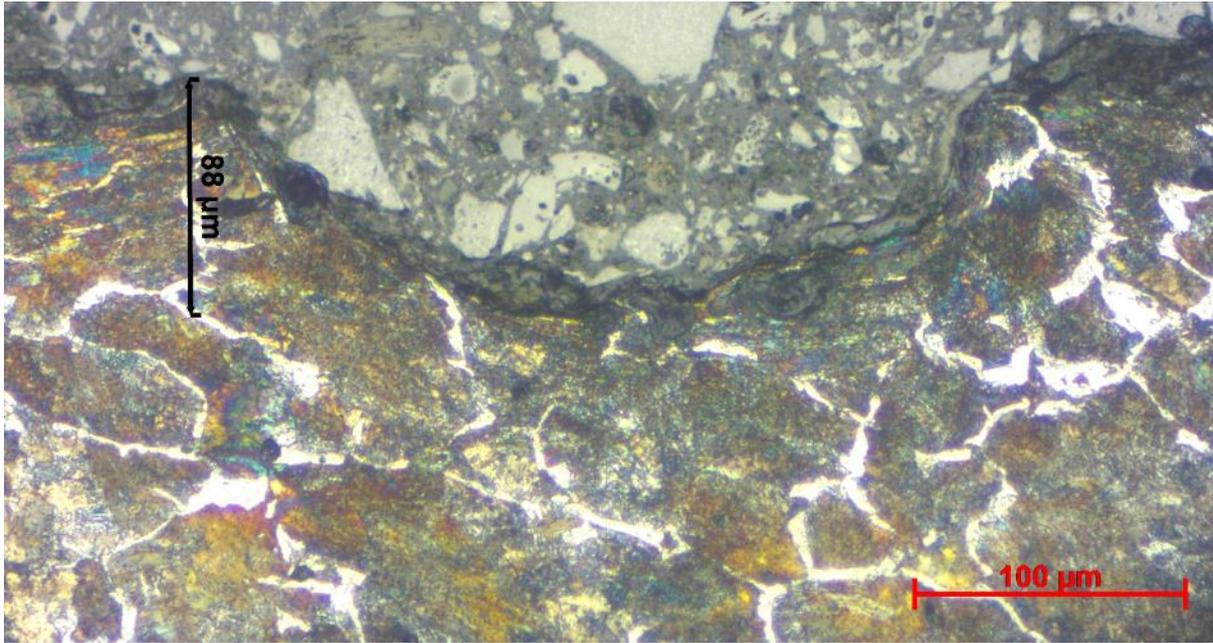
Figure 144: 88 micron deep grind mark found along measurement 1 path, believed to be the same grinding mark measured to be ~30microns deep.

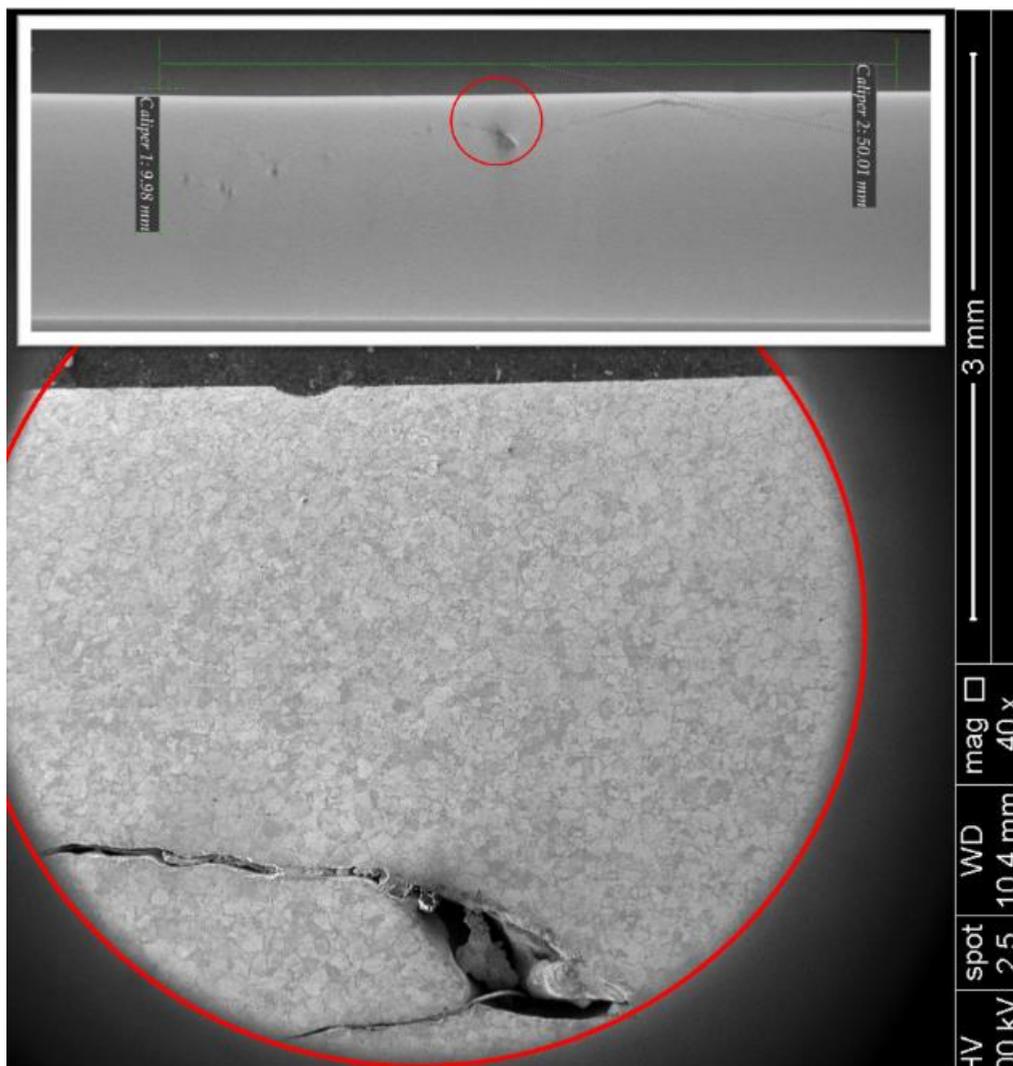
Figure 146: The cause of the shadow in the CT volume. Top) The CT orthoslice showing the shadow and faint downward branching cracks. Bottom) SEM image of the site showing the void caused by rail fretting and a grinding mark can be seen on the surface. The beginning of the TD crack can be seen leaving the bottom left corner of the void.

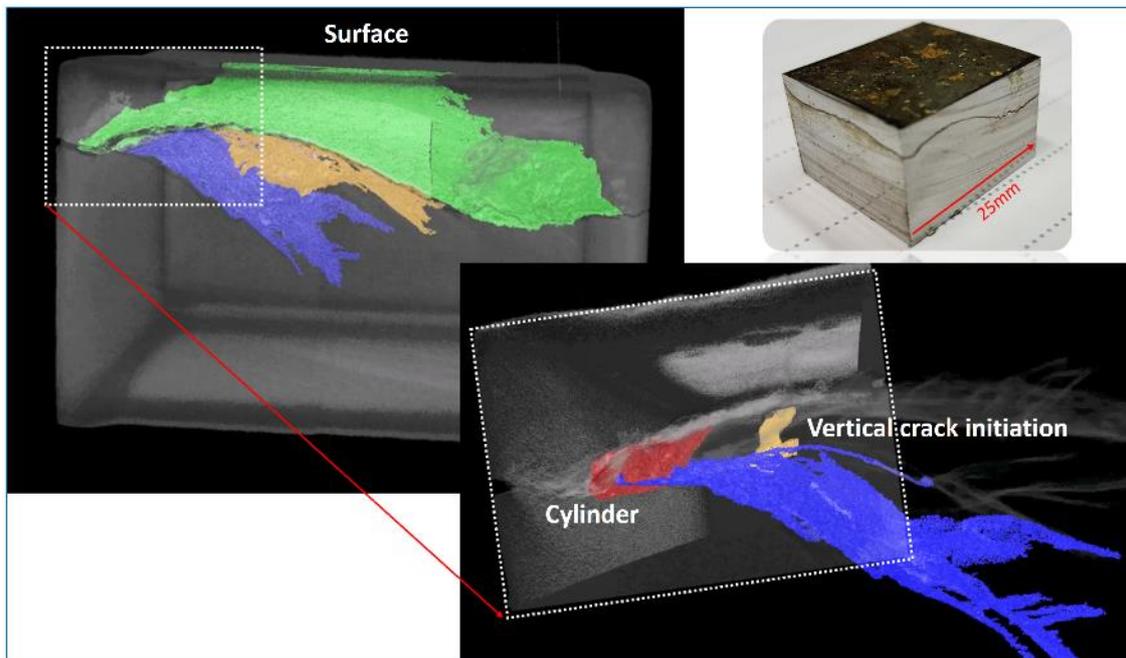
Figure 150: The red 'cylinder' of damage where the blue TD branches from the longitudinal green crack. The yellow crack grew from the vertical crack, which is also yellow in the lower image. The lower image shows the initiation sites in relation to the TD crack plane.

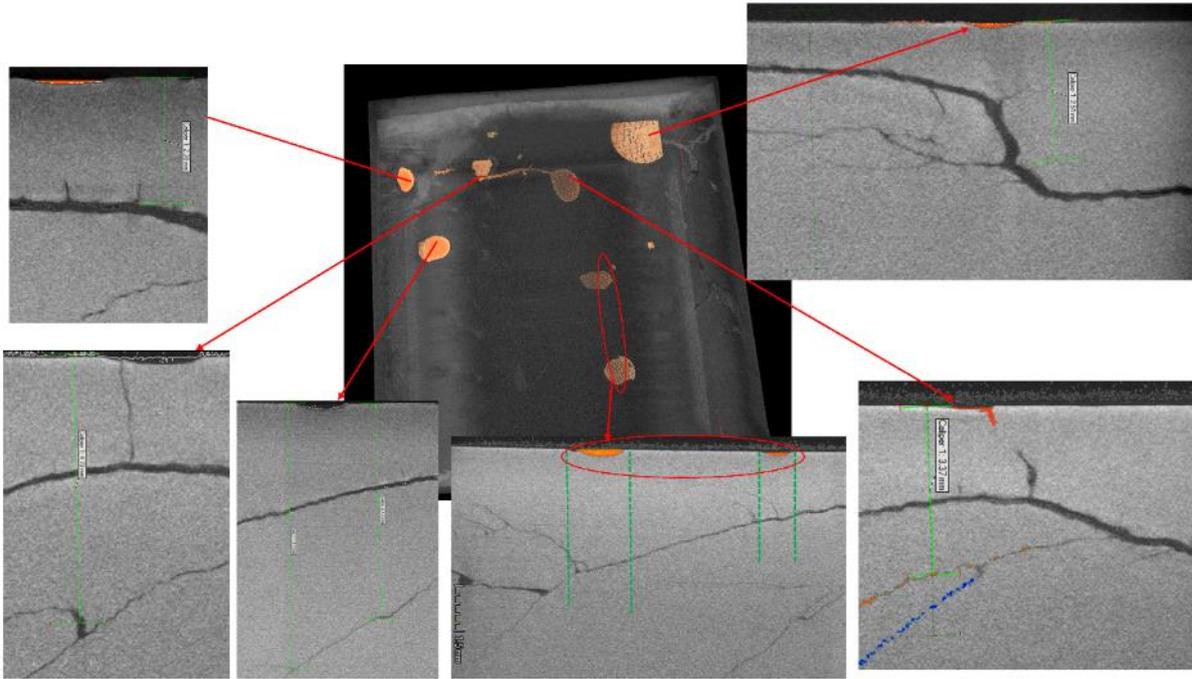
Figure 158: Locations of pits and the corresponding longitudinal view from Sample 2.
