The Dark Side of Bright Metal Coatings

THE DARK SIDE OF BRIGHT METAL COATINGS

Research Staff and Central Laboratory
Ford Motor Company

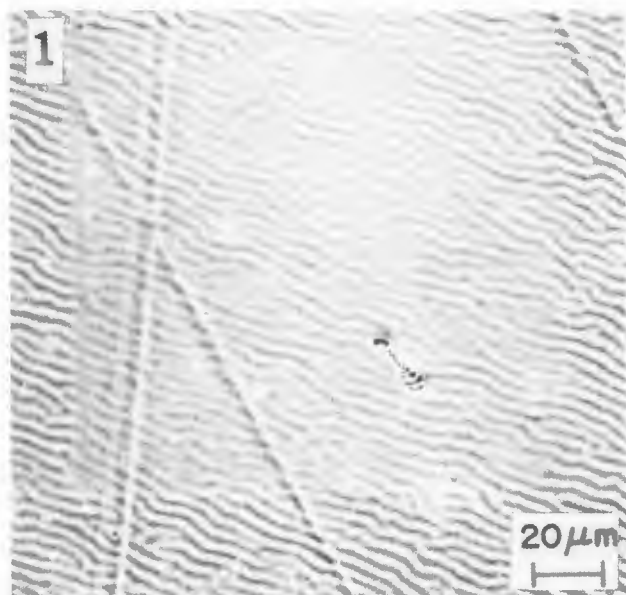
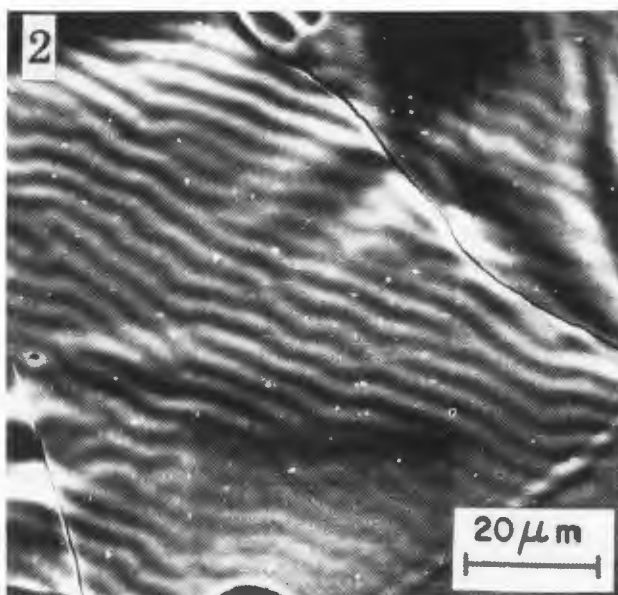
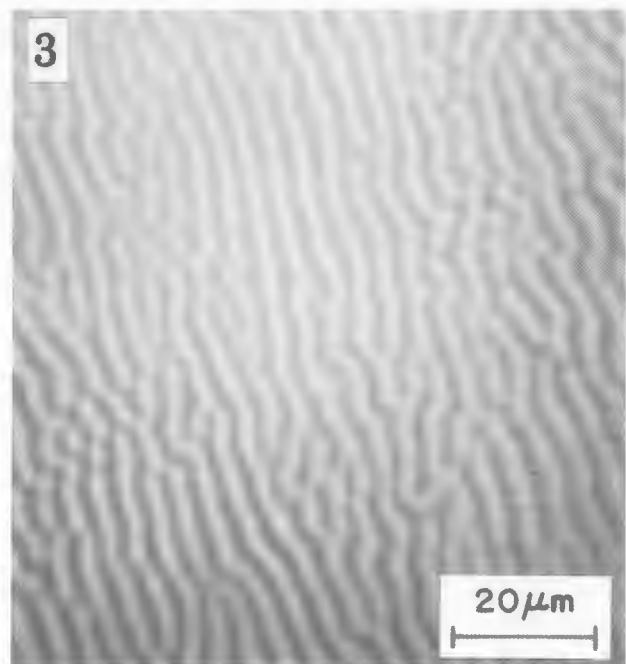
Figs. 1 - 3. Defective reflector surface with coarse corrugations. The uniformity of the wrinkles is noteworthy. The reflector has cured top coat, Al layer, and a base coat.

Examination of the defective reflector surface with scanning electron microscopy (SEM) and incident light optical microscopy revealed a "diffraction grating" or line-type structure². This line-type structure is the result of very fine surface wrinkles. The wrinkles are equidistant parallel peaks and valleys which give the overall lined appearance. Figures 1 and 2

are scanning electron micrographs which show the line-type surface structure of some different areas at varied magnifications. Figure 3 shows similar corrugations using light optical microscopy. The peaks are approximately 1 to 2 microns high which explains the slight out-of-focus image in Figure 3. The peak-to-peak linear distances for several areas are uniform and average approximately 240 lines per mm.

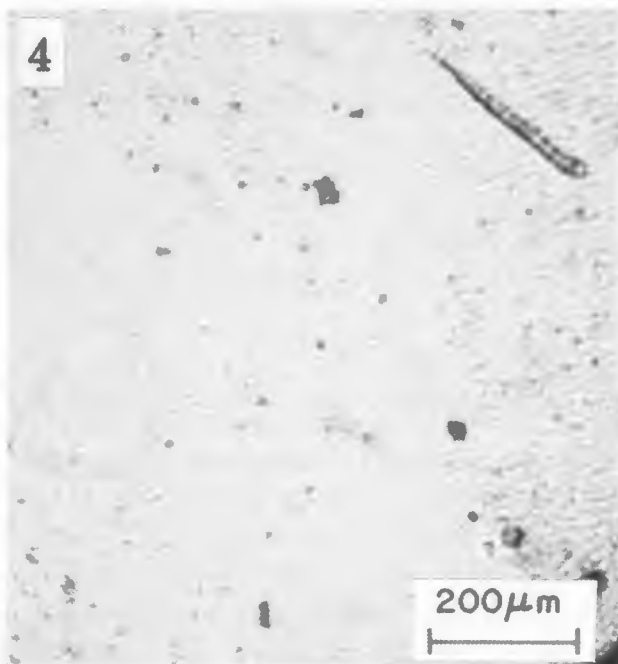
Fig. 4. Typical defect-free reflector surface. The reflector has base coat, Al layer and an uncured top coat.

The surfaces of the two defect-free reflectors were also examined and a typical surface structure is shown in Figure 4. The base-coat-supported surface has imperfections and a fairly large number of contaminating particles. These surface imperfections are not the uniformly spaced line-type structure, therefore, interference colors are not produced. However, reflectivity can still suffer due to these surface anomalies.

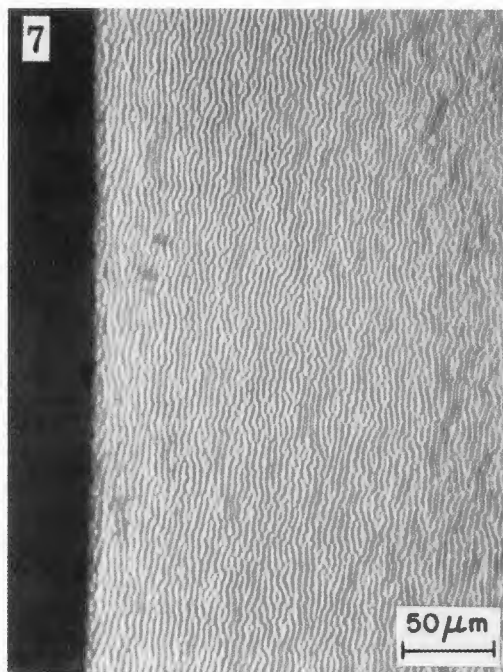
Fig. 7. Defective reflector surface with fine corrugations and cured top coat.
