EVALUATING THE PERFORMANCE OF TiN COATING ON PM MILLING CUTTERS USED IN THE MANUFACTURING OF BANDSAWS

Mohammed Sarwar^{a,*}, Julfikar Haider^a, Martin Persson^b, Håkan Hellbergh^b

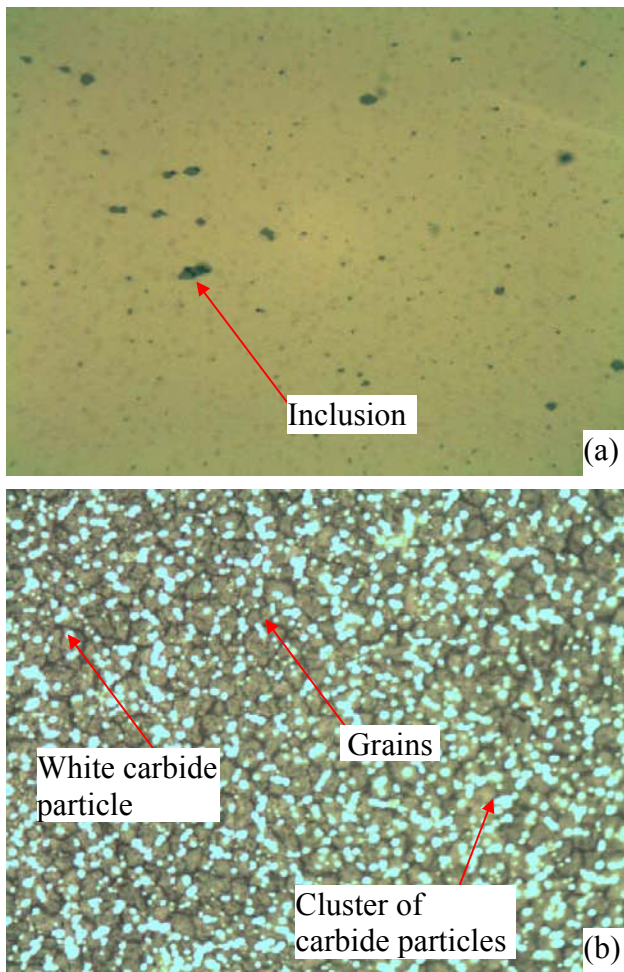
Figure Number: 3

The hardness of cutter substrate (PM REX 54 HSS) varied from 840-860 HV_{1.0} (equivalent to 65.5 - 66 Rc), which was in the given specification. The surface morphology before etching under the light optical microscope showed non-metallic inclusions dispersed in the material (Fig. 3a). These inclusions were believed to be small sulphide particles, which could result in machinability and grindability benefits with no adverse effect on toughness. In the etched sample, optical microscope revealed smaller grains (25 grains across 0.127 mm diameter circle) with uniformly distributed round carbide particles (Fig. 3b), which will provide required strength at the cutting edges of the cutter.

Fig. 3. Surface morphology of the PM Rex 54 HSS material (a) without etching and (b) after etching (Mag. 1000×)

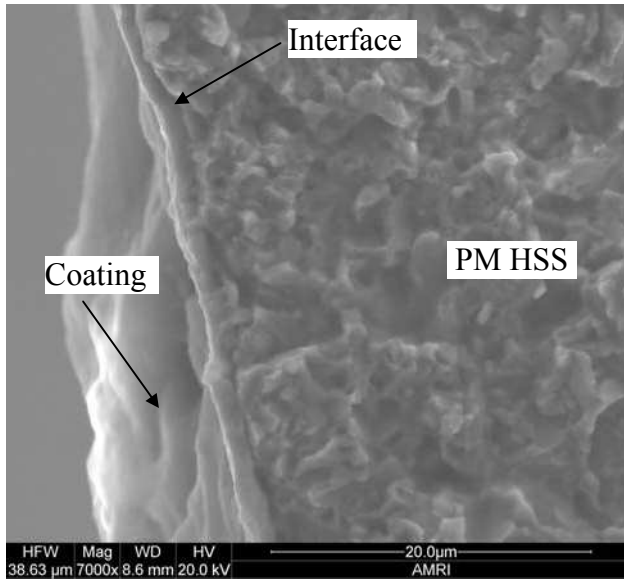
Figure Number: 4

Under SEM, the coating fracture morphology appeared very densely packed with no distinguishable feature, which indicated good quality of coating (Fig. 4). After examining the interface between the coating and the substrate, it appeared that the coating was also well adhered. However, the thickness of the coating varied between 2 µm - 4 µm around cutting edges of milling cutter.

Fig. 4. SEM image of TiN coating fractured morphology on a milling cutter tooth

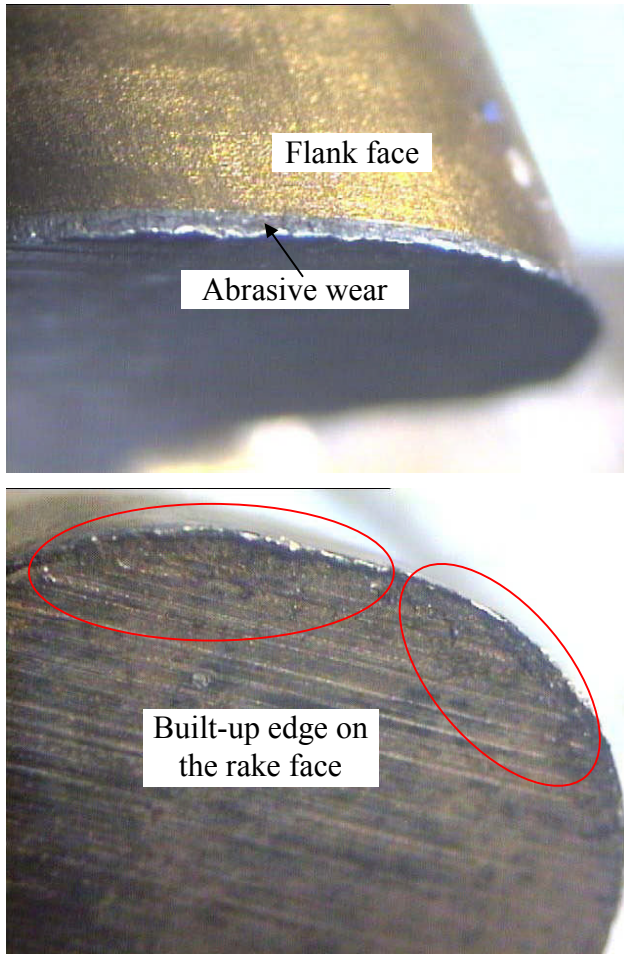
Figure Number: 5

Edge radius of an uncoated cutter at new condition was very small (~ 7 µm -9 µm), which was typical of grinding process. On the other hand, edge radius of a coated cutter at new condition was slightly higher (9 µm - 12 µm) than that of uncoated cutter due to the coating on the cutting edges. At new condition both the coated and uncoated edges were sharp with no burr. After examining many cutters, flank wear and notch wear were identified as the principal mode of wear in both coated and uncoated cutters. The abrasive wear and adhesive wear with the detachment of built-up edges were the governing mechanisms of the flank wear as shown in Fig. 5. No macro flaking of the TiN coating from the flank face was observed. The built-up

Fig. 5. Wear characteristics in a coated milling cutter tooth under optical microscope

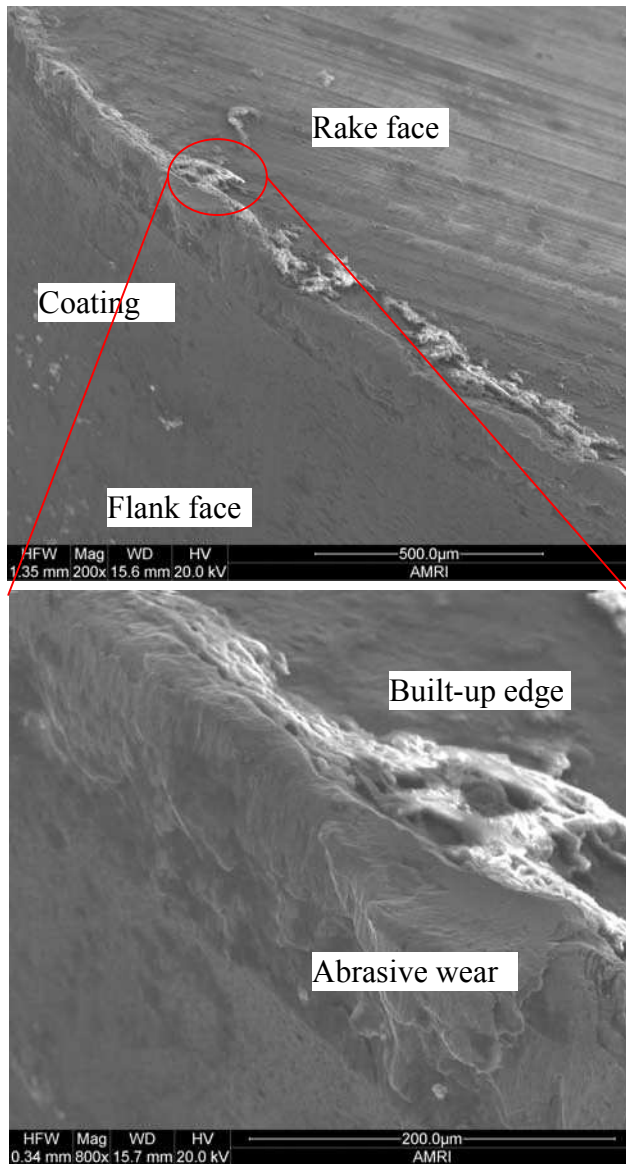
Figure Number: 6

edge and abrasive wear were more clearly revealed under SEM (Fig. 6). Similar abrasive and adhesive wear were also observed in the uncoated cutters. Notch wear at the crossover point on the flank face was quite common in small tooth form cutters. Notch wear was not observed in big tooth form cutters and full form cutters (roughing flute followed by finishing flute). In many coated cutters notch wear was significantly lower. It was established that notch wear at the crossover point on the flank face was related to the tooth tip burr in the bandsaw. In the uncoated and small tooth form cutters, strong burrs are left in the flank face after regrinding due to material flow from the grinding action. In the coated and big tooth form cutters, cutting edges are sharp with no burrs left in the flank face after regrinding. The coating could provide hard surface to prevent any material flow as burr after regrinding. Furthermore, TiN coating on milling cutter also offered more confidence in operating at higher feeds and speeds. The premature failure of the cutter generally occurred due to the rubbing with the band, hard join-up welding in the band or thinner flute width at the end of the cutter life.

Fig. 6. Wear characteristics in a coated milling cutter tooth under SEM

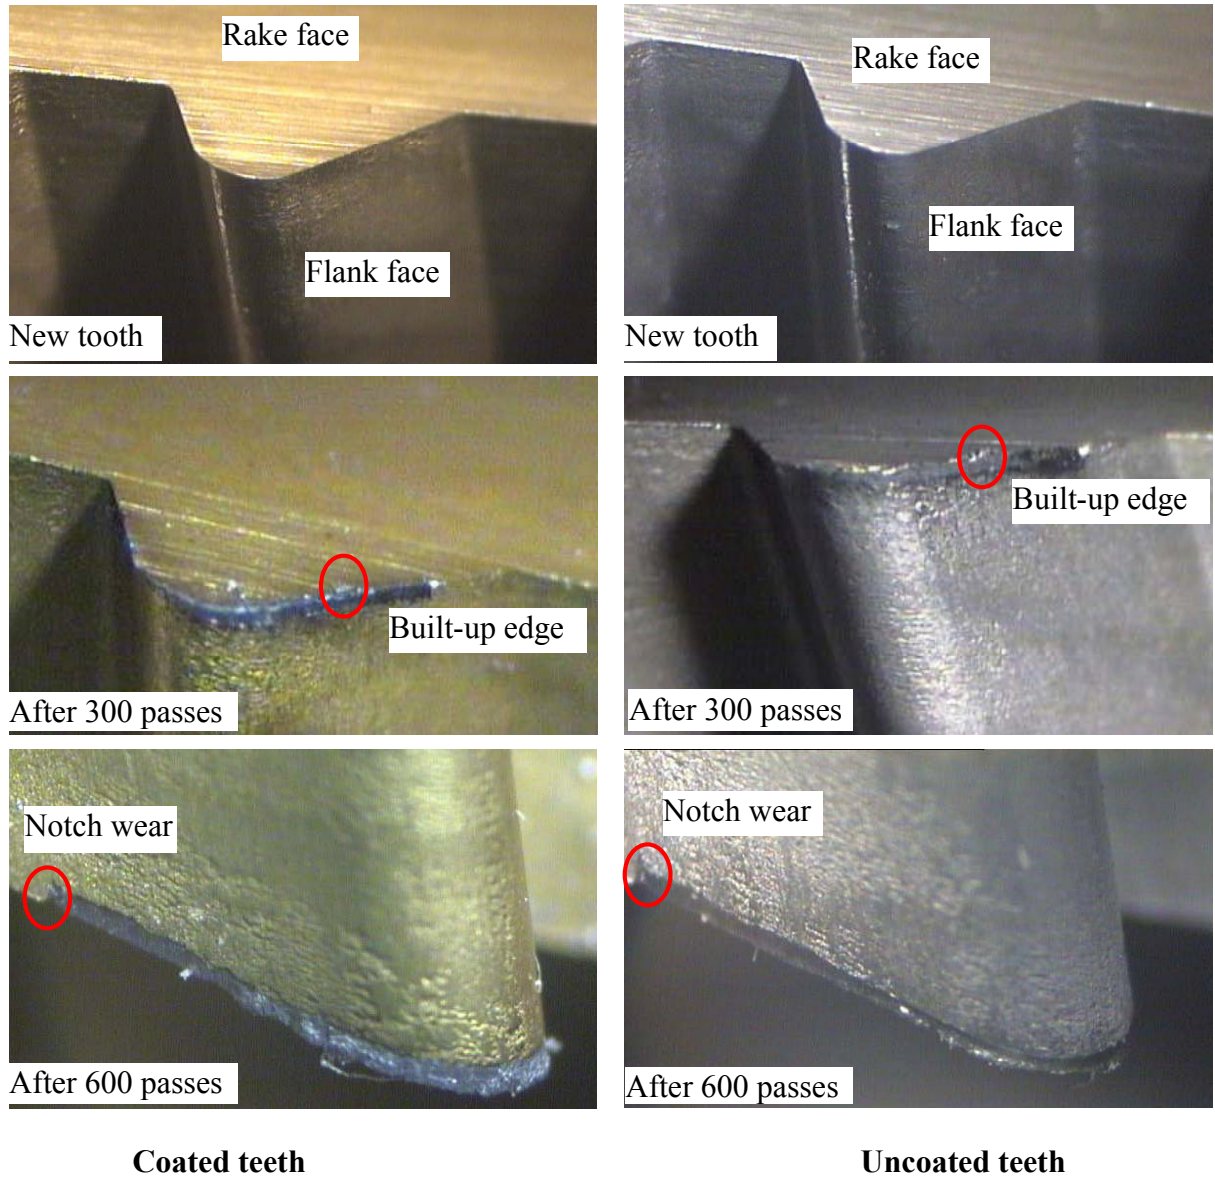
Figure Number: 7

Cutting edges of the new coated and uncoated teeth of the half-length coated cutter were sharp with no burr. After 300 milling passes coating started to break off from the flank face and adhesive wear with built-up edge developed in both coated and uncoated teeth. Flank wear and adhesive wear with the built-up edge also increased after 600 passes. In some flutes the built-up edges broke off along with the cutter material both in coated and uncoated teeth. Notch wear at the crossover point on the flank face of the cutter were also visible in both coated and uncoated teeth. **Fig. 7** shows the coated and uncoated teeth at new condition, after 300 milling passes and after 600 milling passes. Flank wear in the coated teeth after 600 passes was in the range of 0.10 mm to 0.22 mm whereas, the flank wear in the uncoated teeth was in the range of 0.13 mm to 0.35 mm when measured using image analysis software. The measurement was also verified in few selected teeth by profiling them across the flank face. Flank wear in the coated and uncoated teeth of the half-length coated cutter was in the range of 0.17 mm to 0.20 mm and 0.25 mm to 0.34 mm respectively when measured by the Contacer profilometer.

Fig. 7. Coated and uncoated teeth of the half-length coated milling cutter at new condition, after 300 passes and after 600 passes.

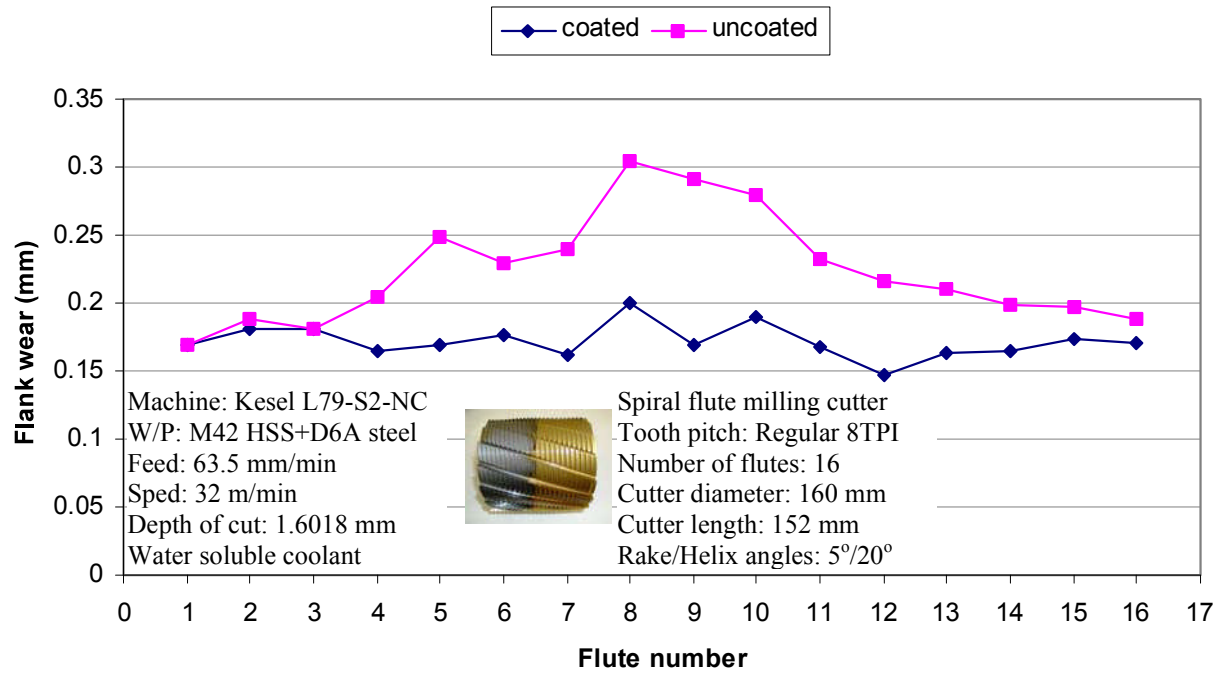
Figure Number: 8

Flank wear in a selected coated tooth and uncoated tooth of all 16 gashes were measured on three different positions on the flank face. **Fig. 8** shows the amount of flank wear at one position near the crossover point and the percentage of reduction of flank wear by TiN coating. The coating reduced the flank wear up to 40% compared to the uncoated teeth. However, the flank wear in the coated teeth was not always consistent. In some flutes flank wear in the coated teeth were equal to the wear in the uncoated teeth. Complex cutting action by the multipoint milling cutters compared to single point cutting tools, lack of manufacturing

accuracy of the cutter teeth and variation in the quality of the coating on complex geometry of every tooth could be responsible for this kind of variation. It should be noted for multi-point tools, such as milling cutters, the overall performance is determined by the combination of cutting edge, rake face and gullet characteristics. Furthermore, it is important that all teeth are manufactured to the same specification in order to maximise the tool performance and life, as a multi-point tool is only as good as its weakest tooth [5]. A total systems approach combining tool materials, tool design, manufacturing quality, surface preparation and appropriate coating characteristics is necessary to achieve beneficial performance from the coated multipoint cutting tools.

Fig. 8. Flank wear plot of the coated and uncoated teeth in all 16 flutes of the half-length coated milling cutter

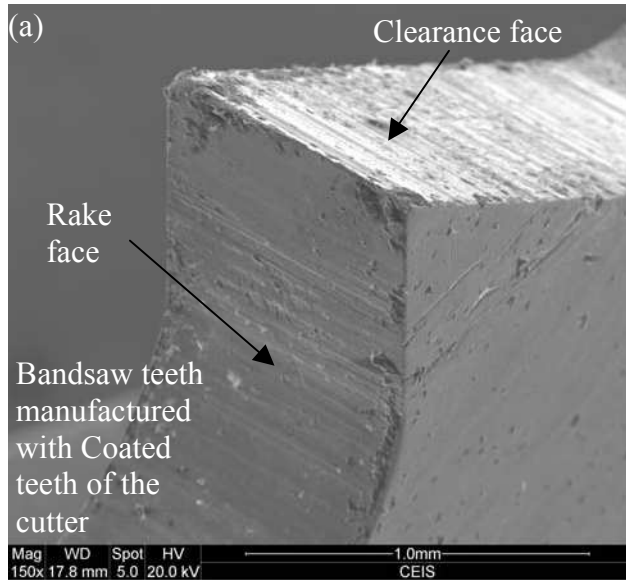
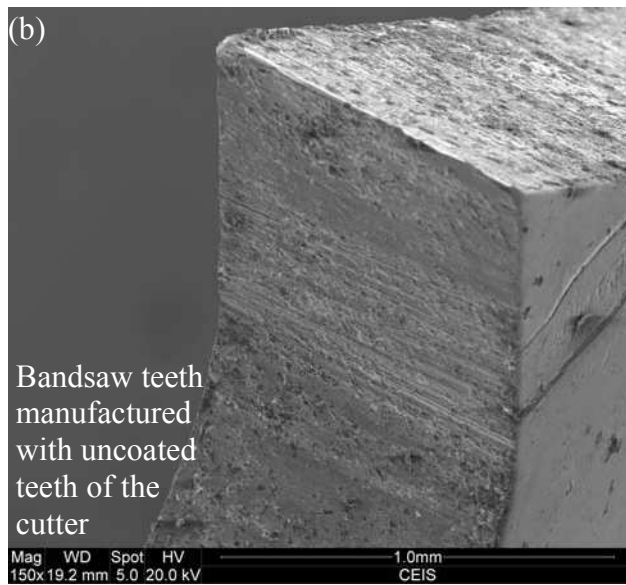
Figure Number: 9

Fig. 9 shows that under SEM a better surface characteristics can be observed in the bandsaw teeth manufactured by coated teeth of the milling cutter. This fact was further evidenced by the surface roughness of the bandsaw teeth manufactured by the coated and uncoated teeth of the milling cutter (Fig. 10). The surface roughness of both the rake and clearances faces was reduced. Less friction between the cutter teeth and workpiece can be attributed for the better surface finish in the bandsaw teeth manufactured by the coated teeth of the milling cutter.

Fig. 9. Bandsaw cutting edges formed by the (a) TiN coated and (b) uncoated teeth of the half-length coated milling cutter

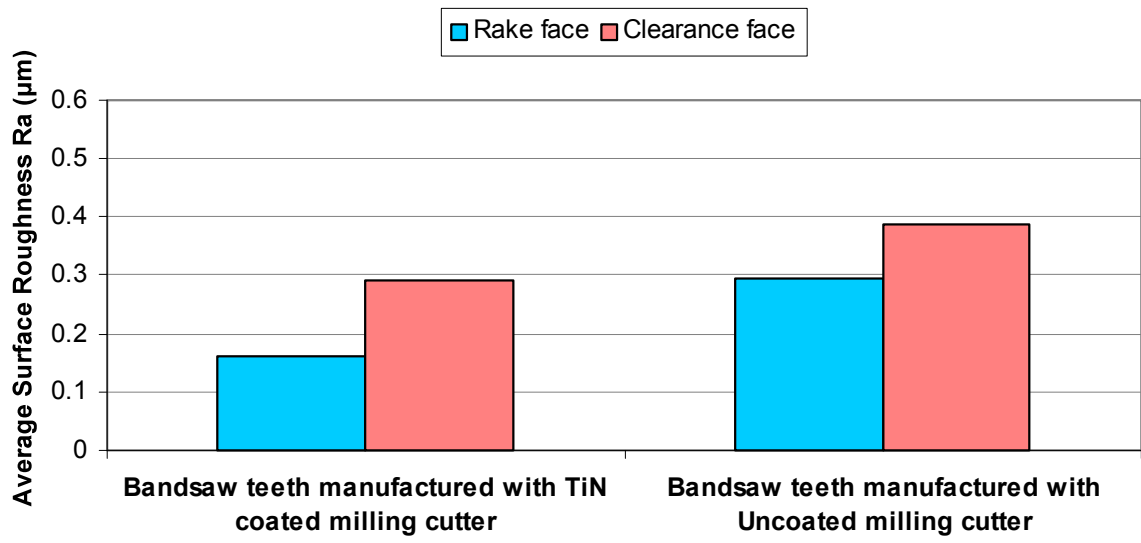
Figure Number: 10

Fig. 10. Average surface roughness of bandsaw cutting edges formed by the TiN coated and uncoated teeth of the half-length coated milling cutter
