WHOI-91-34

ESOM I and II Final Report

Alessandro Bocconcelli, Henri Berteaux, Daniel E. Frye
and Dr. Bryce Prindle

Technical Report

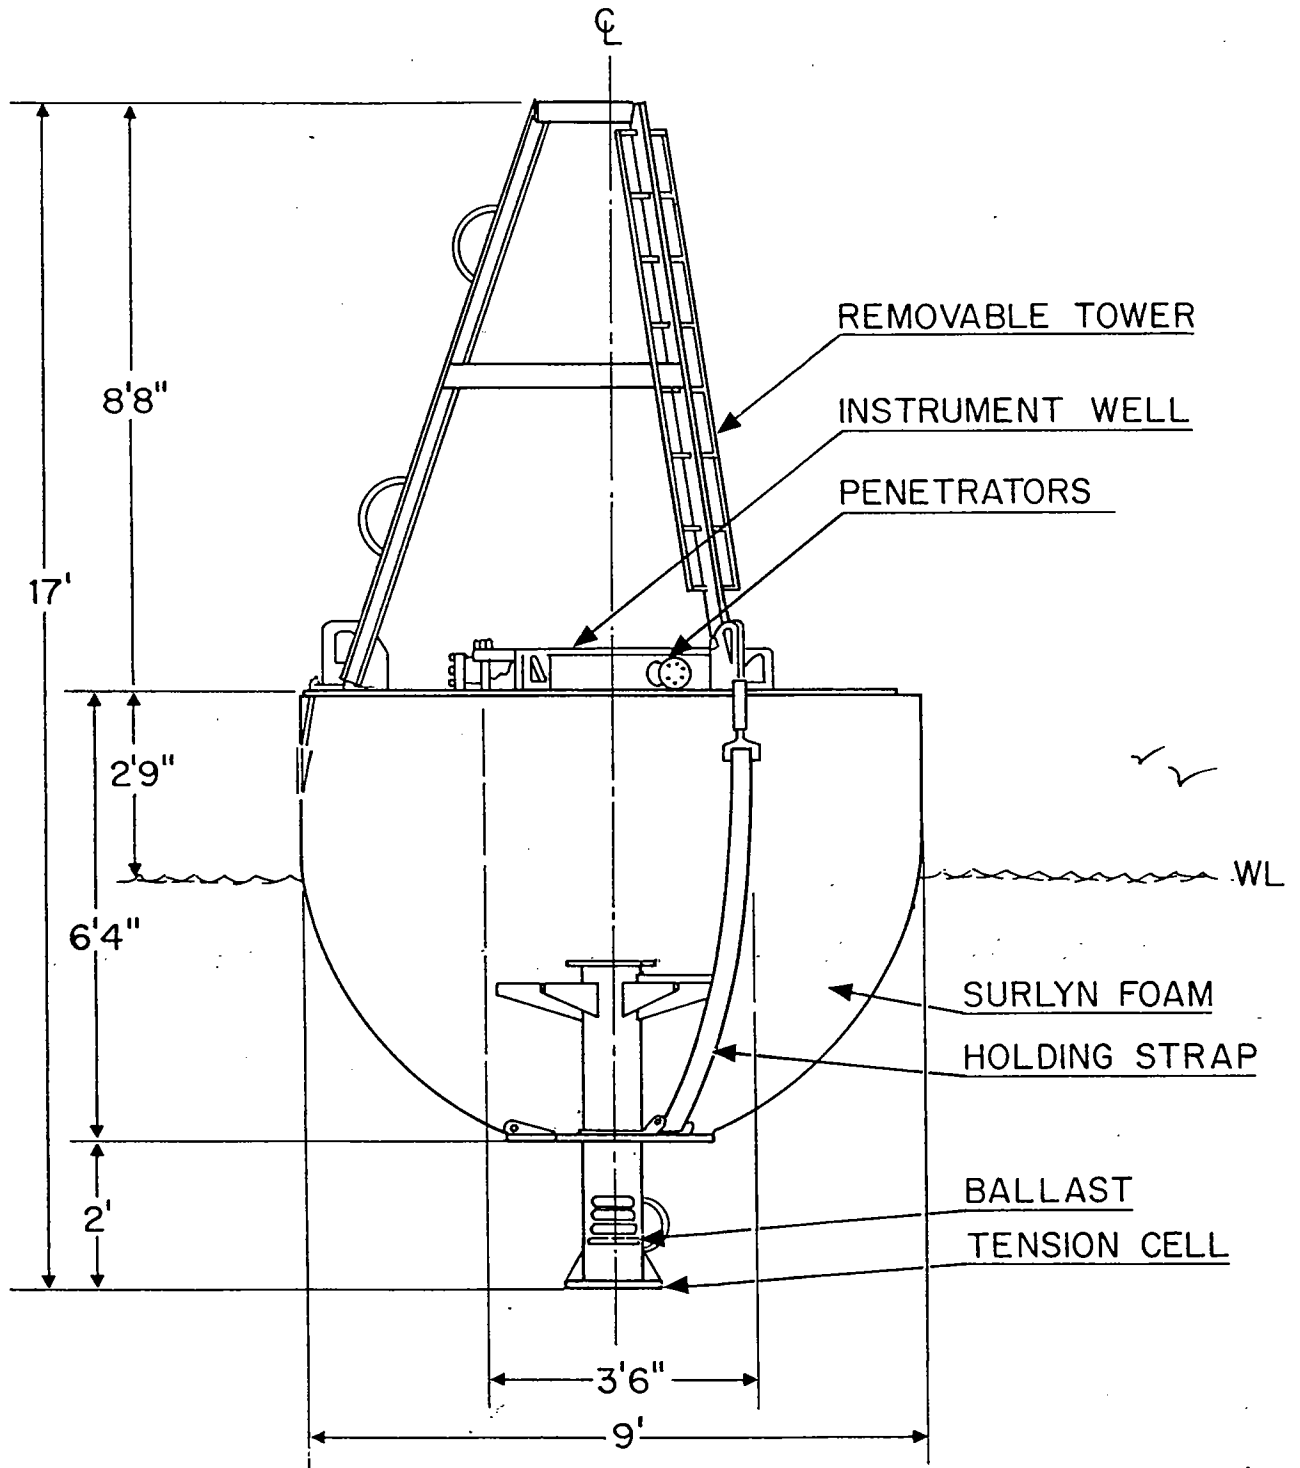
FIGURE 3: ESOM buoy

The ESOM surface buoy was the first operational use of SURLYN foam at WHOI. Although samples had been extensively tested, no records existed for a long-term oceanic exposure [4]. After the 18 month deployment the buoy was recovered in choppy seas without causing any damage to its hull or to the tower structure. The foam material acted as a bumper, absorbing the impact energy during the deck landing. Considering its shape and size, the buoy is very manageable and can be handled safely (Figure 3). A modified folding tower would augment the clearance through the stern A-frame when lifting the buoy [5].

A preliminary inspection showed no signs of material degradation due to environmental agents. No discoloration due to UV action was noticed on the SURLYN foam. No cracks, abrasion or punctures were found on the hardened skin of the foam body. Light biofouling (algae) and some goose barnacles were growing on the immersed section of the hull, which had been coated with antifouling paint. The nylon straps (stitching and hardware) appeared to be in good condition. Overall, the buoy retained its hemispherical shape with no evidence of permanent deformation or bumps.

The aluminum (6061-T6) structure, including the instrument well, deck, tower and point of attachment, was inspected and found to be in

good condition. The buoy keel, also made of aluminum (5086-H34) was covered with biofouling, but when cleaned, no evidence was found of corrosion or welding cracks. The tension cell was removed from it, and the hardware, including the electrical harness, appeared to be intact. The instrument well was found completely dry with no sign of water infiltration or moisture accumulation. The electronics and batteries were removed from the well; the meteorological sensors, antennae and electrical harness were stripped off the tower. All these components were then shipped to WHOI on the R/V Oceanus.

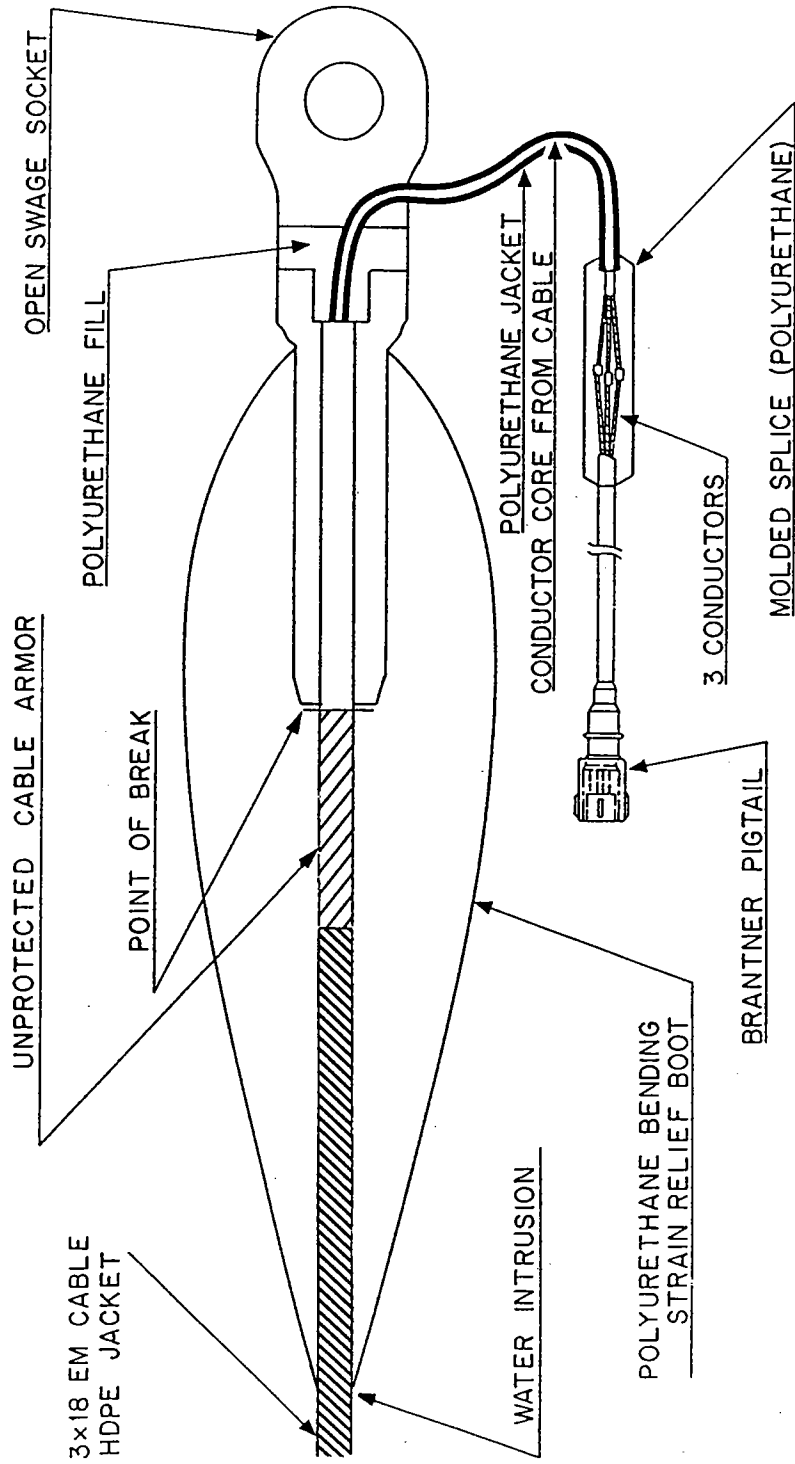
FIGURE 6: Swage socket termination

Two types of EM cable terminations, both designed and built at WHOI, were tested during the ESOM experiment. The "in house" epoxy termination (Fig. 5) for 3x19 EM cables had been previously during the six month STEM experiment with excellent results [9]. The new swage socket termination for the 3x18 EM cables (Fig. 6) was deployed at sea for the first time.

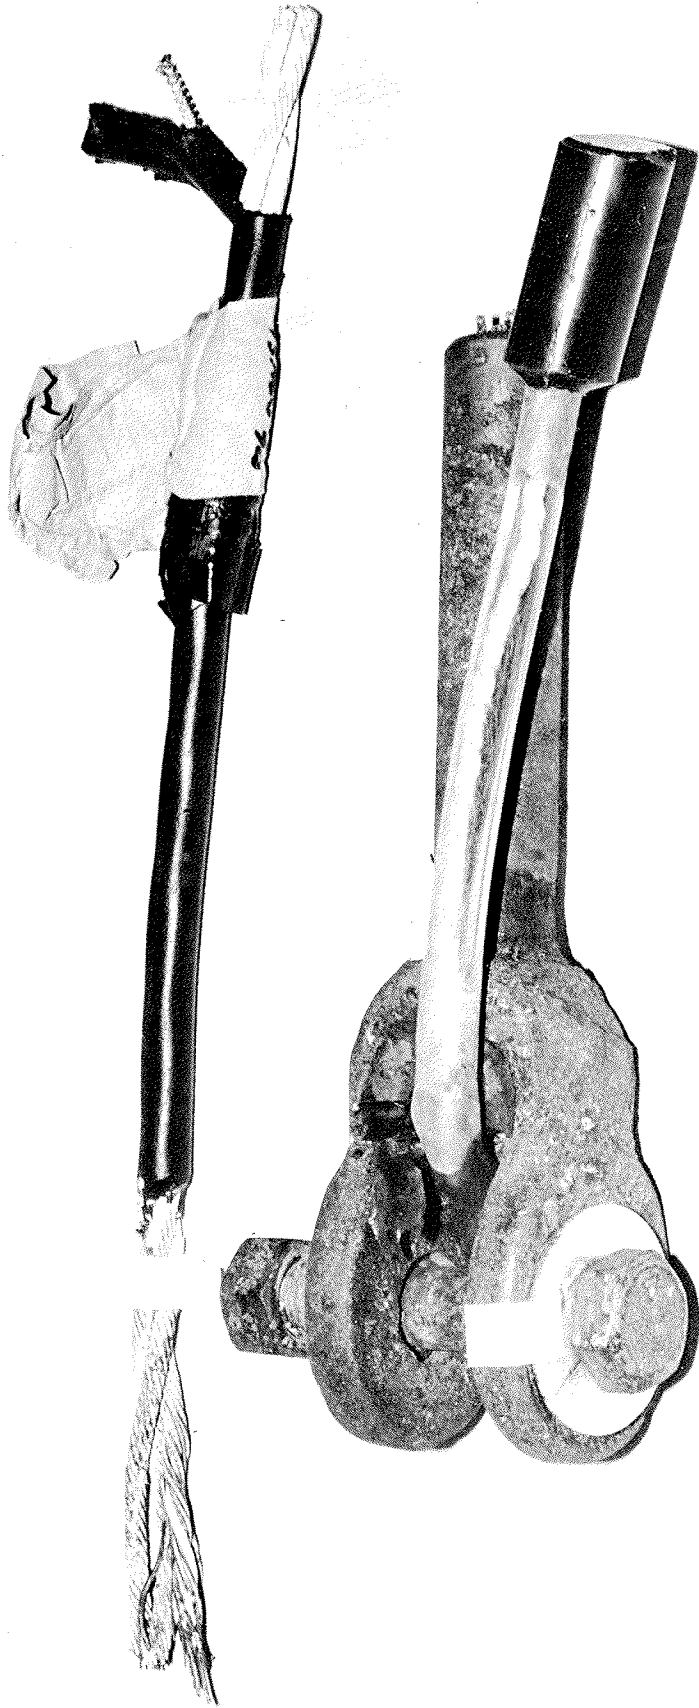
FIGURE 7: Failed swage socket termination

Six months after redeployment, the ESOM II mooring failed due to a mechanical break of the 3x18-7/16" EM cable section (Item 16, Fig.2) This section was carefully examined at WHOI and then sent to Al Lucht, Wire Rope Industry Consultant for microscopic examination and analysis [10]. His conclusions on the modes and causes of cable failure were:

- the cable did break at the end of the swaged fitting shank (Fig.6-7)
- the mode of cable failure was corrosion fatigue
- swaging resulted in initial indentation, or cracks at the surface of the armor wires; the termination mechanical design permitted the wires to flex and twist thus creating the mechanism for crack propagation
- deterioration due to fatigue was accelerated by corrosion resulting from 1) infiltration of sea water over the bare, unjacketed wires inside the boot, and 2) electro-chemical corrosion resulting from rupture in the insulation of the hot electrical wires in a salt environment; the insulation may have been damaged by swaging or by handling during the recovery and redeployment.

The report recommended that future terminations include the following changes:

- Avoid swaging, instead use epoxy filled socket
- Prevent flexing by using stronger, harder stress relief boot
- Provide watertightness and isolate the armor wires from sea water.

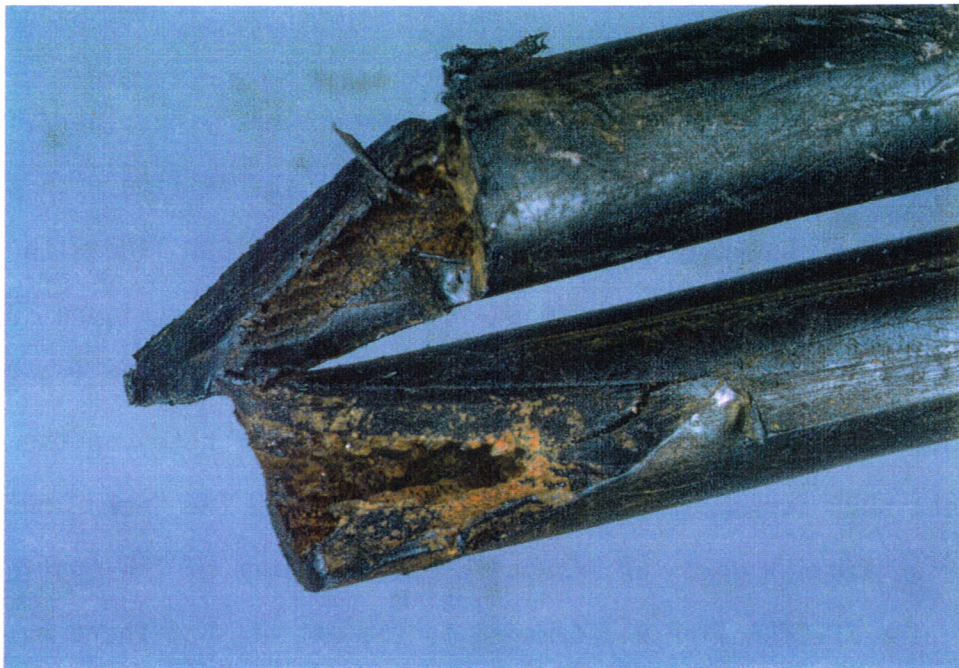
FIGURE 11: ZYTEL jacketed steel wire rope

ZYTEL jacketed samples: although the nylon ZYTEL ST 801 used is substantially harder than HDPE it did not give superior resistance to biting in this test. Bites per 100m of line were higher than the average for all the materials in the same depth zone. The nylon coated line had enough severe bites so that metal was exposed to sea water and in time corrosion would have resulted. A possible reason for its poor performance is the insufficient thickness of the jacket provided with this experimental sample. ZYTEL ST 801 is a compromise material which has good mechanical properties combined with moderate resistance to puncture and cutting.

Protected samples: three sample lines were severely cut: a ZYTEL (nylon) plastic jacketed steel (Figure 11), a KEVLAR line with a braided KEVLAR cover (Figure 12), and a SPECTRA-fiber line with a braided jacket of polyester and stainless steel wires (Figure 13). The ZYTEL jacketed steel wire rope sample parted after the steel had corroded following exposure to sea water. Similar bites on the adjacent HDPE jacketed steel mooring line pierced the jacket but corrosion had not gone far enough to cause failure of the mooring line. The SPECTRA line was damaged to the extent that there was a large slit in the braided cover, exposing the underlying SPECTRA fibers. The stainless steel wires in the braided jacket were found to have clearly severed ends with no sign of rusting. The parted fibers in both the KEVLAR and SPECTRA ropes were examined microscopically and found to have a high proportion of sharp cut ends, characteristic of

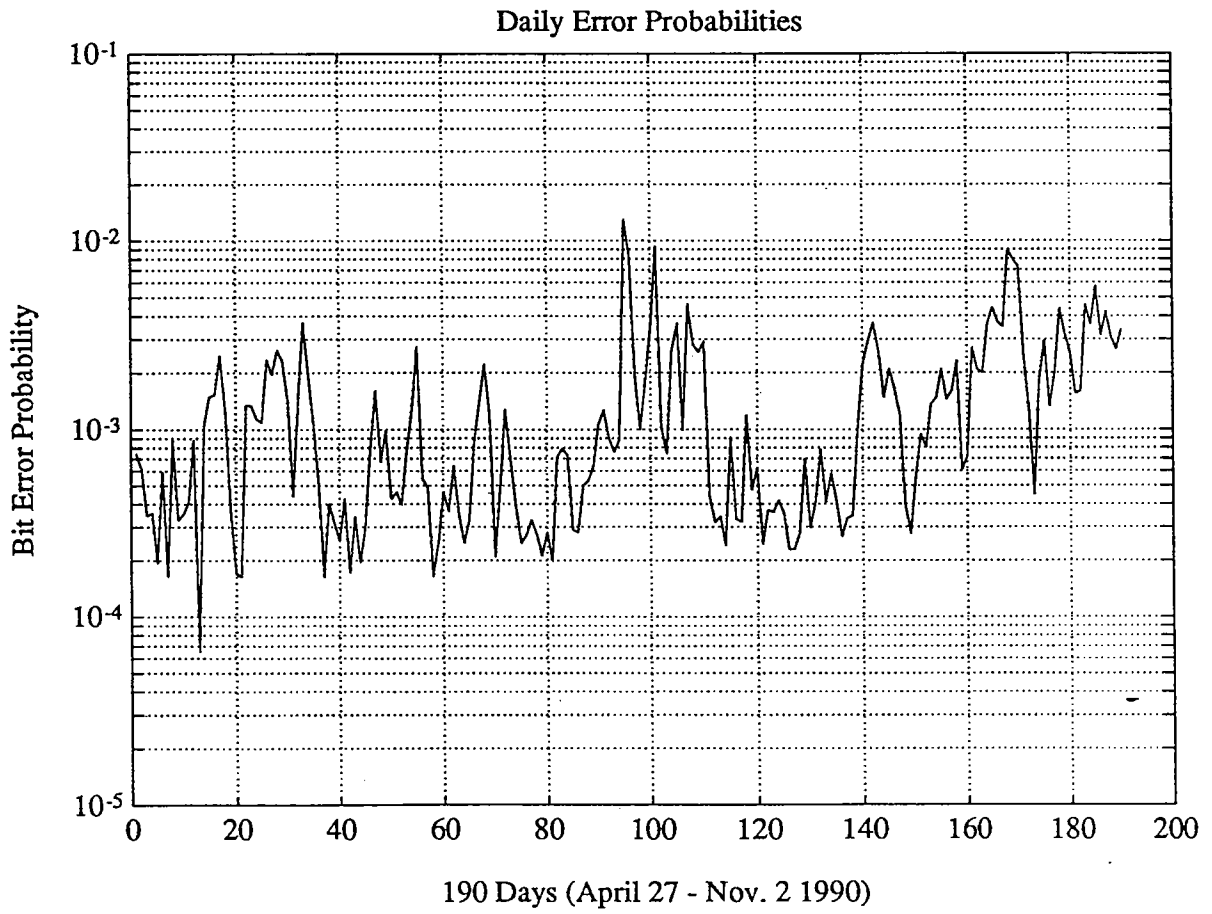
FIGURE 16: Data record from modem at 1500m

After the modem lowering, the ESOM buoy was installed and data were collected regularly over the next six months. Figure 16 (from [14]) show results from the modem deployed at 1500m. This modem operated for the full six month period and transmitted over 20×10^6 data bits at a BER that ranged from 1×10^{-2} to 1×10^{-4} and averaged 1.45×10^{-3} . The other two modems operated much less consistently. The modem at 300m was damaged prior to or during deployment and suffered from a reduced transmit power level. As a result, its performance was marginal. The deep modem, deployed at 2900m failed after 32 days due to an electronic problem. During the time it operated, the average BER for its transmission exceeded 10% and its SNR was of the order of 2 dB, well below the performance level expected based on data from the shipboard lowering. Analysis of the system performance following the mooring retrieval suggests that high levels of surface-generated background noise masked the signal from the 2900m modem. Signal strength from the 1500m modem was higher and its data were seriously degraded much less frequently. Typical SNR for the 1500m modem was 10dB.

The source of the noise is believed to be surface waves and their interaction with the surface buoy and the hydrophone mounting system. This conclusion is based on data shown in Figure 17 (from [14]), which shows daily averaged wind speed at the Bermuda Naval Air Station (20km north of the mooring site) plotted above daily average BERs for the 1500m modem. A clear correlation between high average winds (and presumably high sea state) and high BER is evident.
