Cable Failures off Oahu, Hawaii Caused by Hurricane Iwa

Charles D. Hollister

August 1984

Technical Report

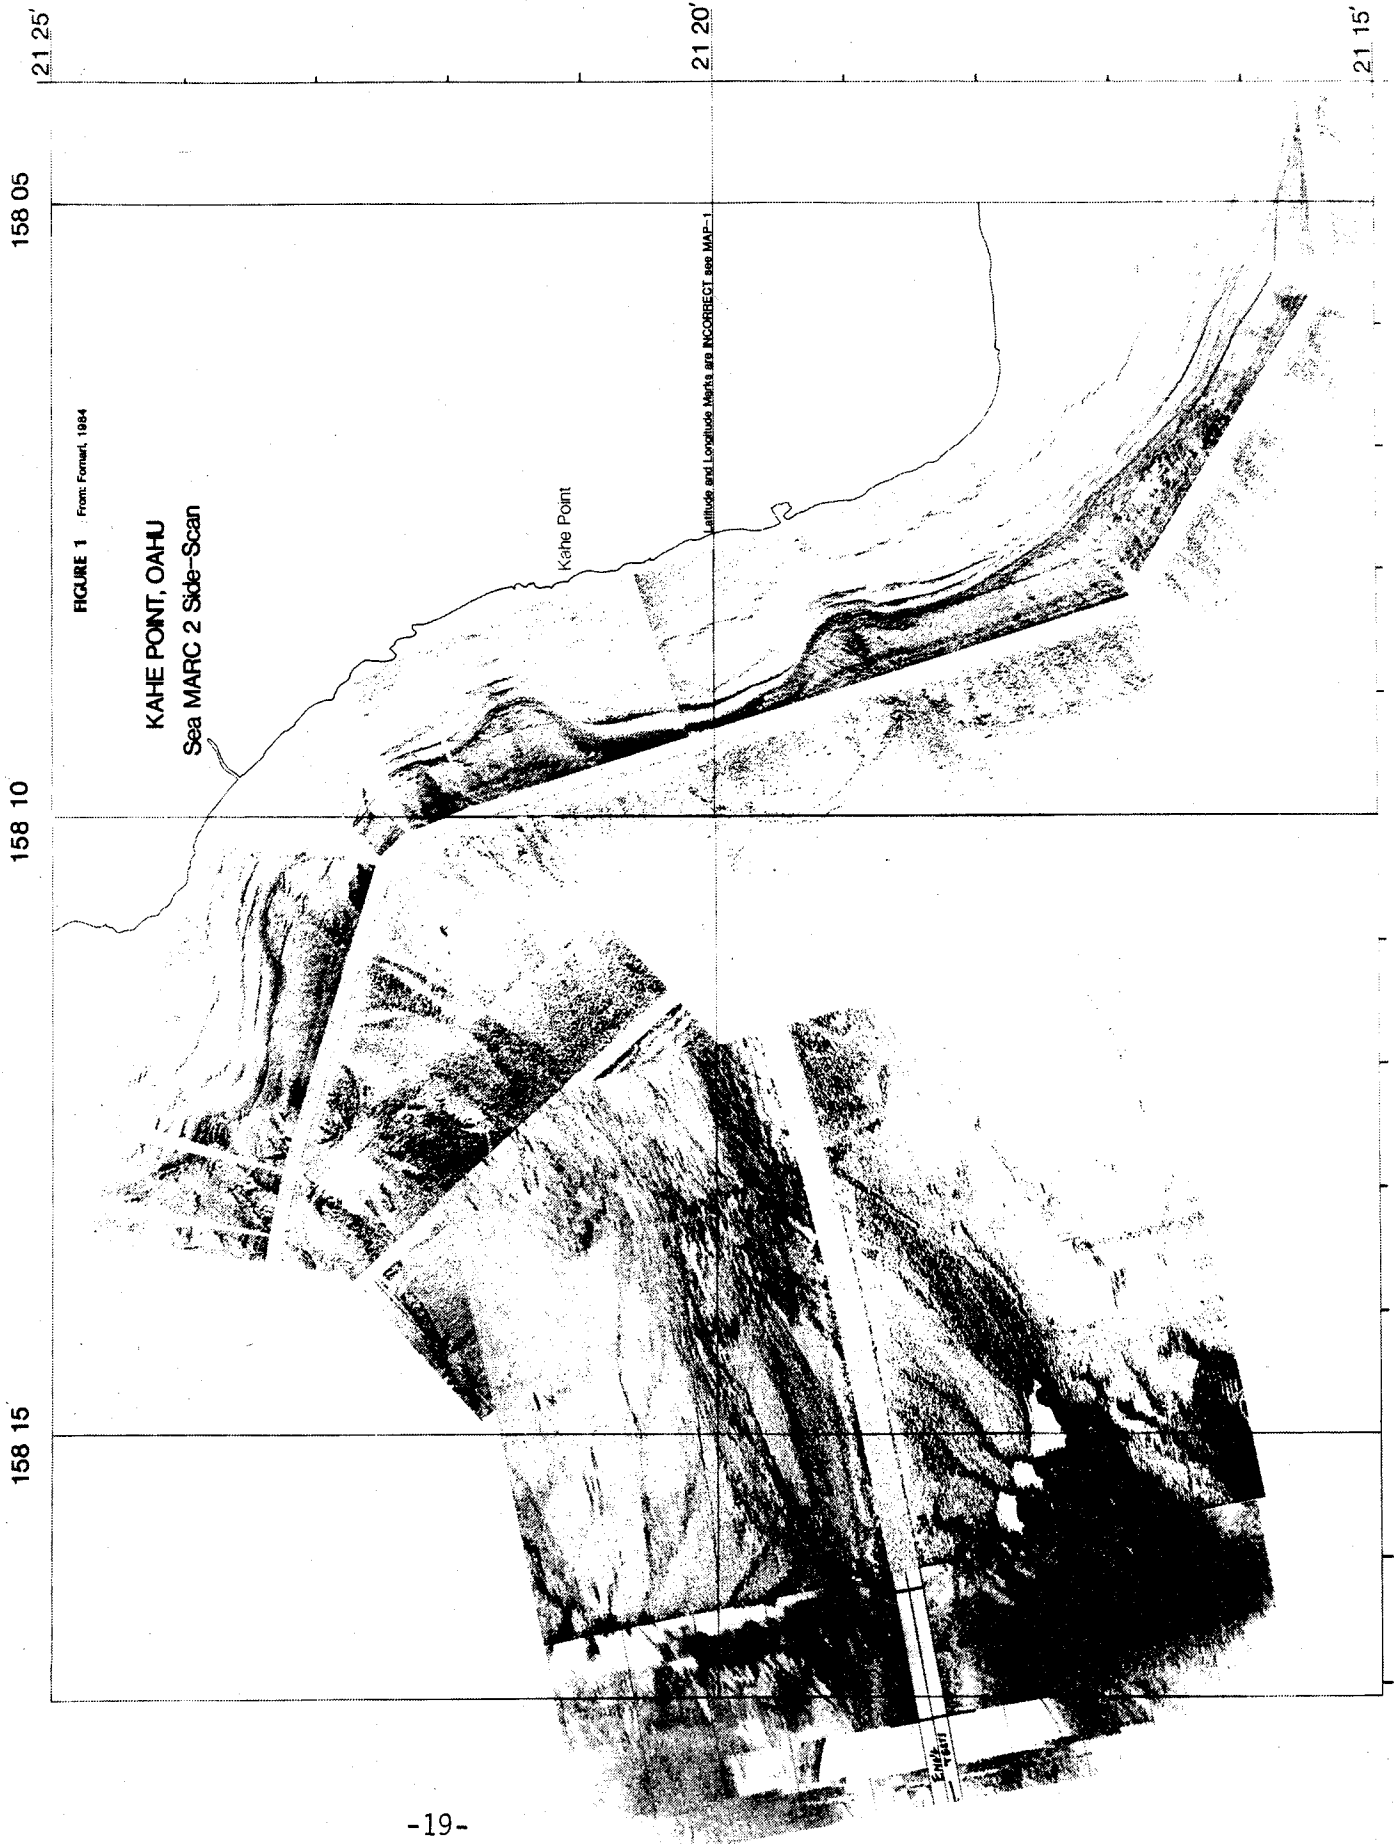
FIGURE 1 From Fornari, 1984

Figure 1 shows the complete side-scan mosaic, as supplied by the Hawaii Institute of Geophysics (HIG). MAP-1 is an interpretative overlay of Figure 1 which portrays a variety of data including: acoustic reflectivity facies; DSV TURTLE dive locations (Fornari, 1983); current meter data (Noda, 1983); cable-break information; and major morphological features of the seafloor in this area.

Near the southwestern edge of the side-scan mosaic in Figure 1, there are several finger-like zones of seafloor which are characterized by narrow, alternating swaths of high and low reflectivity which create prominent acoustic shadows.

When one overlays MAP-1 on Figure 1, it is clear that the cable breaks are located in areas of high-reflectivity, especially the Oahu Tie and California-3 cable breaks which occur in high-reflectivity zones. Highly-reflective echo returns are typical of localized rubble/debris flows which were probably generated in the 400 fathom to 500 fathom area; this material was probably responsible for abrading and breaking the cables.

The most prominent feature in the deeper water area along the western edge of Figure 1 is the zone of landslide lobes. These finger-like acoustic features have positive relief over the surrounding seafloor as evidenced by the prominent acoustic shadows which are cast to the south of the tips of these features (MAP-1). In addition, it should be noted that these features are located at the break in slope between approximately 800 fathoms and 1200 fathoms where Normark et al (1982) suggests that this deep-water sea off Kahe Point may have been subjected to landslides in the geologic past, based on the presence of inferred chaotic terrain recorded on geophysical records.

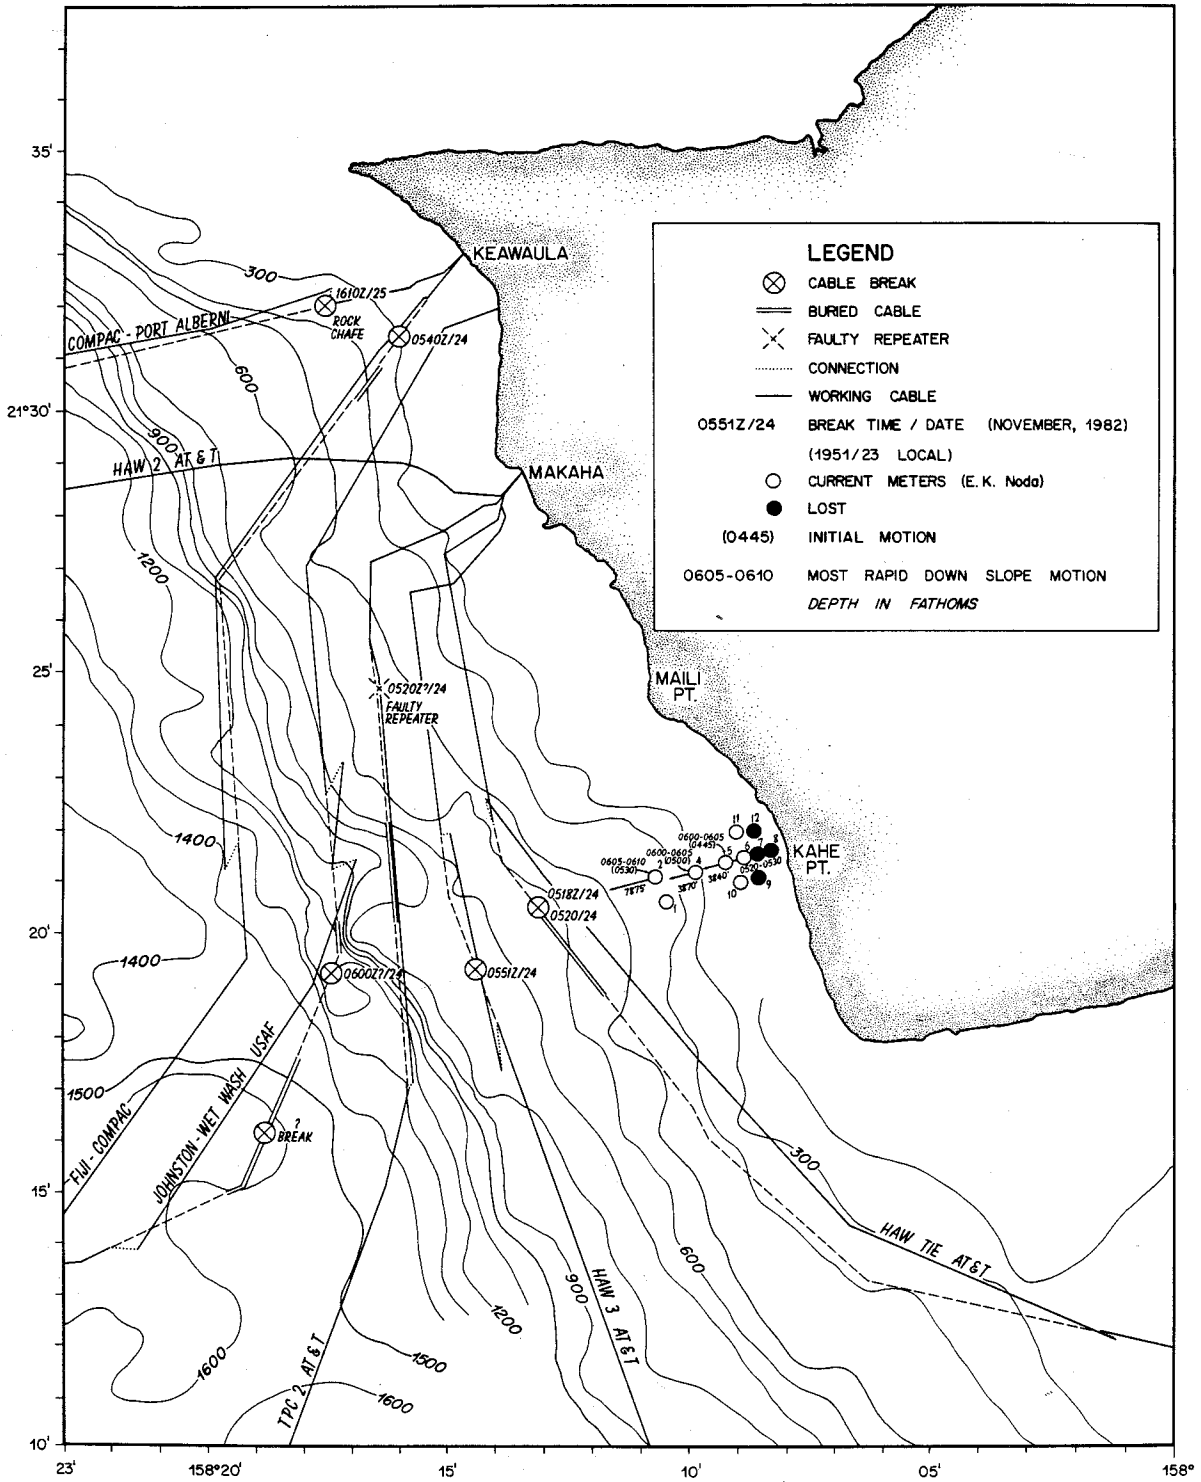
Fig. 1A - Index Map Showing Cable Failures and Current Meters Referred to in Text

MAP-1 contains all cable break data available for the outages which occurred during the Iwa off southwestern Oahu. A sequential, time progression for the breaks in these cables is apparent as one moves offshore. However, the Guam-2 A.T. & T. cable, which is the third cable out from shore (see MAP-1), was not broken.

As discussed in this report, the movement of the current meter arrays was sporadic and occurred over a large time interval between 0500Z and 0610Z, with the major displacement taking place between 0600Z and 0610Z. This time interval is much later than the times when the Oahu Tie and California-3 cables (ones closest to shore and the current meter positions, see MAP-1) parted. In addition, the break times for these two cables is very well constrained based

on the drum recorder records and is well within a few minutes of the times shown on MAP-1. Consequently, it is difficult to conceive of these two events being related by a single event.

The patterns of high-reflectivity seafloor as mapped on MAP-1 appear to coalesce and bifurcate principally in an up-and-down slope direction and the deeper water high-reflectivity zones seem generally continuous with narrower zones of highly-reflective seafloor in shallower depths. While the contrast between the right and left-hand sides of each side-scan record is influenced by whether the instrument is insonifying an upslope or downslope area of seafloor, it is clear that the most highly-reflective zones occur in water deeper than approximately 500 fathoms (uncorrected).

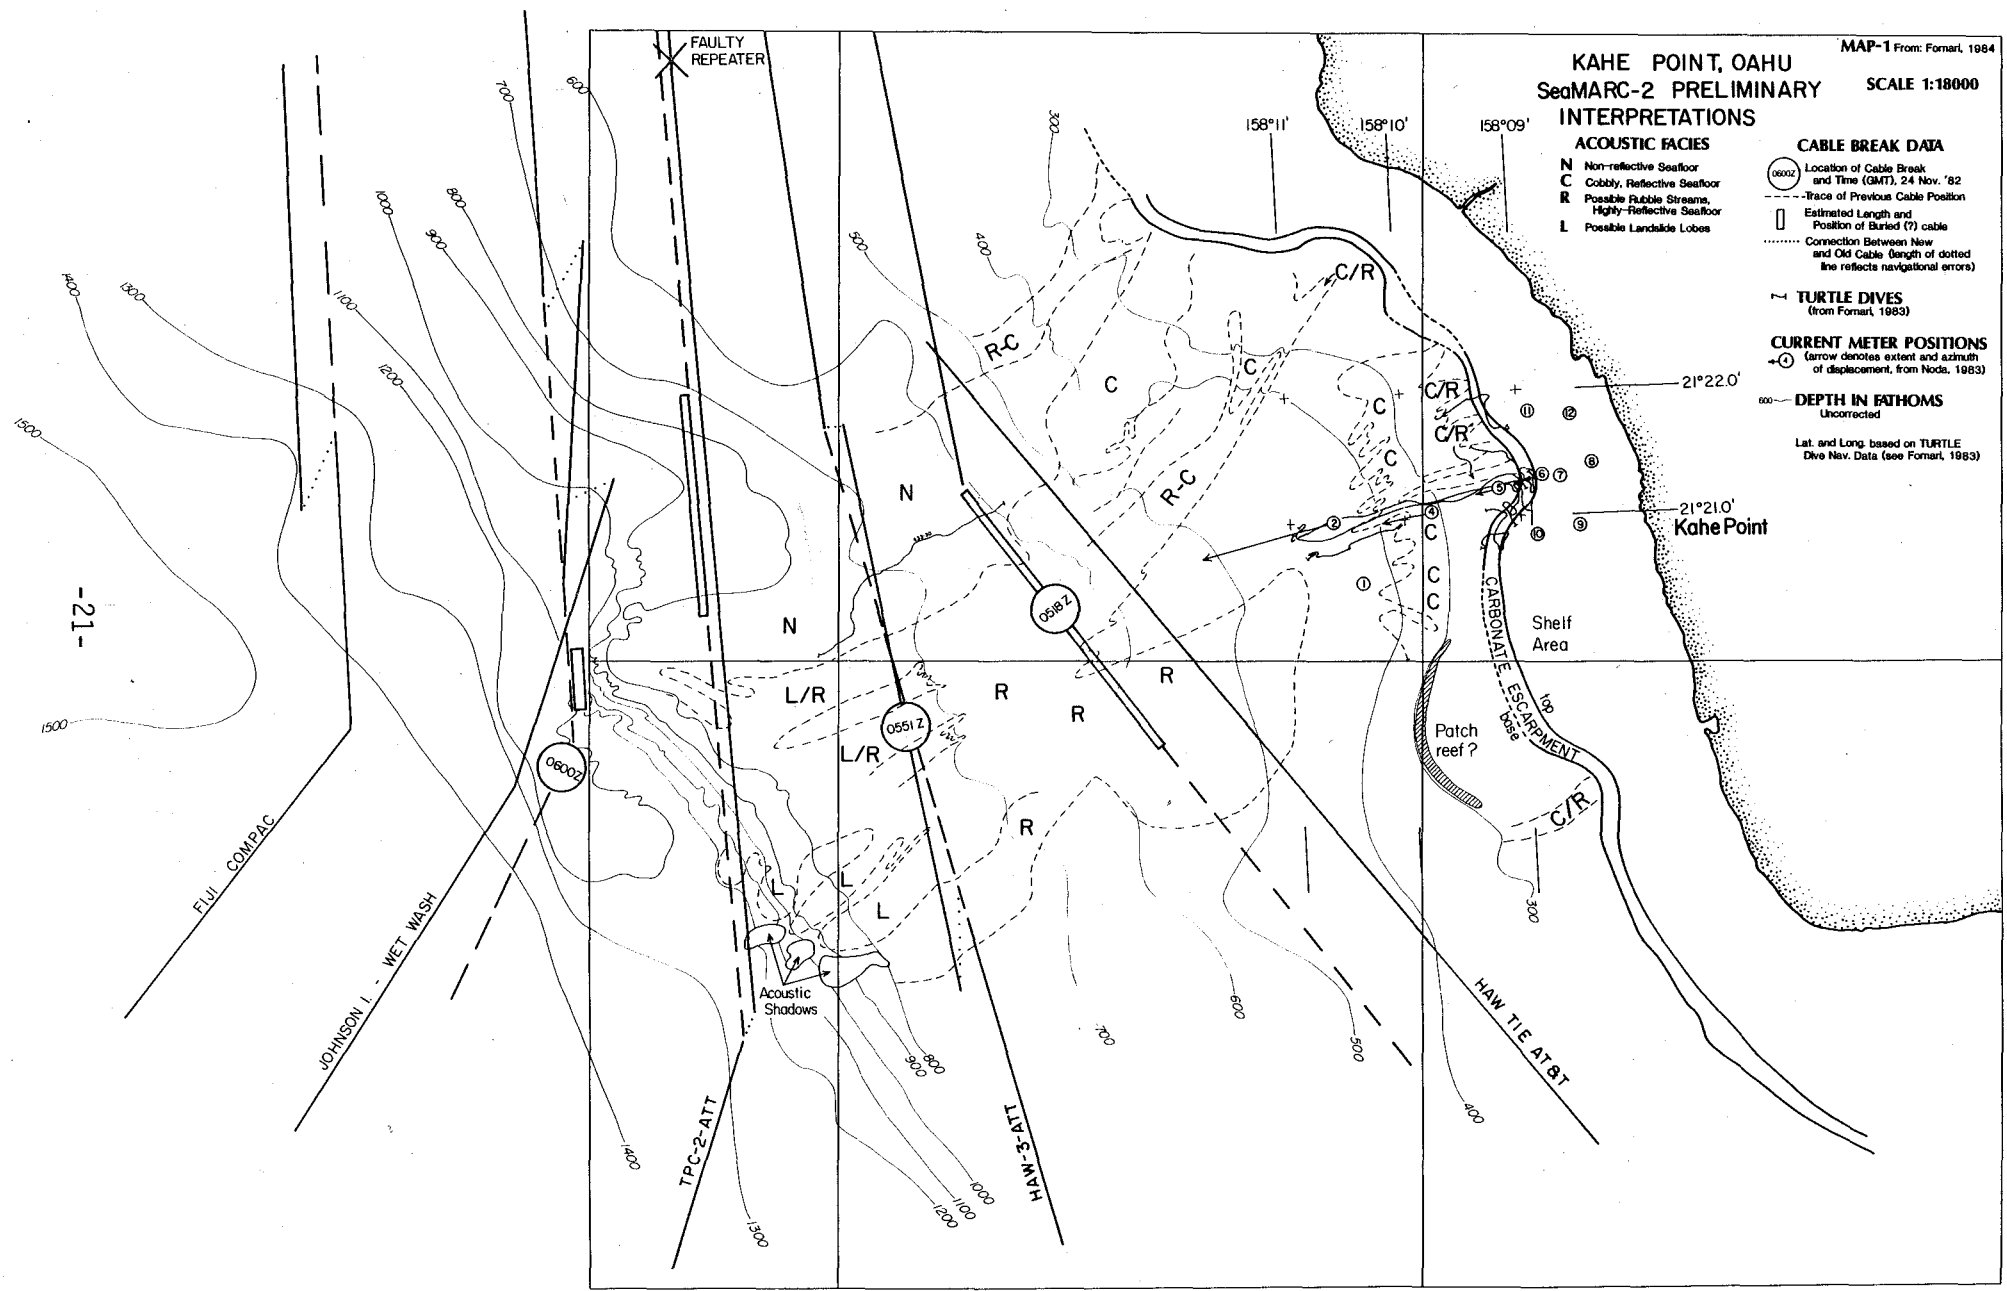
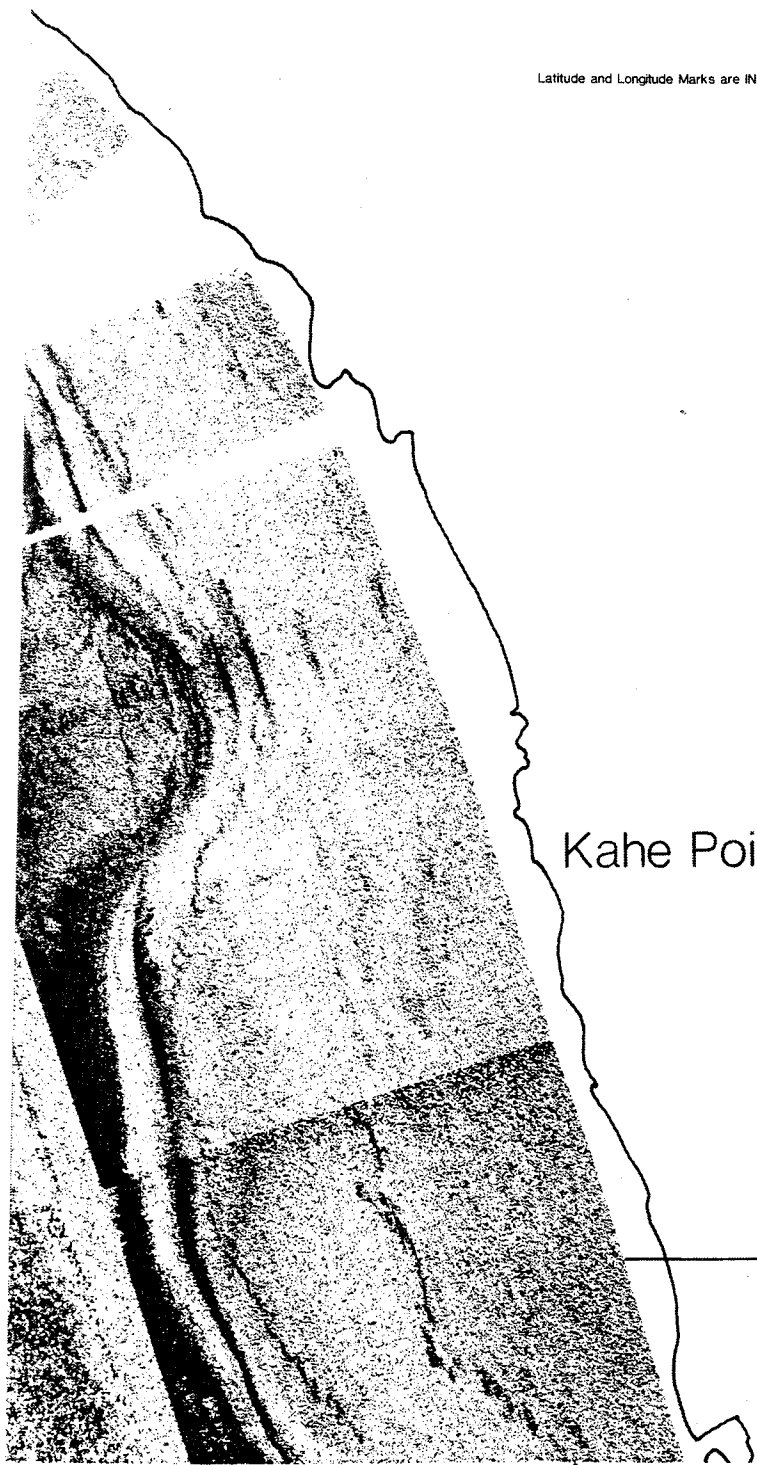
FIGURE 2 From: Fornari, 1984

Figure 2 is an enlarged section of the side-scan mosaic that covers the seafloor west of Kahe Point and is of primary interest with regards to the deployment of an OTEC cold-water pipeline. MAP 2 is the corresponding interpretative map for this record section. The pattern of the fan-shaped reflectivity zones shows a general funneling into the axis of the Kahe Point re-entrant.

The seafloor observed there (TURTLE, Fornari, 1983) is largely sediment-covered with only minor rippled bedforms and no indications of large cobbles or other seabed features that would render the terrain highly-reflective. In the northern part of Figure 2, there is another swath of terrain that appears to follow the axis of the bathymetric re-entrant. The location and character of these more reflective zones could indicate that the axes of the re-entrants act to channel tidal swashing thereby winnowing fine-sediments and leaving behind a gravelly lag deposit that is more reflective.

The trend and character of the carbonate escarpment is easily seen on Figure 2. The width of the escarpment terrain (plan-view map area) is relatively constant. At the southern end of the re-entrant, the width is about 150 m, in the middle it is approximately 200 m, and at the northern end it is only 100 m wide. The base and top of the escarpment are marked by abrupt changes in acoustic reflectivity. The trend of the escarpment top and base on Figure 2 are in excellent agreement with the discrete portions of the escarpment top and base which were mapped with TURTLE (Fornari, 1983).

Although there are problems with multiples on the shelf area, a tentative pick has been made for a terrace step which marks a brief low-stand of sealevel in the Quaternary. There is also a zone of slightly higher reflectivity along the base of the escarpment which, with the aid of TURTLE dive data, has been mapped in as the seafloor area covered by carbonate cobbles and large blocks (shaded area on Figure 2) (Fornari, 1983). During TURTLE diving, the base of the carbonate escarpment was found to merge with the shoreward limit of the boulder zone. The character of the side-scan record in this area supports this interpretation and suggests that it is indeed the case for much of the length of the escarpment in the Kahe re-entrant. Also the tapering of the boulder zone is apparent on the side-scan records and corroborates the findings of dive 423-20 which traversed a much narrower boulder zone than that observed by the dives further to the south (Fornari, 1983).
