Conference Paper

Early Identification for Prospective Housing Area in the Landslide Potential Zone

Helmi Setia Ritma Pamungkas¹, Solihin¹, and Laila Mardlotillah Yogaswara²

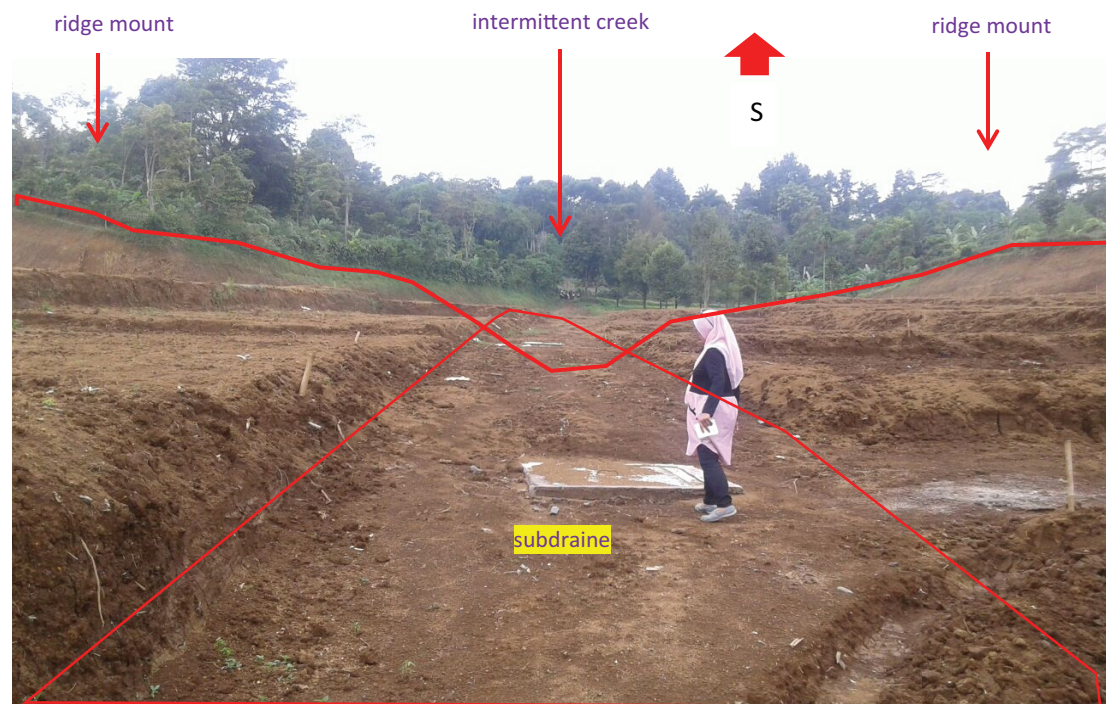
If initial reconstruct of this housing estate, initial morphology is two ridges mount by in the middle is an intermittent creek (Figure 2). This is based on location border contours of the eastern and western edge having a higher elevation than the contours in the center of the housing where condition existing is made subdraine (Figure 3). Above the subdraine is made a path between blocks.

Figure 2: Morphological reconstruction in the prospective housing (Pamungkas et.al., 2018; field work; October 2017).

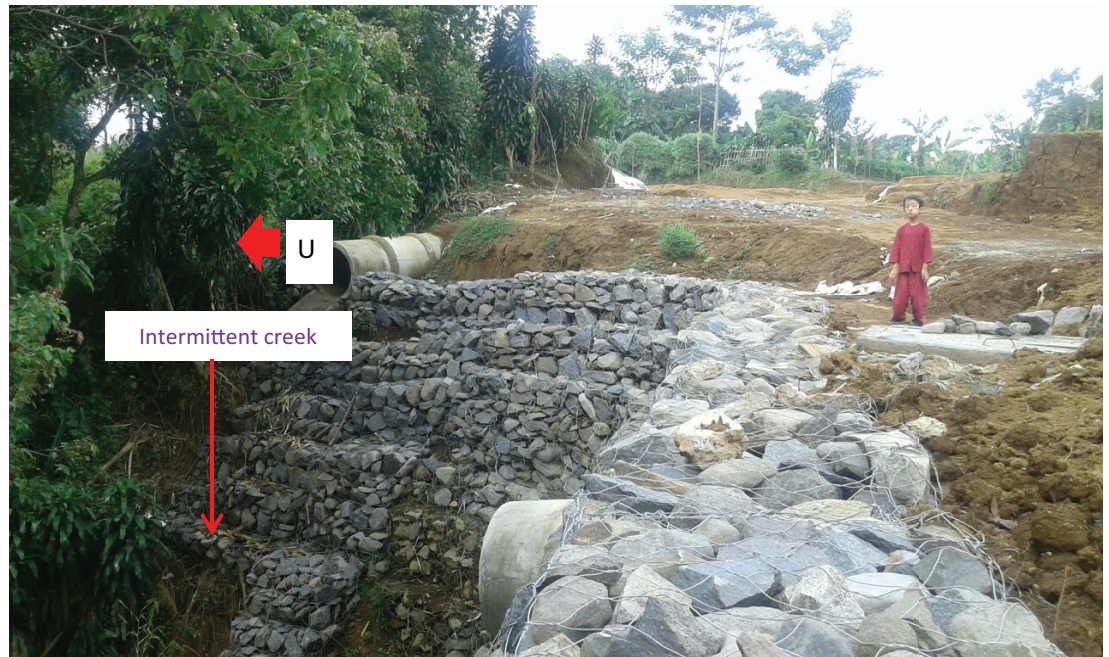
steep slopes will be easy to run off. In the Northeast, there is a gabion with a slope 85° following the pattern of the slope. Besides that, there is a subdrain pipe on the part of the gabion.

Figure 3: Gabion condition and subdrain pipe in prospective housing land (Pamungkas et.al., 2018; field work; October 2017). Soil Type at Cijeruk Area.

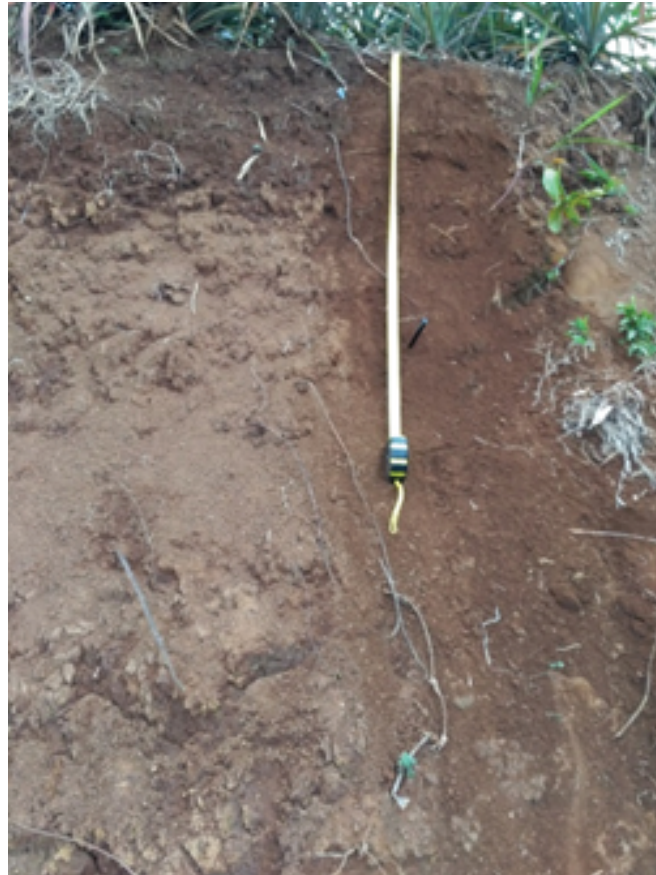
Condition of soil layer at the location of the prospective housing is intense, not founded the main rock for soil compiler until the depth > 2 meters (Figure 4). Latosol is an adult-growing soil, characterized by clay mineral deposits in the eluviation layer. Soils with clay content could shrink in dry conditions and expand at wet times. These conditions affect shallow foundation movement. In dry clay soil surface would be a lot of cracks through this crack, water could get into the bottom of the foundation, and it would weaken the soil under the foundation.

The latosol at previous prospective housing was used as a mixed garden and shrub. On the topsoil layer is dominated by clay texture with slow soil permeability and soil susceptible to erosion.

Figure 4: Soil profile of prospective housing (Pamungkas et.al., 2018; field work; October 2017).

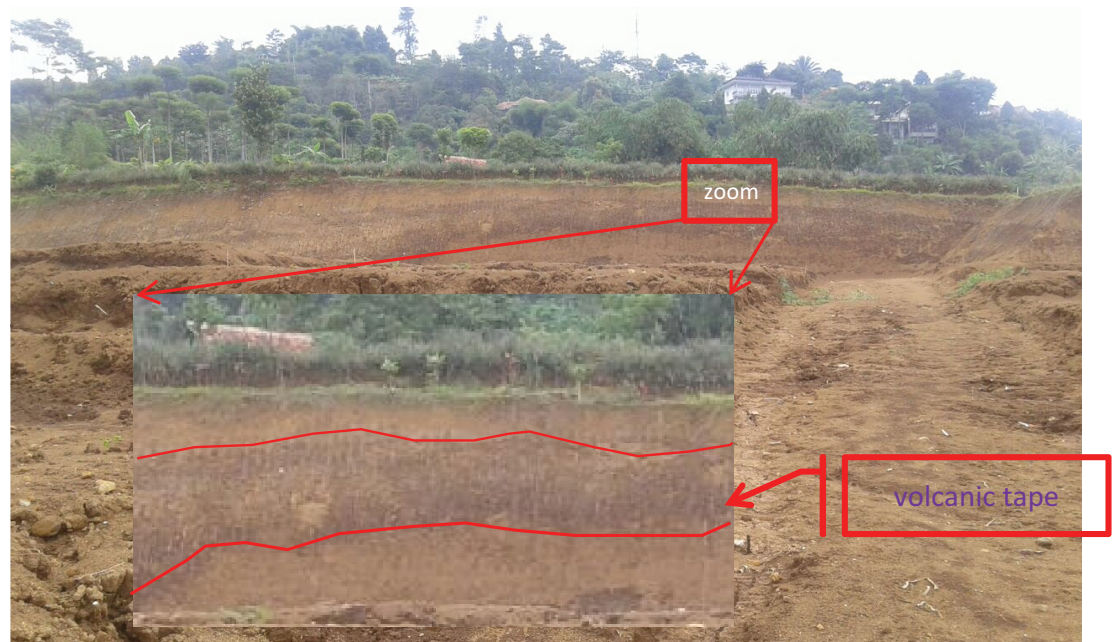
This type of Salak Volcano product is very easily eroded if left without land cover. On the wall that has exfoliated in the southern and southwest is found volcanic tape layer showing eruption Salak volcano period (Figure 5). Level of groundwater in this area is 40 cm, hence this area according to land suitability is not functional because of shallow groundwater levels.

Figure 5: Salak Volcano product in prospective housing land (Pamungkas et.al., 2018; field work; October 2017).

Because rock products are only tuff and lapilli, many layers of clay, and do not lithification, then as a basis for construction generally would be easy to crack, as a result of wrinkles from clay layer of the tuff.

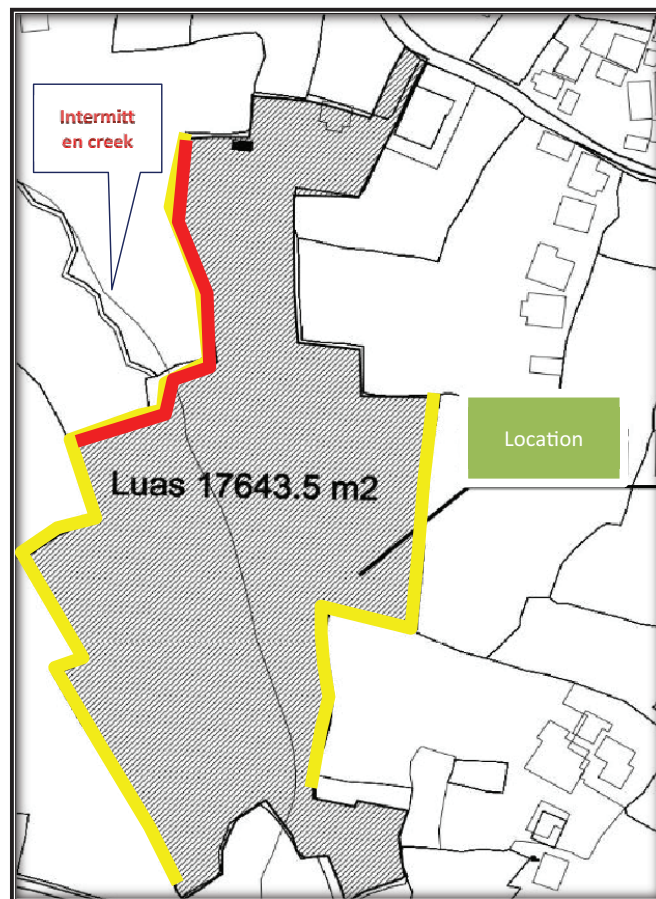
In the western and eastern part of the housing, there is a steep to an extremely steep slope, with land use is mix garden and shrubs for instance pineapple plants. From this vegetation type, the root to retain soil erosion is not strong enough, so that the soil would be easy to erode.

In the northwestern part of this housing, there is an intermittent creek that has a very steep slope. In this part, the creek is only made a gabion to hang on the bottom, with the position of gabion 75° - 80° . Observations results of the housing represent that the position of prone landslide occurrence is in two borders the East and West of the house. In Figure 6 is marked red and yellow lines. Yellow line area has a medium level of land movement, and red lines area has a high level of ground movement.

Figure 6: Susceptibility to landslide map in the prospective housing land (Pamungkas et.al., 2018; field work; October 2017).

Potential landslide in this housing, there is two categories medium and high landslide in the edge of West and East border. High soil movement is found in the intermittent creek path which has a steep slope. Recommendations for maintenance from landslide; hence it is necessary to make gravity type retaining walls and cantilever type retaining walls. The distance between the retaining wall and the housing is 15 meters. Type of foundation to be used is the foundation of spread footing.
