Proposal for optical method of quality control of the surface of the slabs of natural stone for cladding facades

Key words: building technology, natural stone, claddings, finished closings, surface quality control

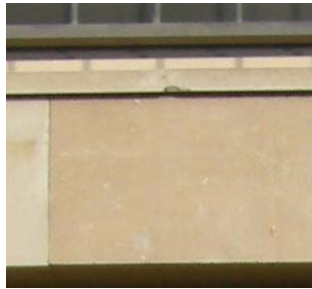
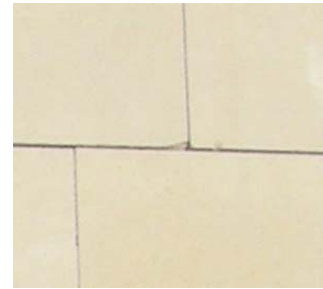
Anomaly 01: There are stone slabs **notched** when present at certain points of perimeter notches (material losses) caused by impact. The anomaly is presented mostly in the corners of the pieces, however, is also present in some edges.

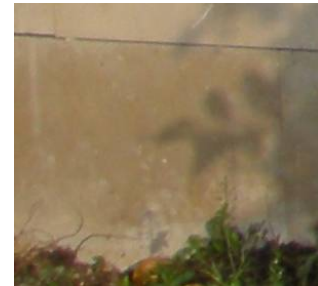
Anomaly 02: There are pieces of stone with **efflorescence** on the surface are manifested when the remains of salt crystals.

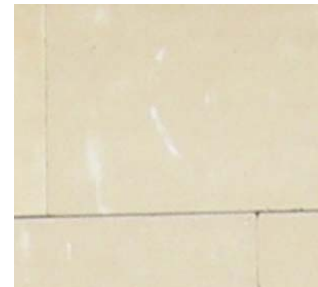
Anomaly 03: There are stone slabs **scratches** when there are material losses in the face of the stone plaque, which follow a linear path parallel to any edge.

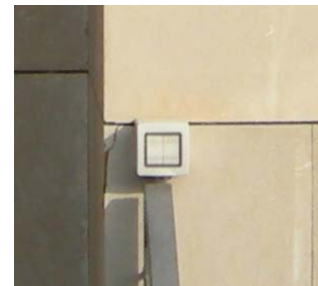
Anomaly 04: The plates are **broken** when the cladding has cracks or fissures from side to side plate of irregular shape, which split the board into two halves.

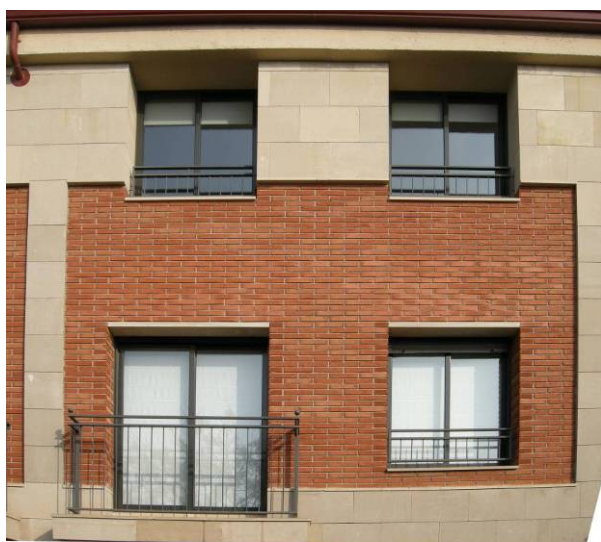
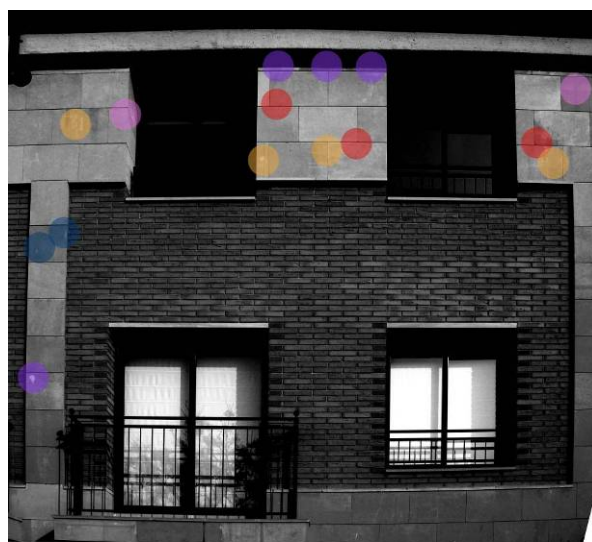
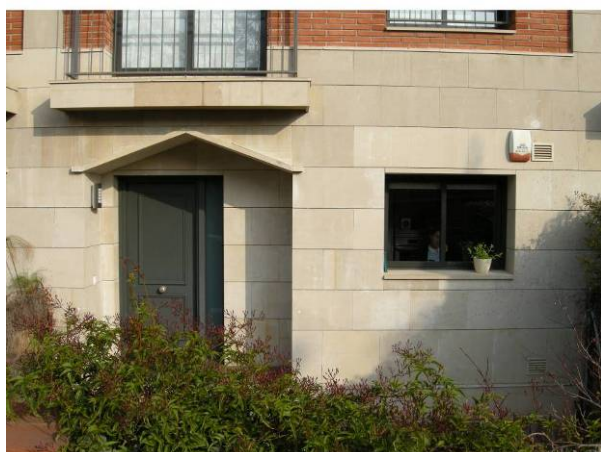
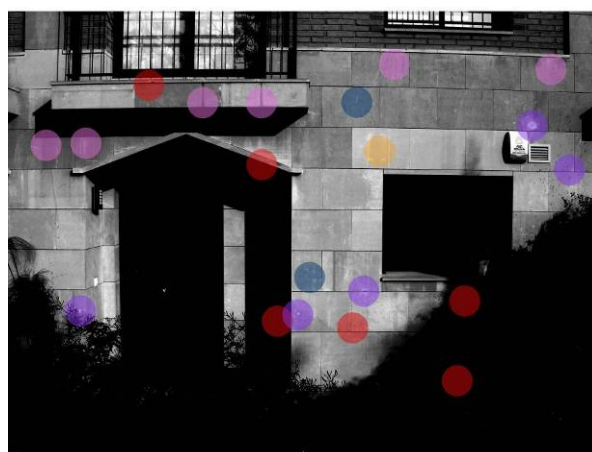
Photo fully treated, with location and classification of different anomalies
