### Preventive Intervention in a Group of Buildings Located in the Historic Centre of Manresa (Barcelona)

C. Diaz<sup>a</sup>, C. Cornado<sup>a</sup>, A. Griera<sup>b</sup>, O. Caselles<sup>c</sup>, V. Alegre<sup>d</sup> & P. Santamaria<sup>a</sup>

# PREVENTIVE INTERVENTION IN A GROUP OF BUILDINGS LOCATED IN THE HISTORIC CENTRE OF MANRESA (BARCELONA)

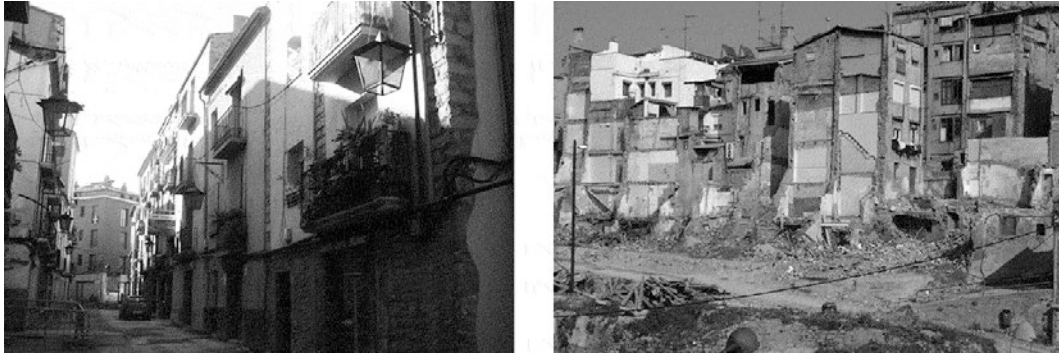
Figure 2: Facades of the buildings and rear view after demolitions had taken place.

The demolition of half of the urban block had the effect of exposing the rear dividing walls of the remaining buildings and eliminating the contact which had previously existed with the demolished buildings. Due to it, this demolition worsened the initial stability of the buildings (figure 2).

It was clear from the initial survey of the building that some safety measures needed to be taken before the diagnosis tasks could be completed and the final recommendations drawn up. These initial measures consisted of the shoring of the rear parts of three of the existing buildings, as it was considered that their level of safety had been severely diminished by the demolition of neighboring buildings whose walls had been providing a structural connection. It was also decided to spray what had been the dividing walls - and any others that had become exposed to the elements by the demolitions - with polyurethane to improve their weathering performance.

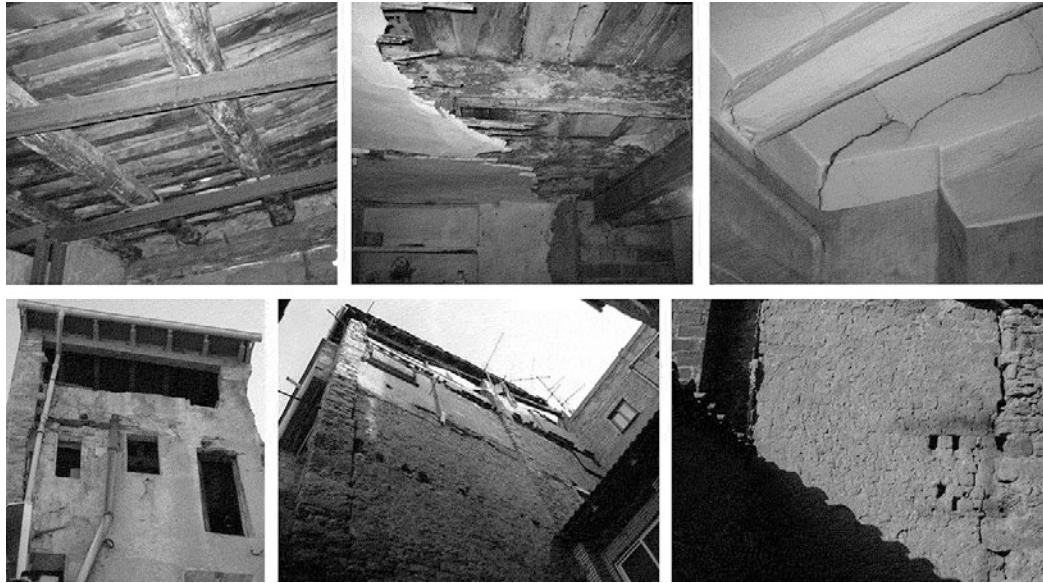
Figure 7: Existing damage and condition of the buildings.

The construction methods used are traditional ones involving stone blocks, adobe blocks, rammed earth, and to a lesser extent ceramic bricks. Floors are made up of timber beams and joists with vaults of ceramic material or wooden boards between beams (figures 5, 6). The stone walls are more common in the basements and ground floors, but can also be found here and there in the rest of the stories. The parts built recently stand out due to the use of perforated or hollow bricks and reinforced concrete joists. The construction is heterogeneous owing largely to the different constructions stages experienced and to the variety of traditional construction techniques utilized, most of which are traditional in the area (figure 7).

The types of damage visible in the buildings are a result of diverse causes. In some cases, they were directly related to the lack of connection in the overall structural system as mentioned previously, especially, when the pillars were showing significant lateral deformation due to the lack of confinement from other parts of the structure (figure 7). In other cases, damage was seen in the form of cracks marking the join between materials behaving differently under vertical loads. Cracking due to concentrated loads were also observed. Other alterations, like the progressive sagging of wooden floors, were due to ageing. Damage due to a lack of maintenance, to dampness or to a combination of the two

was also noted, as is the case, in many instances, of rot and other biological attacks on timber elements (figure 8).

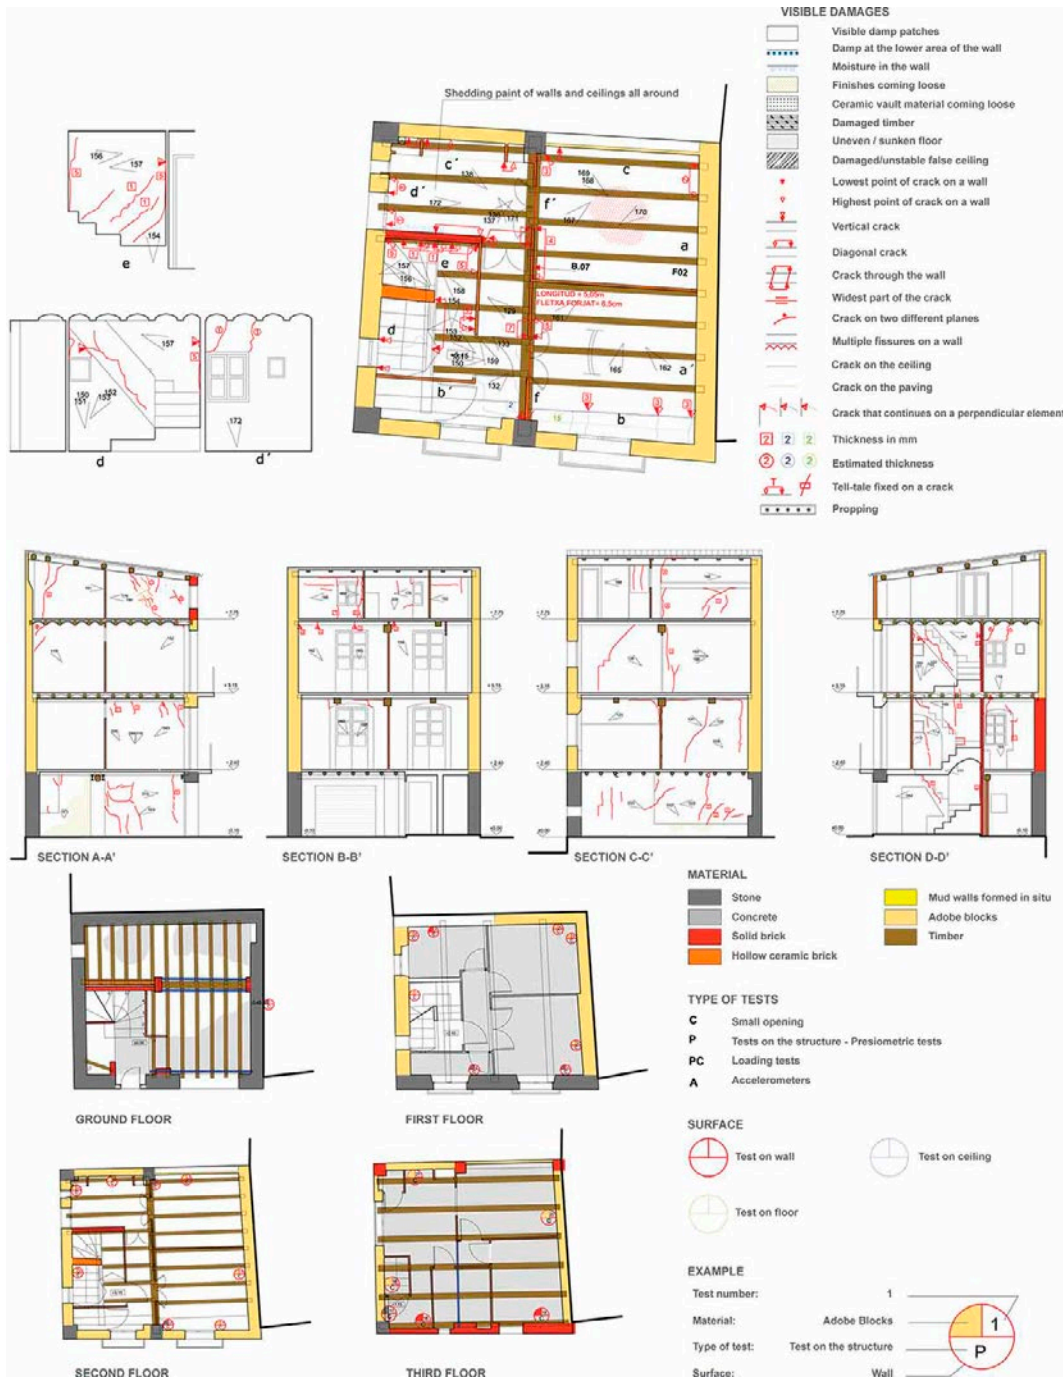
Figure 8: Damage survey showing the trial openings carried out.

c) Locating and representing graphically the damage visible in the structural elements of those buildings, including cracks and fissures, subsidence and swelling in the walls; sagging in the floors; biological attacks, dampness, etc. (section 3).

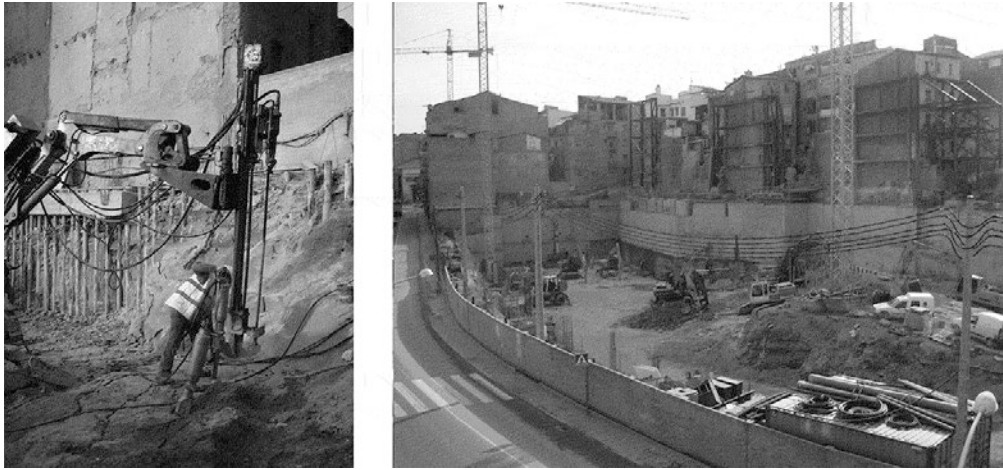
Figure 15: Excavation and the construction of the piled perimeter retaining wall.

During the process of excavating and constructing the foundations of the new building (figure 15), tests were carried out with two different objectives. Firstly, finding out the vibration levels generated by the different excavation processes in order to evaluate their potential effects on the existing buildings; and secondly, monitor the level of vibrations in the base of the existing buildings, in order to make sure that they stayed below the established limits throughout the building of the concrete retaining wall and the excavation.

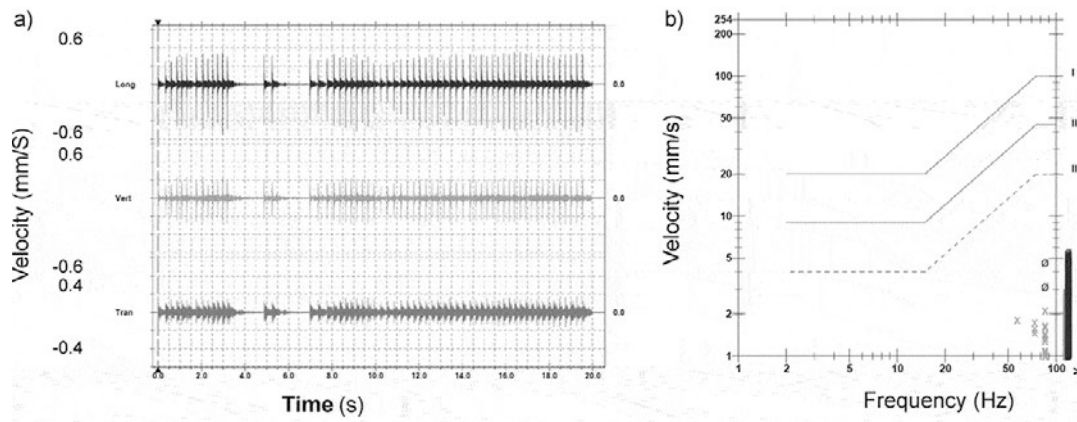
Figure 16: a) Graphic of velocity over time. b) Criterion for compliance with the standard regulation UNE22.381 during the excavation with the 410 J hydraulic hammer.

The maximum vibrations recorded in each one of the tests carried out with the pneumatic hammer were respectively 0.44, 0.75, 1.78 and 10.35 mm/s with predominant frequencies above 100 Hz. The last value exceeds the maximum amount of vibration permitted for buildings classified level III according to the standard regulation UNE 22.381(Asociación Española de Normalización, 1993). These measurements led to the recommendation of a different drilling method in the areas close to the existing buildings.

- a) Although it is verified that excavation using the hydraulic wedge creates very small vibrations, the necessary preliminary drilling has to be controlled when carried out close to existing buildings (at a distance less than 3 m in this case) This control becomes particularly important when the drilling is undertaken close to buildings showing a delicate condition due to their structural vulnerability or their heritage value.
- b) The DTH drill generates a very high level of vibrations over a short distance (above 6 mm/s in this project). However, these vibrations occur with very high predominant frequencies, which according to all the studies and existing regulations are found not to be

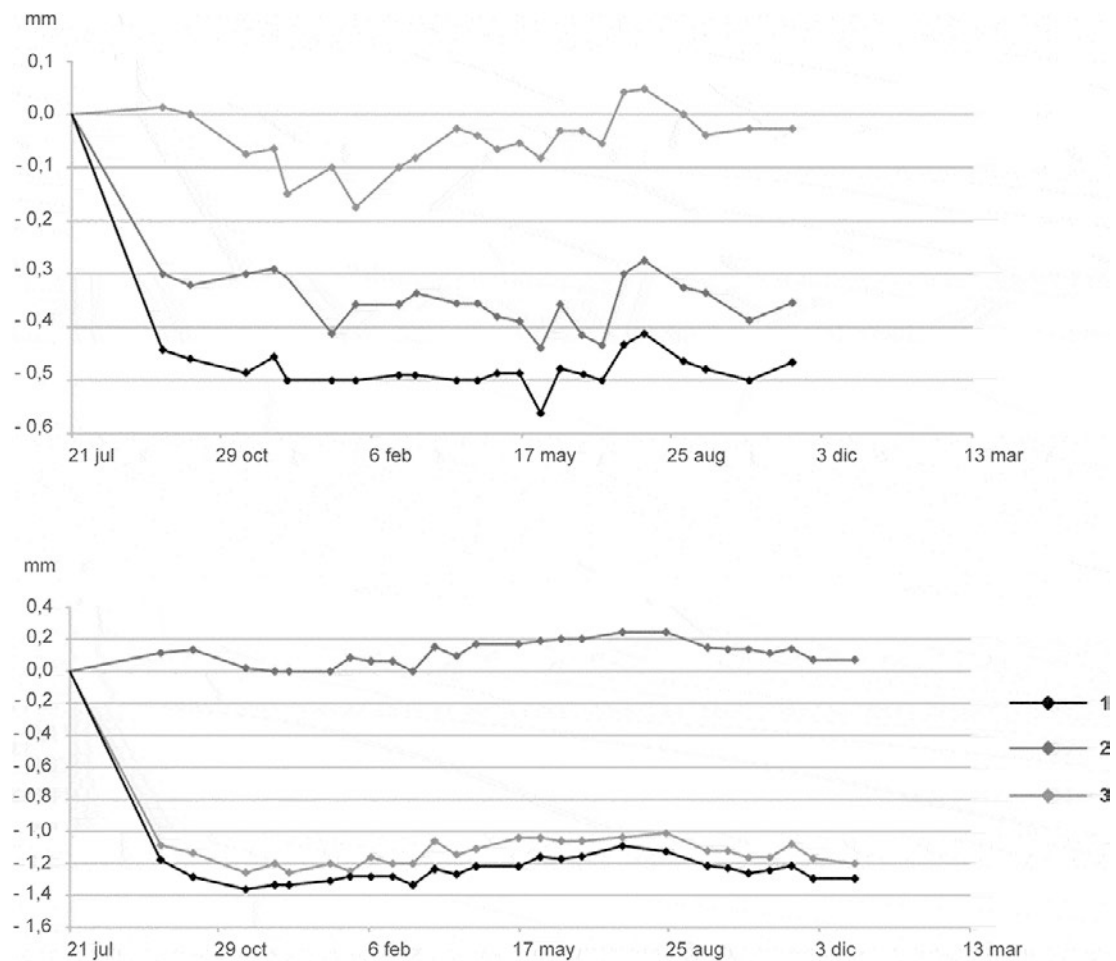
Figure 19: Values from the monitoring of the cracks taken using the calibrated datum points. Escodines 14 up, Escodines 22 down. See figure 17.

For that purpose, the set of the cracks deemed more representative and meaningful were chosen to detect movements in the structural elements. This involved cracks in the form of relieving arches, separation between load bearing elements, and other damage. The procedure consisted of placing a total of 29 tell-tales and 15 calibrated datum points in the cracks selected. In total 24 sets of readings were taken – approximately one every three weeks – over the 18 month duration of the excavation and the construction of the basement floors of the new building. The tool used to take the measurements was a digital caliper with reading accuracy of 0.2 mm and an instrument accuracy of 0.01mm.
