RAPID cruise report for Cruise DY129

8 December 2020 - 26 January 2021
RRS *Discovery* Cruise DY129

B. I. Moat

Cruise report 72

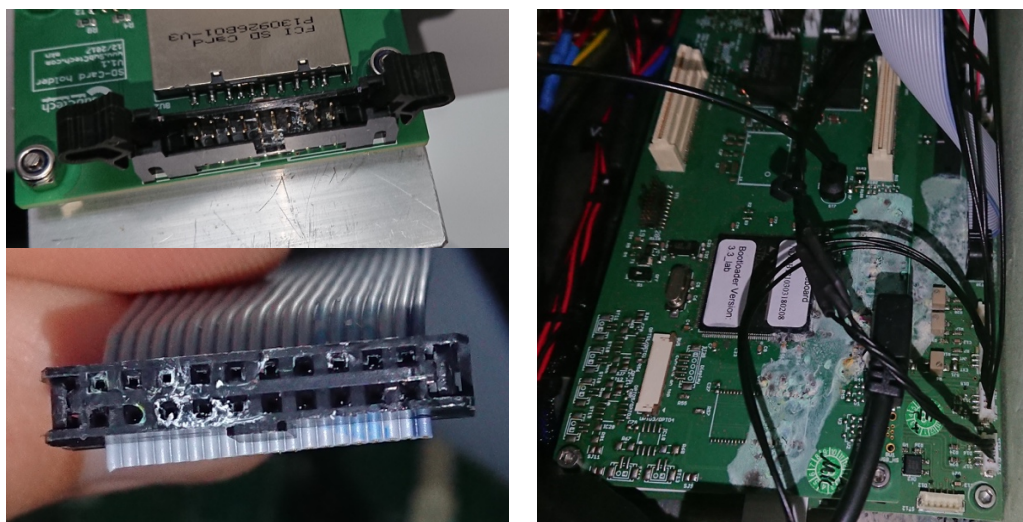
- System was subsequently switched off, and Micro SD card (located in SD card adaptor) removed from slot on top of system.
 - SD card adaptor showed some evidence of corrosion, possibly due to water ingress. Reading of memory card on separate computer found file system intact including calibration and configuration details, and 3.2 GB of available space. Reinsertion into SubCTech system did not result in memory card being read.

- Further advice was to remove the system cover to look for any clues as to the system behaviour inside. This revealed salt build-up on the main processing board, concentrated particularly under the location of the SD card slot and where the cable from the USB port joined the board. Removal of the ribbon cable connecting to the SD card port showed further evidence of water/salt. It is likely that during use of the adjoining sink for sensor cleaning (and from/to which the SubCTech drew/eluted its water) some seawater managed to drop into the top of the system through the SD card port. See Figure 15.2 for photos.

Figure 15.2 Salt damage to SD card port, cable and main board.

- As the system was still able to measure CO₂ just not save it, a standalone PC laptop was connected to the SubCTech through Serial cable-RS232-USB in order to log the live 1Hz outputs. The original phase schedule was reprogrammed enabling measurement of zero and span 1 gas (422 ppm). Due to its memory issues though, only raw, uncalibrated data were output and saved, thus requiring substantial post-cruise calibration processing.

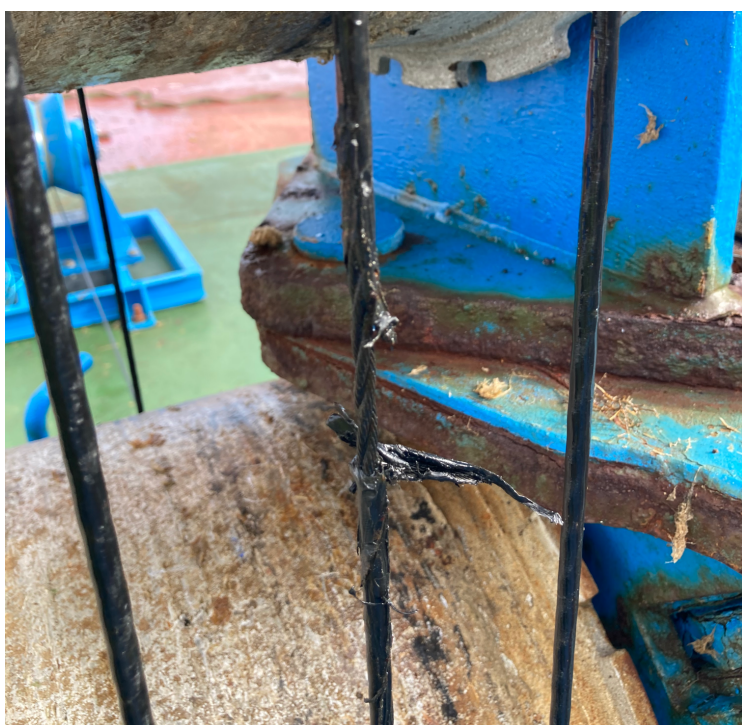
- WB2 had some instances of shredding on the plastic jacket of the wire (around 200m). Figure 17.2.

Figure 17.2 Showing shredding of the plastic jacket on the wire at WB2 around 200m.

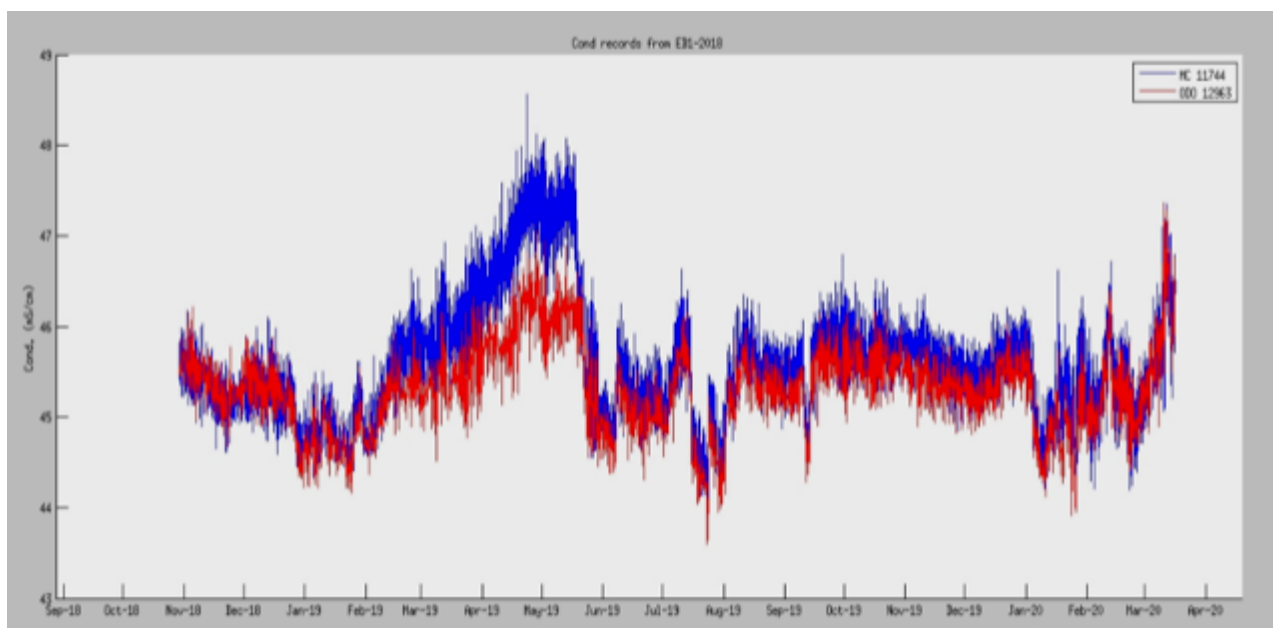
Upon further investigation by Darren Rayner, it appears that MicroCAT s/n 11744 was previously paired with an ODO s/n 12963 on EB1_15_2018 at 250m. Comparing the conductivity between s/n 11744 and the ODO 12963 (Figure 17.3), there appears to be some anomalous drift towards elevated values around February – May 2019. The offset between the two then recovers towards 11744 being mildly elevated relative to 12963 through January 2020. At the end of the deployment, the two instruments appear to be reading the same values. This behaviour does not match expectations for conductivity cells: that they may have unusually low values when biological material gets stuck in the cell, or otherwise suffer from drift which is linear with time.

Figure 17.3 Conductivity record from two microcats: 11744 and ODO 12963. Note the period around Feb – mid-May 2019 when the MicroCAT (blue) is elevated relative to the ODO (red). This offset then reduces in mid-May 2019, and appears to decrease to negligible levels by the end of the deployment (April 2020).

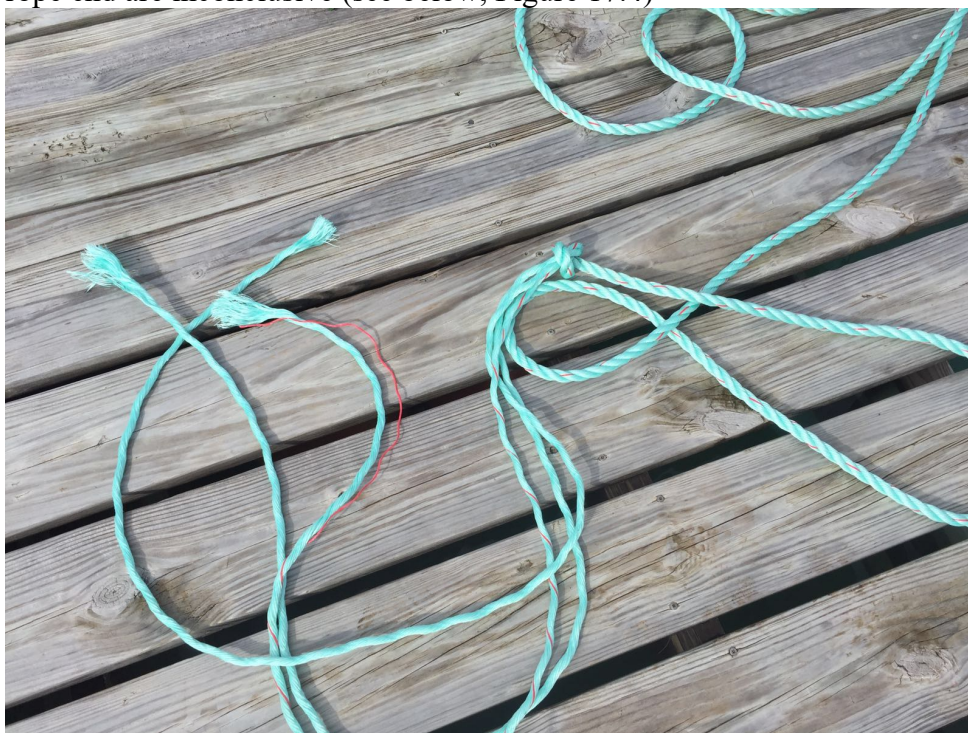
WBAL6 – The buoyancy from the lander surfaced two months after deployment. The frame was confirmed to still be at the deployment position on the subsequent cruise. Photos of the recovered rope end are inconclusive (see below, Figure 17.4)

Figure 17.4 Recovered rope end from WBAL6.

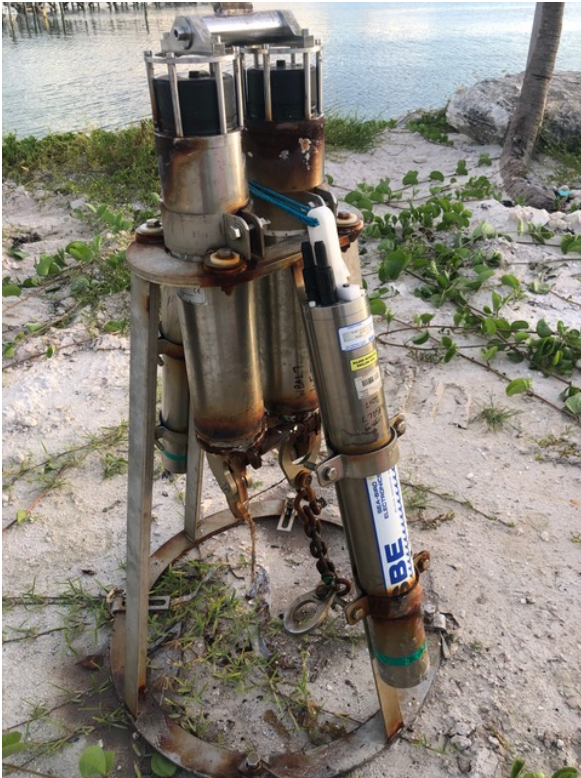
WBAL7 – the whole lander (buoyancy and frame) was recovered to Abaco by small boat. Photos appear to show one of the releases has been triggered (see photo below, Figure 17.5). The cause of the release was down to release s/n 822 moving $\frac{1}{4}$ turn and releasing the lander from the ocean floor. The releases did not respond when tested on board the ship. And further testing will be conducted back at NOC. There were no messages from the Argos beacon but the lander was found adrift by a passing fishing boat near the Pelican Sea Reserve off Abaco.

Figure 17.5 Photo of WBAL7 lander frame as recovered by a University of Miami professor.
