ADVANCED MASTERS IN STRUCTURAL ANALYSIS OF MONUMENTS AND HISTORICAL CONSTRUCTIONS

Master's Thesis

Investigation of a Faulty Historical Structure: Saint Barbara Church

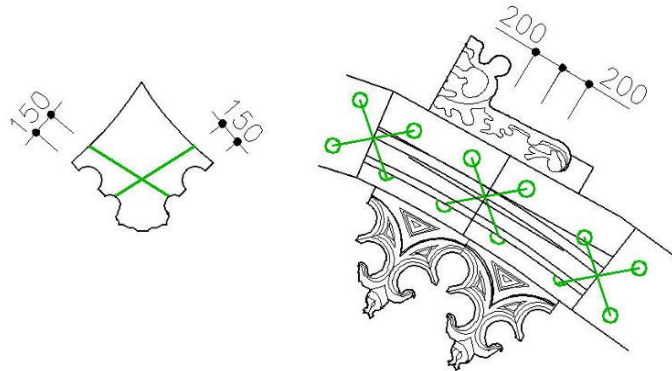
Figure 18 Reinforcement a) Section b) View [11]

The restoration implemented during 2003 on the four buttresses of Section 1 consists in connecting adjacent stones of the arches using stainless rods [Figure 18]. Every two consecutive stones, a

common joint was defined through drilling holes on the stones and then introducing the rod. Afterward, the joints were grouted with new elastic mortar. In that way an invisible repair was done. The reinforcement transfer the shear forces and avoid stones to fail. Special attention was paid to the location of the rods, since they need to be near the neutral axis in order to ensure not to change the location of the forces inside the flying arches. After the restoration fifteen monitoring points were set on the buttress to observe its behavior. A complete description of this part of the restoration is available in [11].

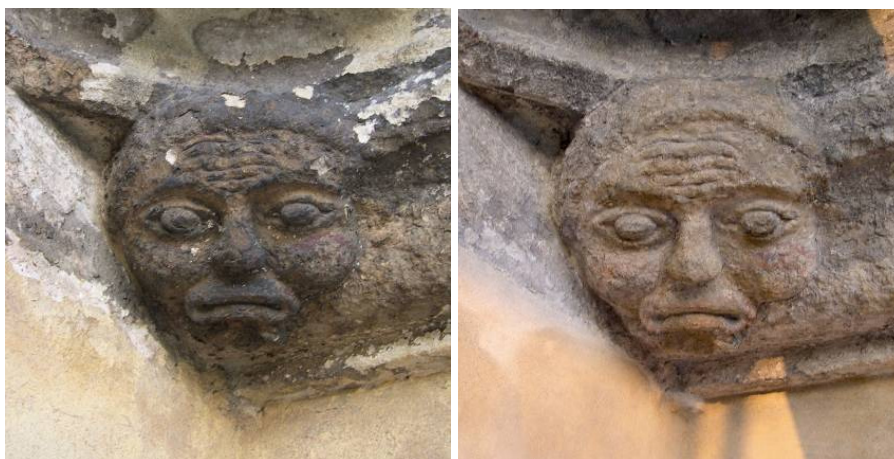
Figure 19 Mascarons a) Before restoration b) After restoration [7]

The works performed on 2003 included as well the restoration of 12 mascarons that form part of the external decoration and are placed under the cornice in the corners of the chapel walls and buttresses. Those sculptures from limestone, originally made between 1521 and 1524, were damaged as a consequence of air pollution and water penetration in the cornice. The selection of the more suitable materials to restore them was based on test on different possible combinations. In the restoration process, the mascarons material was solidified and then additions were placed where necessary to guaranty the flow of water. Finally the sculptures were covered with impermeable surface material and the cornice was covered by lead sheets.

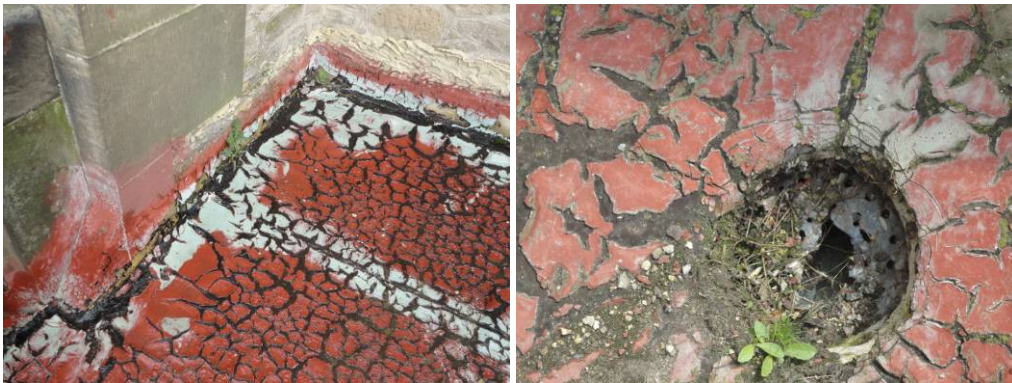
The floor of the balcony of the façade is in a very poor condition showing a cracked pattern as a consequence of the temperature cycles. It can be deduced that during past restorations successive layers of asphalt paint were applied. The total thickness of layer can be estimated around 8 cm.

Figure 23 Asphalt layers of the balcony floor

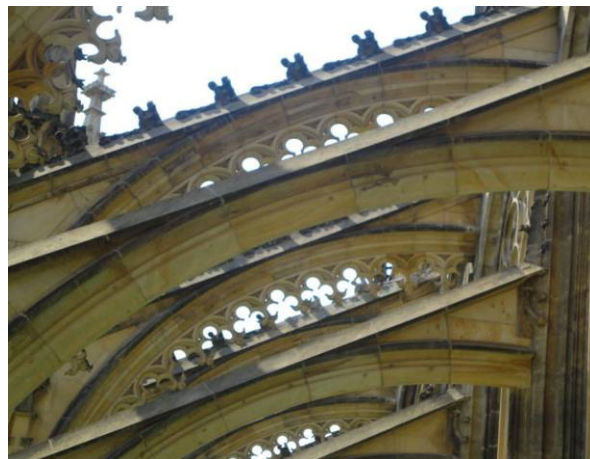
Unfortunately, by the time of the visit the scaffoldings were already removed and it was not possible to see the buttress from a near point of view. However they seem to be in a good condition. In the buttresses that have been restored small dark spots can be seen. They are located in the places were the holes were made and then filled with lime mortar. [Figure 26]

Figure 26 Strengthened flying arches

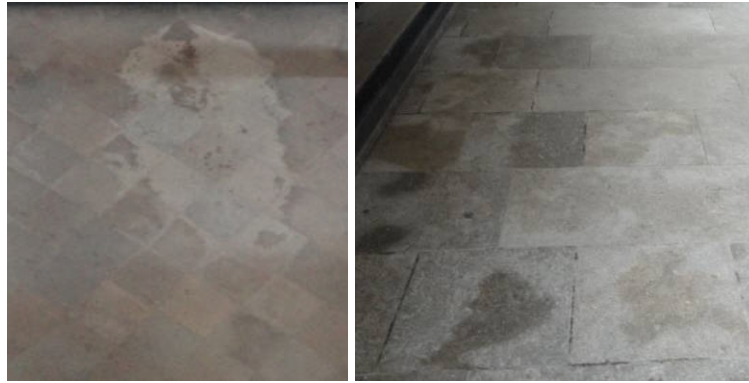
The access to the interior building is located on the north transept. The first interior part of the church that was inspected was the floor. There are some spots which reflect variations in temperature and moisture. Those differences appear due to the presence of various tunnels and crypts that go through the cathedral subsoil.

Figure 27 Spots on the floor

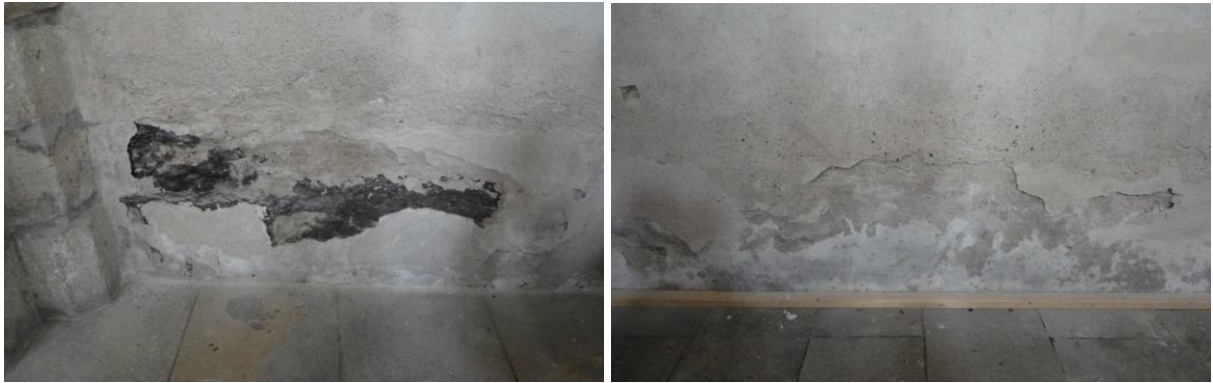
Trough the visit to the chapels around the presbytery, the presence of paints allusive to miners and their lifestyle is noticed which is unusual for a church. The paints are not complete since parts of them have been lost along the years. The last restoration of the paints was made in 1937. Figure 28 shows different interior paintings of the church. The lower levels of some interior paints and walls show layering and lost of cohesion between layers caused by the presence of moisture. [Figure 29]

Figure 29 Damage on the interior walls

The presence of moisture seems to be due to rain water that was not well evacuated and remains near the base of the wall. This water can draw up by capillarity action into the masonry generating the humidity spots. To eliminate the rising damp it is necessary to control the localize water sources. Figure 30 shows the current works from the outside wall. A geotextile is being place between the soil and the masonry and then the space between pillars is being covered by a porous fill. The pipes and gutters have already been renovated.

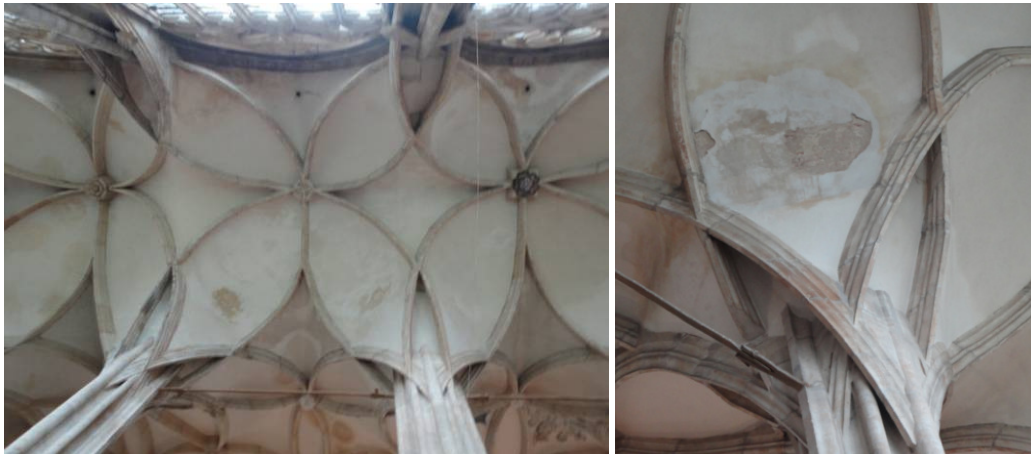
The jumping vault of the principal nave has a design composed by a combination of six pointed ribs in the central part and four pointed ribs in the vaults corresponding to the tribunes. On the vaults it can be seen humidity spots and detachment of the surface covers. [Figure 36] These decays were originated due to the bad state of the roof. After the restoration of the roof the water filtration was stopped. However the vaults were not restored yet.

Figure 36 Decay of the vaults

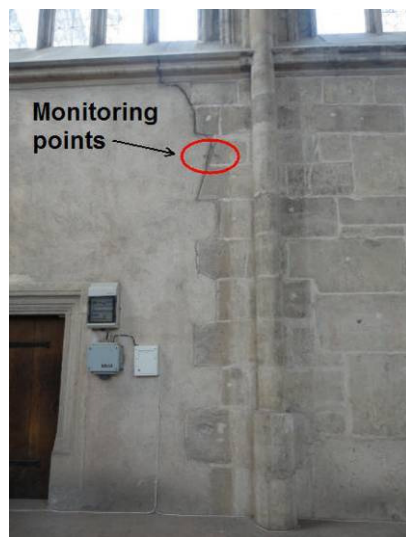
In the visit of the tribunes, it can we notice that the windows from this level have transparent glasses. On the south side of the tribunes, a crack is present in correspondence with the construction joint between the gothic construction and the part that was added in the intervention of the 19th century. In order to monitor the crack, some fixed points are defined. Measurements are taken at least once a month. [Figure 39] In correspondence with this crack there are two smaller cracks on the north side.

Figure 39 Location of crack

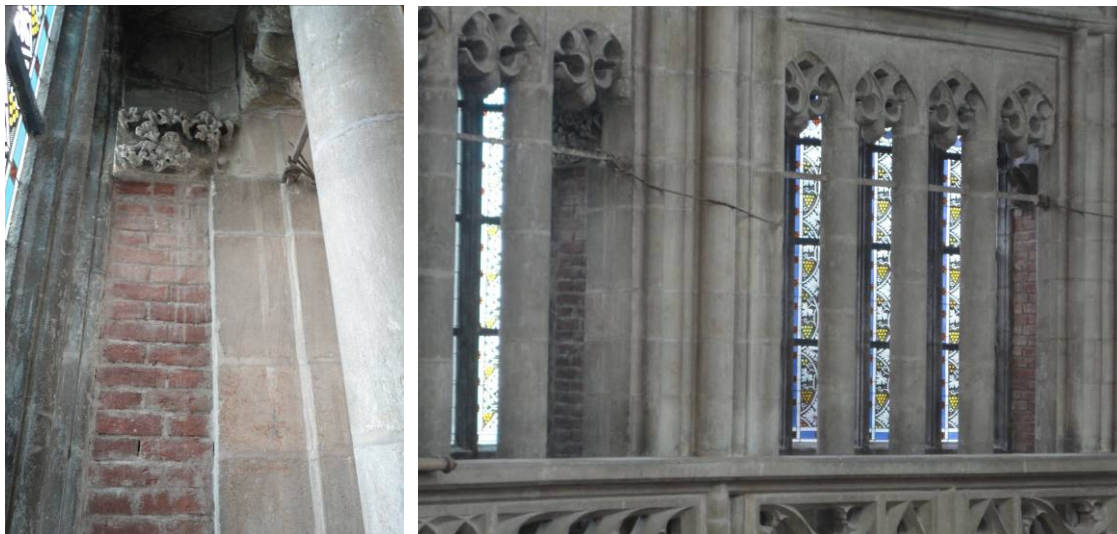
From the tribunes some parts of the triforium and the exterior passages that surround the roof of the chapels were accessed. Nowadays only four passages of the triforium are reachable because in 1884 some of them were walled up in order to increase the security of the pillars and its stability. [Figure 40]

Figure 40 Walls in the passages of the triforium

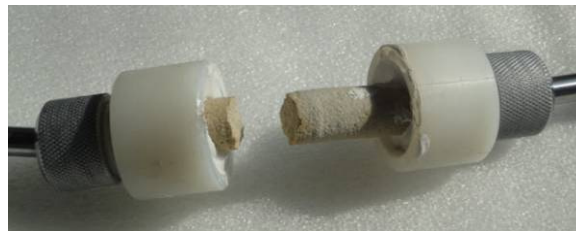
Figure 49 Fracture plane of Specimen N°3
