## Mechanical Properties of Abandoned and Closed Roadways in the Kushiro Coal Mine, Japan

*The objective of this research is to clarify the mechanical properties and self-healing ability of Excavation Damaged Zone (EDZ) around rock caverns in clastic rock. Observations of nearly 100 closed roadways up to 50 years old, which can be regarded as very severe EDZs with no initial sealability and are up to 300 m deep in clastic rock, were made at Kushiro Coal Mine, Japan, to accomplish the objective. Most old roadways were closed, though a few remain open. Closure of old roadways was mainly due to roof deflection and/or floor heave. Large plastic deformations dominated; however, severe fractures were seldom observed in closed old roadways. Rayleigh wave velocity and hydraulic conductivity in the closed old roadways were in the range of 0.3 km/s to 1.2 km/s and  $5 \times 10^{-7}$  m/s to  $1 \times 10^{-7}$  m/s, respectively, and*

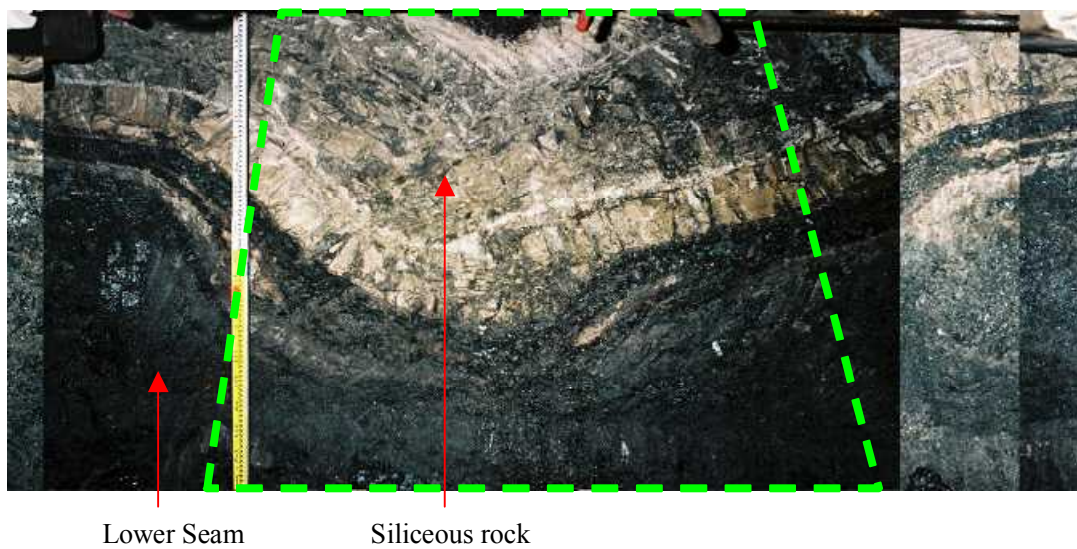
Old roadways in this mining panel were level roadways with a square or trapezoid cross section and were supported by 3-part wooden frame. They were excavated by continuous miners, used for approximately three years, and sealed when abandoned. Then the roadway was back filled by the mound method. The main seam was excavated in 2003 (Table 2). Most old roadways were completely closed by significant roof deflections (Figs. 4 and 5). Siliceous rock and clay exhibited large plastic deformations and filled the

Fig. 4 Old roadway observed in Jobu Hidari Lower Seam No. 1 SD. Roadway which is denoted by the broken line is closed by the deflected and sagged roof. Heights of all photos of old roadways in Figs. 4 to 14 are approx. 2.5 m.

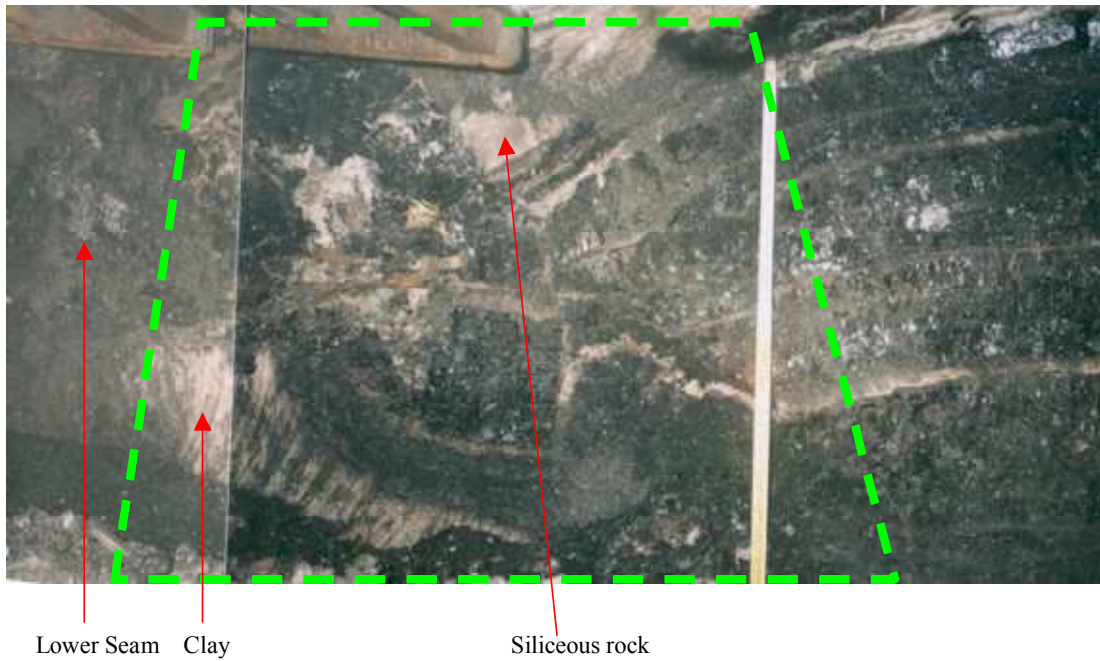
Fig. 5     Old roadway observed in Jobu Hidari Lower Seam No. 1 SD. Right part of the roof kept deflected shape. Left part was crushed by compression.

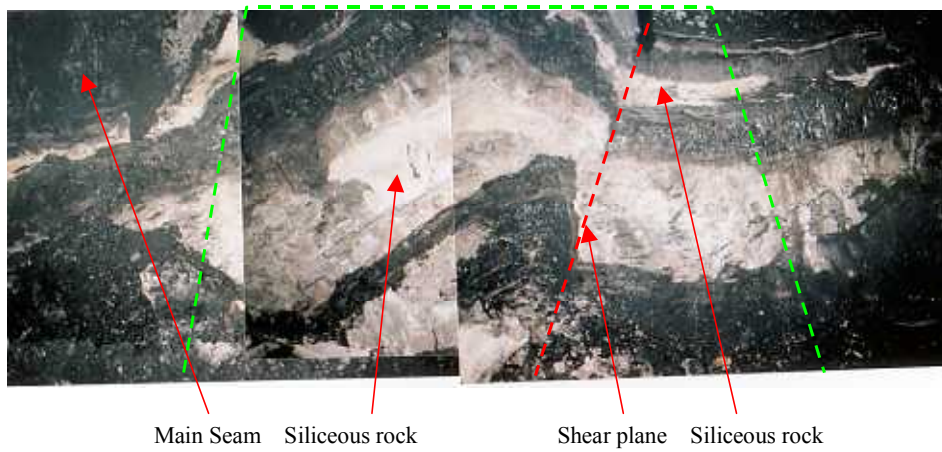
Old roadways in this mining panel were another level roadway. Sections, support, excavation methods and filling conditions were the same as stated above. The Main seam was excavated in 2002 (Table 2). Most old roadways were completely closed. Some were closed by significant floor heaving (Fig. 6), and some were closed by fragments of the roof and the filling-material mixture of fine coal powder produced during coal processing (Fig. 7).

Fig. 6     Old roadway observed in Jobu Hidari No. 6 SD. The deflected floor was sheared. Variation in width of siliceous rock can be seen.

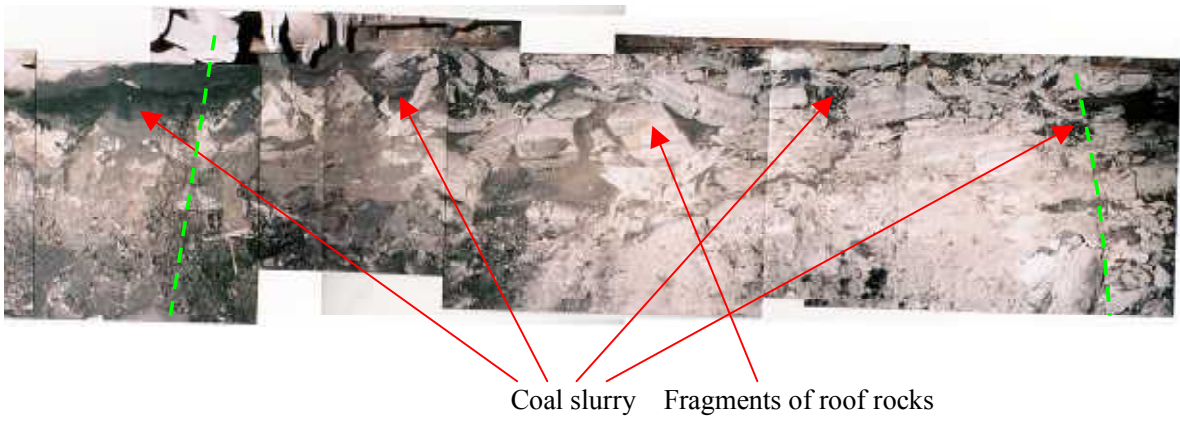
Fig. 7 Old roadway observed in Jobu Hidari No. 6 SD. Fragments of roof rock distributed in coal slurry (gray part seen around the top of the old roadway), the mixture of water and fine coal powder produced in coal processing.

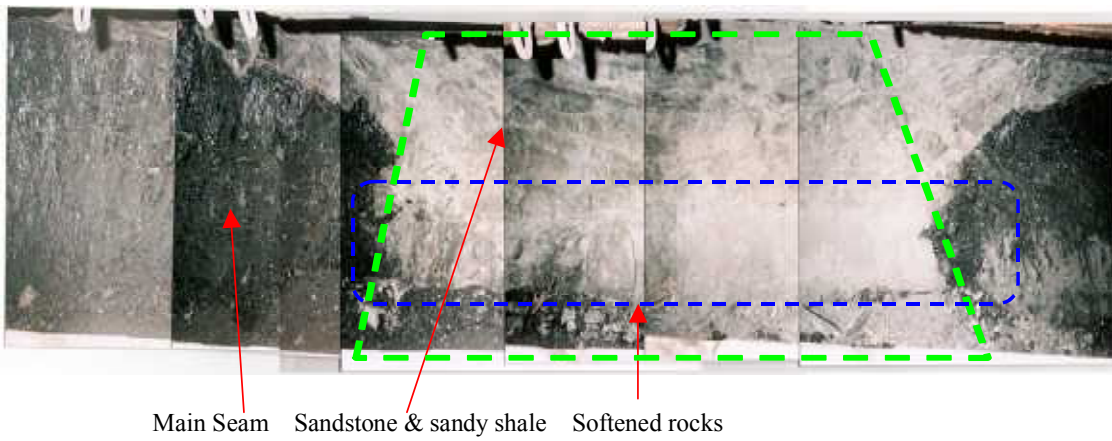
Old roadways in this mining panel were roadways made by the room method (Section 2). Sections, supports and mining equipment were substantially the same as those above. The roadways were sealed several months after mining and abandoned. The roadway was filled by the drilling method. Most old roadways were completely closed by significant roof deflections and softened roof rocks (Figs. 8 and 9) or by significant floor heaving (Fig. 10).

Fig. 8 Old roadway observed in Jobu Hidari No. 5 SD. Old roadway was closed by the deflected and sagged roof. Rocks below the deflected roof were softened.

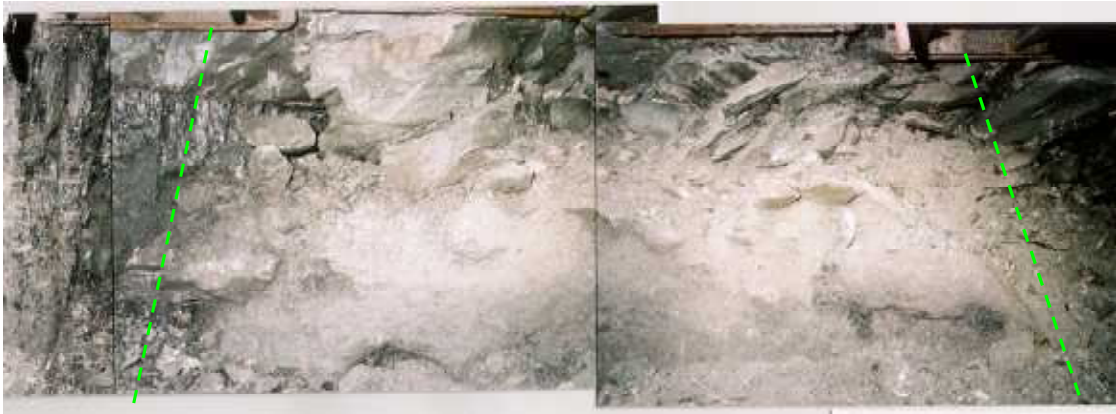
Fig. 9 Old roadway observed in Jobu Hidari No. 5 SD. Old roadway was closed by the deflected and sagged roof. Rocks below the deflected roof were softened.

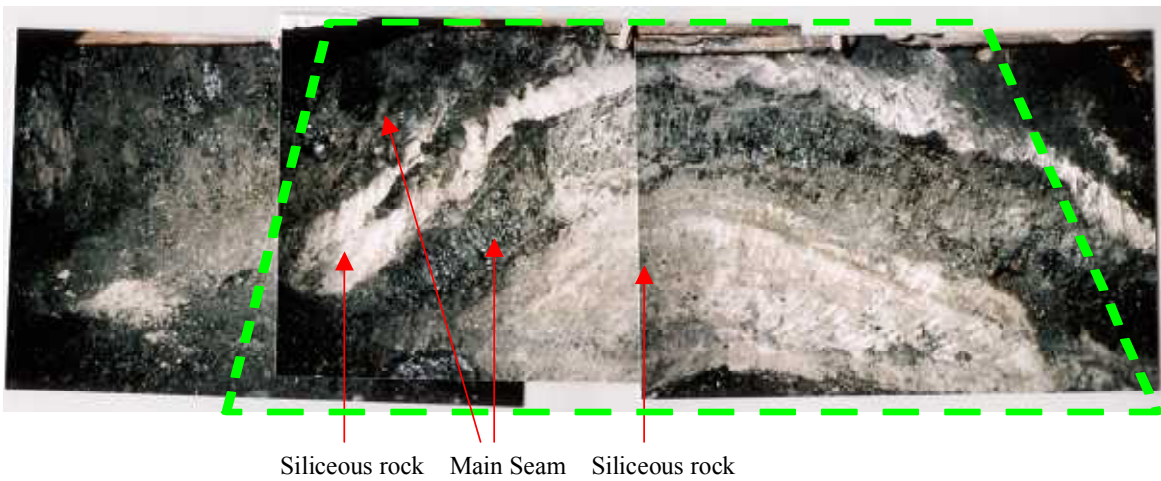
Fig. 10 Old roadway observed in Jobu Hidari No. 5 SD. Roadway was closed by deflected and heaved floor.

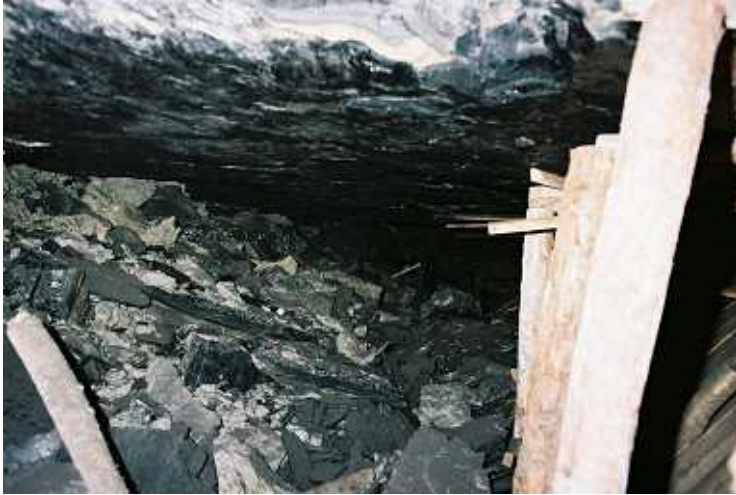
Old roadways in this mining panel were roadways of the room method. Sections, supports, mining equipment and filling methods were substantially the same as those above. Some completely open old roadways were still observed (Fig. 11). Piles of thin slabs of roof shale were observed.

Fig. 11 Old roadway observed in Jobu Chuo No. 0 SD tailgate. Fallen rock slabs piled up on the heaved floor.

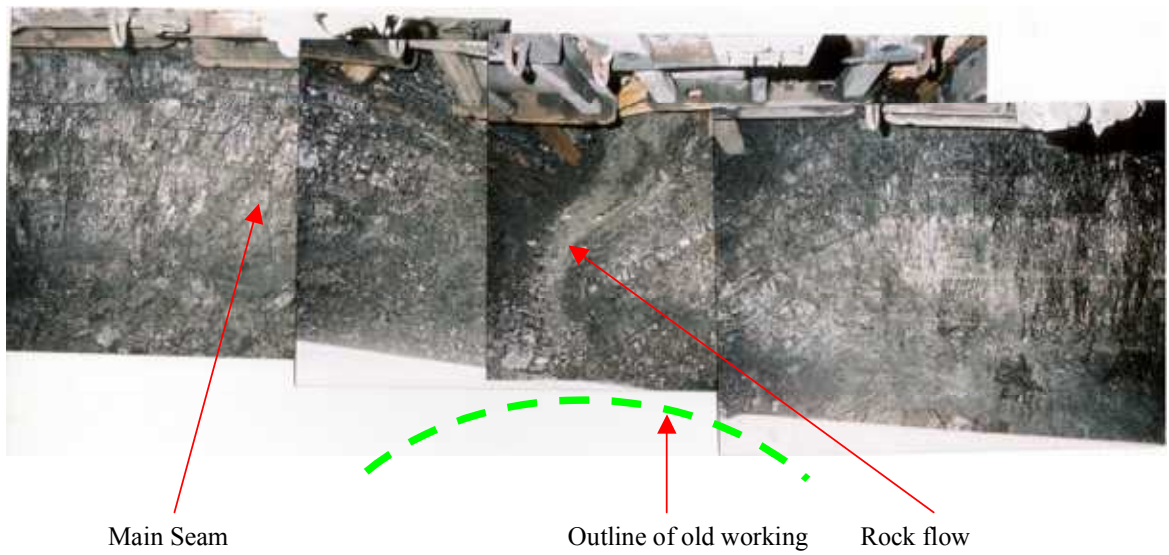
When the old roadway was below the face, significant roof deformations were observed (Fig. 12). Shear fractures in the sidewalls were also observed when the roadways were almost in the working coal seam (Fig. 13). Significant floor deformations were observed for old roadways located above the working coal seam, even though the distance between the coal seam and the roadway was 6 m (Fig. 14).

Fig. 12      Roof just above an old roadway observed in Jobu Chuo No. 1 SD. Crushed roof rocks flowed into the gape of the deflected coal seam.

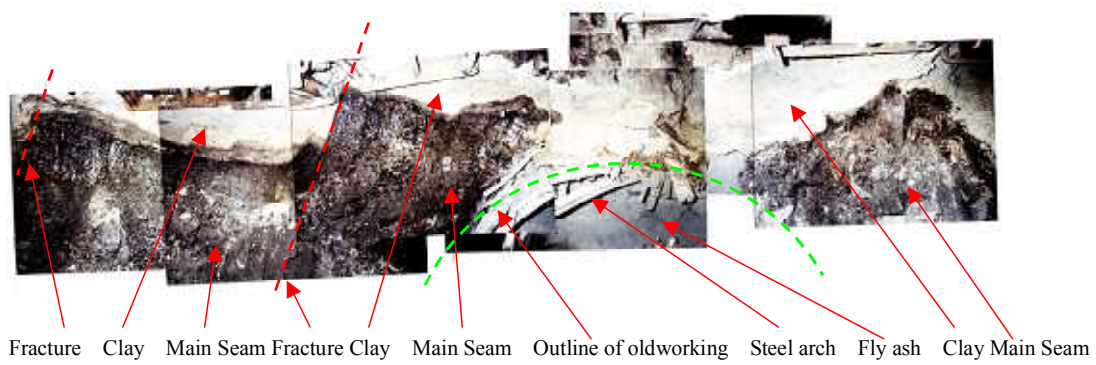
Fig. 13      Old roadway observed in Jobu Chuo No. 1 SD. Shear fractures and variation of clay thickness can be seen.

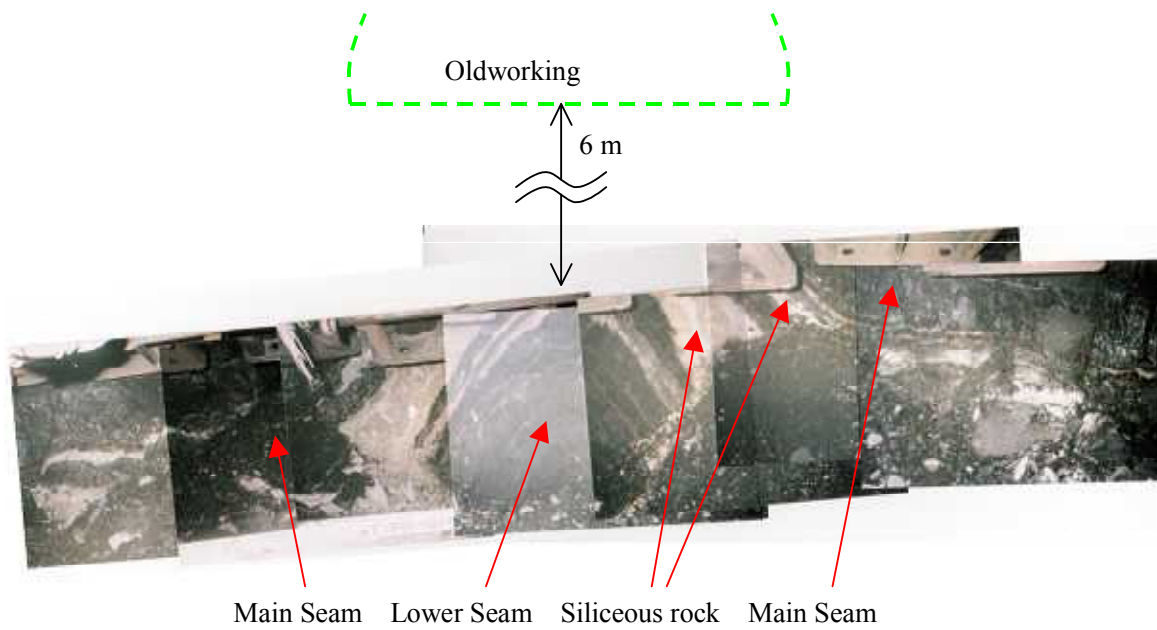
Fig. 14 Observation at 6 m below the old roadway in Jobu Chuo No. 1 SD. Severe floor heave can be seen.

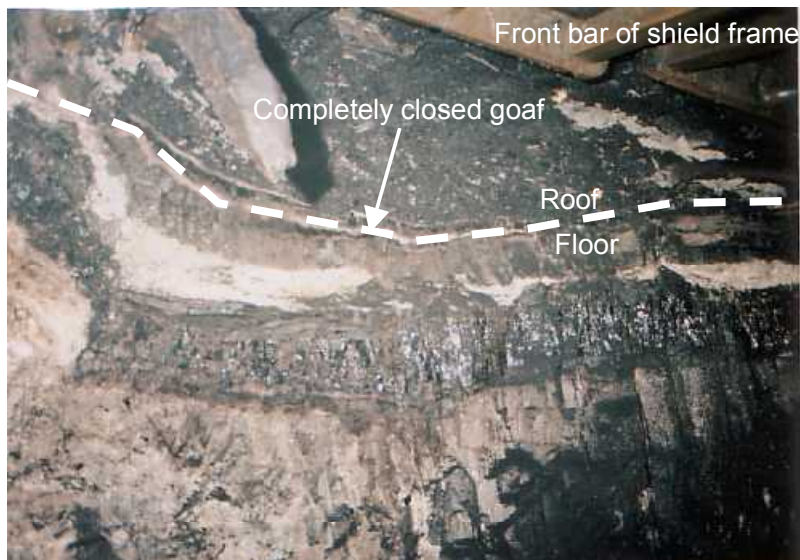
The Lower seam was first mined at Jobu Hidari No. 6 SD; the face moved to the Main seam because the Main seam near the starting point had already been mined 52 years ago. The 52-year-old longwall goaf in the Main seam was observed when the face switched from the Lower seam to the Main seam. The longwall goaf was completely closed, and there was no aperture between the sandy shale seam and the thin sandy shale seam that formed the immediate roof and the floor of the Main seam, respectively (Fig. 15).

Fig. 15 A goaf of the Main seam mined in 1954, appeared at the working face of Jobu Hidari No.6 SD. The white broken line indicates the boundary between the roof and the floor of the excavated Main seam.

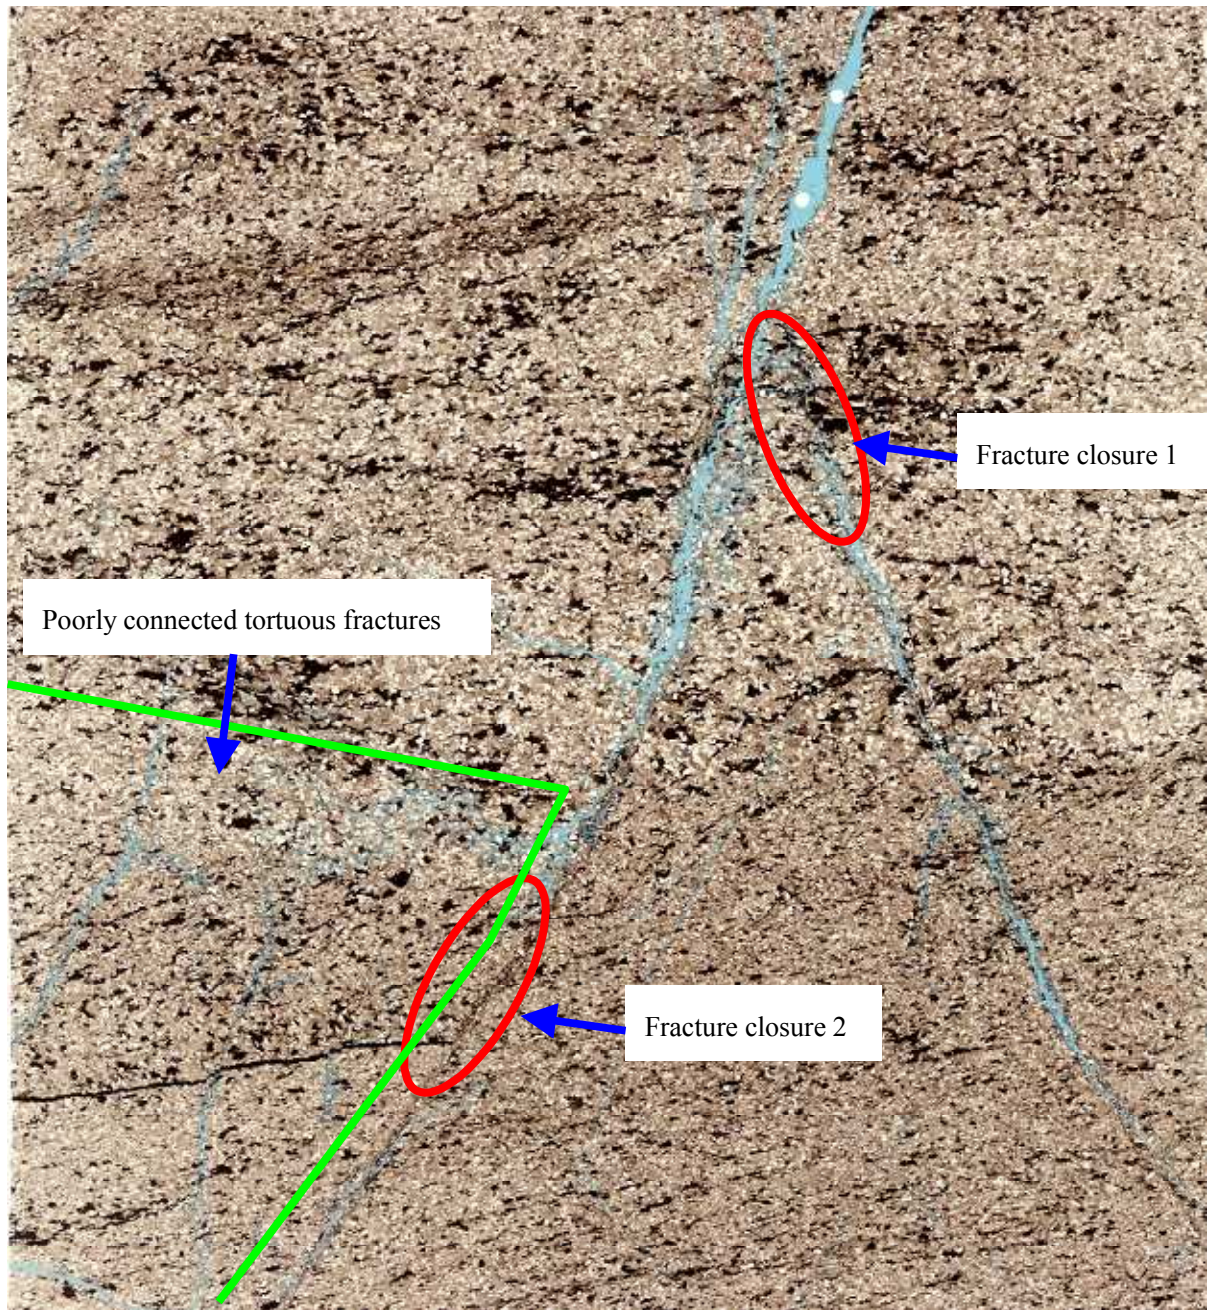
The specimen was immersed into blue resin, and a thin section was made after the resin hardened. Fracture closures and poorly connected tortuous fractures were observed in the thin section (Fig. 20). These were likely the causes of the decrease in hydraulic conductivity with time in the residual state. The mechanism of the fracture closure should be considered further. The authors, however, think that the fracture closure occurred mainly by crushing of the mineral particles and visco-elastic deformation around the rupture plane and not by the pressure solution because the duration and temperature were much shorter and lower than those deep underground where the pressure solution dominates.

Fig. 20 Micrograph of the thin section prepared from the rock specimen used for the triaxial test shown in Fig. 19. The photo corresponds to the thin section of 23 mm wide. Vertical direction of the photo coincides with the loading axis. Test piece was impregnated with blue resin before preparation of the thin section.
