PV cell and module degradation, detection and diagnostics

Eleni Kaplani

RES Lab, Mechanical Engineering Dept., Technological Educational Institute of Western Greece,
Meg. Alexandrou 1, Patra-26334, Greece
ekaplani@teiwest.gr

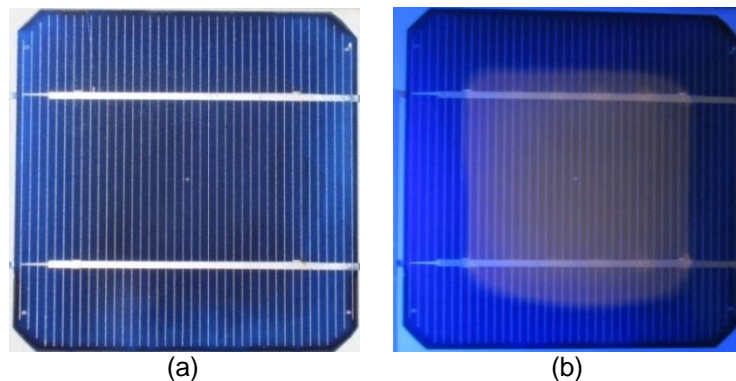
Fig.1(a) digital image of PV cell with mild EVA browning, (b) the same cell illuminated with UV light. The module operates outdoors in the RES Lab for 20 years.

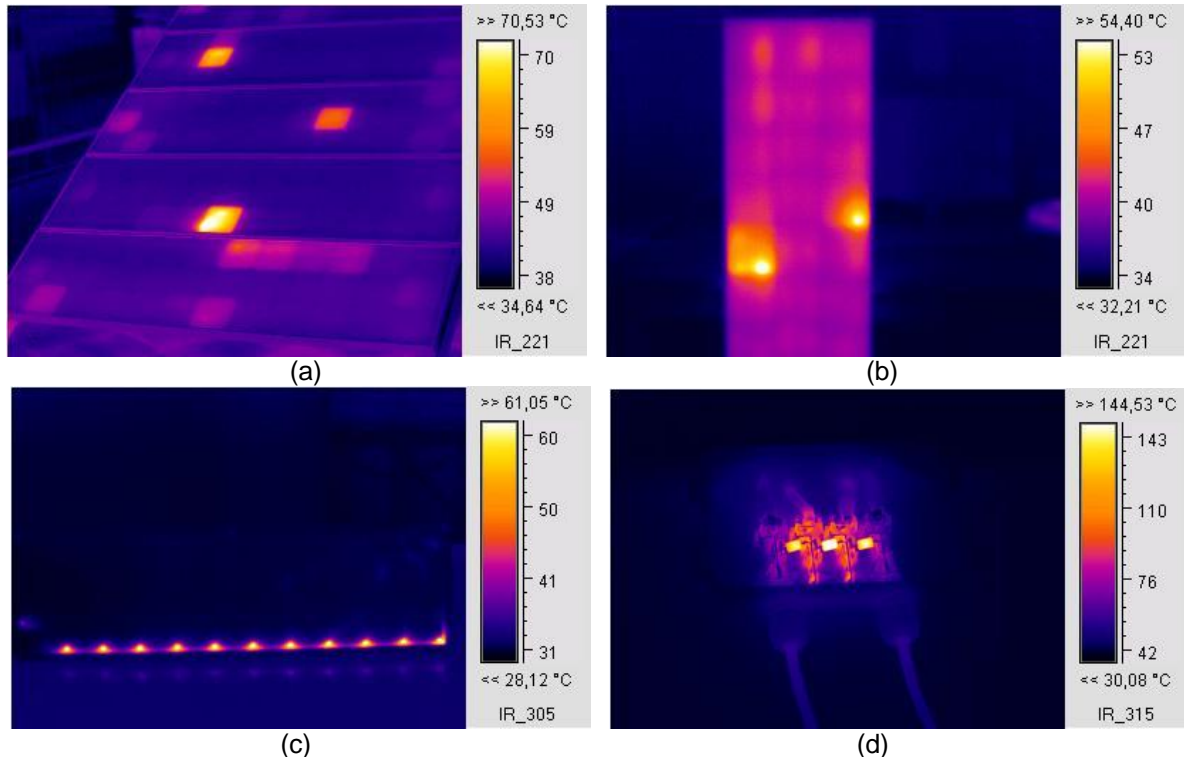
Infrared (IR) thermography is a powerful tool for the location of defected cells or cell areas that exhibit higher or lower localised temperature than the remaining part of the module or cell respectively. Fig.2(a) shows the IR image of several modules of a PV generator operating in field conditions for 20 years. The IR image is captured by means of an IR camera with spectral range 7.5 to 14 μm . Hot cells operating in temperatures of 20° to 30°C higher than the average temperature of the remaining part of the module are visible. Such large temperature differences signify defected cells. IR thermography may also be taken in the dark with the module forward-biased using a DC power supply. Fig.2(b) shows a sc-Si PV module with 20 year outdoor operation tested in the lab. The IR image reveals two cells having a hot spot at the busbar. By reverse-biasing the module in the dark it is possible to check diode functionality. Fig.2(c) shows the IR image of a flexible a-Si PV module with bypass diodes connected across each of the 11 cells, and Fig.2(d) shows the junction box of a pc-Si PV module reverse-biased showing the operation of the three diodes.

Fig.2. Infrared thermography of (a) a sc-Si PV generator operating at load in the RES Lab for 20 years, (2) a sc-Si PV module forward-biased in the dark within the lab, (c) a flexible a-Si PV module reverse-biased in the lab, (d) the junction box of a pc-Si PV module reverse-biased in the lab.

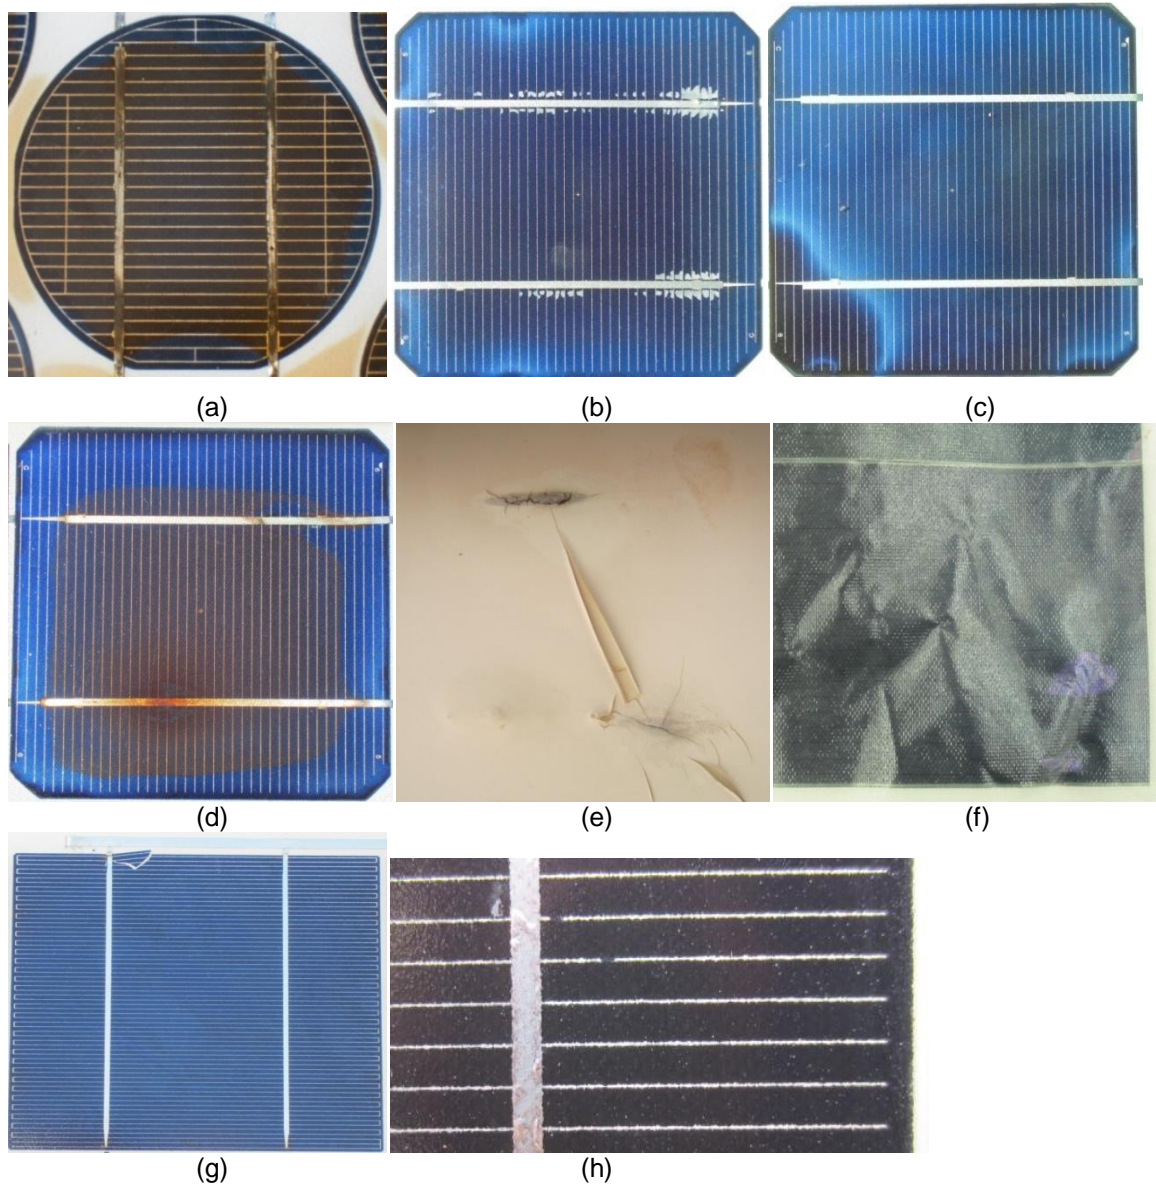
Degradation phenomena observed in the PV modules operating outdoors for several years in the RES Lab include discoloration of the EVA with different patterns and yellowness index (Fig.3(a),(b),(c),(d)), degradation of the AR coating with different degree of severity (Fig.3(b),(c),(d)), degradation of the cell-encapsulant interface between the gridlines in the proximity of the busbars (Fig.3(b)) and in a flexible a-Si PV module in the form of delamination (Fig.3(f)). Furthermore, corrosion and burn marks were observed mainly on the busbars and cell interconnections, usually also visible at the back side of the module together with bubbles, cracks, and tears of the Tedlar (Fig.3(d),(e)). Finally, broken cells, micro-cracks and interrupted gridlines (Fig.3(g),(h)) were also observed.

Fig.3. Degradation phenomena observed in PV modules operating outdoors in the RES Lab, (a) EVA browning, (b) deterioration of the cell-encapsulant interface and other effects, (c) degradation of the AR coating and other effects, (d) corrosion, burn mark, EVA browning and other effects, (e) corrosion, burn marks, tear and bubble at the back of the module, (f) delamination in a flexible a-Si module, (g) broken cell, (h) broken gridlines.

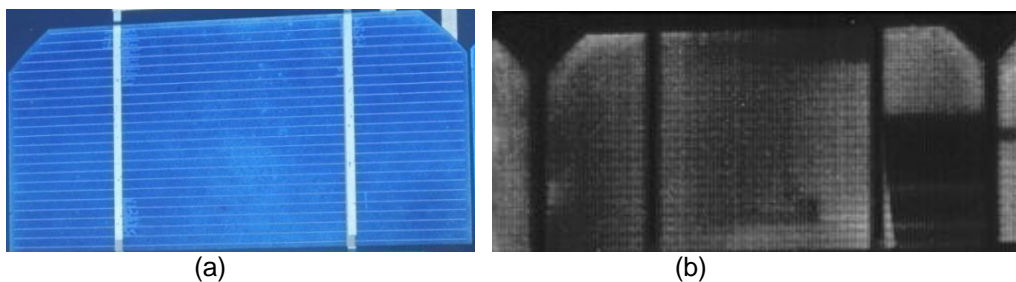
The visual inspection of a new sc-Si PV module that has operated outdoors only for several hundred hours and has experienced initial rapid light-induced degradation, has revealed slight deterioration of the cell-encapsulant interface at the proximity of the busbar (Fig.4(a)). Electroluminescence with the module forward-biased at near V_{oc} , revealed a crack in one cell with a large region appearing dark in the EL image (Fig.4(b)). The EL image of part of the module reveals several grid finger interruptions and a rather inhomogeneous EL emission in some cells (Fig.5(a)). The IR thermography revealed some cells exhibiting about 10°C higher temperature than the average temperature of the module,

Fig.4. A new sc-Si PV module with only several hundred hours of outdoor operation in the RES Lab. (a) digital image of a cell exhibiting slight deterioration in the cell-encapsulant interface, (b) EL image of the same cell revealing a crack.

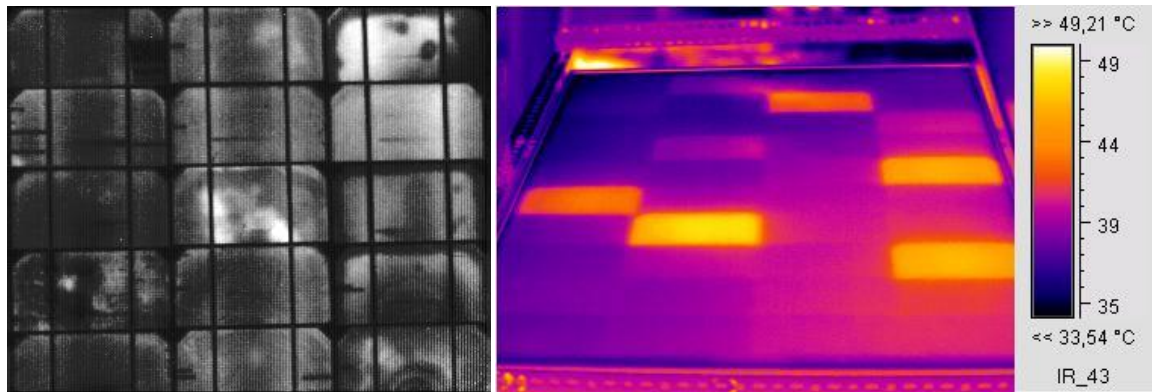
while some correlations between the IR image and EL image were observed (Fig.5(b)). I-V curve analysis and translation to Standard Test Conditions (STC), gave a 3.7% reduction in power output.

Fig.5. Image from part of a new sc-Si PV module with only several hundred hours of outdoor operation in the RES Lab, (a) EL image (b) IR image.

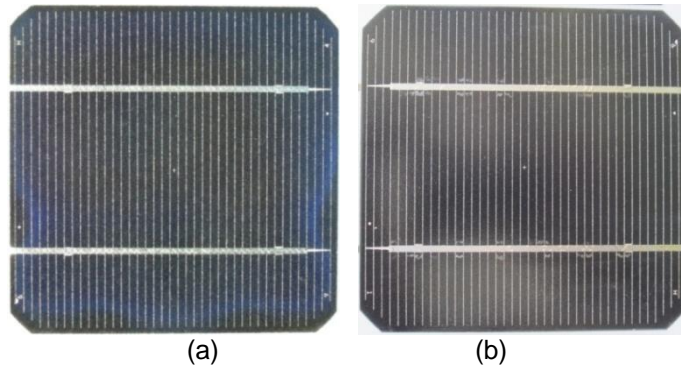
A sc-Si PV module operating outdoors for 15 years exhibits mild signs of AR deterioration and degradation in the cell-encapsulant interface at the proximity of the busbars, see Fig.6. IR thermography shows a rather uniform temperature distribution of the module with only one cell exhibiting higher temperature by about 10°C from the average temperature of the module, Fig.7(a). EL imaging further reveals cells with several interrupted grid lines, Fig.7(b).

Fig.6. sc-Si PV module operating outdoors in the RES Lab for 15 years exhibiting mild signs of degradation of the (a) AR coating, (b) the cell-encapsulant interface.

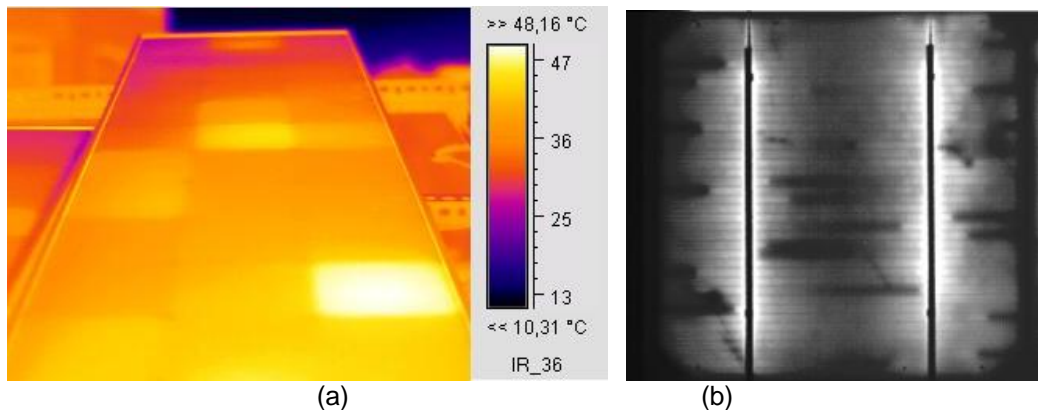
Fig.7. sc-Si PV module operating outdoors in the RES Lab for 15 years exhibiting mild signs of degradation (a) IR image (b) EL image of one of the cells

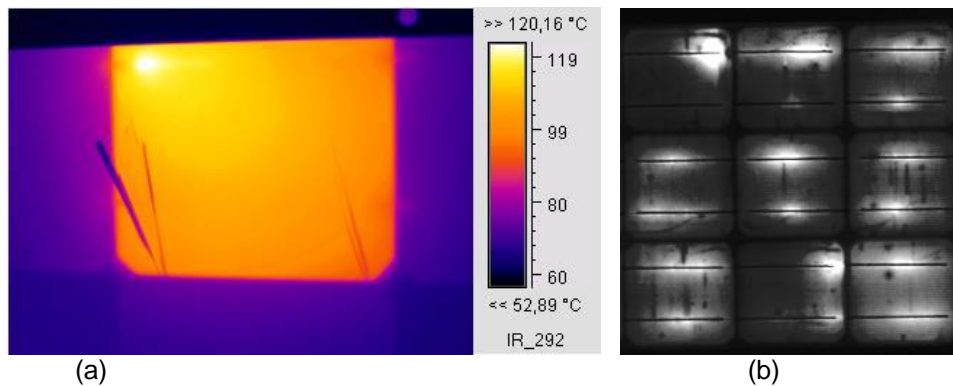
[9]. As an example, the IR image of one of these modules reveals a hot cell with a hot spot on the busbar exhibiting a temperature difference greater than 40°C from the average temperature of the module, Fig.8(a). The cell and spot temperature exceeds 100°C, which is detrimental for the operational life of the cell and module. The EL image of part of this module (Fig.8(b)) reveals inhomogeneous EL emission, several interrupted gridlines, shunts and microcracks.

Fig.8. sc-Si PV module operating outdoors for 20 years, (a) IR image at the back side of the module at the hot cell, (b) EL image of part of the module.

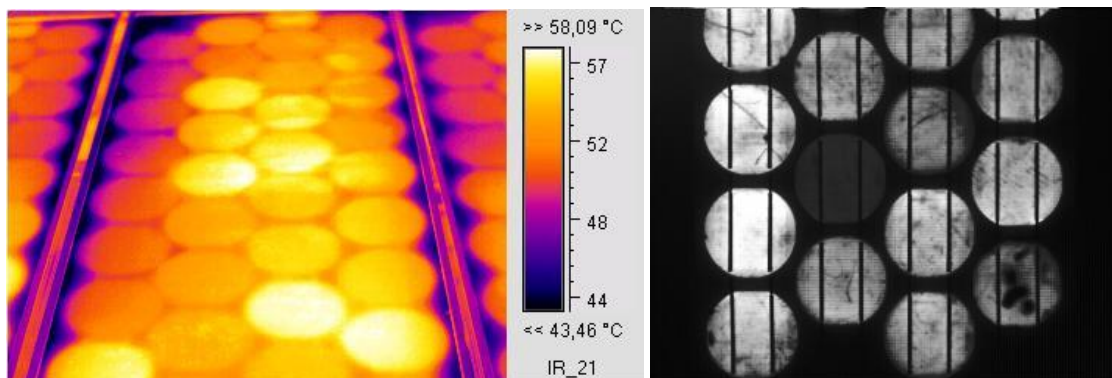
Other sc-Si PV modules operating outdoors in the RES Lab for 24 and 25 years, and have aged naturally, exhibit a rather uniform temperature distribution (Fig.9(a)). Further investigation through electroluminescence reveals the existence of cracks in several cells, some of which isolate a part of the cell, inactive areas and inhomogeneous EL emission, Fig.9(b),10.

Fig.9. sc-Si PV module operating outdoors in the RES Lab for 25 years -naturally aged, (a) IR image, (b) EL image.

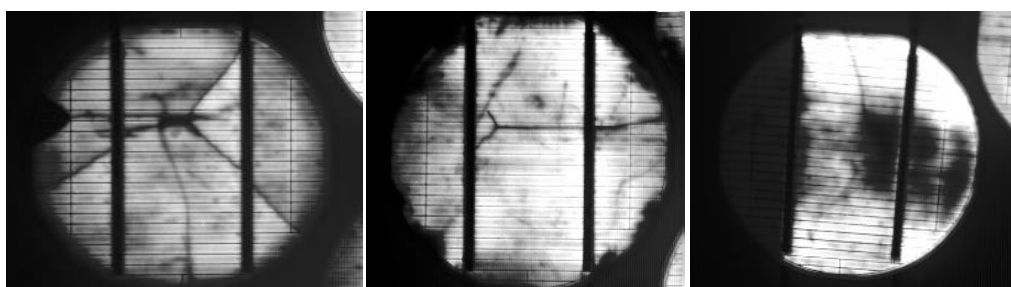
Fig.10. EL image of cells from the module in Fig.9 exhibiting cracks

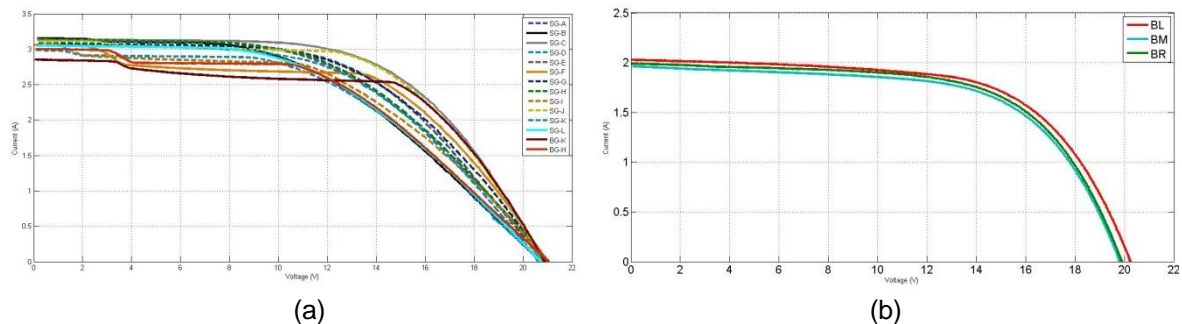
An estimate of the degradation of the 20 and 25 year old PV modules experiencing induced and natural ageing respectively is carried out through I-V curve analysis. The STC normalised I-V curves of the modules that experienced induced shading effects in the past are displayed in Fig.11(a). Large deviations in the I-V curve characteristics are observed in this modules, some of which reveal the

existence of some optically degraded cells, while others reveal an increased series resistance due to corrosion, as regarded in the slope of the curve at open circuit voltage. The relative reduction in power output ranges between 25%-41%, in the short circuit current 6%-15%, in the open circuit voltage 3%-5% and in the fill factor 12%-34%. On the other hand, the naturally aged 24-25 year-old modules have non-deformed I-V curve characteristics, with relative reduction in the fill factor of only 4%-5%. The relative reduction in power output ranges between 20%-25%, which is mostly attributed to the short circuit current with a relative reduction of 13%-15%. This is only partly due to the optical losses caused by the severe EVA browning that affects all cells of the module (Fig.3(a)), but is also due to the several cracks and inactive areas in the cells revealed by the EL image. The reduction in the open circuit voltage is in the range of 5%-7%.

Fig.11. STC normalised I-V curves (a) 20 year-old modules with induced shading effects, (b) 24-25 year-old modules with natural ageing.
