Continuous debonding monitoring of a patch repaired helicopter stabilizer: Damage assessment and analysis

S. Pavlopoulou^{a,*}, S. Grammatikos^b, E. Z. Kordatos^c, K. Worden^d, A. Paipetis^e, T. Matikas^e, C. Soutis^a

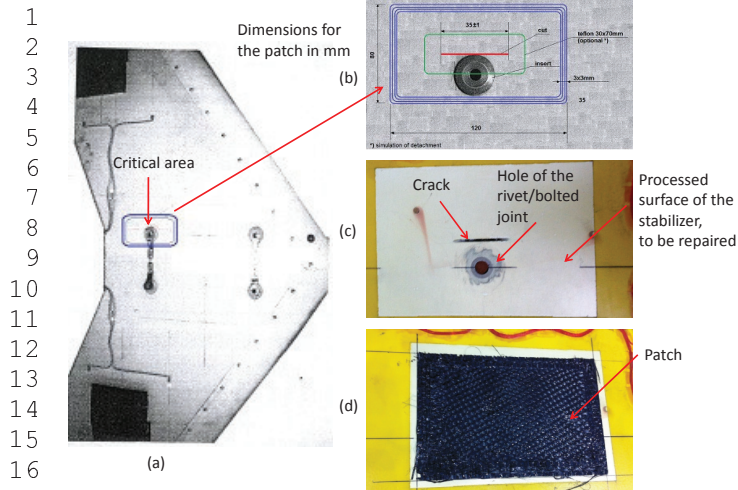
Figure 2: (a) Critical area and proposed location (blue line) for the attachment of the repair patch (b) schematic illustration of the repaired region (c) image of the processed surface of the stabilizer around the crack and the hole before the attachment of the patch (d) final implementation of the patch.¹

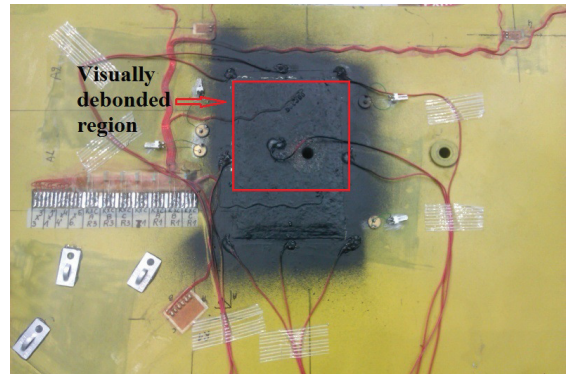
Figure 8: Final debonding after 580,000 cycles of bending fatigue testing.

After 580k fatigue cycles, at the end of the test, a clear debonding could be visually observed as illustrated in Figure

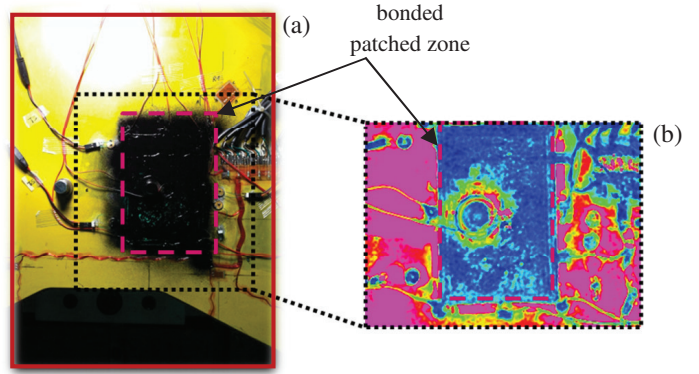
Figure 16: (a) Monitored area, (b) representative thermographic image.¹

Starting with the first lock-in amplitude image in 16b, the applied bonded patch is clearly identified. As may be observed next to the bonded patch, the piezoelectric sensors for Lamb wave monitoring may be discerned. The rivet/bolted joint thermal imprint is also clearly visible. Moreover, a relatively small high amplitude or stress concentration area around the rivet was acquired. The rest of the patched area does not exhibit any significant variations, suggesting a uniform temperature and stress distribution all over the bonded zone. At this stage, the arti-

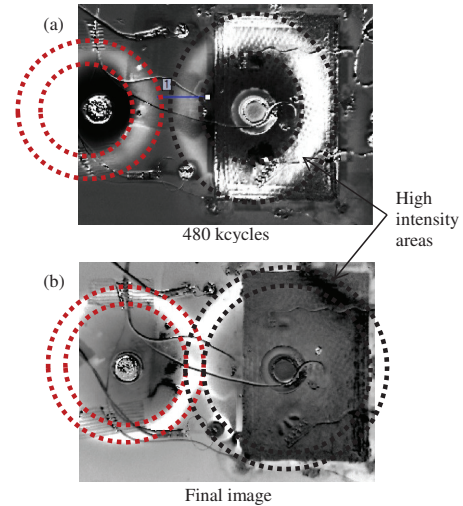
Figures 18a and 18b depict a comparative evaluation between a lock-in image at 480kcycles and the one acquired at the final stage. The stress concentrations around the bolted joints of Figure 18a form patterns possessing a radial symmetry. These circular patterns indicate high amplitude areas/stress concentrations both in the unrepaired and the repaired rivet sites. Mechanically-induced stresses around the patched joint can be distinguished, due to the fact that the patch remains bonded on the substrate. However, this is not the case in the final recorded

Figure 18: Lock-in phase images at (a) 480kcycles and (b) 561kcycles (final stage).

image (Figure 18b). After the almost complete separation of the patch, the suggested high amplitude /stress concentration areas were not detected on the patched zone. To further elucidate the above statements, circles showing the presence (or absence) of stress concentration areas around the bolted joints were drawn (Figures 18a and 18b). The centers of the drawn circles correspond to the position of the rivets (unpatched-left side and patched-right side).

Moreover, the juxtaposition of images in Figure 18 denotes that the diameters of the figurative high amplitude /stress concentration circles around the rivets have increased. This suggests that apart from the degradation of the patch /substrate interface, a second deterioration mechanism may be present; as the interrogated vertical stabilizer is a sandwich structure, it is highly probable that the local stress concentration also invoked the failure of the interface between the honeycomb and the aluminum skin. Ultrasonic imaging verified this hypothesis.

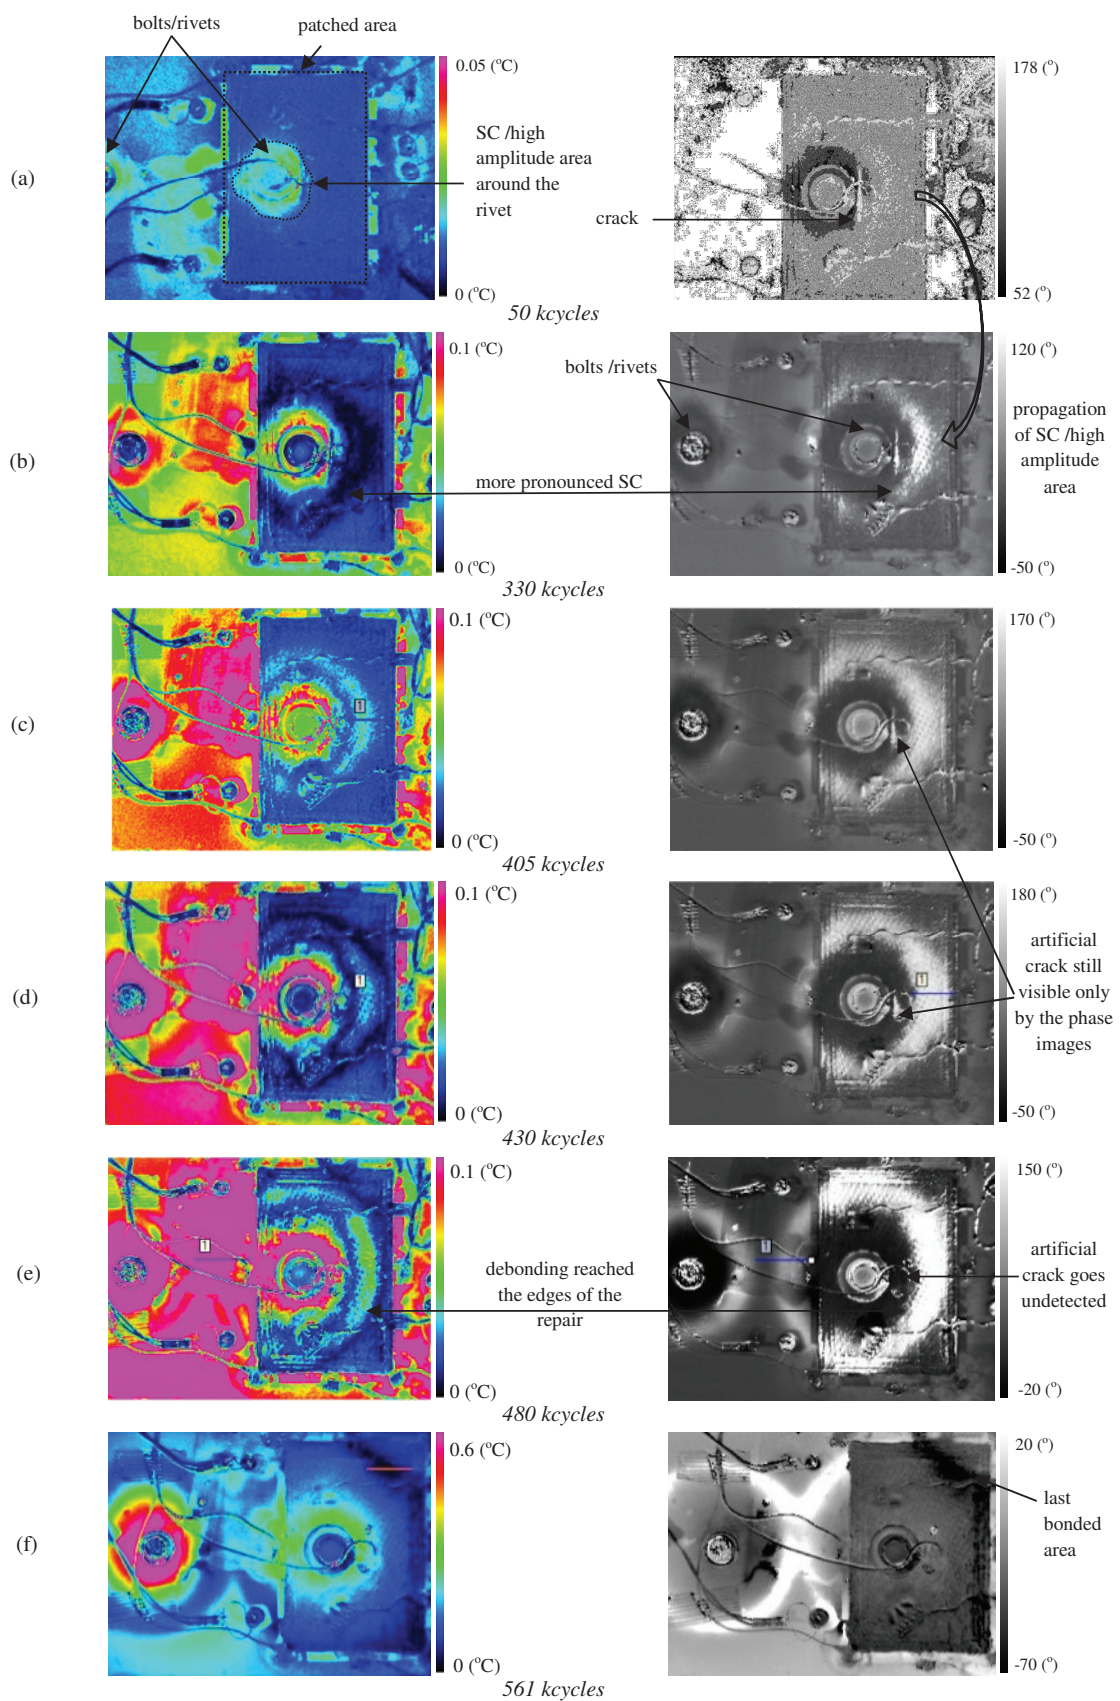
cially induced crack is not discernible, suggesting that the patch eliminates locally induced stress concentrations. At 50 kcycles, the phase and amplitude gradients become significant and in both lock-in (magnitude and phase) images (Figure 17a) the crack was visible. In the phase image, the full length of the crack can be seen. This is not the case for the amplitude image, probably because the surface topology inhibits the observation of internal defects. As the load level increased, stress concentrations around the rivet became more pronounced. The relative phase and amplitude gradients increased, suggesting a substantial increase of the stress concentration in the region surrounding the rivet. At 330 kcycles (Figure 17b) a dark region was detected in the amplitude image. The same region was clearly presented with bright color by the phase one. With the increase in load level and fatigue progression this behavior became more prominent with the enlargement of the dark region shown in the amplitude imprint as well as its gradual shifting towards the horizontal axis of the image (Figure 17c). At 430 kcycles (Figure 17d) the dark region on the amplitude image reached the right edge of the patch. This is verified by the phase image (430 kcycles), which shows an extended bright area which propagates to the tapered right edge of the patch.

This gradual radial propagation of stress concentration areas with the same profile was noted, as fatigue loading continued. At 480 kcycles (Figure 17e), the area with increased stress concentration caused by the bolted joint, reached the left (as indicated on the image) edge of the patch. The same behavior consistently continued up to the final loading step of the fatigue testing (Figure 17f) at 561 kcycles. At the acquired last lock-in images (Figure 17f), only a small dark region is presented on the right upper corner of the patch. This was considered as the last bonded area of the patch. For this reason, it was decided to stop the test process and verify this observation with c-scanning of the patched area. The verification with ultrasonic imaging would assure the effectiveness of the thermographic method on monitoring damage initiation and propagation during service.

A closer examination of the whole lock-in image sequence denotes that besides stress concentration around the patched rivet, circularly-shaped high intensity areas were recorded around the patch-free rivet. It is noteworthy, that as the last recorded lock-in images indicate, the mechanical stresses /high amplitude areas have diminished from the patched rivet. This observation suggests the following (and probably complementary effects): i) complete stress relaxation on the patched area and ii) complete failure of the patch /substrate interface. The latter inhibits the visibility of high amplitude areas /stress concentrations around bolted joint which are clearly identified around the un-patched rivet area (Figure 17f).

Figure 17: Amplitude (left-hand side) and phase (right-hand side) images.

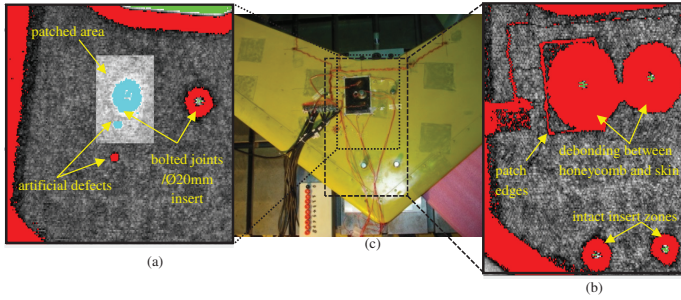
As is shown in Figure 19a where the C-scan of the repaired stabilizer prior to testing is shown, the rectangle-shaped CFRP patch can be seen upon the $\varnothing 20\text{mm}$ insert. The patched and unpatched cylindrical insert, where the rivets are fixed are well discerned and, in addition, two artificially induced flaws (simulating manufacturing defects) were also visible. On the contrary, in the post-testing C-scan imaging, the patch goes totally undetected. Only the edges of the patch can be seen, at the very same external areas where sealant tape was placed to prevent from water penetration after immersion in the C-scan tank.

Together with the edges of the patch, the debonded honeycomb /skin interface is well verified with ultrasonics. Fatigue mechanical testing led to the detachment of the internal core of the stabilizer from the aluminum skin, at the very same areas where the cylindrical inserts of the rivet /bolted joints are located. Figure 20 shows an overlapping of an optical, the final phase and the post-testing C-scan image. The areas around

Figure 19: Ultrasonic images of the stabilizer (a) prior and (b) post testing, (c) repaired wing stabilizer.¹

C-scanning inspection, prior to and after testing, verified this hypothesis. The post-failure ultrasonic image could not identify the patch, albeit it showed an extensive debonding between the skin and the underlying honeycomb core of the sandwich structure. The combined image where thermographic, ultrasonic and optical photographs are juxtaposed is also indicative of the honeycomb core/skin interlaminar failure, Figure 20. Finally, post-failure optical images show the disruption of the film in most patch edges, except for those around the small remaining bonded areas as was observed via the evaluation of the thermographic images, Figure 8.

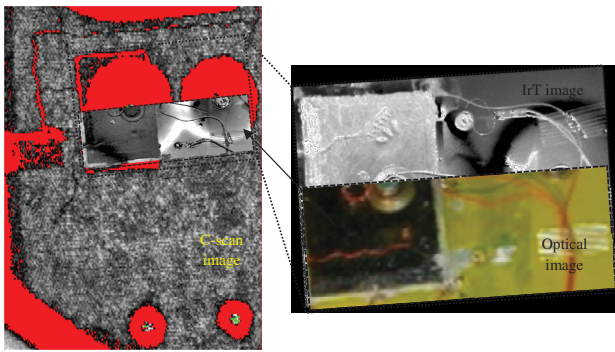
Figure 20: Overlapping of ultrasonic, optical and thermographic images.¹

the inserts /rivets which exhibited high amplitude areas/stress concentrations can be identified and correlated both via the ultrasonic and thermal imaging. It is also worth mentioning that the area in the vicinity of the other two bolted joints remained intact after the test procedure (discernible in the C-scan image and Figure 19b).
