Bevan, Adam and Klecha, Stephanie (2016) Use of Magnetic Flux Techniques to Detect Wheel Tread Damage. Proceedings of the ICE - Transport, 169 (5). pp. 330-338. ISSN 0965-092X

Use of Magnetic Flux Techniques to Detect Wheel Tread Damage

Dr Adam Bevan*, Institute of Railway Research, University of Huddersfield, UK

Stephanie Klecha, MRX Technologies, Derby, UK

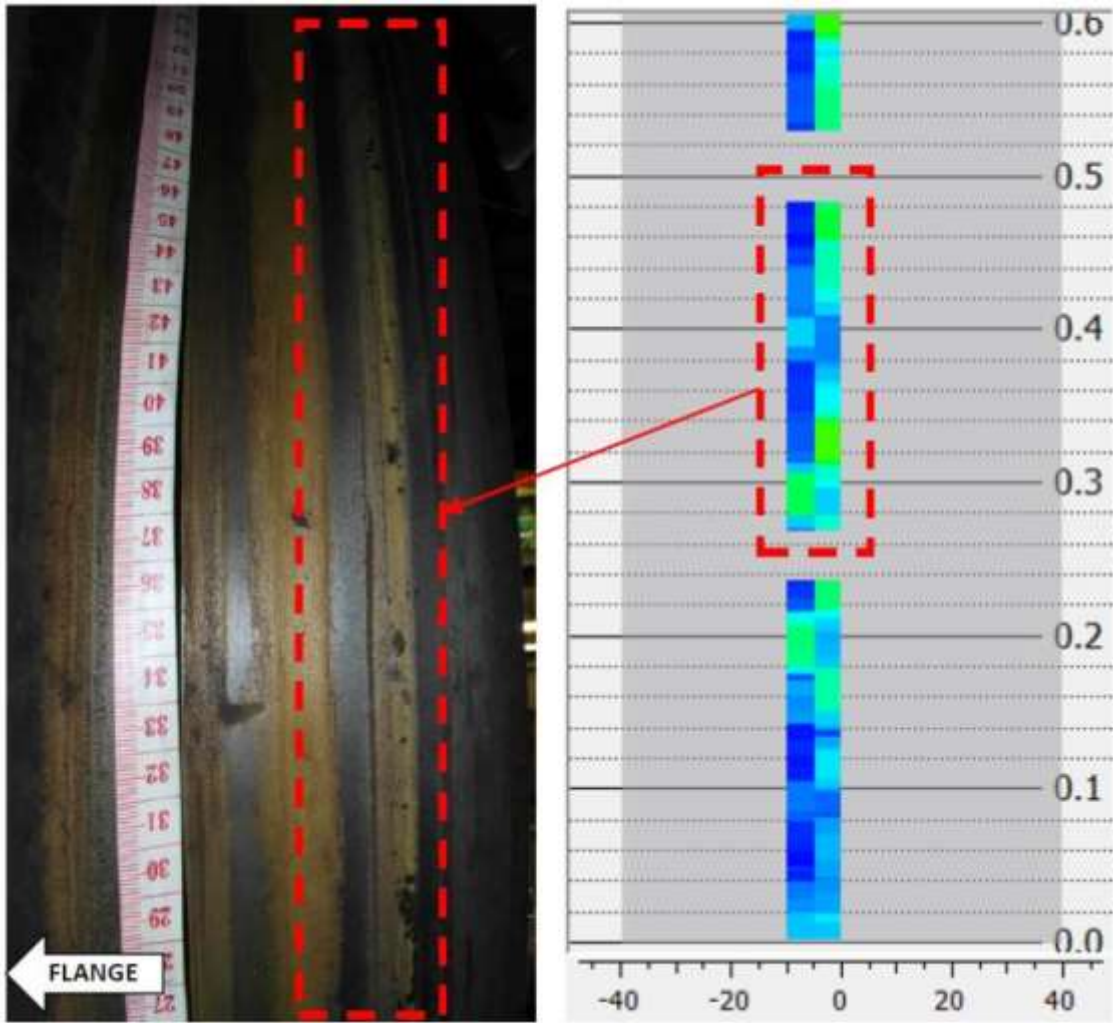
Figure 7 illustrates a scan of a wheel with mild to moderate field side RCF damage. In this case the cracking was difficult to identify visually on the surface of the un-cut wheel, but apparent in the HHU output and confirmed during turning on the wheel lathe. Figure 8 illustrates a scan of a wheel with severe field side RCF damage. In this case cavities have formed resulting in a 10 mm damage depth measurement.

Figure 7. Mild to moderate field side RCF

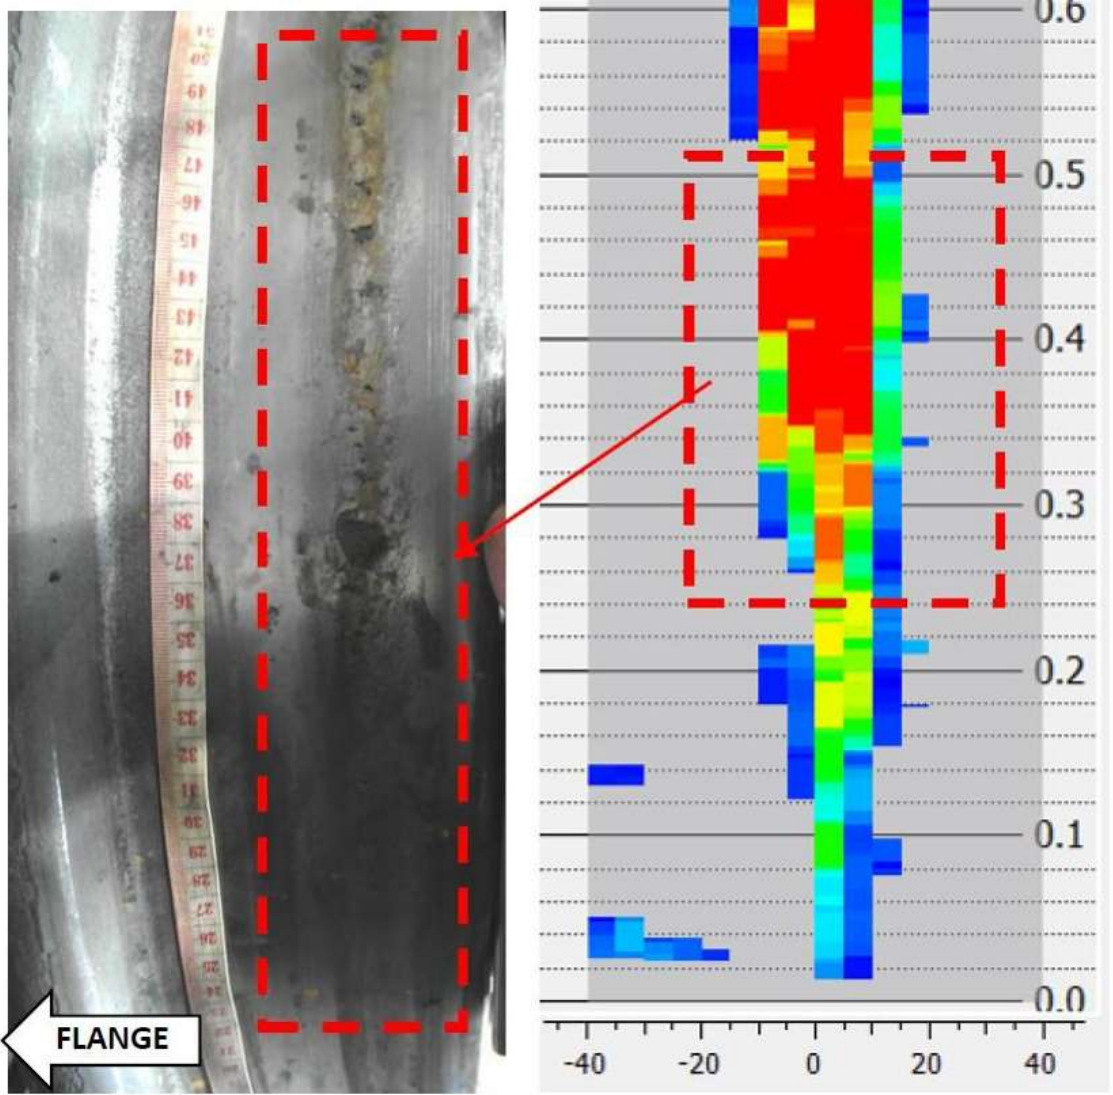
Figure 8. Severe field side RCF

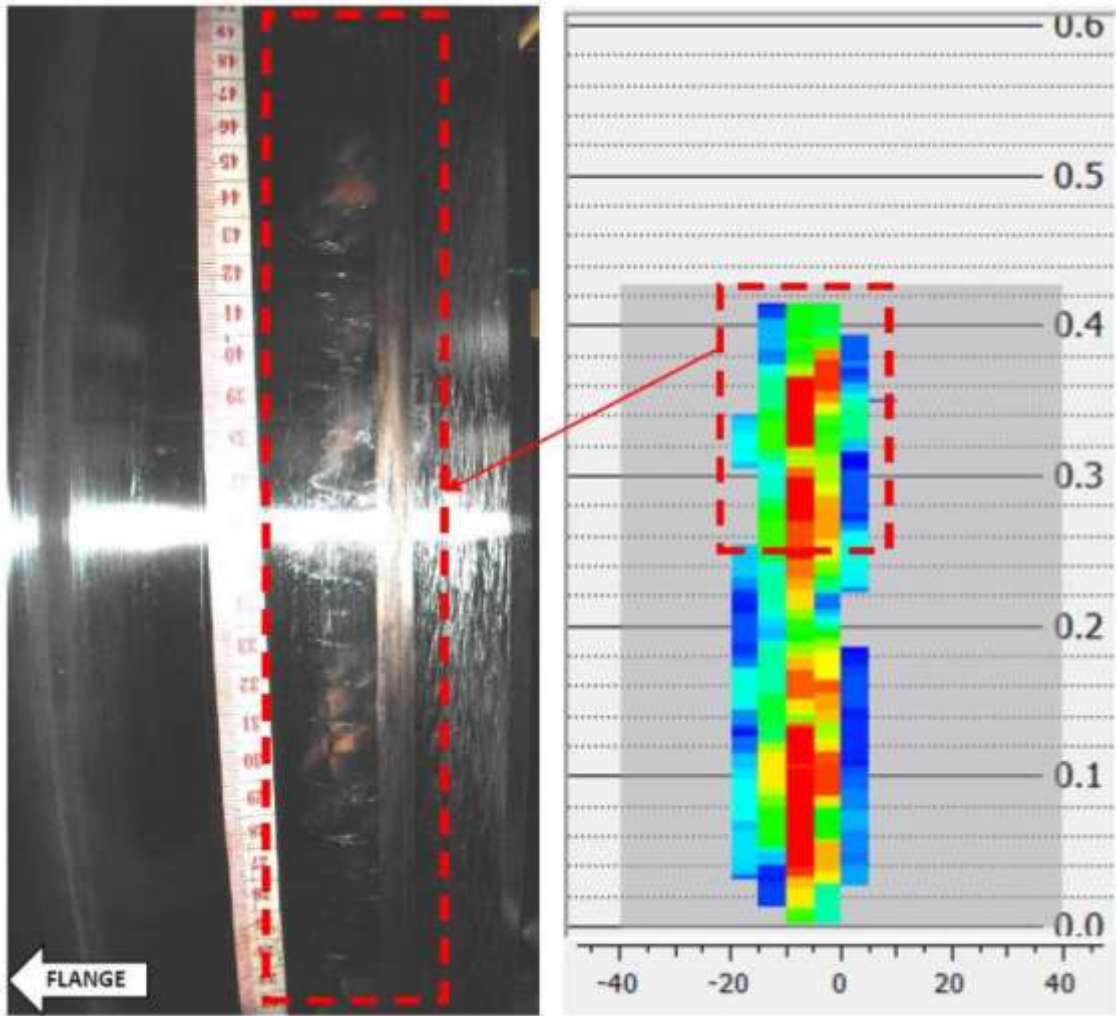
Figure 9 shows an example scan of a wheel with running band RCF following first cut on the wheel lathe. In this case the running band RCF was measured by the HHU, but only visible following the first cut on the wheel lathe.

Figure 9. Running band RCF

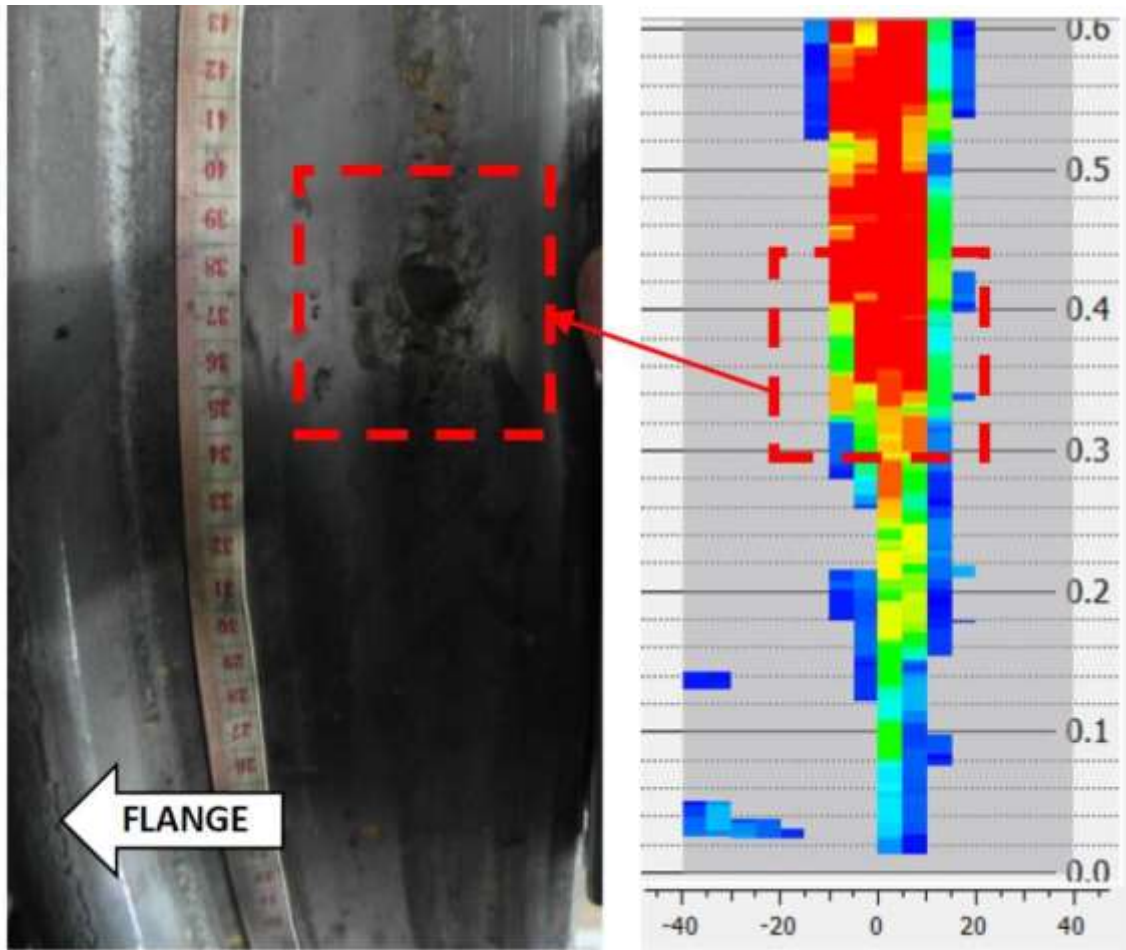
Figure 10 shows the surface appearance and HHU output for an RCF initiated cavity, whereas Figure 11 shows the surface appearance and HHU output for a thermal initiated cavity. In this case the damage measured by the HHU (with a maximum damage depth of 7.3 mm) was not visible in the un-cut wheel (Figure 11(a)) and only became apparent following the first cut on the wheel lathe (Figure 11(b)).

Figure 10. RCF initiated cavity

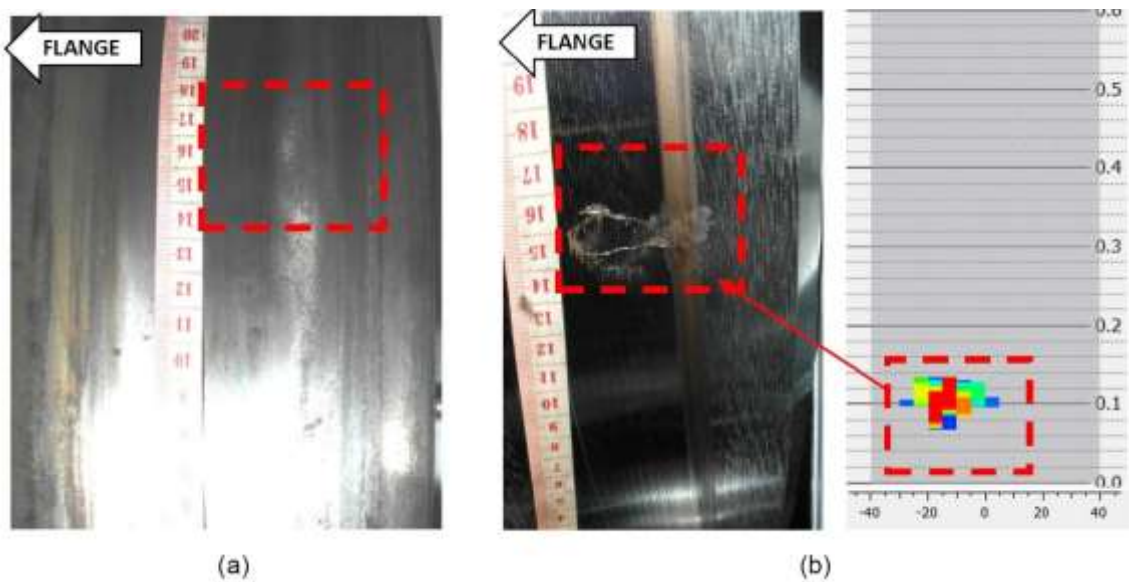
Figure 11. Thermal initiated cavity

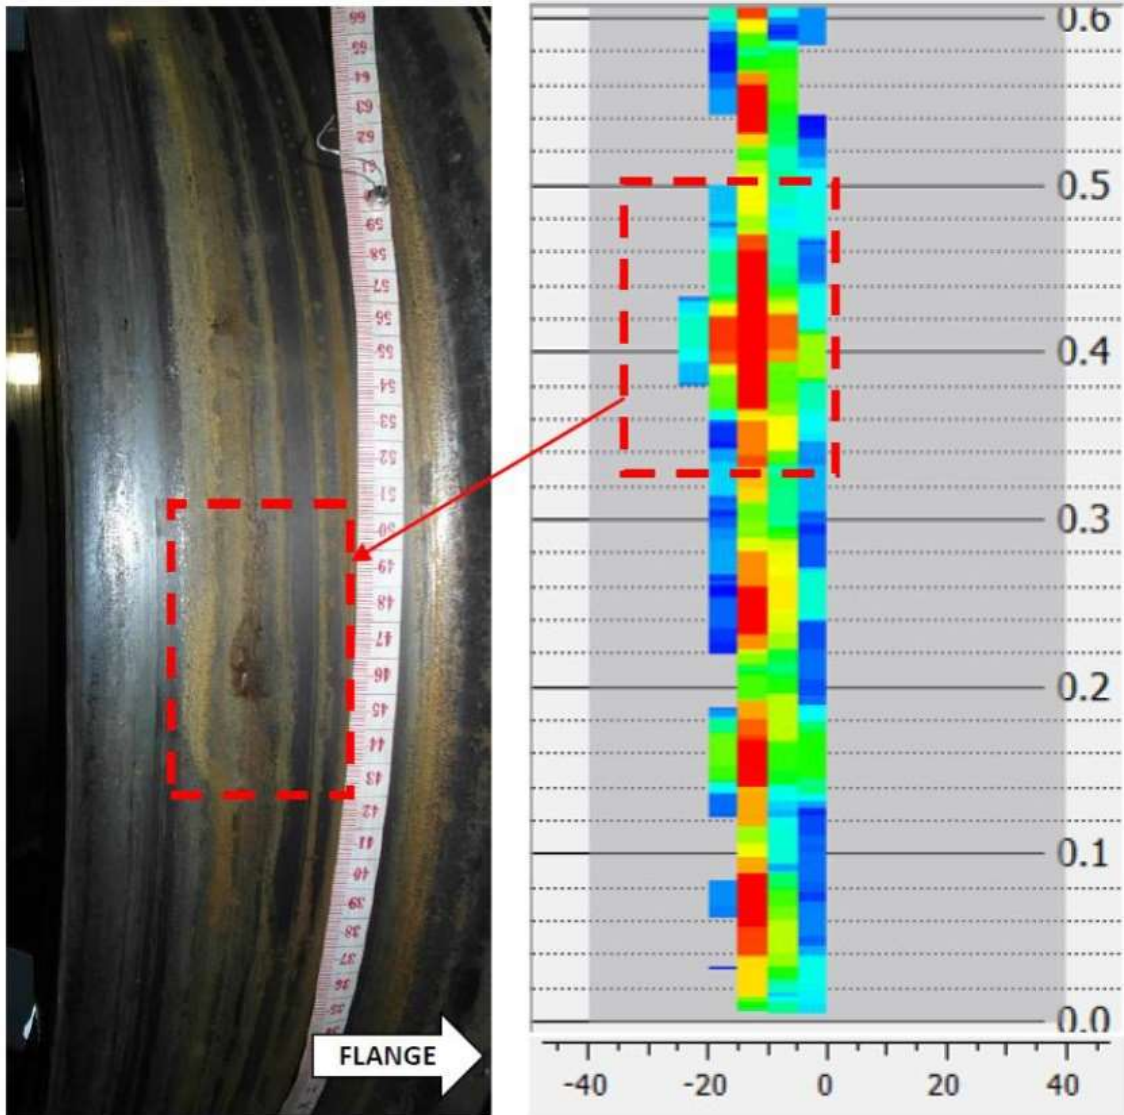
Figure 12 illustrates a thermal induced wheel flat identified using the HHU. In this case the flat could be visually classified by a flattened portion of the wheel tread (leading to wheel out-of-roundness).

Figure 12. Thermal wheelflat

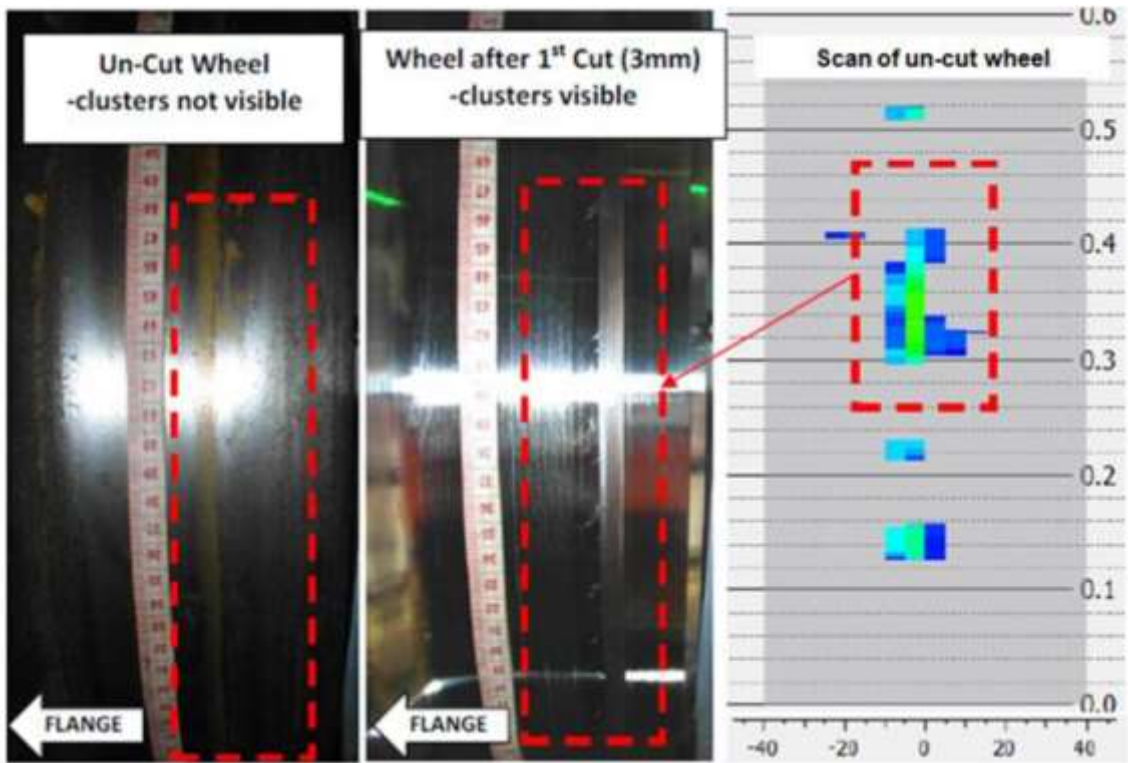
As previously discussed the potential benefit of the HHU is the ability to identify damage that is not visible in the un-cut wheel. The example presented in Figure 13 shows a maximum damage depth of 4.2 mm measured by HHU on the un-cut wheel. This damage was not visible on the surface of the un-cut wheel, but was visible following the first cut of 3 mm on the wheel lathe.

Figure 13. RCF damage not visible during visual inspection but measured by HHU
