Lessons on internal erosion in embankment dams from failures and physical models

J.J. Fry

EDF-CIH 73 373 Cedex, Le Bourget du Lac, France

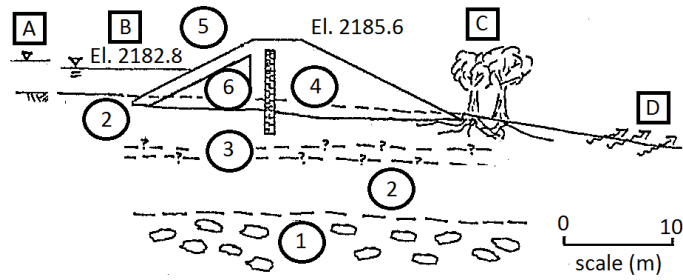
Figure 2. The Laguna Dam – section at location of failure.

The dams highlighted in grey in Table 6 were built during the 20th century and failed after more than ten years. No information was found on Lake Toxaway, and Baldwin Hills was discussed above. La Laguna dam is the only case of failure at long term: it failed after more than 60 years of operation. The embankment comprises an upstream zone of silts and clays compacted by hand and a downstream zone of soil and stones placed in layers. A one meter thick core wall of concrete or masonry separates the upstream and downstream zones. The core wall penetrates 2-5m into the underlying foundation soils. The dam is founded on residual soils (laterite) derived from weathered tuff and basalt. The foundation soils comprise high plasticity silts and clays. Sedimentation tests indicated that the soils did not flocculate in reservoir water (i.e., they were dispersive). Horizontal permeability tests conducted in boreholes indicated that the foundation soils were highly pervious, with permeability in the order of 10⁻⁴ m/s. 'Basaltic pudding', interpreted as weathered basalt with core

stones, underlies the residual soils. The permeability of this material is also relatively high. Seepage was observed emerging at several locations 10 to 20 m downstream of the dam toe after first filling of the reservoir in 1908 (Fig. 2).

6pm of the same day, a hole with water issuing under pressure was observed on the left abutment. The concentrated leak increased rapidly and started to erode the downstream slope of the dam. At 10:45pm, the masonry cutoff wall was exposed and a few minutes later the embankment was breached.

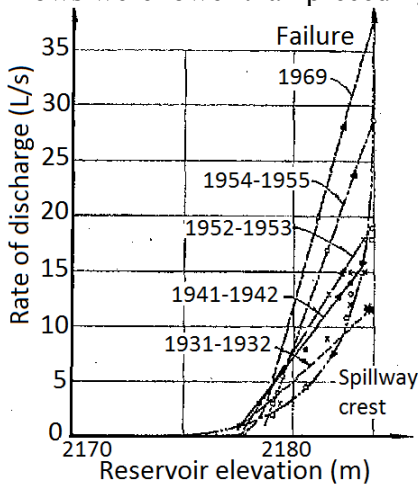
Figure 3. Monitoring of leakage at Laguna Dam. Rate of discharge versus reservoir elevation at different years.

Seepage flows are measured by two weirs, one on each abutment. The seepage flows on the right abutment are relatively constant with time; however there is an apparent long-term trend of increasing seepage at maximum reservoir level on the left abutment. This is reflected in the plot of seepage vs. reservoir level. Fig. 3 shows the history of seepage measurements for the left abutment from 1927 up to the time of failure. From 1960 to 1968, the reservoir did not reach max reservoir level and the seepage flows were lower than preceding 5 years.

In mid September 1969, the measured seepage flow on the left abutment exceeded the highest previous recorded flow of 30 L/s. This did not cause alarm as the total seepage was 50 L/s lower than the total seepage of 78 L/s recorded in 1942.

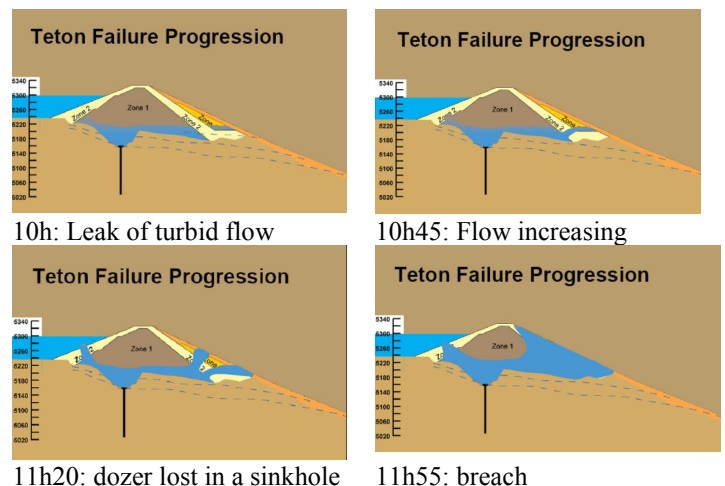
Figure 5: Progression of failure at Teton dam from Snorteland.

Teton dam is a zoned embankment (H=93m) impounded in 1976. The filter, omitted in the trench, was very thick under the shoulder. However, it was a natural alluvium with excessive % of plastic fines; its permeability was in some places as low as 10^{-7} m/s. It was placed on jointed rock, with open joints not always sealed with gunite or concrete. In consequence, the pipes, increasing from hydraulic fractures through the core, were stopped by the filter, the

flow was diverted into the unsealed cracks, passed the filter, exited on the downstream surface of the shell, developed backward erosion, and finally the hydraulic head below the filter fractured it.

The two review panels concluded that piping or seepage erosion was the failure mechanism. The core-to-shell downstream transition zone gradation did not meet either the Bureau of Reclamation criteria or the older, widely accepted Terzaghi-Bertram criteria. Was the gradation the initiator of the fail-

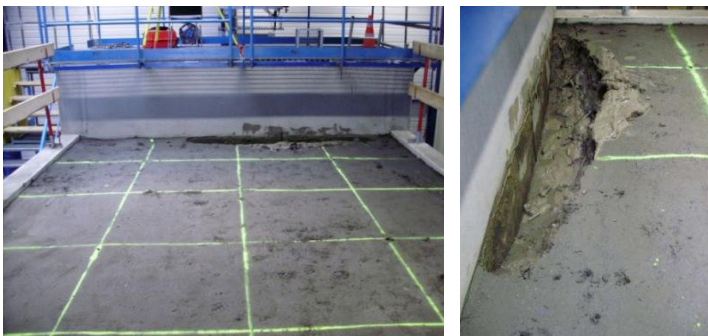
Figure 12. The sinkhole at the end of the test 1 (after 99h).

At Hour 79 during the last step (at an upstream head of 2.5 m and flow rate of 20 L/s), a massive surge of transported fines transport was suddenly triggered. The eroded fines came from the upstream part of the model. At Hour 83, the flow rate began to decrease at constant head. There was a sharp decrease of hydraulic head under the downstream part of the model. This was the consequence of a decrease of the downstream permeability (as shown in Fig. 10). At Hour 84, downstream settlement occurred (Fig. 11). At Hour 96, a sinkhole occurred

The interpretation of the data is that during the three first steps, erosion at the contact interface was brief, the gravel was merely washed. The massive erosion occurred at the last step under a Darcy flow velocity of 3.5 cm/s and hydraulic gradient of 0.28 in the gravelly foundation. This massive transport of eroded silt leads to clogging of the gravel and a decrease in the flow velocity. This arrested the contact erosion. The sinkhole was observed at Hour 17 following the start of the massive erosion. Its location near the wall was a boundary effect, although it should have been prevented by the geotextile protection! The same process was observed in Tests 2 and 3, but at higher flow velocities and increased erosion rates, with the 20/40 mm gravel in foundation. Interestingly, with the 20/40 mm gravel, the contact erosion was increased and the silt was subject to suffusion: some fine particles were washed out in the sinkhole collapse chimney and sand lenses were founded blocked by the coarsest particles of the silt at the base of sinkhole chimney just above the gravelly foundation (Fig. 13). The coarse particles played the role of a natural filter, stopping contact erosion at their location. However, the contact erosion moved downstream and could cause a second sinkhole (see test 3 Fig. 13).

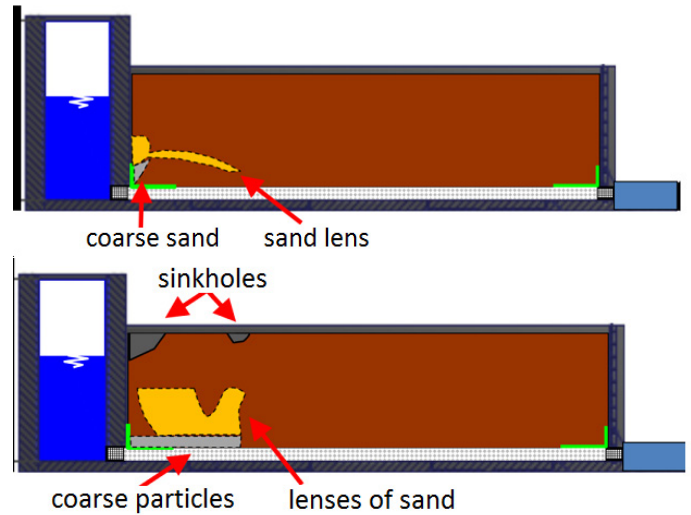
Figure 13. The segregated areas (coarse particles and sand lenses) at the end of the test 2 (above) and 3 (below).

That paving of coarse particles has been observed by Beguin (2011), it decreases the erosion rate and sometimes it stops the contact erosion. This formation of natural filter in alluvium is a first explanation for the low rate of contact erosion and lack of failure in embankment made of fine alluvium on coarse alluvium foundation.

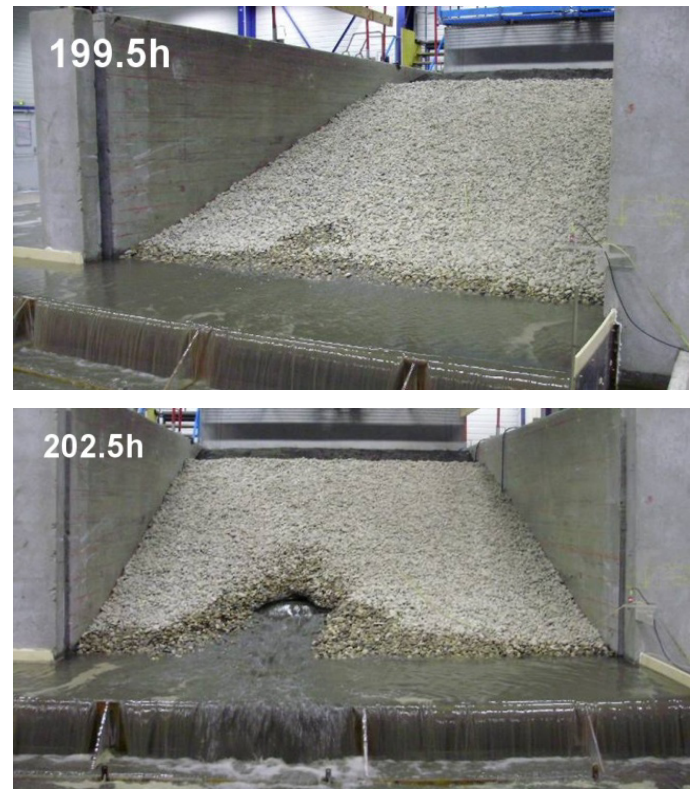
Fig.16: Piping exit in a levee suffering contact erosion (from Beguin, 2011).

a very substantial flow was discharged as shown in Figure 16.

Based on this result, it appears that contact erosion could lead to the failure of levees if the following four conditions are met.

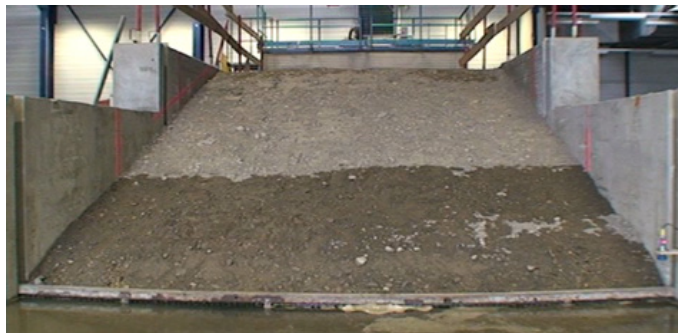
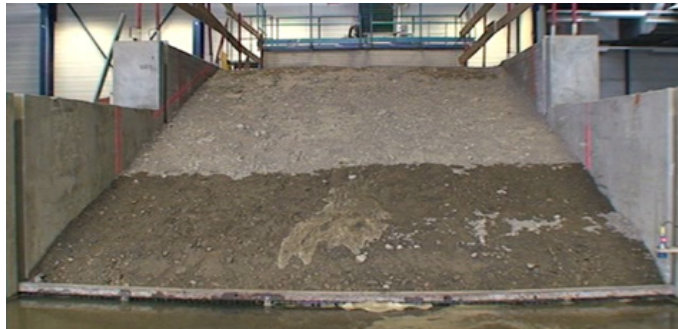
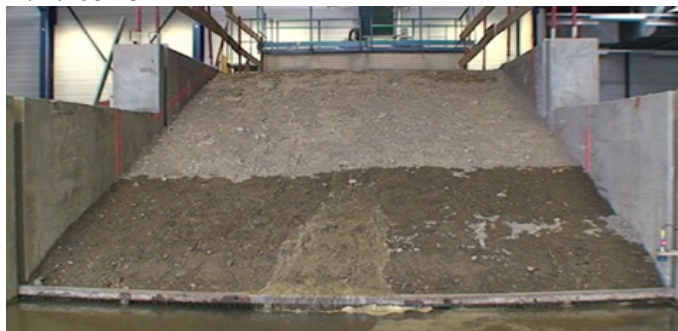
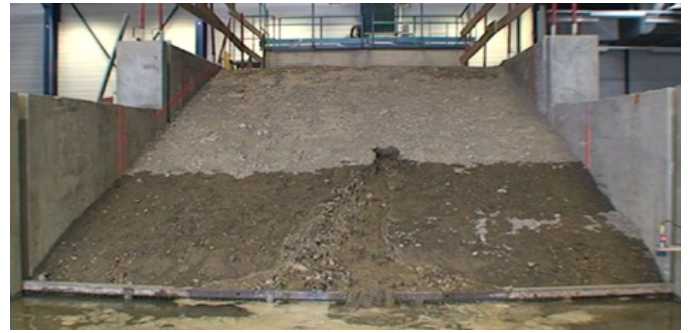
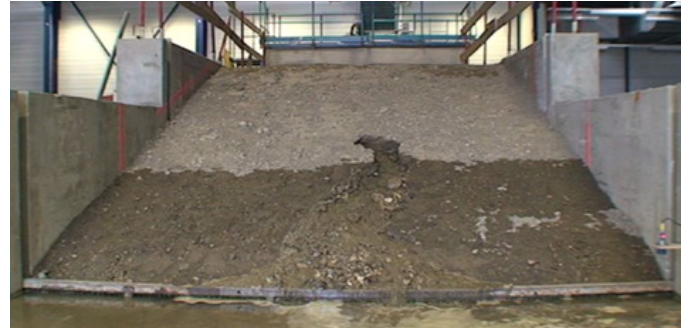
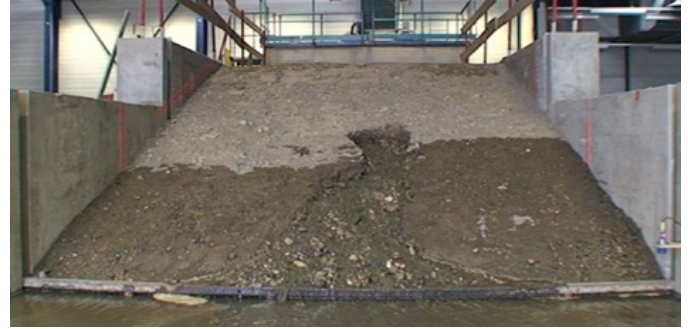
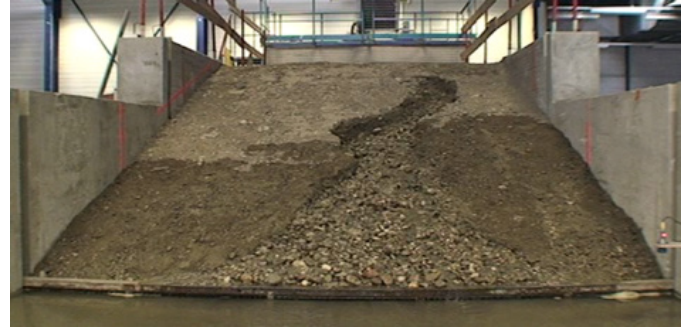
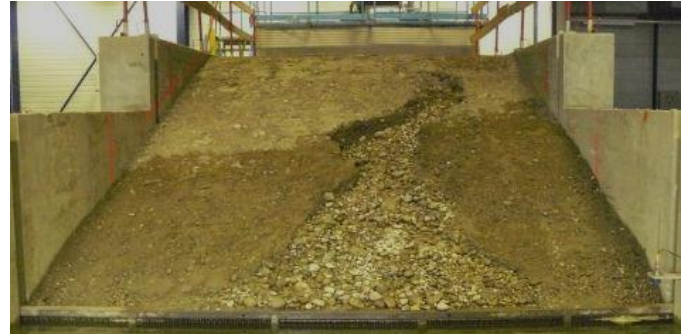
Figure 17: Progression of erosion on the downstream face of test 2.2

In Test 2.2 global backward erosion occurred and excavated a gully from the toe to the top of the slope as shown in Figure 17. It looked similar to the upward erosion observed on the downstream face of the Teton dam.

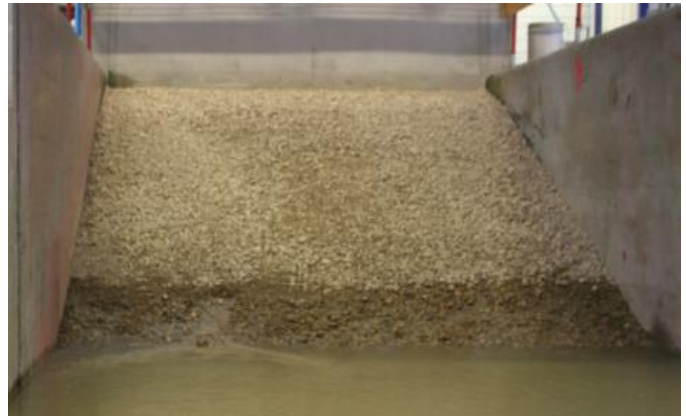
Test 3.1 2D flow erosion initiation $H_w=0.9$ m shoulder thickness $h=1.5$ m

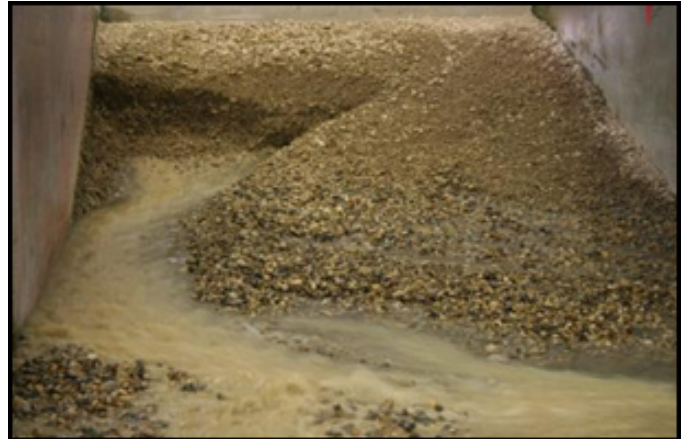
Test 3.1 2D flow - Failure. $H_w=1.66$ m $h=1.5$ m.

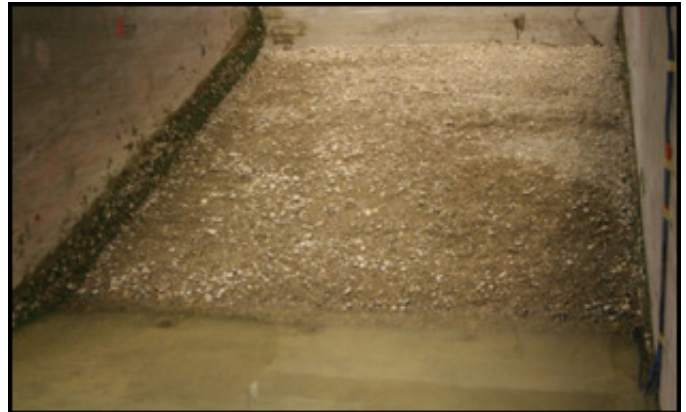
Test 3.5 Concentrated leak - No failure. $H_w > 3$ m $h=1$ m.

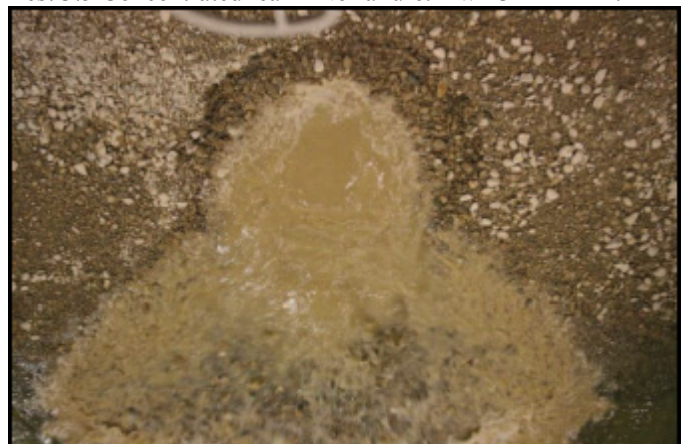
Test 3.7 Concentrated leak $H_w > 3$ m $h=0.5$ m. Heave & backward erosion on a stable gravel.

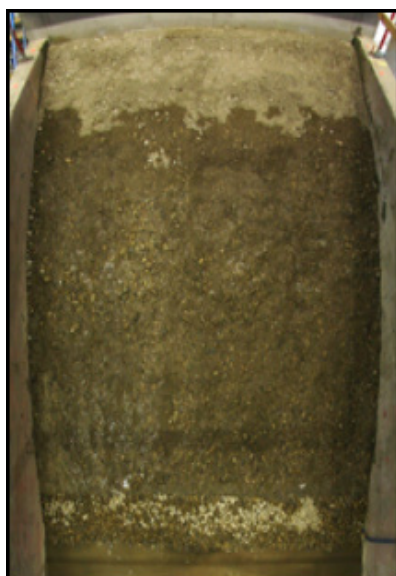
(1) Surface sliding caused by 2D flow under the shoulder made of suffusive alluvium.

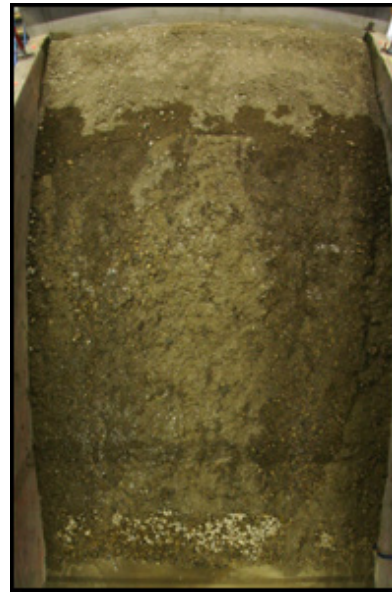
(2) Horizontal crack and sudden increase of discharge flow through the crack.

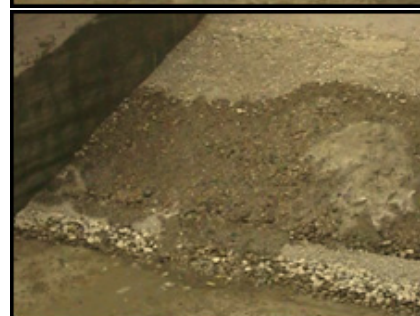
(2) Horizontal crack and sudden increase of discharge flow through the crack.

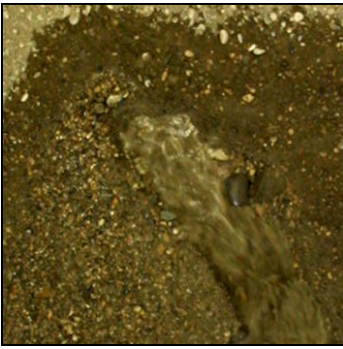
(3) Scour or sloughing downstream and below the crack.

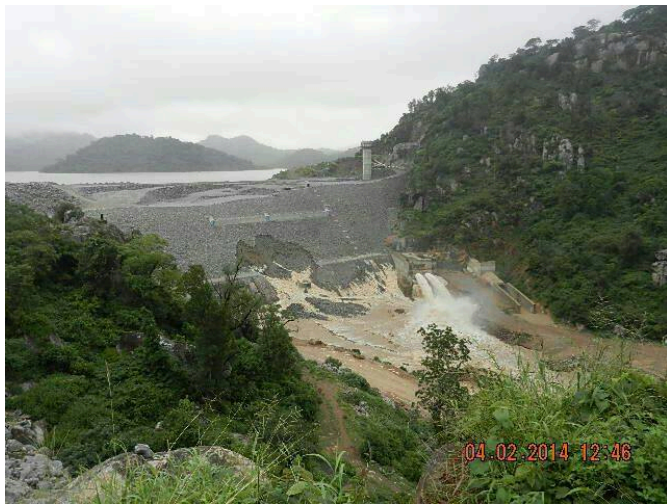
Figure 28. Backward erosion during the construction of the Mokwe Mukorsi CFRD dam

The large drainage capacity shoulders have to be protected from backward erosion. This phenomenon is sometimes observed when an extreme flood occurs during construction of CFRD (concrete faced rockfill dams), before the concrete slab placing. It was the cause of the failure of Hell Hole dam (1964). It occurred on the 4th February 2014 at Tokwe-Mukorsi dam (Fig. 28).

To protect this type of shoulders from backward erosion, the smallest blocks and more graded curve with low permeability and high density are placed in the dam center and the largest rip-rap blocks are placed on the downstream face. The slope has to be designed using the Kovacs (1981) relationship and the refined Solvik equation (3) by EBL Kompetanze (2003) or the Knauss equation (1975) or Martins relationship (1982).
