## Water Loss Test Results: West Main Canal United Irrigation District of Hidalgo County

Eric Leigh Texas AgriLife Extension Associate, Biological and Agricultural Engineering, College Station

Guy Fipps Texas AgriLife Extension Professor and Extension Agricultural Engineer, Biological and Agricultural Engineering, College Station

**April 6, 2006**

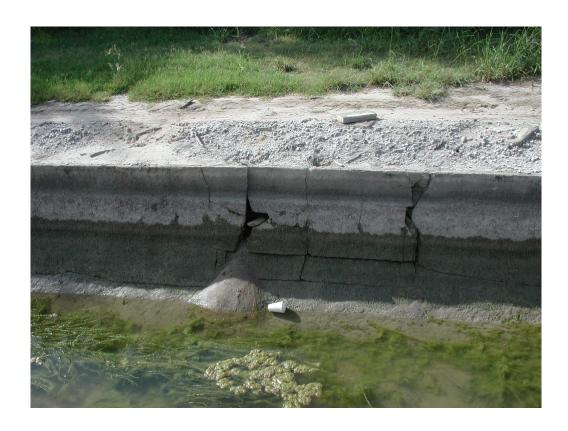
Figure 1. Large cracks and aquatic vegetation shown above contribute to higher total losses of canal segments.

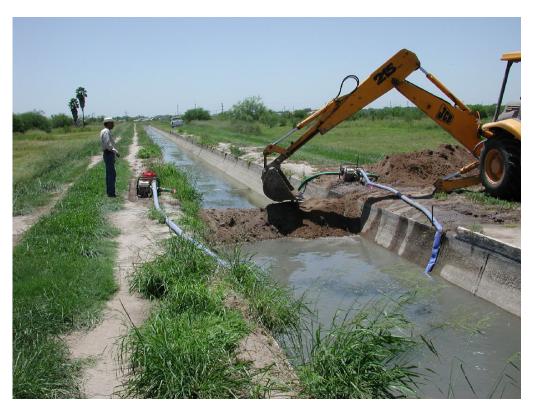
Figure 3. Photo of the earthen dam being built on test segment UN1.

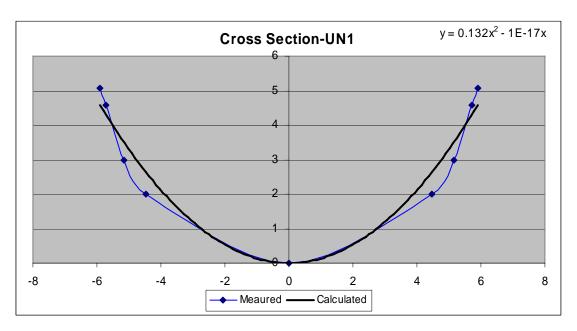
- The average seepage loss rate measured for Test Segment UN1 was 2.29 gal/ft<sup>2</sup>/day.
- The average seepage loss rate measured for Test Segment UN2 was 2.11 gal/ft<sup>2</sup>/day.
- Test Segment UN3 had two turnout gates (unable to be verified as leaking) that may have contributed to the total loss rate of 2.11 gal/ft²/day. Test was performed with water level being only 50% total depth.

Figure 4. Cross-section for Test Segment UN1.

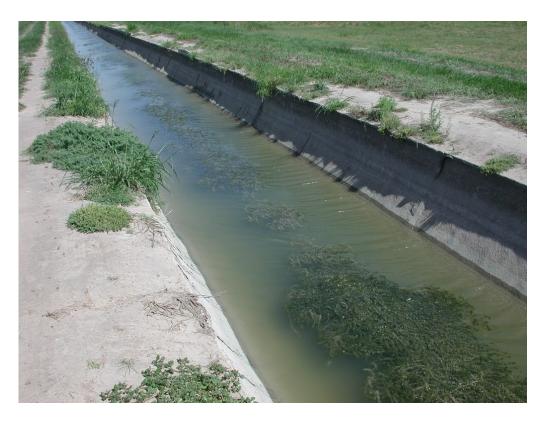
Figure 5. Photo of test segment UN1 showing aquatic vegetation problems.

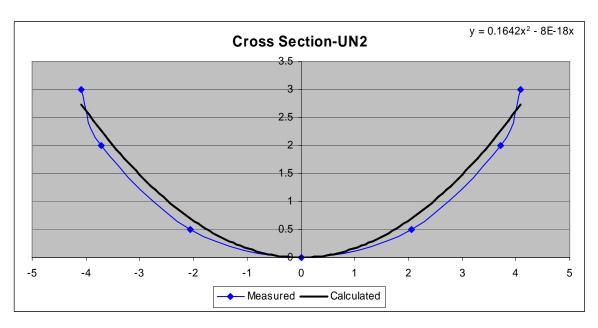
Figure 6. Cross-section for Test Segment UN2.

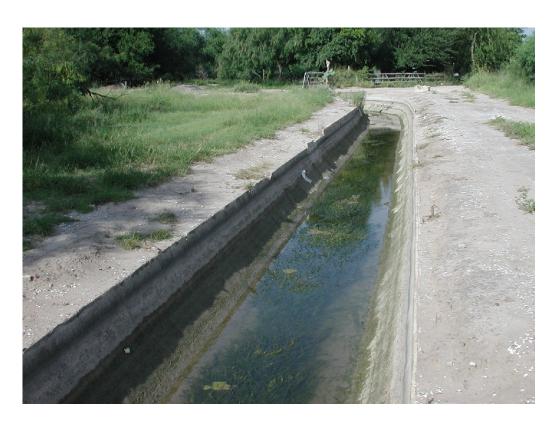
Figure 7. Photo of test segment UN2 showing aquatic vegetation problems.

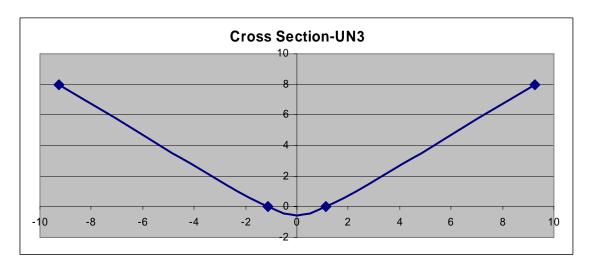
Figure 8. Cross-section for Test Segment UN3.
