**Water Loss Test Results for the Pipeline Units:
I-19/I-18, I-7A and I-22
Hidalgo County Irrigation District No. 2**

**Texas Water Resources Institute Technical Report
October 2008**

Report Prepared by:
Eric Leigh and Guy Fipps, P.E.¹
June 1, 2007

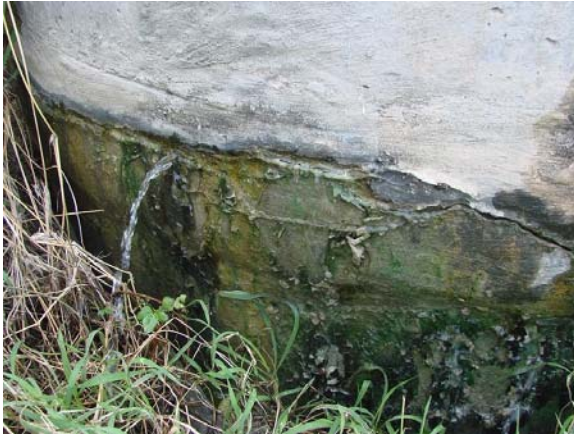
The pipelines were tested using the ponding method. These tests accounted for all the leaks occurring from gates, valves, and pipeline joints that are either undetectable or are difficult to measure (figures 6 and 7), classified as *total loss* tests; thus, measuring the total water loss rate.

Figure 6. Leaking from standpipe

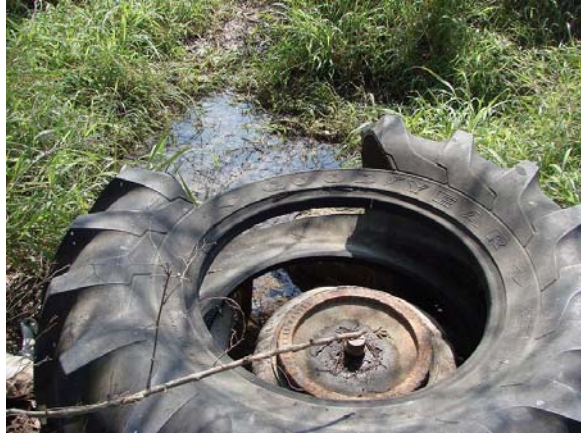
Figure 7. Leaking from turnout valve
