**TR-335  
2008**

## **Thermal Imaging of Canals for Remote Detection of Leaks: Evaluation in the United Irrigation District**

**Texas Water Resources Institute Technical Report  
November 2008**

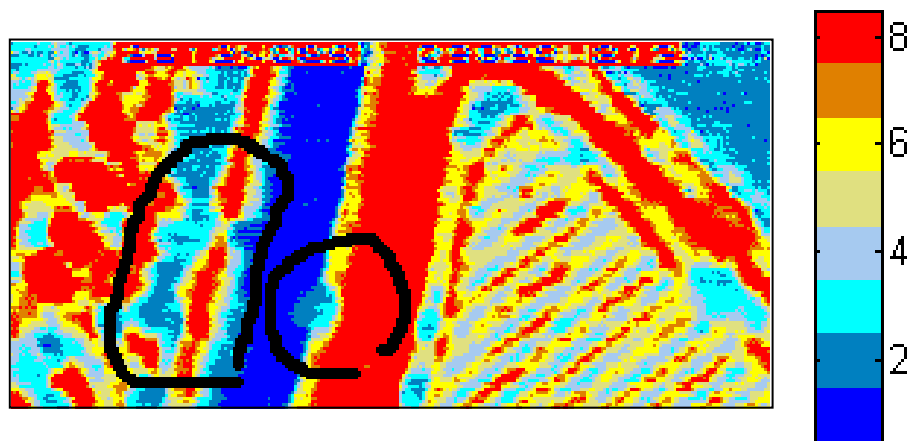
Figure 2a. Site 1 - Original processed image.

As seen in figure 2a, on one side of the canal (right side on the image) there is a wide strip which is likely a dirt road on the canal levee. On the same side beside the canal, an area showing the possibility of wetness or vegetation (mark circled on the right of the image). On the other side of the canal (left side on the image), there is another area of vegetation and/or wetness and a narrow dirt road (mark circled on the left of the image).

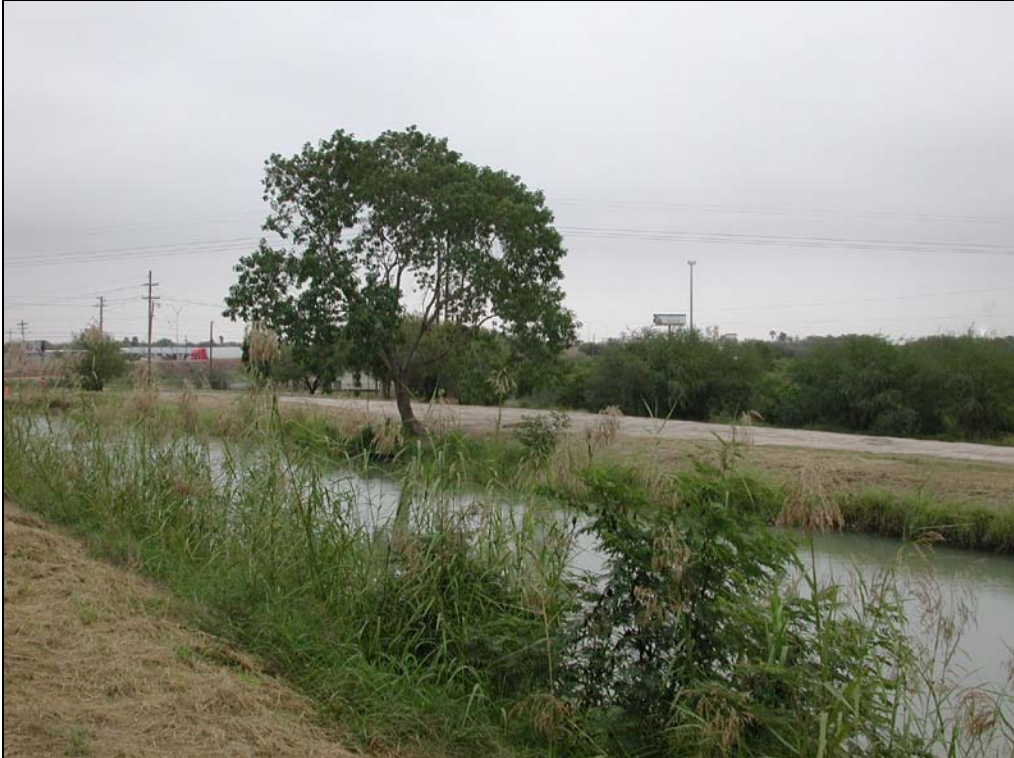
- Wetness: 2
- Vegetation:
  - Grass – 2
  - Trees – 2
  - Crops – 0
- Seepage: 2
- Cracks: 0
- Holes: 2

Photographs taken at this location show a large tree and the dirt road on the same side of the canal (Figure 2c). Water appears to be flowing out of the canal through a large hole located near the tree. Figure 2d shows thick vegetation (grasses and bushes) with a narrow stripe of dirt road. The site evaluation matched very well our interpretation of the thermal imagery.

***Conclusion: this canal segment has a severe seepage problem at this location caused by a hole in the canal.***

Figure 2c. Photograph of Site 1 – an unlined canal segment with a hole in the embankment.

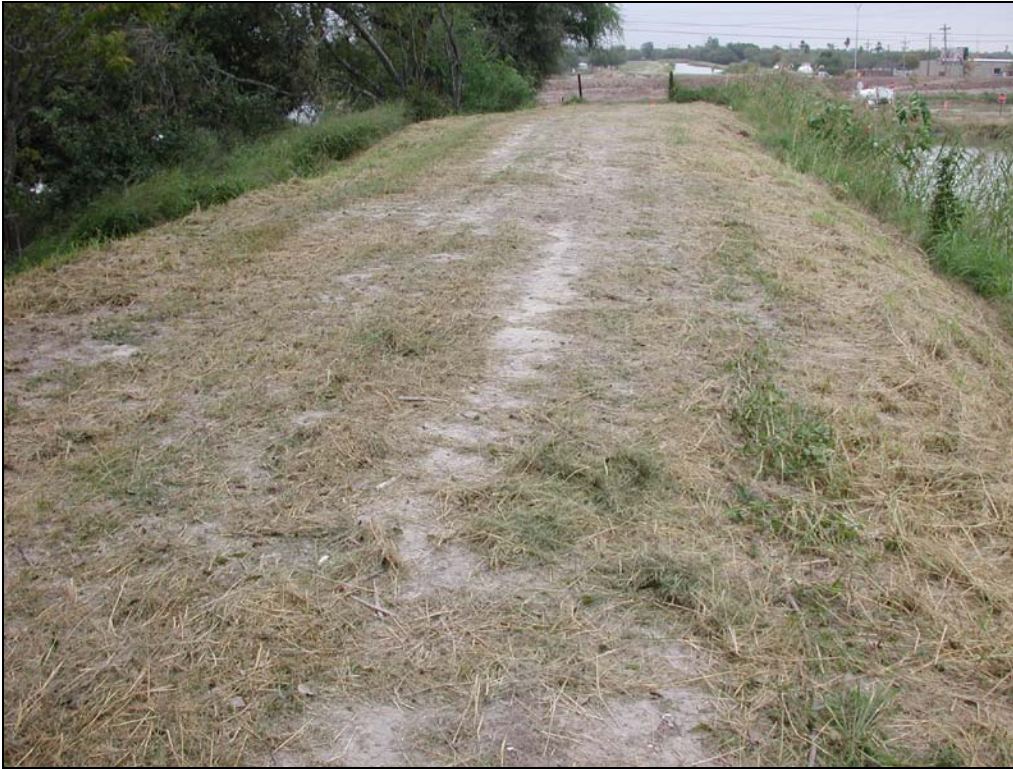
Figure 2d. Photograph showing dirt road on canal embankment at Site 1.

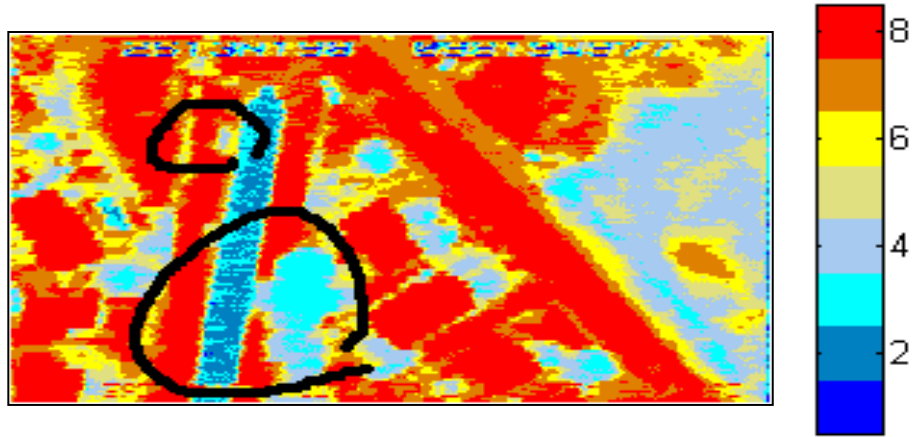
Figure 3a. Site 2 - Original processed image.

As shown in Figure 3a, the thermal image shows two areas of wetness (mark circled on the image) on either side of the canal. Figure 3b shows the inverted image overlaid onto the DOQQ (Figure 3b). The results of the field evaluation are as follows:

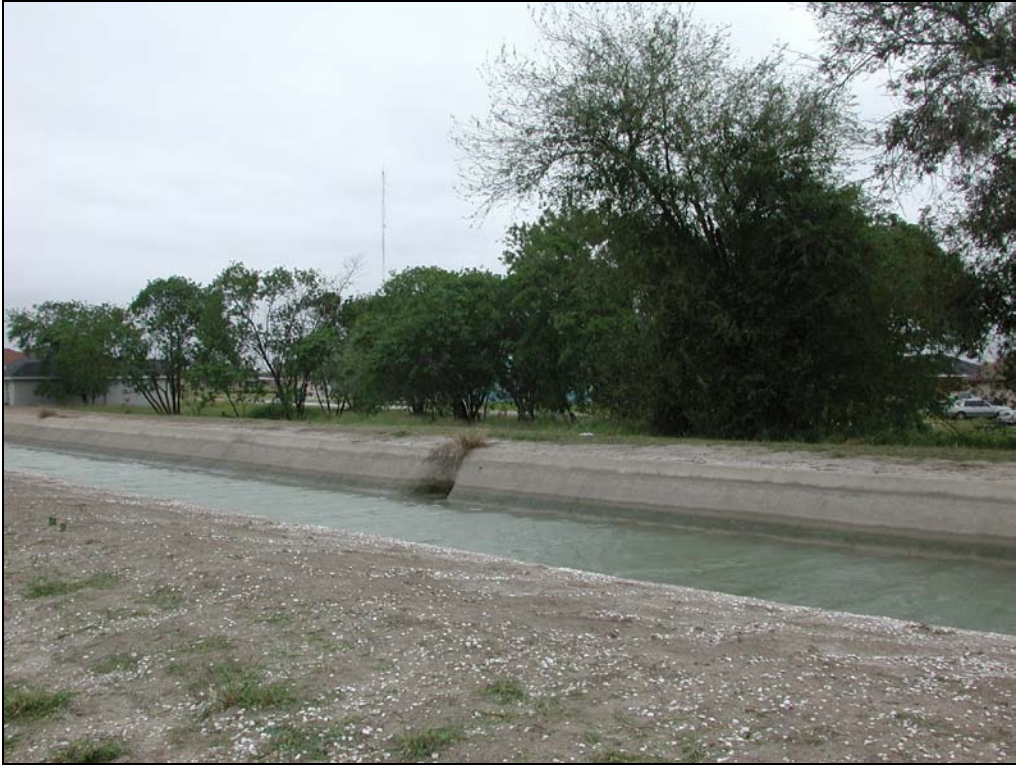
Site photographs (Figure 3c-d) show a structure on the side of the canal which appears to be an abandoned gate through which water is flowing. As this is the only place along the canal with thick vegetation, the abandoned gate is likely the only source of the leak.

Figure 3c. Site 2 – thick vegetation along the canal.

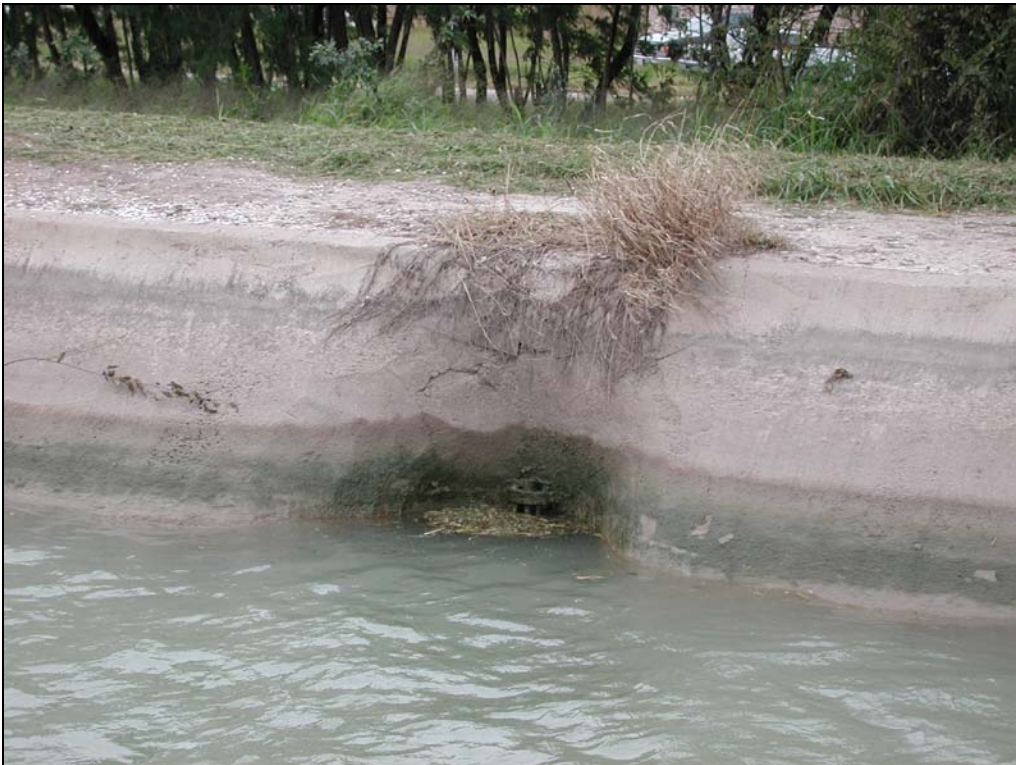
**Conclusion: thermal imaging clearly identified the source of a significant leak being caused by an abandoned gate.**

Figure 3d. Site 2 – an abandoned gate associated with the area of thick vegetation.

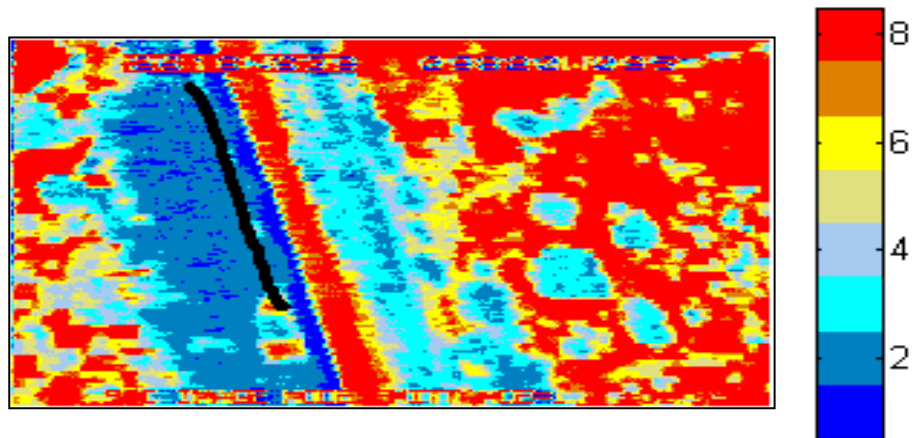
Figure 4a. Site 3 - Original processed image.

As shown in figure 4a, there is likely a seepage area along one side of the canal (left side on the image). The rating of this site is as follows:

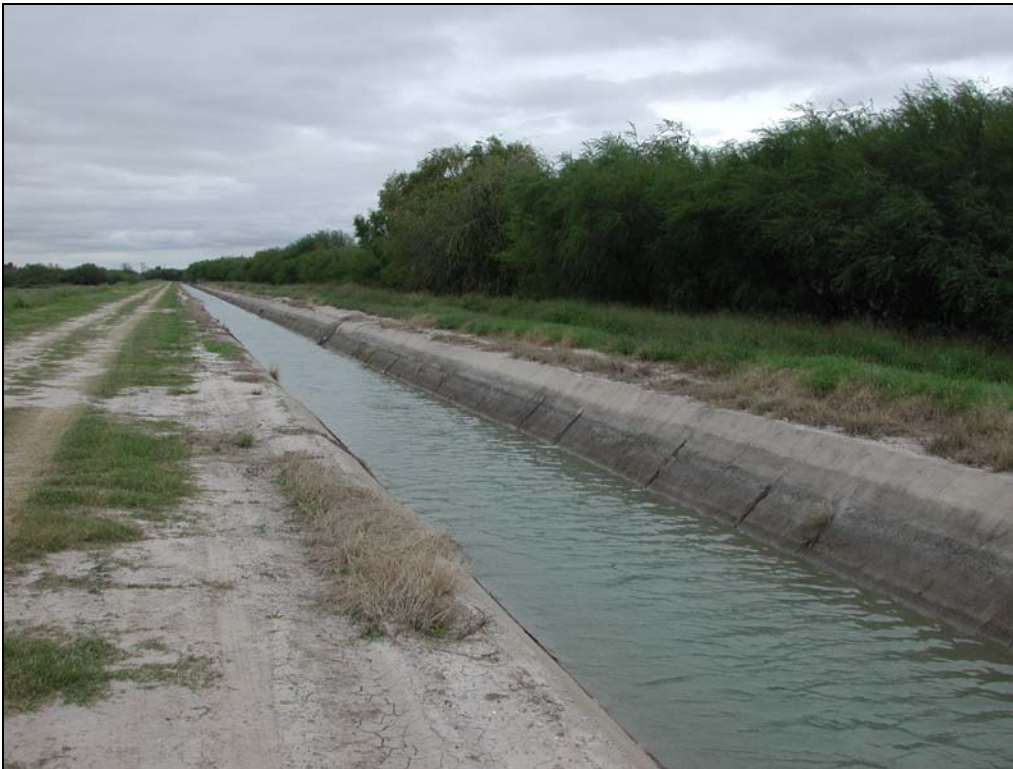
The field photograph (Fig. 4c) shows thick vegetation on the side of the canal having and many cracks. Some of the cracks are sealed but others are not. These unsealed cracks appear to be the cause of the seepage from this canal segment.

***Conclusion: thermal imaging detected seepage caused by cracks in a canal.***

Figure 4c. Site 3 – showing cracks and thick vegetation on one side of the canal.

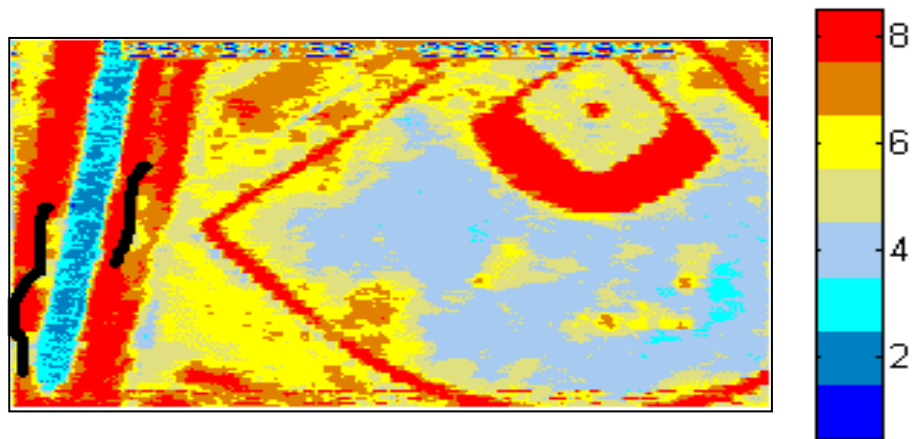
Figure 5a. Site 4 - Original processed image.

Figure 5a shows a canal segment beside a baseball field. While there is no indication of vegetation or wet areas along this segment, there is something other than a dirt road (line-marked on the image). This image was inverted and overlaid on the DOQQ image (Fig. 5b). The rating results are as follows:

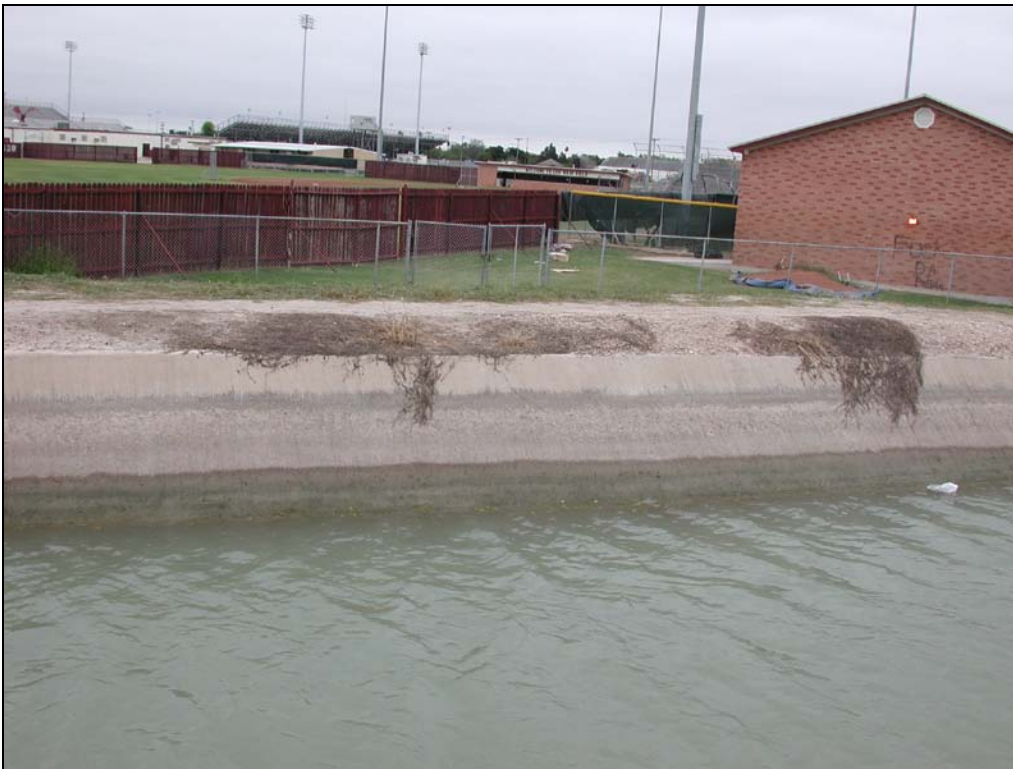
The photograph (Fig. 5c) shows some dead vegetations spread over the sides of the canal, but otherwise the conditions of the canal is good. This canal segment does not have a detectable leak.

*Conclusion: this canal segment is unlikely to have a leak.*

Figure 5c. Site 4 – Photograph showing the dead grass along the canal and that the canal segment is in good condition

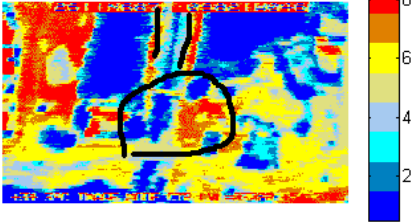
Site 5 - Image 10 at (2611N687, 09821W046)

<p>A thermal image showing a field with a central area circled in black. To the right of the circle are several parallel lines. A color scale on the right ranges from 0 (blue) to 8 (red).</p>	<p>Investigate:</p> <ul style="list-style-type: none"> <li>• Leakage or thick vegetation at the circled spot</li> <li>• Seepage, vegetation, or shadow at the lined areas</li> </ul>
---	--

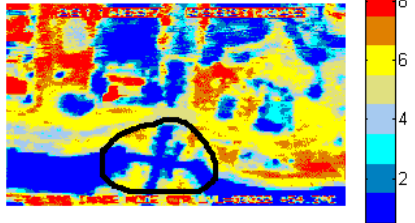
Site 6 - Image 11 at (2611N687, 09821W046)

<p>A thermal image showing a field with a central area circled in black. A color scale on the right ranges from 0 (blue) to 8 (red).</p>	<p>Investigate:</p> <p>Junction leakage at the circled spot</p>
--	---

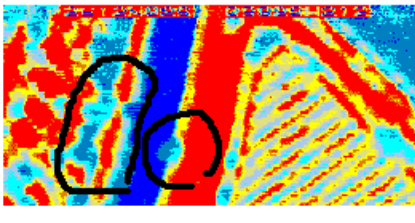
Site 7 - Image 18 at (2612N026, 09820W212)

<p>A thermal image showing a field with two areas circled in black. A color scale on the right ranges from 0 (blue) to 8 (red).</p>	<p>Investigate:</p> <p>Leakage or vegetation at the circled spots</p>
---	---

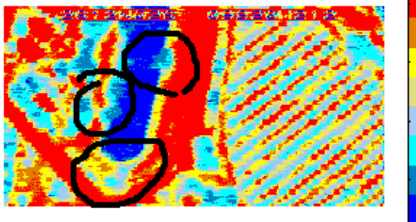
Site 8 - Image 19 at (2612N026, 09820W212)

<p>A thermal image showing a field with three areas circled in black. A color scale on the right ranges from 0 (blue) to 8 (red).</p>	<p>Investigate:</p> <p>Leakage or vegetation at the circled spots</p>
---	---

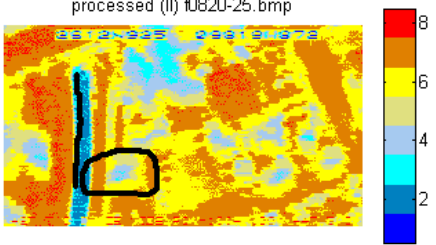
Site 9 - Image 25 at (2612N925, 09819W872)

<p>Investigate:</p> <ul style="list-style-type: none"> <li>• Leakage or thick vegetation at the circled spot</li> <li>• Seepage, vegetation, or shadow at the lined area</li> </ul>
---	---

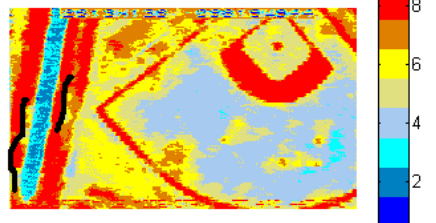
Site 10 - Image 29 at (2613N136, 09819W944)

<p>Investigate:</p> <p>Seepage, vegetation, or shadow at the lined areas</p>
---	--

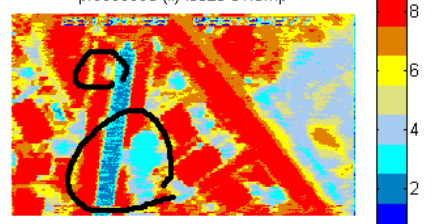
Site 11- Image 31 at (2613N198, 09819W977)

<p>Investigate:</p> <p>Leakage or thick vegetation at the circled spots</p>
--	---

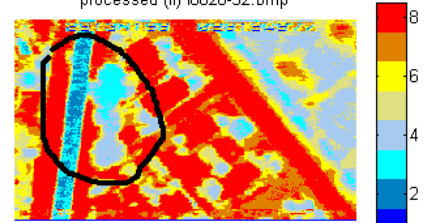
Site 12 - Image 32 at (2613N198, 09819W977)

<p>Investigate:</p> <p>Leakage or thick vegetation at the circled spot</p>
---	--

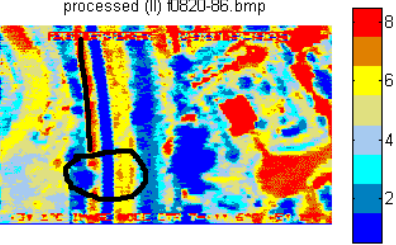
Site 37 - Image 86 at (2616N235, 09819W945)

<p>processed (I) f0820-86.bmp</p> <p>The image shows a thermal scan with a color scale from 0 (blue) to 8 (red). A vertical line is drawn through the center, and a small spot is circled on the left side of the line.</p>	<p>Investigate:</p> <ul style="list-style-type: none"> <li>• Leakage or thick vegetation at the circled spot</li> <li>• Seepage, vegetation, or shadow at the lined area</li> </ul>
---	---

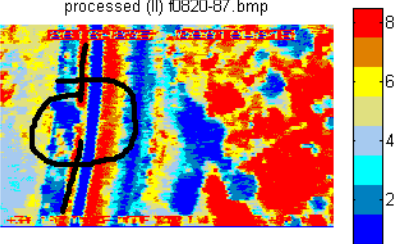
Site 38 - Image 87 at (2616N235, 09819W945)

<p>processed (I) f0820-87.bmp</p> <p>The image shows a thermal scan with a color scale from 0 (blue) to 8 (red). A vertical line is drawn through the center, and a spot is circled on the left side of the line.</p>	<p>Investigate:</p> <ul style="list-style-type: none"> <li>• Leakage or thick vegetation at the circled spot</li> <li>• Seepage, vegetation, or shadow at the lined areas</li> </ul>
---	--

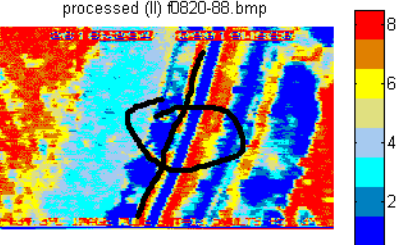
Site 39 - Image 88 at (2616N294, 09819W968)

<p>processed (I) f0820-88.bmp</p> <p>The image shows a thermal scan with a color scale from 0 (blue) to 8 (red). A vertical line is drawn through the center, and a spot is circled on the left side of the line.</p>	<p>Investigate:</p> <ul style="list-style-type: none"> <li>• Leakage or thick vegetation at the circled spot</li> <li>• Seepage, vegetation, or shadow at the lined areas</li> </ul>
--	--

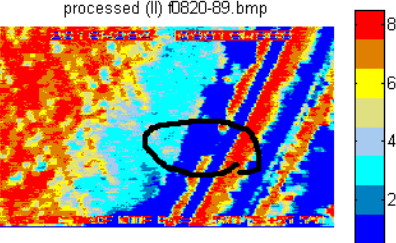
Site 40 - Image 89 at (2616N294, 09819W968)

<p>processed (I) f0820-89.bmp</p> <p>The image shows a thermal scan with a color scale from 0 (blue) to 8 (red). A spot is circled in the lower center of the image.</p>	<p>Investigate:</p> <ul style="list-style-type: none"> <li>• Leakage or thick vegetation at the circled spot</li> </ul>
--	---

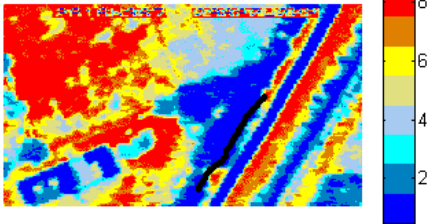
Site 41 - Image 90 at (2616N367, 09820W002)

<p>Investigate: Seepage, vegetation, or shadow at the lined area</p>
---	--

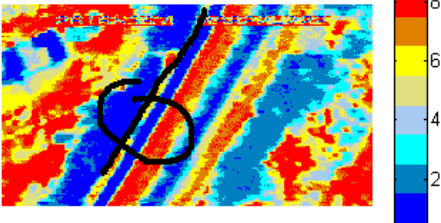
Site 42 - Image 91 at (2616N367, 09820W002)

<p>Investigate:</p> <ul style="list-style-type: none"> <li>• Leakage or thick vegetation at the circled spot</li> <li>• Seepage, vegetation, or shadow at the lined area</li> </ul>
---	---

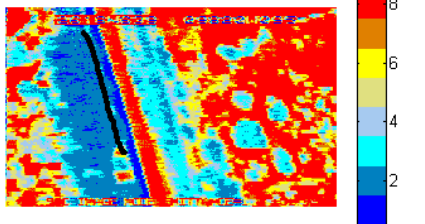
Site 43 - Image 95 at (2616N639, 09820W095)

<p>Investigate: Seepage, vegetation, or shadow at the lined area</p>
---	--

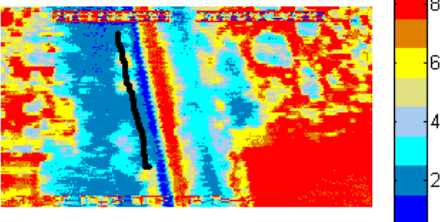
Site 44 - Image 96 at (2616N639, 09820W095)

<p>Investigate: Seepage, vegetation, or shadow at the lined area</p>
---	--
