THE REHABILITATION OF PIPE NETWORK FROM SPRINKLER IRRIGATION PLOTS

Mihail LUCA¹, Alexandru-Lucian LUCA², Nicolae MARCOIE¹ Ilie LOGIGAN¹

The case study was drawn up for an sprinkler irrigation plot located in the „Albița – Fălciu Complex Facility” Vaslui County. The irrigation plot 7 is located at the southern boundary of Satu Nou - Berezeni village, Berezeni commune, Vaslui County (Luca M., 2015). The total irrigated area within the plot is 1222 ha. The irrigation system was designed by I.S.P.F. Bucharest in 1977 and was executed between 1977 and 1980.

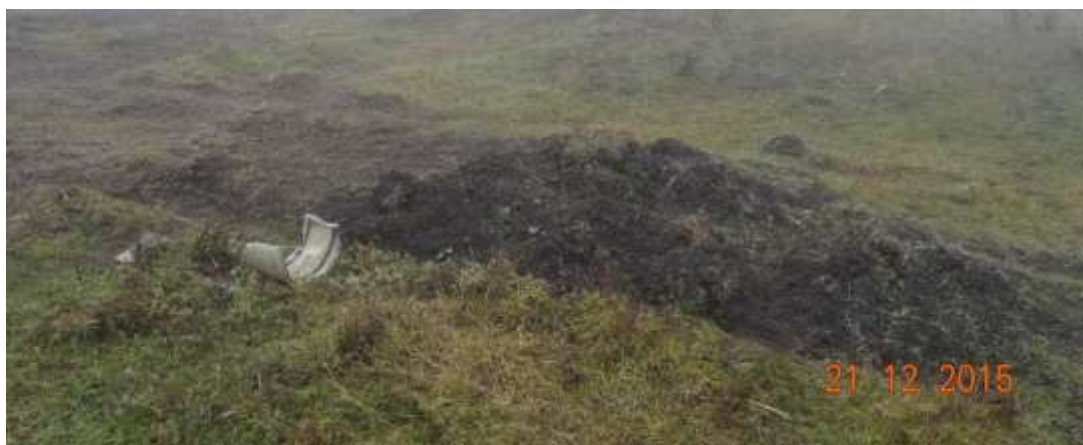
Figure 3 Detail on the state of pipe sections made of asbestos tubes (damage to joints, tube breaks) (Luca M., 2016)

- tertiary irrigation lines with serial connected pipe sections are degraded and the material is aged; the bursting percentage of asbestos pipes is high in the current state (*figure 3, 4, 6*);
- irrigation hydrants are worn out, have a high percentage of damage and do not allow the connection of modern watering equipments;
- simple and reinforced concrete chambers have degraded structural components, with internal infiltrations, uncovered plasterings, cracks in the wall, absence of covers, etc.;
- the hydraulic installation used for hydraulic shock protection is not complete or is missing;

a. Replacement of sections from tertiary irrigation pipes (degraded sections are replaced, and those with good structural condition are preserved). The materials used must be mechanically and hydraulically viable for the irrigation plot (steel, HDPE, ductile iron, etc.). The materials used must allow quick interventions and repairs in case of damage.

b. Total replacement of the tertiary irrigation pipe. This option is more expensive but is

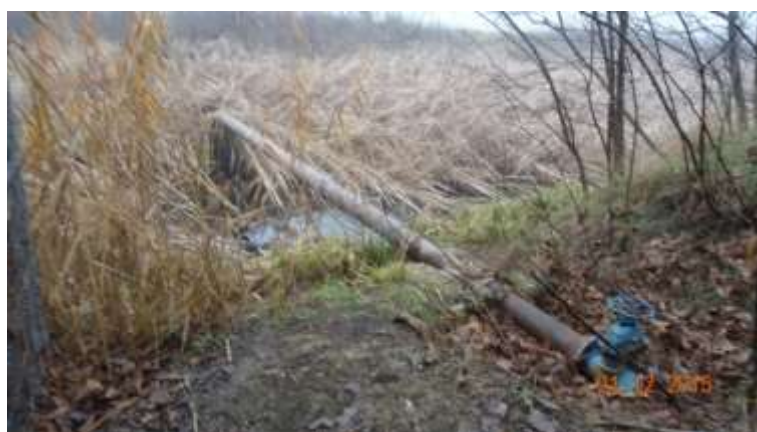
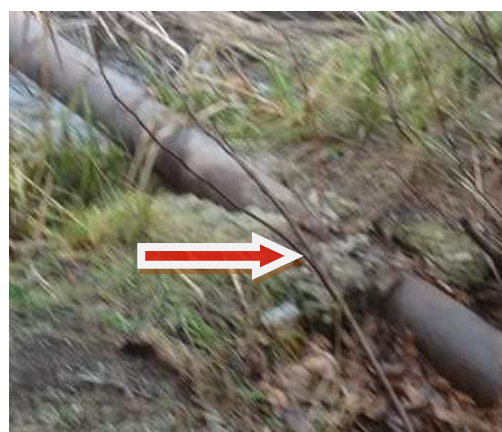
- canal overcrossing pipes are worn out, corroded, show displacements from the original position; anchorage blocks made of simple concrete are structurally degraded, settled, and do not ensure anymore that the pipes are properly supported (figure 5);

due to the large quantity of alluviums transported, influences the degree of silting of the distribution pipes, especially on the final sections (figure 5a).

Figure 5 View of the structural condition of the supply canal crossing: a – general view of the pipeline location; b – the state of the right bank anchorage block (Luca M., 2016)

a. Preservation of the current pipe section with the rehabilitation of joining fittings and anti corrosive insulation. Verifying and restoring the assemblage slope.

b. Complete restoration of simple concrete anchorage blocks.

c. Installing the ventilation system.
