N Alvares, K Staggs, G Rein, Investigation of a Fatal Fire in a Moving Vehicle, Proceedings of the 5th International Seminar on Fire and Explosion Hazards, pp. 800-809, Edinburgh, 2007. Presentation slides available at <http://www.see.ed.ac.uk/feh5>

INVESTIGATION OF A FATAL FIRE IN A MOVING VEHICLE

Norman Alvares¹, Kirk Staggs¹ and Guillermo Rein²

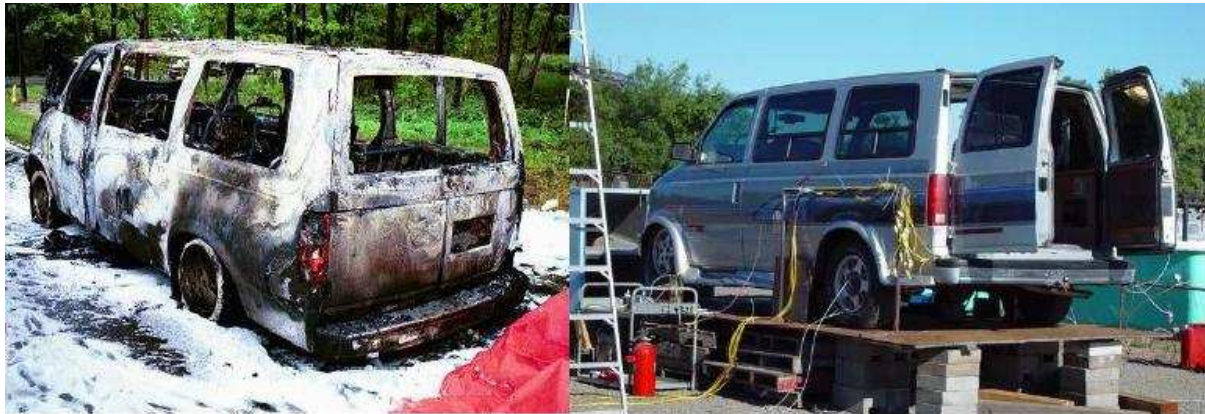
This paper presents the investigation conducted by the authors to test conflicting scenarios regarding the cause and origin of an accidental fire. This tragic fire (Fig. 1) occurred in a moving mini van, after 5 to 6 min of driving, and resulted in the death of three passengers, injuries to the surviving passenger and the driver and the complete loss of the vehicle. The initial fire investigators proposed that the fuel source was a fuel spray released from a degraded supply or return line next to exhaust components under the vehicle. Supposedly, the resultant flame exposed the rear floor pan of the vehicle to intense heat transfer resulting in the ignition of interior materials, and the subsequent fire burned out the vehicle interior. Allegedly, interior materials were ignited while the vehicle was traveling at moderate city

speed and without enough warning to the occupants. However, this assumed scenario is not supported by the accounts of the main witness, who report no pre-fire indicators such as odors, smoke, irritating gasses or buildup of heat by any of the occupants. The driver describes the event as being a sudden conical plume of white smoke at the rear of the van, followed shortly thereafter by rapid fire growth. She was immediately alerted of the plume because she heard a “pop”, and one of the passengers said “what’s that?”. The driver immediately stopped, ran around the back and opened the right side-sliding door and was able to remove one child from the middle row of seats. The driver attempted to re-enter, but could not because the interior of the van was filled with flames and smoke. Three passengers were unable to exit and perished in the fire. The driver’s description of the fire spread suggests dramatically fast time-line.

Figure 1. Vehicle testing site (right) and the post fire remains of the real case (left).

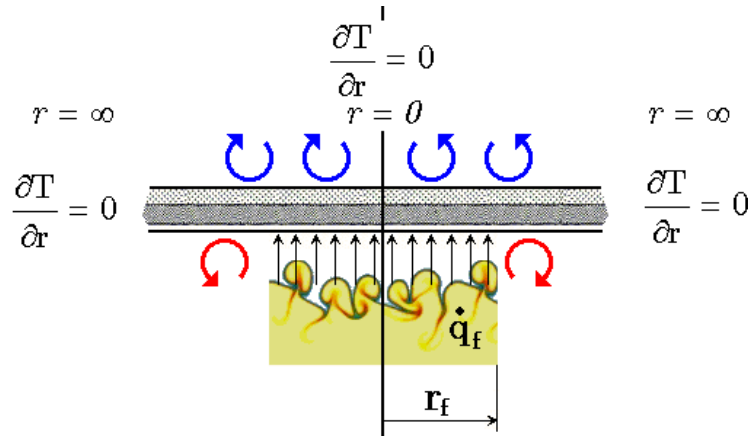
The transient heating of the floor from the exterior (Fig. 2, left) by a flame on the bottom was modeled to allow calculating the approximate ignition times of the floor-covering materials inside the vehicle. The goal was to assess both the auto ignition and the piloted ignition.

Figure 2. Schematic of the floor heated from below in the thermal model

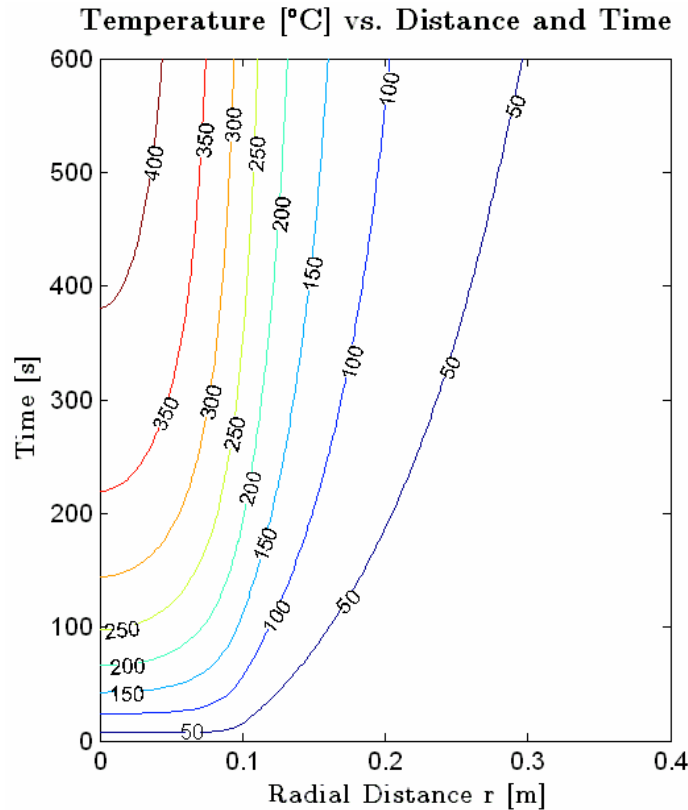
The results (Fig. 2, right) show that the center of hot spot heats up at an initial rate of about 130 °C/min. The heating slows down significantly after reaching 300 °C and reaches steady state temperature (450 °C) after about 600 s. A typical auto-ignition temperature for carpet material is about 600 °C [1], so the calculations predict that auto ignition of the floor-covering will not take place. If a pilot source is present in the vicinity (holes in the floor) and assuming a piloted ignition temperature of carpet of 400 °C [1], ignition would occur 380 s after flame exposure started. These results are later compared to experimentally measured temperature profiles (Figs. 5 and 6).

Figure 3. Analytical results of temperature in the space vs. time domain in the thermal model

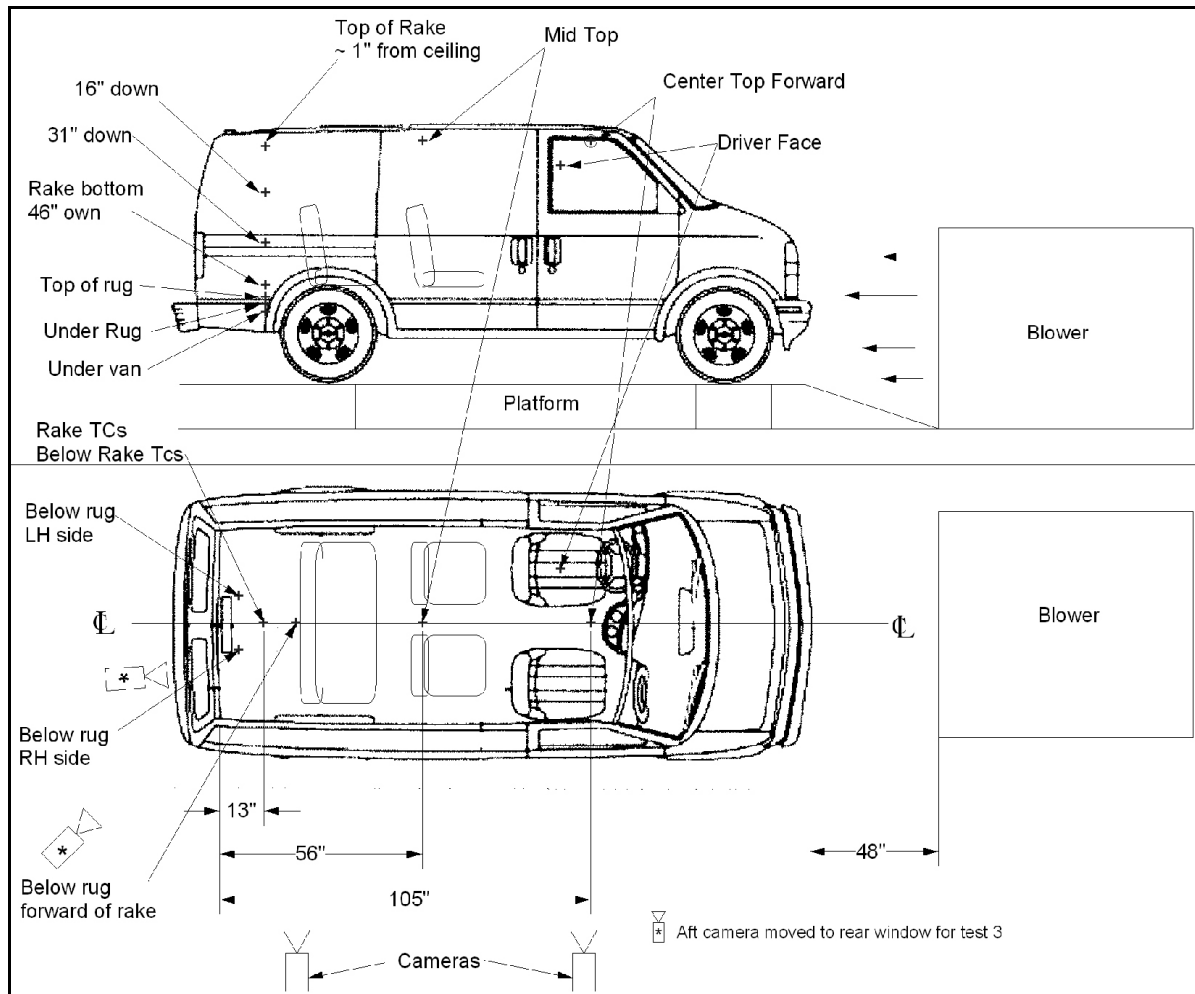
Figure 4. Location of thermocouples inside the vehicle for the full scale tests.

Each test was instrumented using thermocouples and video cameras. Fig. 4 is a schematic of the test set-up showing location of the measurement locations. The instruments were placed at selected locations throughout the inside and outside of the vehicle, with more measurement points right above the area of fire impingement (note vertical rake with thermocouple at the rear). Results from the FDS model were used to help determine the best location of the thermocouples and the video cameras. A thermocouple in front of the nozzle recorded flame duration and ambient conditions were also recorded. Gas measurements of the interior atmosphere at the driver position were taken during each test using acetaldehyde and acrolein sensitive Dreager tubes. The threshold detection level of these tubes was 10 ppm. These measurements were made to see if these common irritant gasses, produced during degradation of plastic materials, could alerting the passengers to the impending fire. The spray nozzle was located under the van next to the alleged degraded fuel line. The nozzle was pointed so that the center of the spray pattern contacted the under floor pan aft of the rear axle. There was only one exemplar van of this vintage available for the tests. Consequently, we needed to be frugal with the floor covering materials, the head liner and the seats so that we had enough virgin materials to conduct three tests. Thus the termination requirement for all but the last test was to stop the experiment when flames spread to the

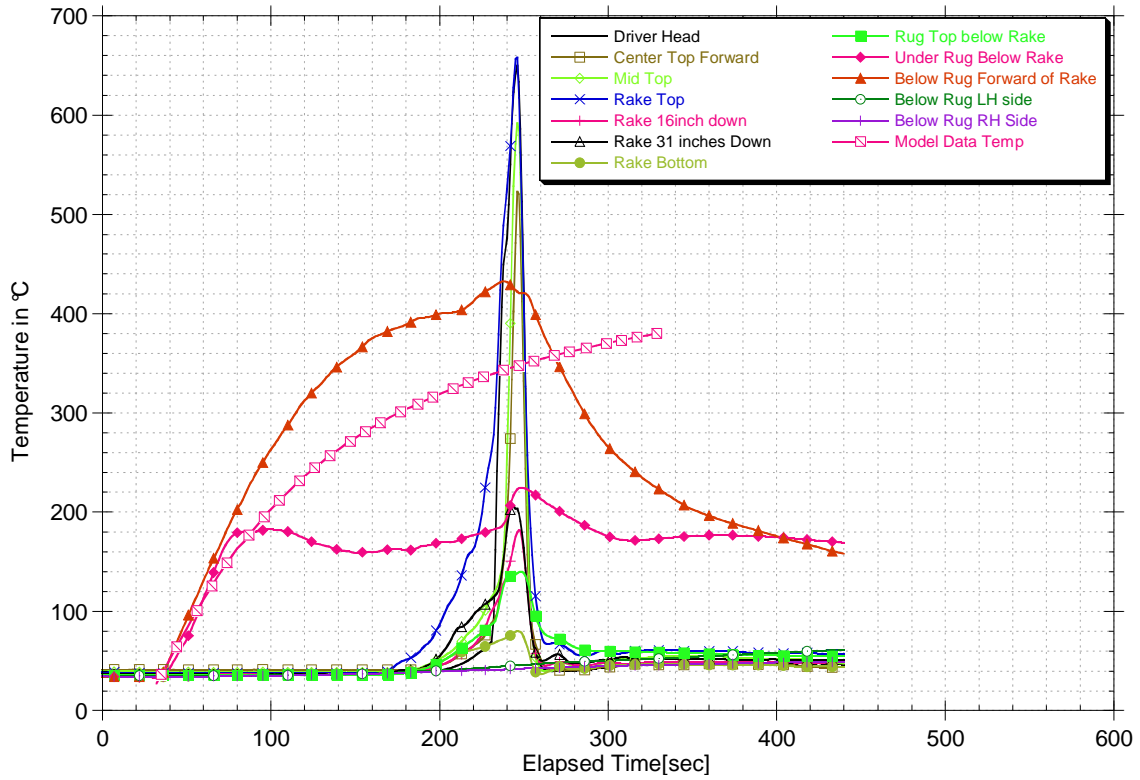
External Fire - Piloted ignition scenario: Fig. 5 shows the temperature measurements in the passenger compartment for the test where penetrations were present in the floor pan. At $t=0$, the spray-fire was initiated under the van and the temperature of the floor-covering material started to increase after 40 s. Piloted ignition occurred approximately after 210 s, and it is seen in Fig. 5 as the temperature of the rake location reached 400 °C. Temperature rise at the ceiling thermocouples ('rake top') is first sensed at about 170 s after spray-fire initiation, and flames reached the height of the head liner at about 230 s when the fire was manually extinguished. Video records showed visual evidence of smoke at the back of the van approximately 120 s after spray-fire initiation and 80 s before fire reached the headliner in the test with floor pan penetrations. Both acetaldehyde and acrolein were detected inside the compartment before the tests was terminated. Comparison with the results from the ignition model of Eqs. (1) and (2) shows good agreement. Translating the time zero of the heat transfer model results to the first measured temperature increase ($t=40$ s). When flames penetrate the compartment at 210 s, the model predicted temperatures of 350°C, which compares well with the 400°C measured below the rake. The affected carpet material was replaced after this experiment to allow the next large-scale experiment.

Sudden Internal Fire: Test results from a rapid cloud fire located behind the rear seat of the van are nearly identical to the gas temperature measured in Fig. 5 at $t=240$ s when flaming ignition took place. Flame propagation took place rapidly and acetaldehyde and acrolein were not detected inside the compartment in the short time of the experiment.

Figure 5. Under-floor spray test: penetrations at flame impingement site. Temperature measurements and heat transfer modeling results.

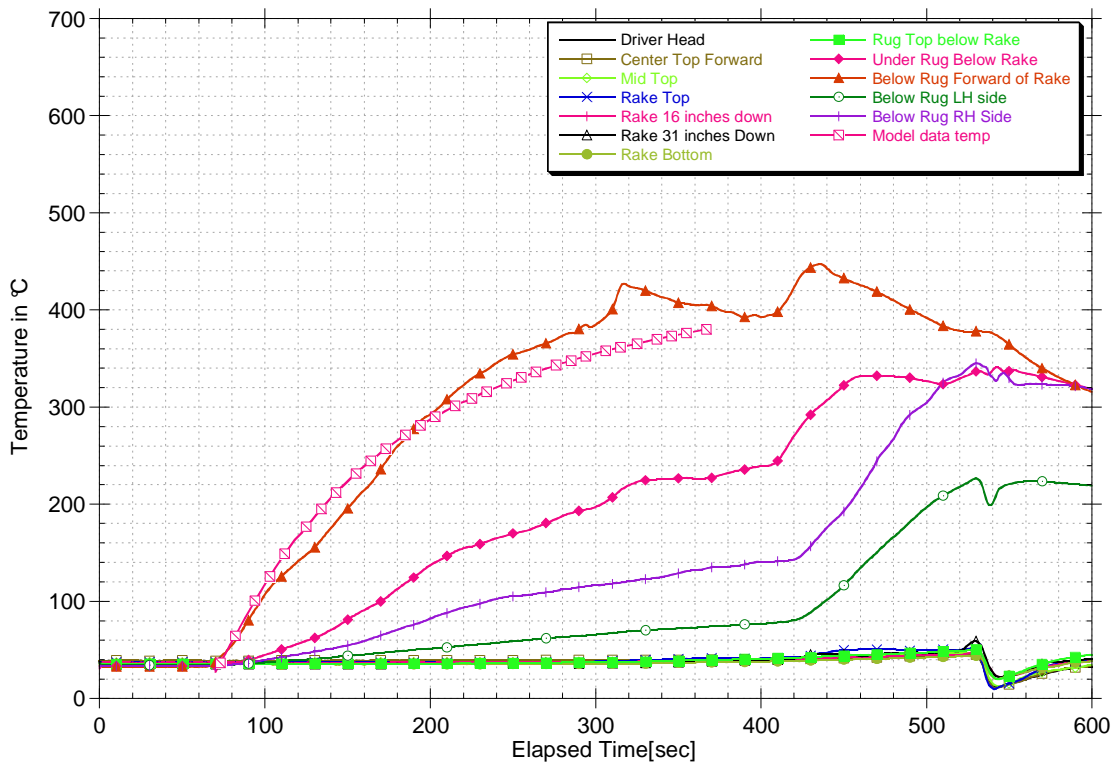
External Fire - Auto ignition scenario: Fig. 6 shows the temperature measurements in the compartment for the test where there were no penetrations in the floor pan. Significant heating of the steel floor is starts at 70 s and the subsequent rise is very similar to that in the previous test since the outside spray-fire and air flow conditions were the same. However, there is no fire ignition in the compartment in more than 500 s. Smoke was visible at 230 s at the back of the van for the test where there were no floor pan penetrations – filling the van and becoming progressively denser until the test was terminated. Thermocouples inside the compartment show essentially no temperature rise. The heating of the floor caused extensive thermal degradation of the floor-covering materials in a radius of about 0.5 m around the flame impingement point but were not high enough to cause spontaneous ignition. This time line correlates well with camera recordings of the experiment. Both acetaldehyde and acrolein were detected inside the compartment before the tests was terminated. In order to test the effect of the external airflow, at 300 s the air fan was shut down. Thus, external convective heat-losses were substantially reduced and the effect in the steel floor is immediate, showing at sudden rise of 40°C at 300 s (see thermocouple 'below rake forward' in Fig. 6). For this experiment both acetaldehyde and acrolein were also detected inside the compartment before the tests was terminated.

Comparison with the results from the ignition model of Eqs. (1) and (2) shows very good agreement. It is seen the heating curves are the same and predictions are within the expected experimental error range (± 5 %). The comparison in this test is even better than for the previous one because the model assumptions do not contemplate the effect of the penetrations in the floor-pan.

Figure 6. Under floor spray test: no penetration at flame impingement site. Temperature records and heat transfer modeling results.
