Diagnosing fouling of hollow fibre MF membranes in wastewater reclamation

Long D. Nghiem and Andrea I. Schäfer *

Environmental Engineering, University of Wollongong, NSW, 2522, Australia
E-mail: dln16@uow.edu.au, Tel: +61 2 4221 3033, Fax +61 2 4221 3238
E-mail: schaefer@uow.edu.au, Tel: +61 2 4221 3385, Fax +61 2 4221 4738
(*Corresponding author)

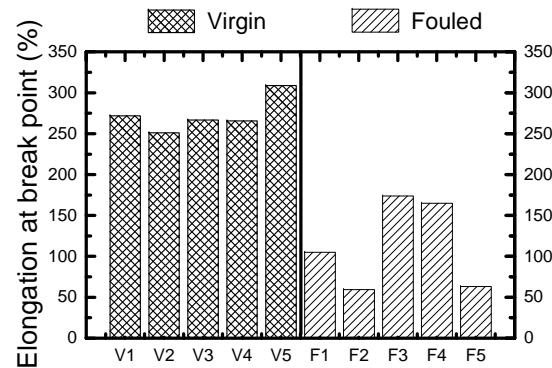
Figure 4: Elongation at break point of the fouled membrane fibres as compared to virgin membrane fibres.

In this case, it appears that the fouled membrane has become more brittle, possibly because the membrane has been allowed to dry prior to testing. This may also be attributed to normal wear and tear during the filtration process and backflush operation. A significant variation in elongation at break point can also be observed for the fouled membrane. However, it is interesting to note that both fouled and virgin membranes have approximately the same young modulus, yield point & elastic profile (data not shown). No clear evidence of material degradation could be observed for the membranes investigated.

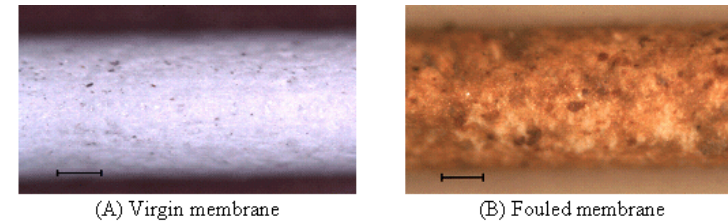
A picture of the virgin, as well as fouled membranes is shown in Figure 6. Visual investigation reveals a strong discolouration of the fouled membranes with a reddish fouling layer. The fouled membrane also demonstrates a severe expansion of the fibres, presumably due to the mechanical stress of filtration and backflushing. Some fragile and brittle characteristics upon touching, in particular near the end of the modules where the fibres were attached to the plotting resin, can also be observed. This is consistent with the results obtained from mechanical testing described above.

Figure 5: Light microscopic pictures of a virgin membrane (A) and fouled membrane (B). Bar presents 150 μm .

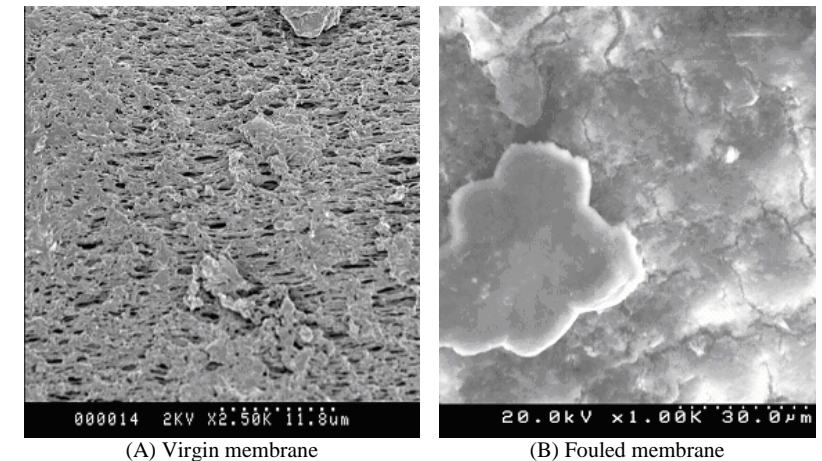
Figure 6: Electron microscopic pictures of a virgin membrane (A) and fouled membrane (B) taken by the FESEM.

The fouling layer morphology is further examined in detail and an electron microscopic picture of the fouling layer is shown in Figure 6. An electron microscopic picture of the clean membrane surface is also presented for comparison purposes. Schäfer *et al.* [1] methodically summarise four distinctive common fouling categories namely scaling/inorganic, organic, colloidal/particulate, and biofouling. There is no evidence of bacteria or fungi on the fouling layer and biofouling is unlikely the main cause in this instance. Figure 6 reveals a firm cake layer on the membrane surface. This cake layer is probably made up of organic matters or colloidal particles or most likely the combination of both. While scaling is uncommon in microfiltration processes and no evidence of crystallisation can be observed on the fouling layer, it is possible that multivalent cations, for example Ca^{2+} , can act to cement colloidal particles, organic matters, and the membrane surface one another as previously shown in another of our study [10]. This phenomenon has also been exquisitely examined by Li and Elimelech by measuring attractive force between these entities with and without the presence of multivalent cations [11].

It is noteworthy that a reddish colour observed in Figure 6 may reflect the presence of iron oxide. Clays together with silica colloids are typical particulate matters encountered in exhibit and road hose down runoffs, which make up most of the influent in this case, in particular during the construction phase. This hypothesis can be confirmed by examining the elementary composition of the fouling layer and foulant characterisation as showed in the following section.

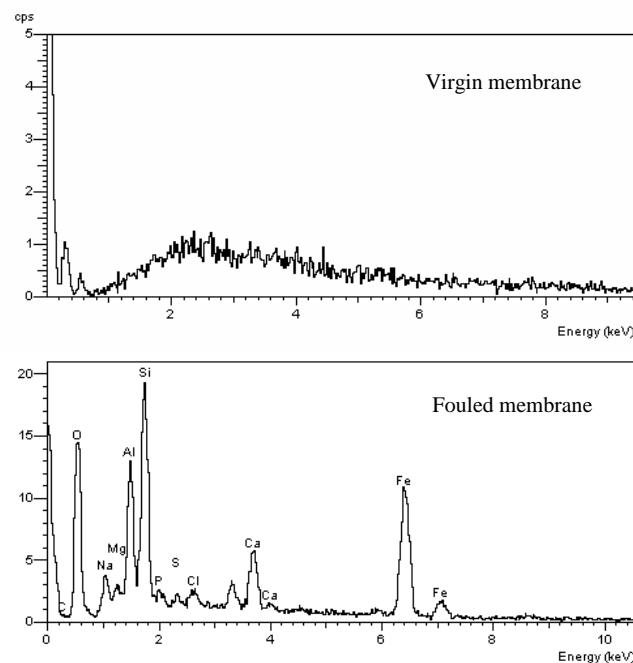
The presence of metallic elements such as iron, aluminium, calcium, and magnesium is clearly evident in the energy dispersive X-ray (EDX) spectrometry graph of the fouling layer as shown in Figure 8. A significant amount of silica can also be observed. Furthermore, Figure 8 reveals a large peak of oxygen and trace amount of other non-metallic elements such as chlorine, sulphur, and phosphate. Such significant amount of oxygen may be attributed to organic matters present in the fouling layer, although it is prudent to note that it can also be from the membrane polymeric material. While a small peak of oxygen can be observed in the EDX spectrometry graph of the virgin membrane, no chlorine, sulphur, or phosphate can be found (see Figure 8).

Figure 7: Energy dispersive X-ray spectrometry of the virgin membrane surface (top) and the foulant layer (bottom). Excitation energy was set at 20 000 kV (note difference in y-axis scale).
